The May 25th 2011 Railroad Embankment Failure in Ann Arbor, Michigan, As a Means for Teaching Geotechnical Engineering

ABSTRACT: A 30-m long railroad embankment failure that occurred on May 25 2011 in the city of Ann Arbor, Michigan, is presented. Emphasis is given on the field observations of the failure, the characterization of the site conditions and the seepage and slope stability analyses, all of which represent important components of the training and practice of a geotechnical engineer. The failure occurred following a record wet season that resulted in ponding water against the embankment and high enough water pressures and exit gradients that resulted in instability of the railroad embankment. Detailed background material and the methodology for using the case history in geotechnical engineering education are presented.

Reference: Zekkos, D., Athanasopoulos-Zekkos, A., Grizi, A., and Greenwood, W. (2016). *The May 25th 2011 Railroad Embankment Failure in Ann Arbor, Michigan, As a Means for Teaching Geotechnical Engineering*.

International Journal of Geoengineering Case histories, Vol.3, Issue 4, p.234-245. doi: 10.4417/IJGCH-03-04-03

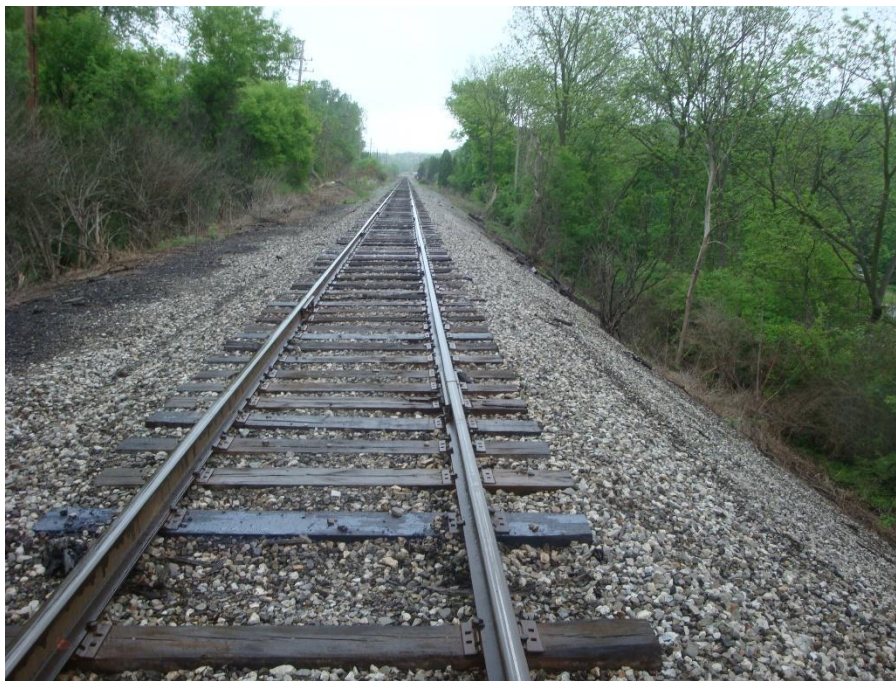
The failure site is located to the north of downtown Ann Arbor in Michigan, USA, as shown in Fig. 2b. The failure took place on the railroad embankment that is heading parallel to Plymouth Rd and adjacent to residential structures. Fig. 3 illustrates an intact portion of the embankment immediately to the East from the failure location. The failure resulted in:

Figure 3. View of intact portion of the embankment immediately to the East of the failure area. One can see that the uphill part of the embankment (left) is supported by natural ground that is at a much higher elevation than the downhill part of the embankment (right).
