The May 25th 2011 Railroad Embankment Failure in Ann Arbor, Michigan, As a Means for Teaching Geotechnical Engineering

ABSTRACT: A 30-m long railroad embankment failure that occurred on May 25 2011 in the city of Ann Arbor, Michigan, is presented. Emphasis is given on the field observations of the failure, the characterization of the site conditions and the seepage and slope stability analyses, all of which represent important components of the training and practice of a geotechnical engineer. The failure occurred following a record wet season that resulted in ponding water against the embankment and high enough water pressures and exit gradients that resulted in instability of the railroad embankment. Detailed background material and the methodology for using the case history in geotechnical engineering education are presented.

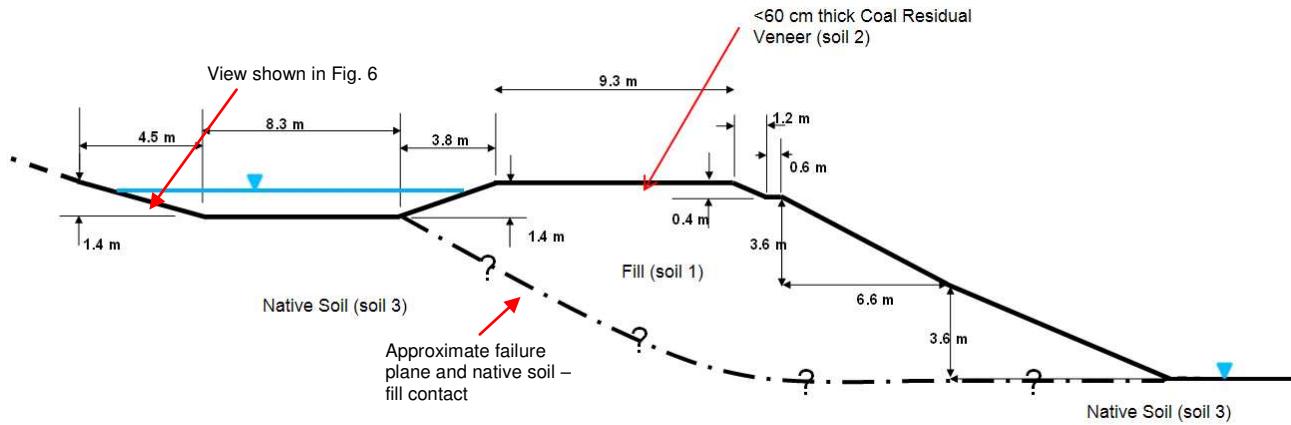
The embankment is constructed partially on a naturally sloping ground and has a total height of 7.6 m as shown in Fig. 5. Its crest, that supports the railroad lines, has a width of 9.3 m. The embankment fill consists of two layers. The main layer (Fill Soil 1) is a silty sand (SM). A surficial layer of very small thickness is also present and consists of coal ash residuals (Soil 2). The natural soil that underlays the embankment is a sandy clay of low plasticity (CL) that geologically is described as very dense glacial deposits (Native Soil-Soil 3).

Figure 5. Cross-section of the railroad embankment at the location of the failure.
