# A Large Scale Landslide in a Coal Mine in Marly Formations: Evaluation, Analysis and Rehabilitation

**ABSTRACT:** *This paper describes a large scale landslide in a coal mine in Servia area in Kozani, Greece, which occurred in February 2011. The landslide, of ~250m width and ~350m length, took place in marly lacustrine sediments. The main factors for the manifestation of the landslide were a temporary interruption of works, the existence of a specific weak surface, the clayey nature and the sensitivity of marl to environmental agents, the action of water and the large slope height. Due to the magnitude and the position of the failure, a geotechnical solution was proposed that involved rearrangement of ground masses. The proposed solution led to successful rehabilitation and unimpeded continuation of the exploitation process.*

**KEYWORDS:** Landslide, marl, progressive failure, coal mine, rehabilitation

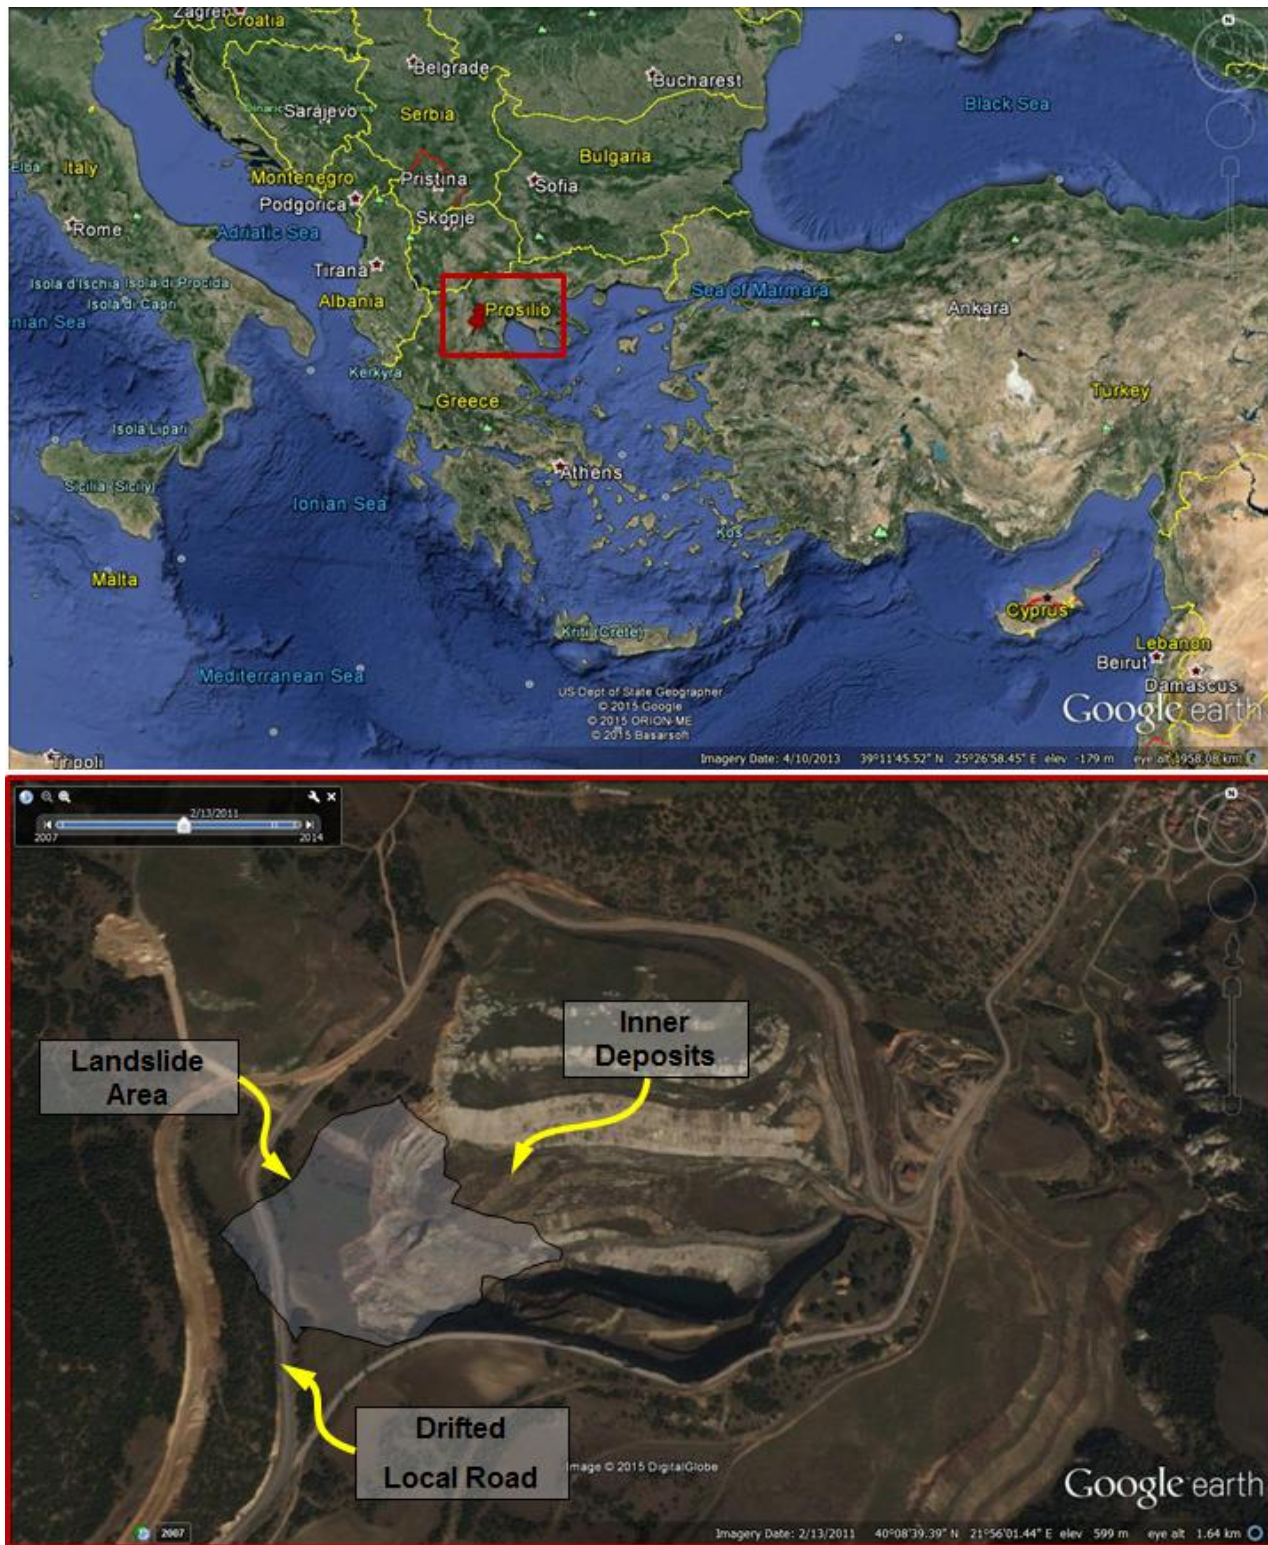
Figure 1 includes a demarcation of the position of the landslide, together with an aerial photo of the coal mine, only few days before the landslide. The landslide area, the local road affected by the landslide and the initially placed deposits for lateral retaining action to the mine slope are indicated on the satellite photo.

Figure 1. Position of landslide (up – red pin inside the red rectangle) and aerial photograph of the coal mine 2 weeks before the landslide (down). The area that was later occupied by the landslide is indicated with the transparent shape.

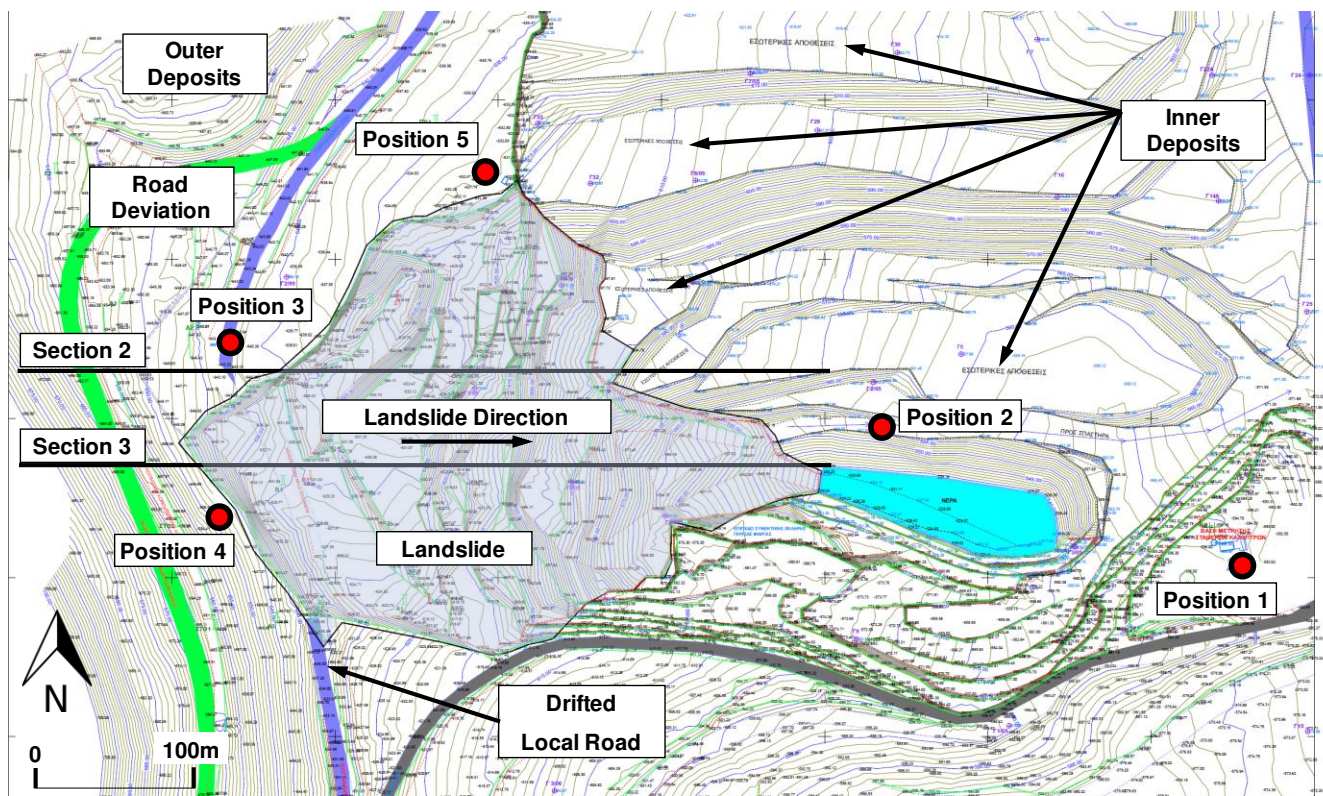
Figure 2 shows a plan view of the landslide area, with demarkation of the main features of the incident, as mentioned or referred to in the present paper. After examination of historical, geometrical and geotechnical data provided by the exploitation contractor, in-situ inspections and evaluation of the available information, it was concluded that the factors that played an important role in the initiation and triggering of sliding movement and the evolution of the landslide were:

Figure 2. Topographic mapping (plan view) of the coal mine after the landslide with demarkation of some key features

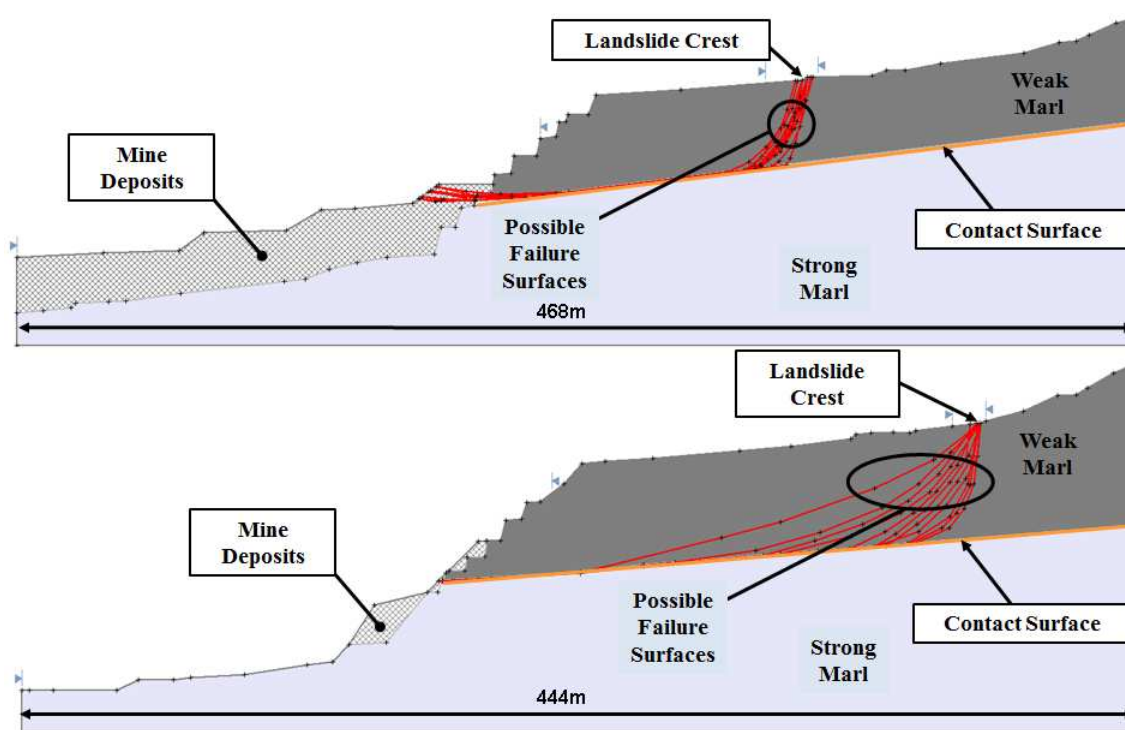
1. After in-situ inspection and study of available surveying mapping, conclusions were reached concerning the general shape of the failure surface along Section 2 (subvertical near the crest) and Section 3 (with more gentle slope near the crest). Based on these conclusions, a set of possible failure surfaces was considered for each Section, with varying inclination and part of the surface passing through the weak marl formation and along the contact surface between the weak and the competent marl.

Figure 5. Analysis Section 2 (up) and 3 (down). Slide software model.

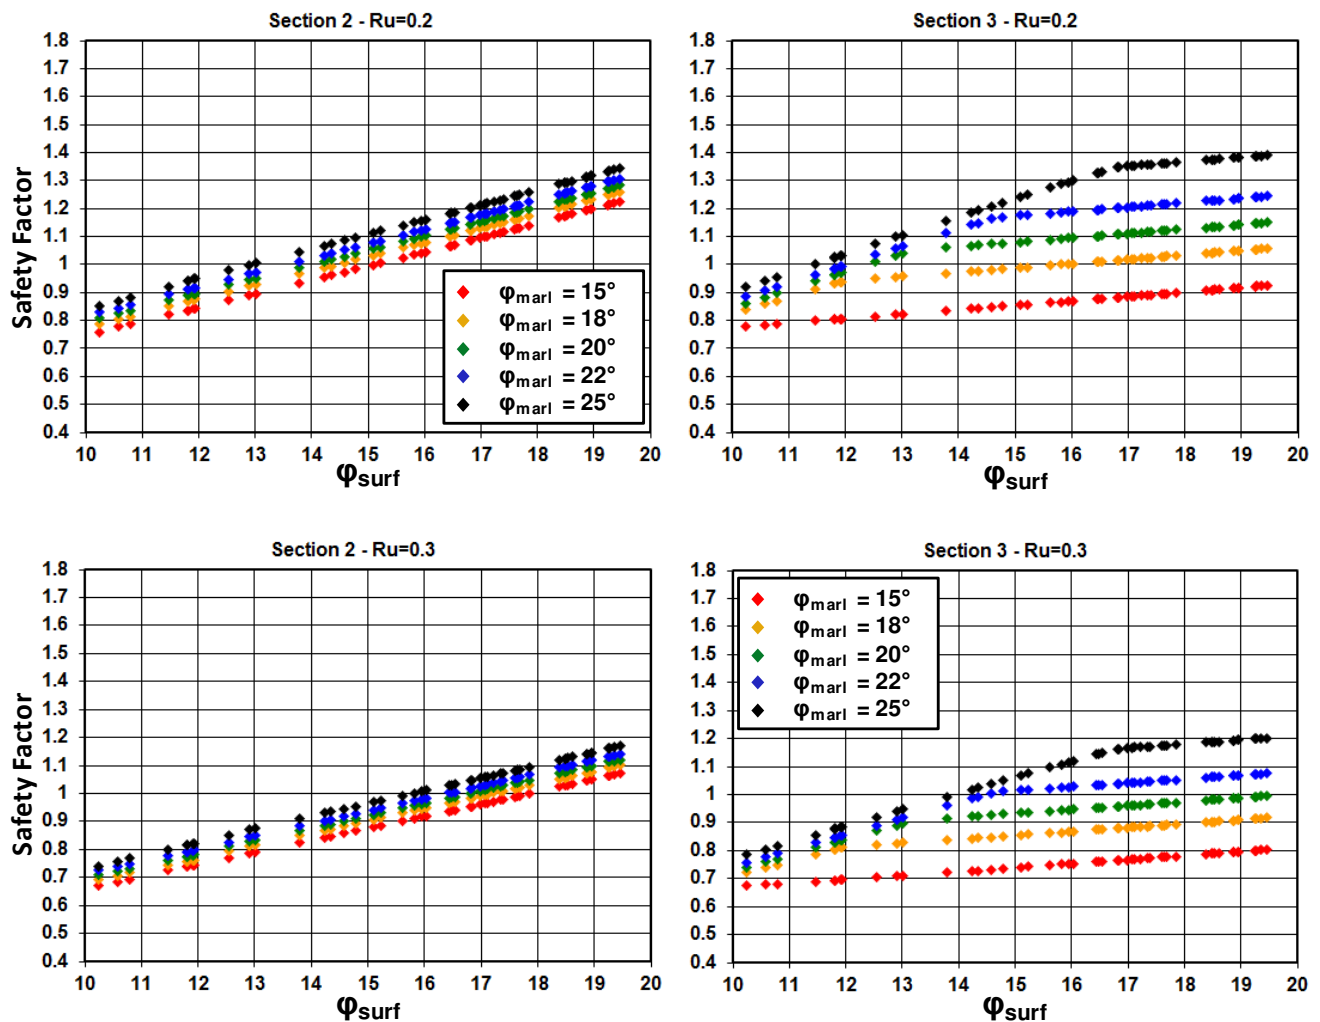
Figure 7. Variation of safety factor for different values of  $\phi_{marl}$  and  $\phi_{surf}$  for  $R_u=0.2$  (up) and  $R_u=0.3$  (down), as computed for Section 2 (left) and Section 3 (right)

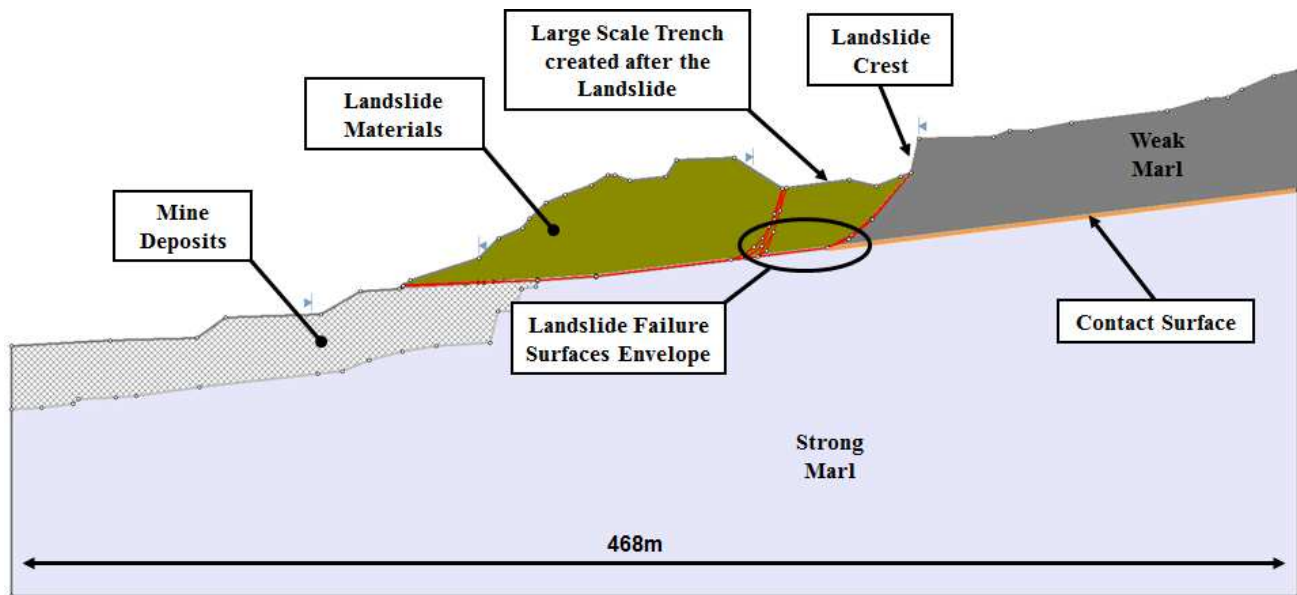
Figure 9. Analysis Section 2 after the landslide

The relevant analyses yielded results of the safety factor between 1.06 and 1.11, which were considered marginal, given the possible further deterioration of the shear strength of the materials involved in the slides, due to ongoing movements, especially during the rainy season in the area. Specifically, analyses of Section 2 resulted in a minimum value of the safety factor equal to 1.11, whereas the corresponding minimum value from Section 3 was 1.06. Analyses with free selection of surfaces by the software were not performed, as these would yield unrealistically low values of the safety factor (considerably  $<1$ ), under the assumption that the total mass included in the landslide envelope had been downgraded to its residual strength (zero cohesion and low friction), which was not the case due to monolithic, undisturbed blocks existing within the slid mass. The fact that the resulting safety factor values were rational, i.e. marginally larger than unity, indicating a temporarily stable situation after a main landslide event, enhanced our confidence in the assumptions that were made.
