A Large Scale Landslide in a Coal Mine in Marly Formations: Evaluation, Analysis and Rehabilitation

ABSTRACT: *This paper describes a large scale landslide in a coal mine in Servia area in Kozani, Greece, which occurred in February 2011. The landslide, of ~250m width and ~350m length, took place in marly lacustrine sediments. The main factors for the manifestation of the landslide were a temporary interruption of works, the existence of a specific weak surface, the clayey nature and the sensitivity of marl to environmental agents, the action of water and the large slope height. Due to the magnitude and the position of the failure, a geotechnical solution was proposed that involved rearrangement of ground masses. The proposed solution led to successful rehabilitation and unimpeded continuation of the exploitation process.*

Reference: Prountzopoulos, G., Fortsakis, P., Marinou, V. and Marinou, P. (2016). *A Large Scale Landslide in a Coal Mine in Marly Formations: Evaluation, Analysis and Rehabilitation*. International Journal of Geoengineering Case histories, Vol.4, Issue 1, p.29-45. doi: 10.4417/IJGCH-04-01-03

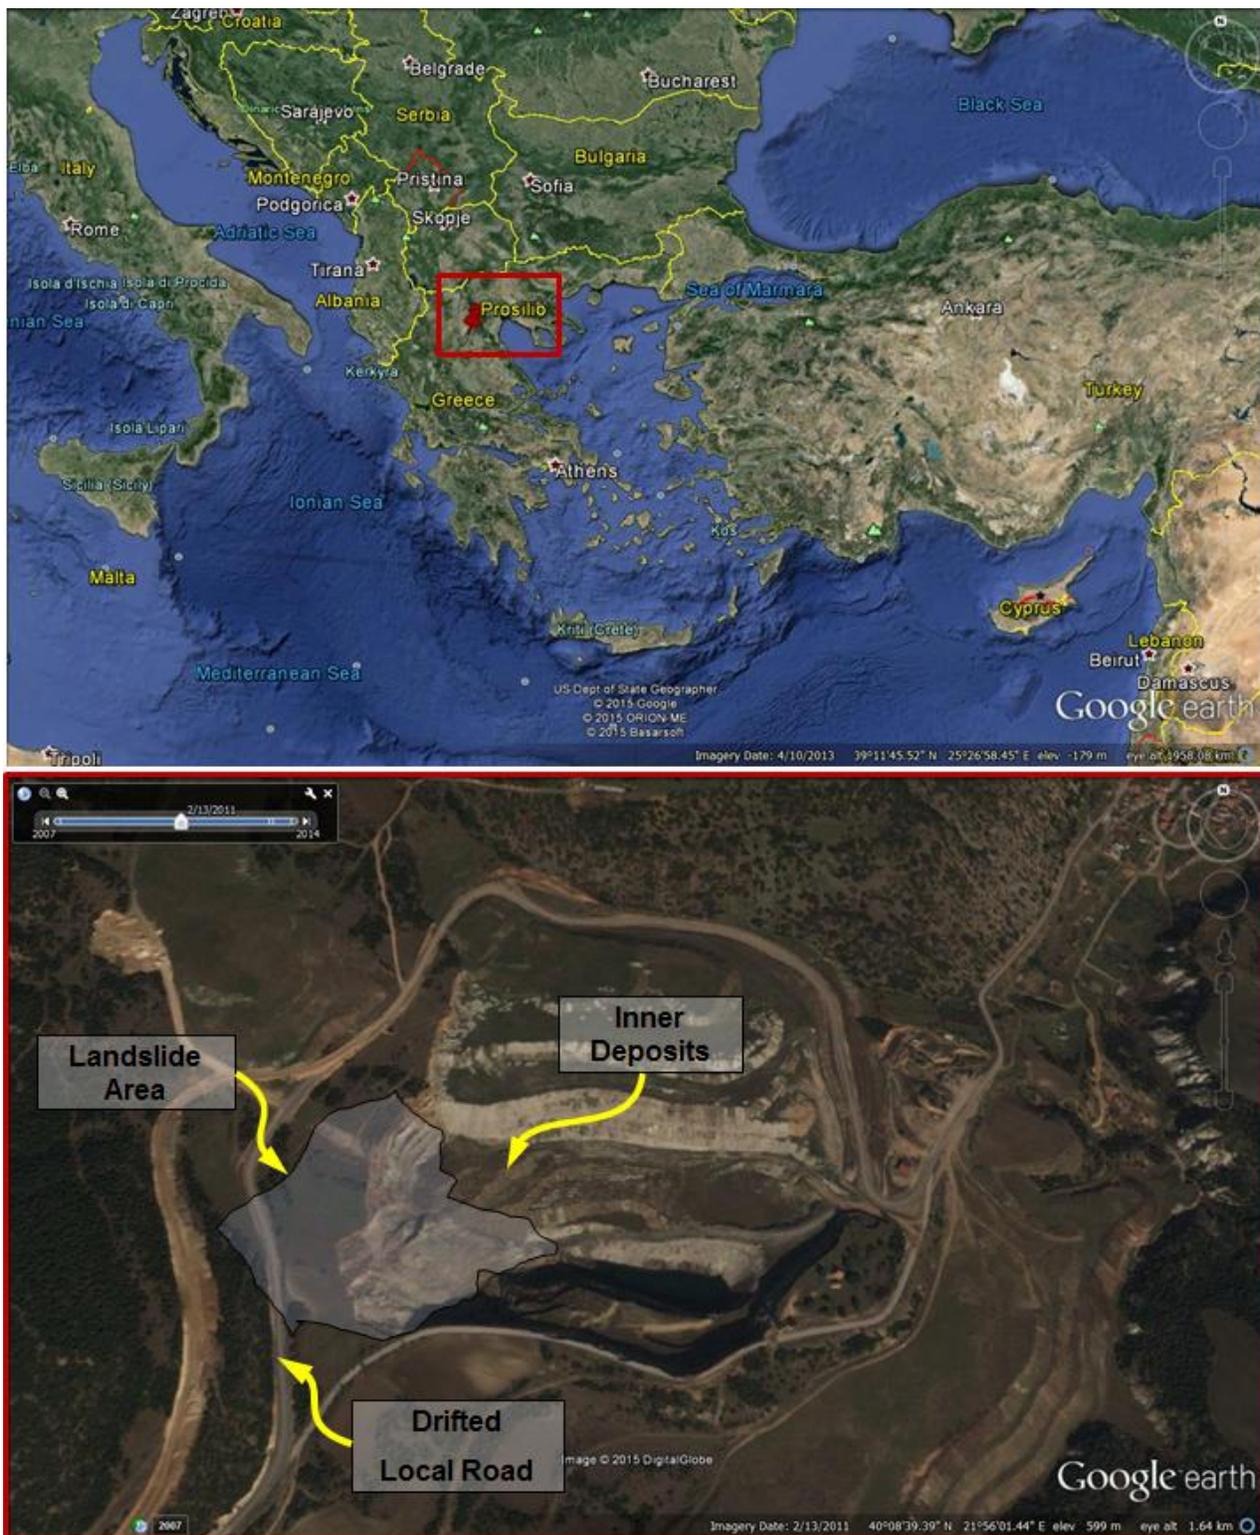
Figure 1 includes a demarcation of the position of the landslide, together with an aerial photo of the coal mine, only few days before the landslide. The landslide area, the local road affected by the landslide and the initially placed deposits for lateral retaining action to the mine slope are indicated on the satellite photo.

Figure 1. Position of landslide (up – red pin inside the red rectangle) and aerial photograph of the coal mine 2 weeks before the landslide (down). The area that was later occupied by the landslide is indicated with the transparent shape.

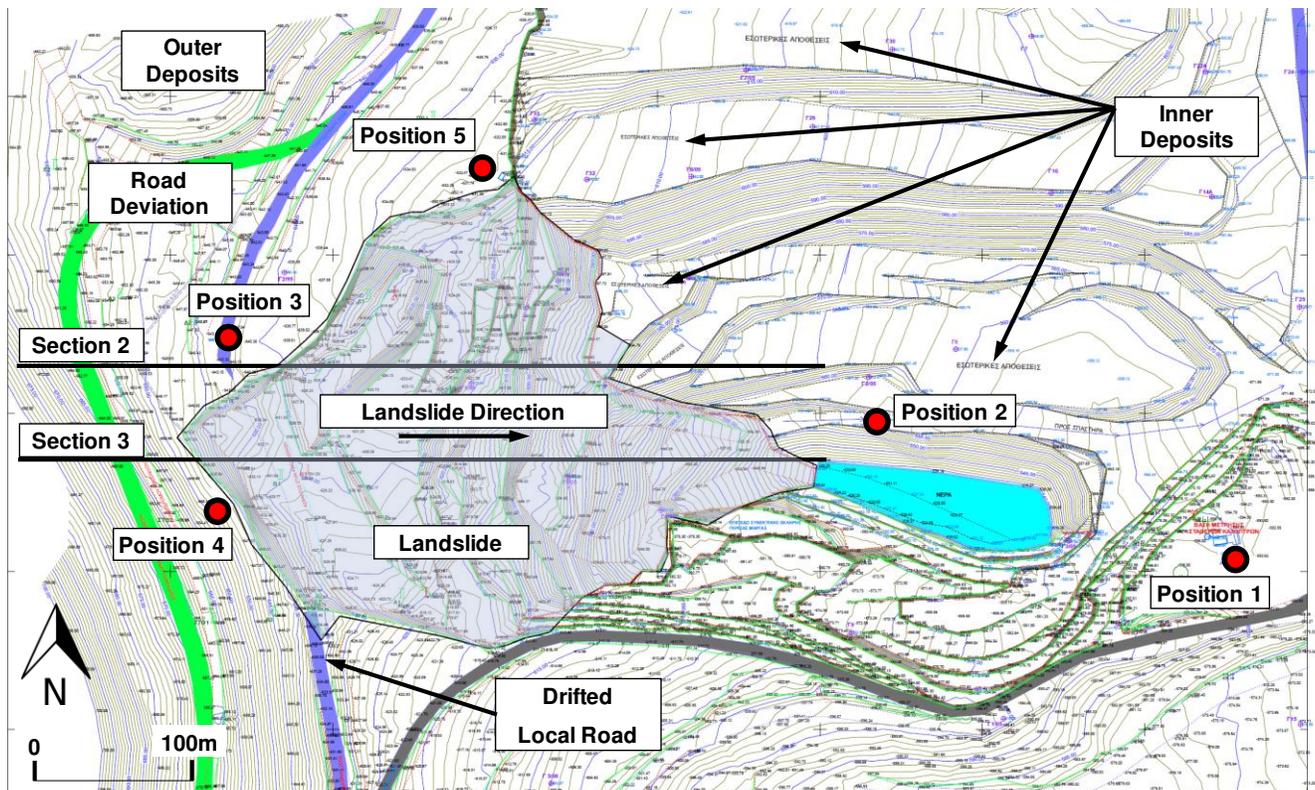
Figure 2 shows a plan view of the landslide area, with demarcation of the main features of the incident, as mentioned or referred to in the present paper. After examination of historical, geometrical and geotechnical data provided by the exploitation contractor, in-situ inspections and evaluation of the available information, it was concluded that the factors that played an important role in the initiation and triggering of sliding movement and the evolution of the landslide were:

Figure 2. Topographic mapping (plan view) of the coal mine after the landslide with demarcation of some key features

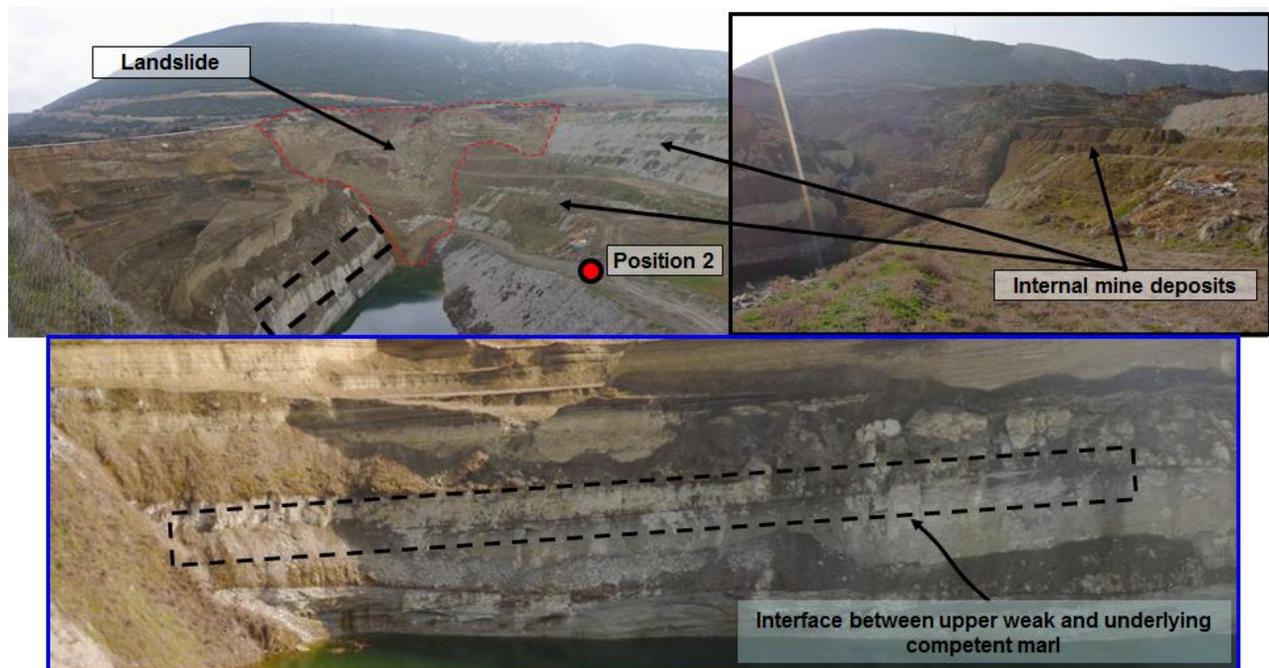
Figure 3 illustrates a general aspect of the landslide from its E and NE side (Positions 1 and 2 in Figure 2) and a view of the contact surface between the weak and the competent marl, which played a major role in the landslide manifestation. Figure 4 illustrates various aspects of the landslide and its main features.

Figure 3. Aspect of the coalmine and the landslide from Position 1 (upper left), the landslide from Position 2 (upper right) and the contact surface between the weak and the competent marl (bottom)

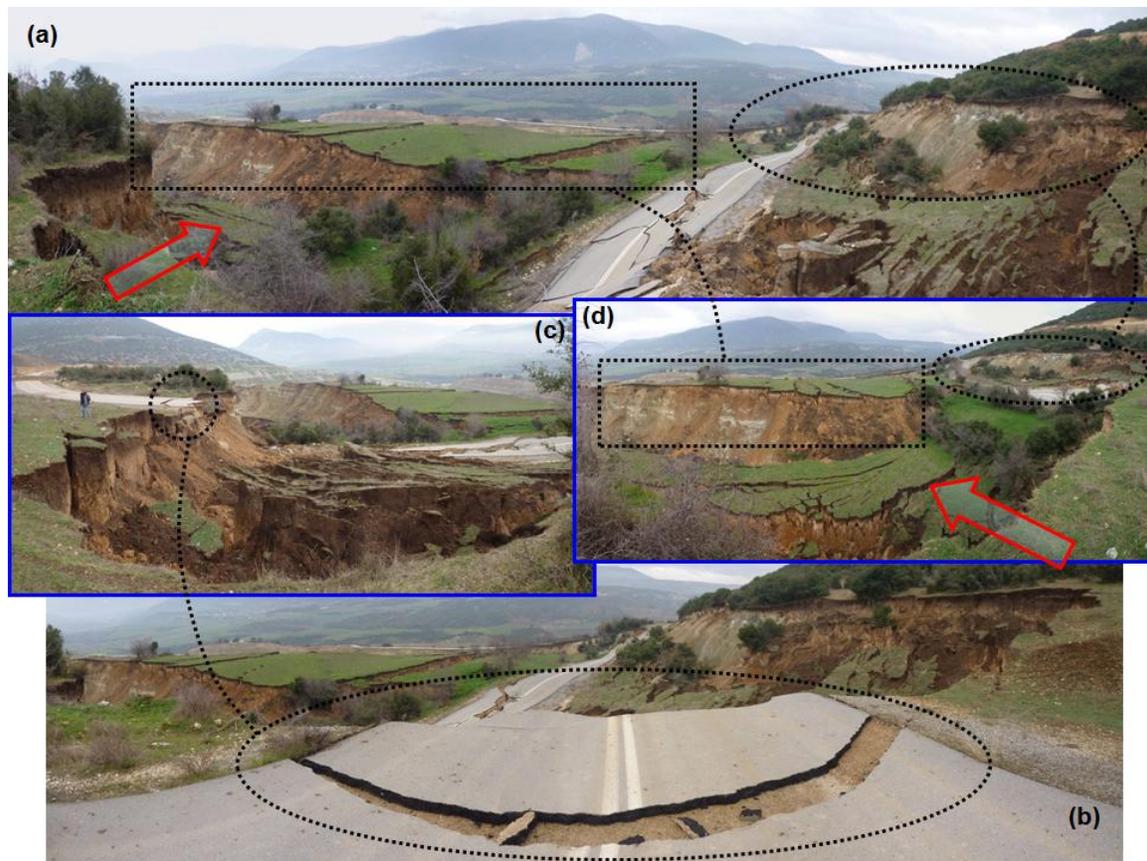
Figure 4. Aspect of the landslide from Position 3 (a & b), Position 4 (c) and Position 5 (d), the landslide crest (oval shape in a & d), the block that moved almost monolithically downstream (rectangle in a & d) and the mass that sank behind the block (arrow in a & d).

To evaluate the stability conditions of the landslide before any intervention, it was assumed that the critical failure surfaces either pass through the total failure envelope of the event, or through zones where significant shearing and relative movements were observed between “intact” parts of the marl formation, such as the zone downslope of the large scale trench that is shown in Figure 4.

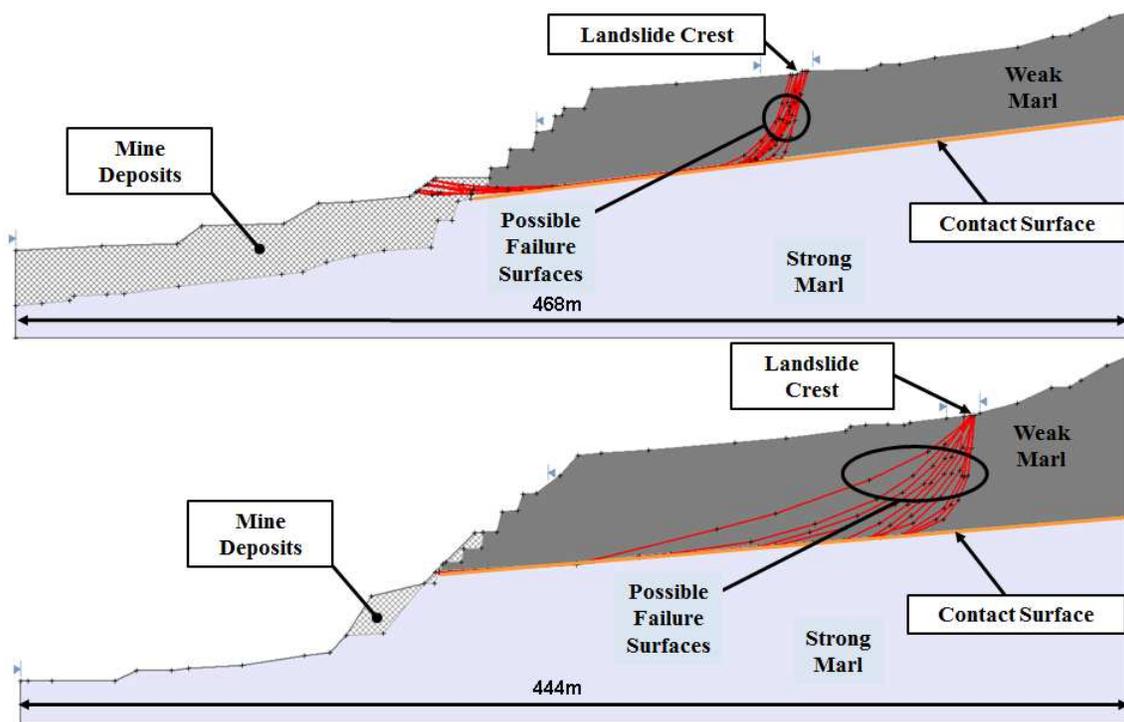
1. After in-situ inspection and study of available surveying mapping, conclusions were reached concerning the general shape of the failure surface along Section 2 (subvertical near the crest) and Section 3 (with more gentle slope near the crest). Based on these conclusions, a set of possible failure surfaces was considered for each Section, with varying inclination and part of the surface passing through the weak marl formation and along the contact surface between the weak and the competent marl.

Figure 5. Analysis Section 2 (up) and 3 (down). Slide software model.

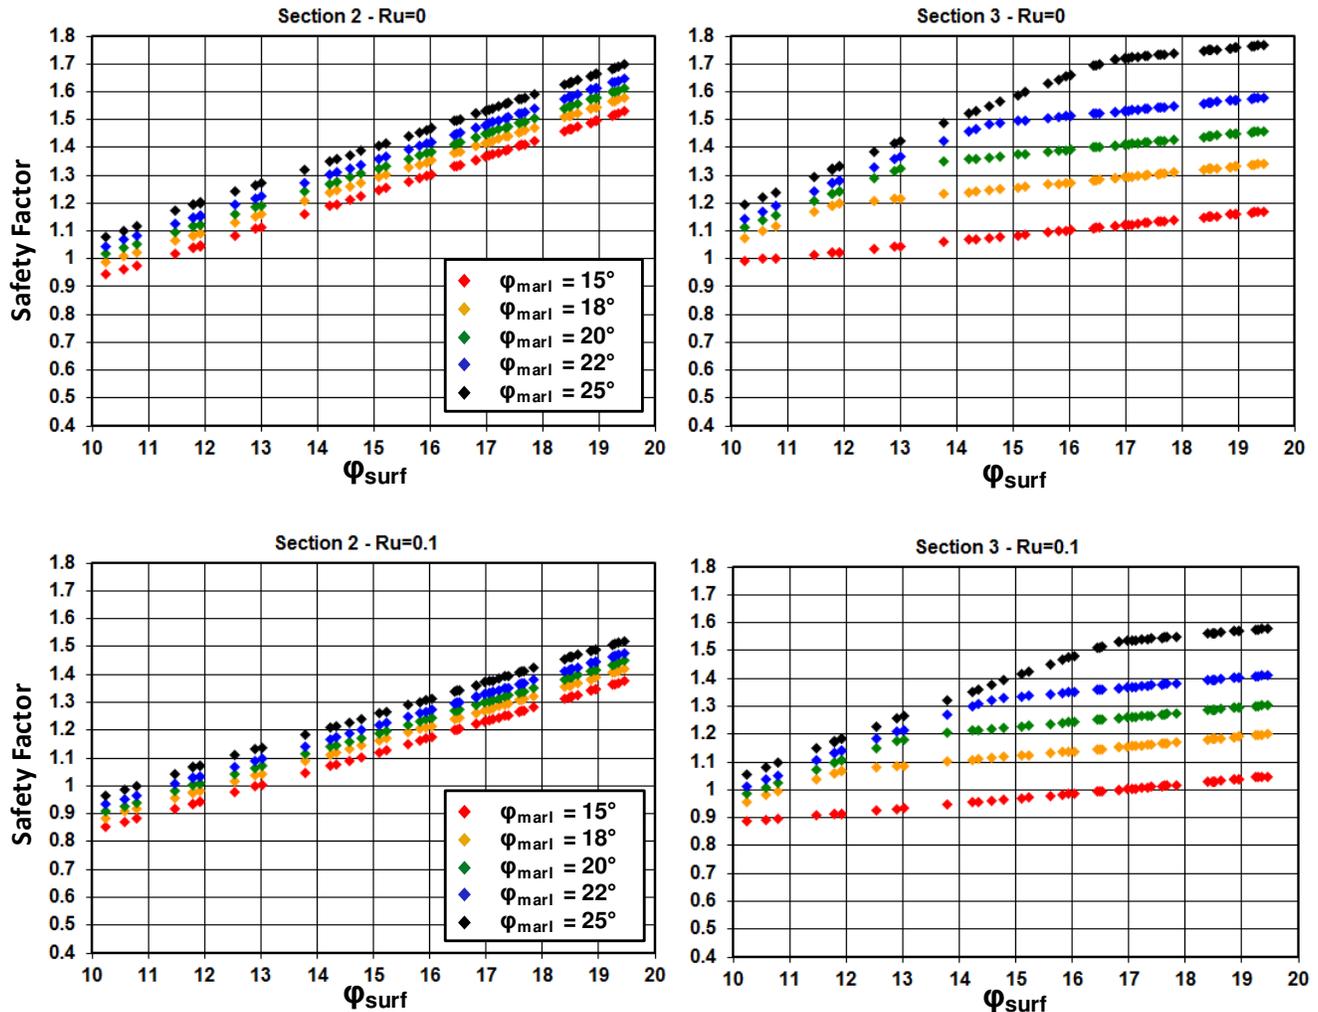
2. Values of the safety factor for values of pore pressure ratio $R_u=0-0.1$ generally lie above unity for both Sections analyzed (see Figure 6), especially for $\phi_{surf} > 13^\circ$ and were therefore excluded. This result was actually anticipated, since water seemed to have had a major role in the landslide triggering.

Figure 6. Variation of safety factor for different values of ϕ_{marl} and ϕ_{surf} for $R_u=0.0$ (up) and $R_u=0.1$ (down), as computed for Section 2 (left) and Section 3 (right)

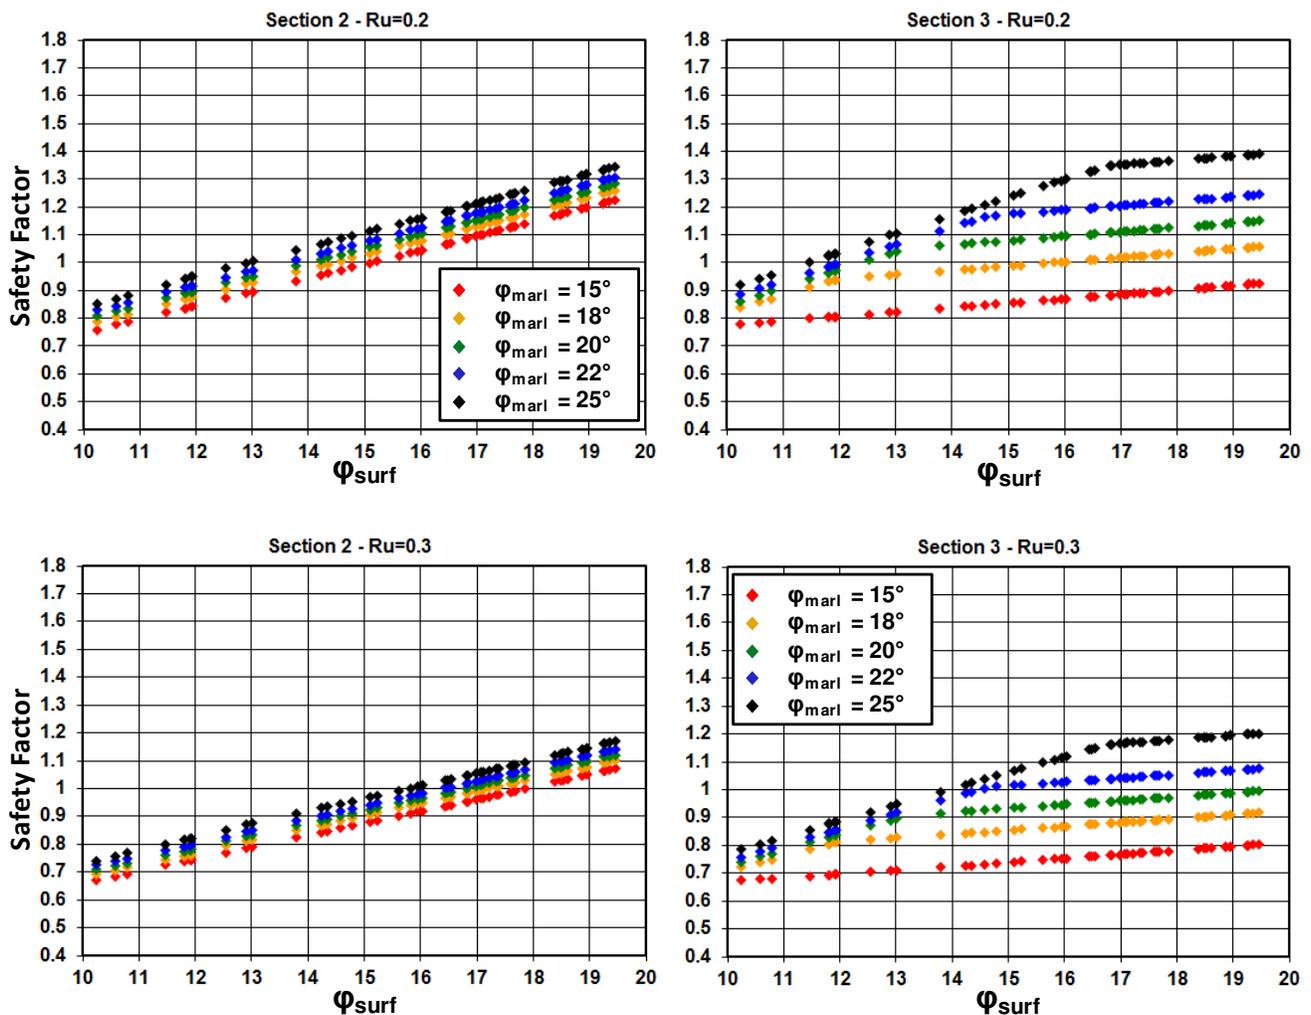
Figure 7. Variation of safety factor for different values of φ_{marl} and φ_{surf} for $R_u=0.2$ (up) and $R_u=0.3$ (down), as computed for Section 2 (left) and Section 3 (right)

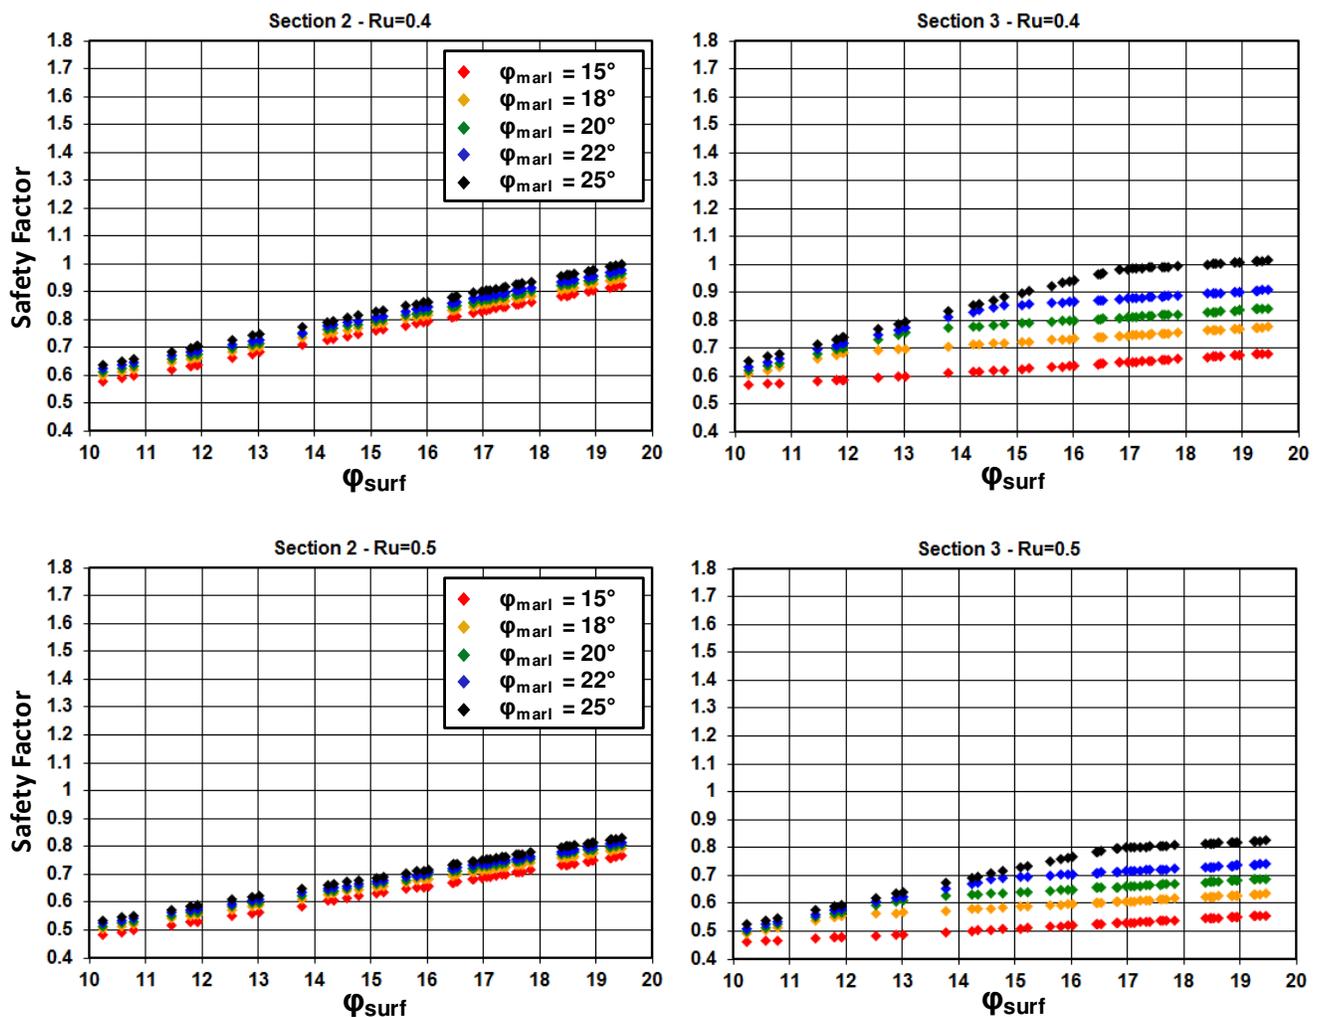
3. Values of the safety factor for values of the pore pressure ratio $R_u=0.4-0.5$ were generally well below unity for both analysis Sections (see Figure 8), especially for $\phi_{surf} < 17^\circ-18^\circ$ and were not considered likely. Values of the safety factor for $\phi_{surf} > 18^\circ$, given the nature of the specific surface and the fact that are assumed to refer to residual strength, were not considered reasonable.

Figure 8. Variation of safety factor for different values of ϕ_{marl} and ϕ_{surf} for $R_u=0.4$ (up) and $R_u=0.5$ (down), as computed for Section 2 (left) and Section 3 (right)

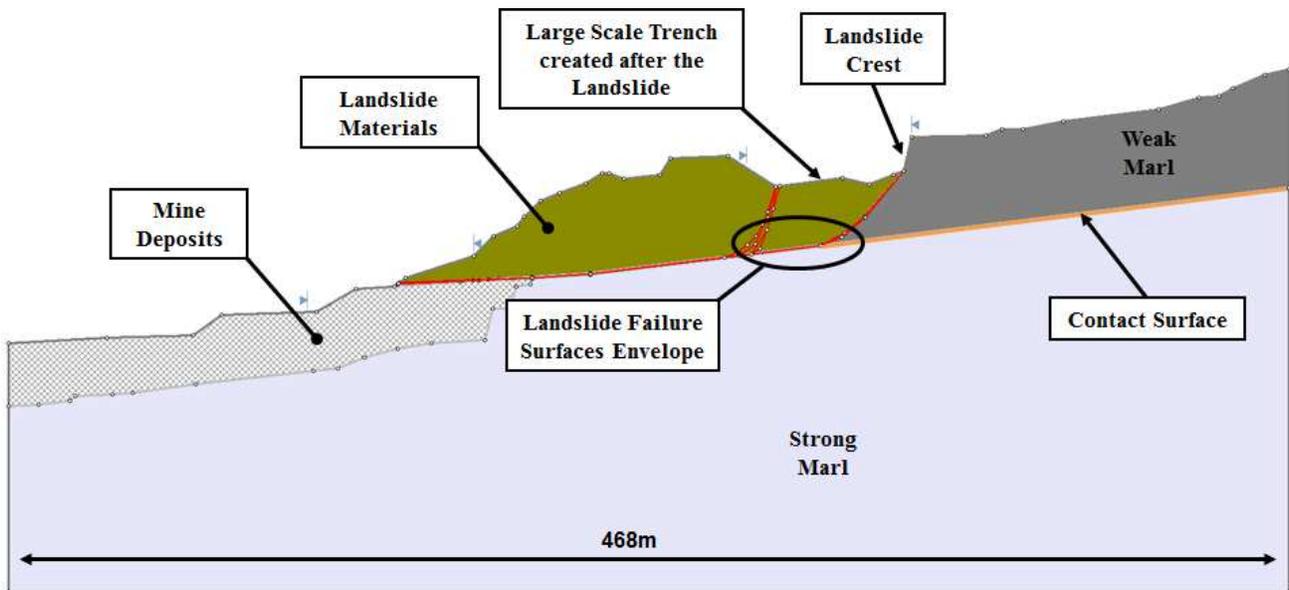
Figure 9. Analysis Section 2 after the landslide

The relevant analyses yielded results of the safety factor between 1.06 and 1.11, which were considered marginal, given the possible further deterioration of the shear strength of the materials involved in the slides, due to ongoing movements, especially during the rainy season in the area. Specifically, analyses of Section 2 resulted in a minimum value of the safety factor equal to 1.11, whereas the corresponding minimum value from Section 3 was 1.06. Analyses with free selection of surfaces by the software were not performed, as these would yield unrealistically low values of the safety factor (considerably <1), under the assumption that the total mass included in the landslide envelope had been downgraded to its residual strength (zero cohesion and low friction), which was not the case due to monolithic, undisturbed blocks existing within the slid mass. The fact that the resulting safety factor values were rational, i.e. marginally larger than unity, indicating a temporarily stable situation after a main landslide event, enhanced our confidence in the assumptions that were made.

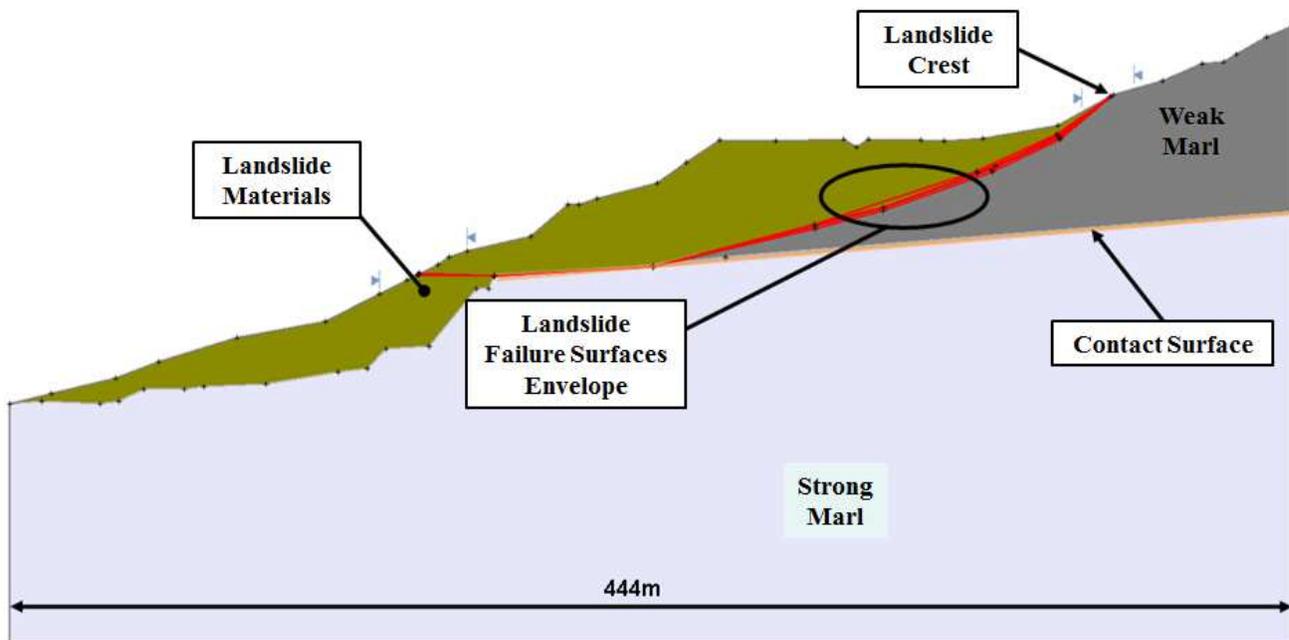
Figure 10. Analysis Section 3 after the landslide

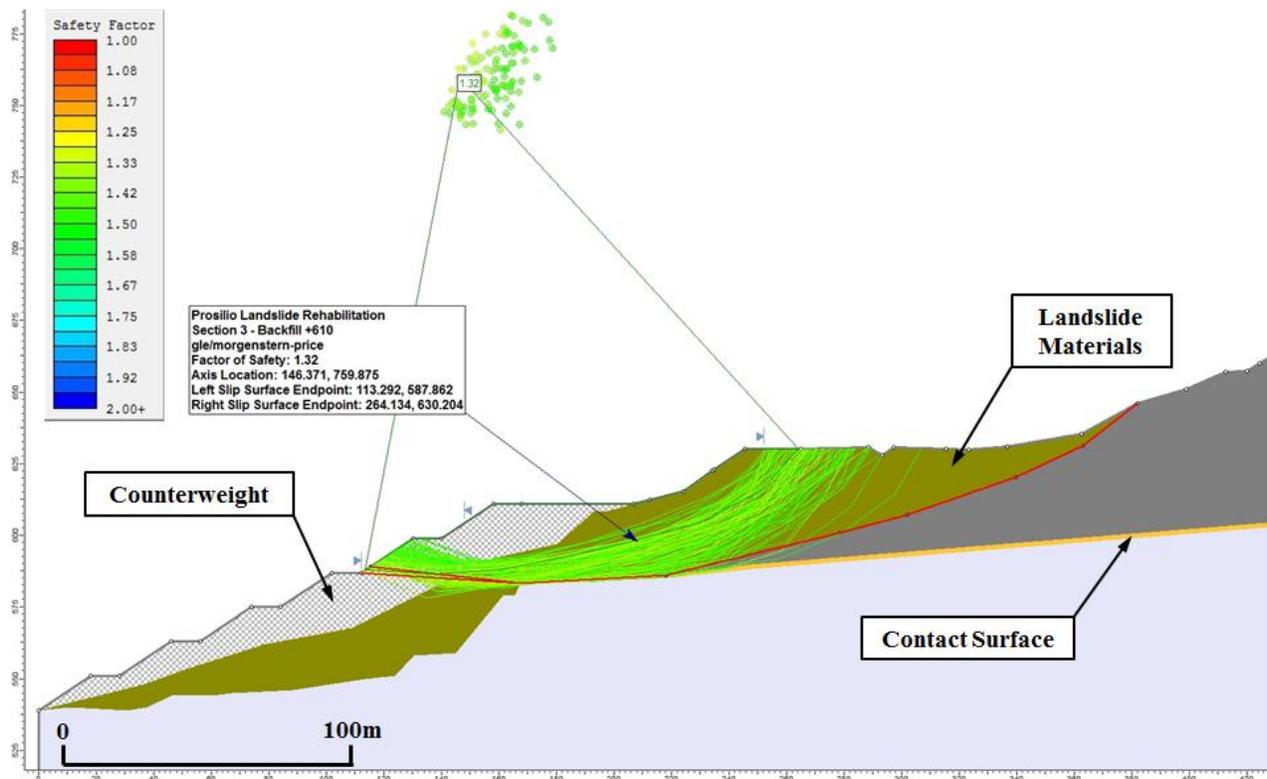
Figure 11. Analysis Results for Section 3 with backfill at the toe up to elevation +610 (F.S. = 1.32)

1. Placement of non commercial deposits at the toe of the landslide up to an elevation approximately 25 m above the contact surface between the upper weak and the underlying competent marl (~+610 m absolute elevation), significantly increased the safety factor. Specifically, considering the envelope of the landslide or surfaces along obvious large scale movements within the total landslide mass as potential failure surfaces, the computed values of the safety factor ranged between 1.52 and 1.63. Assuming that any failure surface within the total landslide envelope was possible (a quite conservative approach, since residual shear strength parameters were assigned in the analysis model) the safety factor ranged between 1.32 and 1.56. These values, even with the second, conservative approach, were considered adequate.

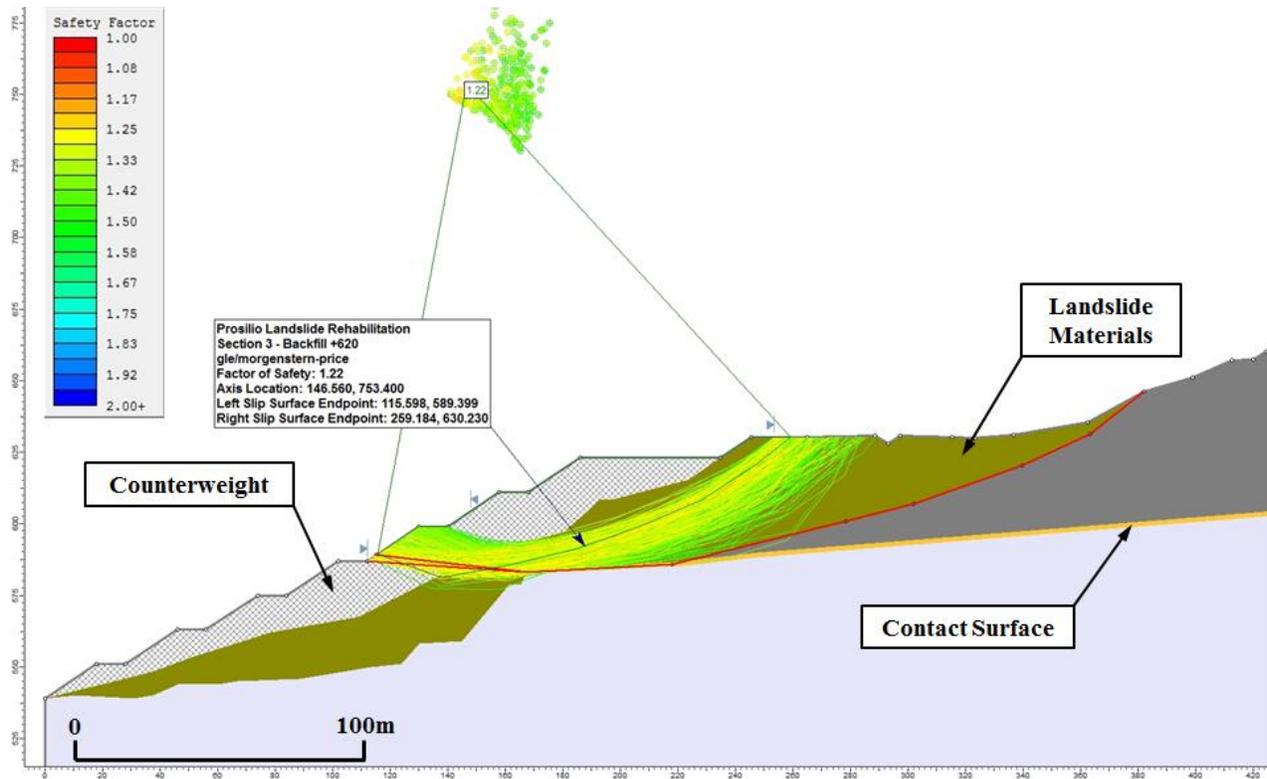
Figure 12. Analysis Results for Section 3 with backfill at the toe up to elevation +620 (F.S. = 1.22)

2. Placement of non commercial deposits at the toe of the landslide up to an elevation approximately 35 m above the contact surface between the upper weak and the underlying competent marl (~+620 m absolute elevation), did not significantly differentiate the safety factor. Specifically, considering the envelope of the landslide or surfaces along obvious large scale movements within the total landslide mass as potential failure surfaces, the computed values of the safety factor ranged between 1.56 and 1.70. Assuming that any failure surface within the total landslide envelope was possible, the safety factor ranged between 1.22 and 1.57. Therefore, it was shown that the additional placement up to the specific level was only to facilitate the landslide removal and exploitation procedures and was not necessary for the stabilization of the landslide. In fact, locally, due to the existing geometry and morphology of the landslide, this additional placement could somehow reduce the available safety factor, as part of the deposits would actually increase the sliding moment for certain potential failure surfaces (pose additional loading to the landslide - see Figure 12 above).

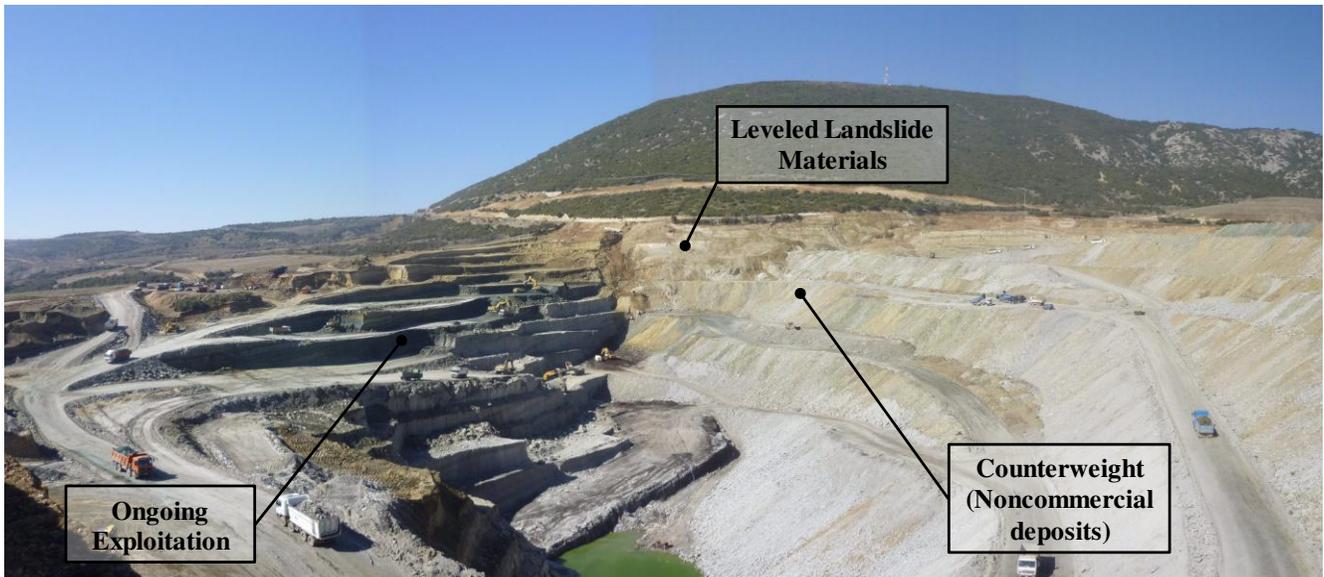
Figure 13. Aspect of the coal mine area after completion of counterweight construction and leveling works (March 2012).

The proposed rehabilitation scheme was successfully applied in order to stabilize the landslide before any intervention to its mass. The operation of the coal mine has continued without significant instability incidents ever since. The following figures show an aerial photo of the coal mine area and an aspect of the same from within the mine area, after completion of landslide counterweight construction and leveling of the landslide materials.

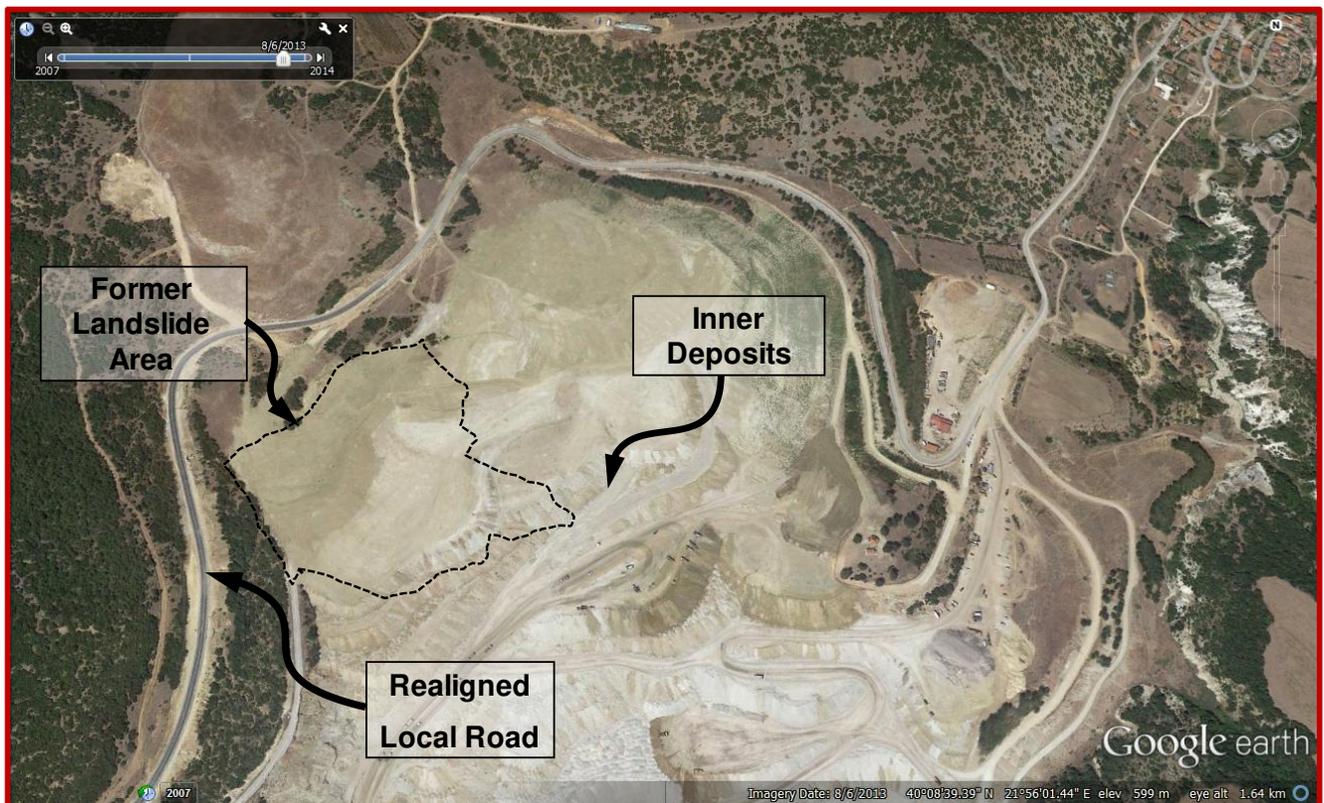
Figure 14. Aerial photo of the coal mine area after completion of counterweight construction and leveling works.
