A Large Scale Landslide in a Coal Mine in Marly Formations: Evaluation, Analysis and Rehabilitation

ABSTRACT: This paper describes a large scale landslide in a coal mine in Servia area in Kozani, Greece, which occurred in February 2011. The landslide, of ~250m width and ~350m length, took place in marly lacustrine sediments. The main factors for the manifestation of the landslide were a temporary interruption of works, the existence of a specific weak surface, the clayey nature and the sensitivity of marl to environmental agents, the action of water and the large slope height. Due to the magnitude and the position of the failure, a geotechnical solution was proposed that involved rearrangement of ground masses. The proposed solution led to successful rehabilitation and unimpeded continuation of the exploitation process.

Reference: Prountzopoulos, G., Fortsakis, P., Marinos, V. and Marinos, P. (2016). *A Large Scale Landslide in a Coal Mine in Marly Formations: Evaluation, Analysis and Rehabilitation*. International Journal of Geoengineering Case Histories, Vol.4, Issue 1, p.29-45. doi: 10.4417/IJGCH-04-01-03

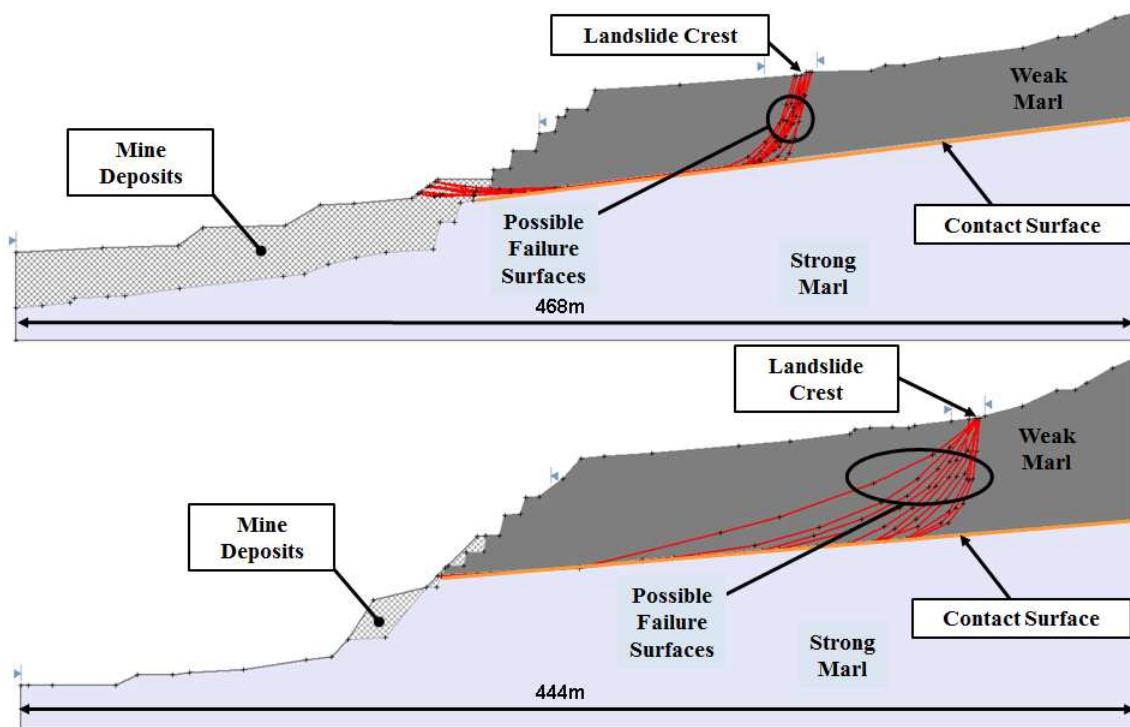
Given the three dimensional character of the landslide, as mentioned earlier, two analysis sections were systematically checked (Sections 2 and 3) so as to estimate some rational parameters for the assessment of rehabilitation proposals. Figure 5 illustrates the analysis sections along with their main features. The process that was adopted is summarized in the following steps:

1. After in-situ inspection and study of available surveying mapping, conclusions were reached concerning the general shape of the failure surface along Section 2 (subvertical near the crest) and Section 3 (with more gentle slope near the crest). Based on these conclusions, a set of possible failure surfaces was considered for each Section, with varying inclination and part of the surface passing through the weak marl formation and along the contact surface between the weak and the competent marl.

Figure 5. Analysis Section 2 (up) and 3 (down). Slide software model.

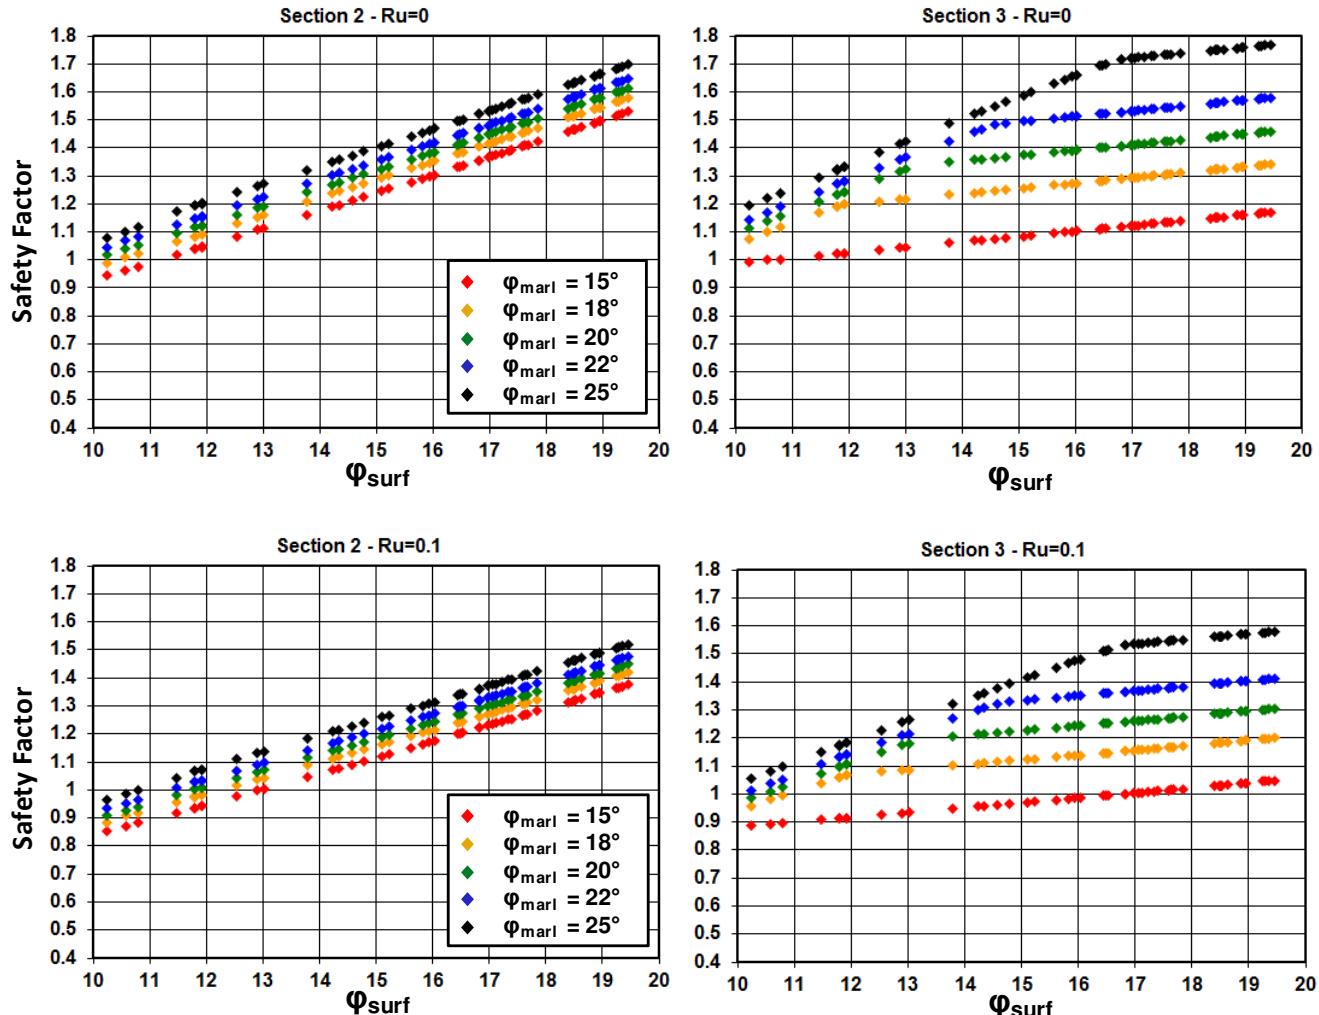
2. Values of the safety factor for values of pore pressure ratio $R_u=0-0.1$ generally lie above unity for both Sections analyzed (see Figure 6), especially for $\varphi_{surf} > 13^\circ$ and were therefore excluded. This result was actually anticipated, since water seemed to have had a major role in the landslide triggering.

Figure 6. Variation of safety factor for different values of φ_{marl} and φ_{surf} for $R_u=0.0$ (up) and $R_u=0.1$ (down), as computed for Section 2 (left) and Section 3 (right)

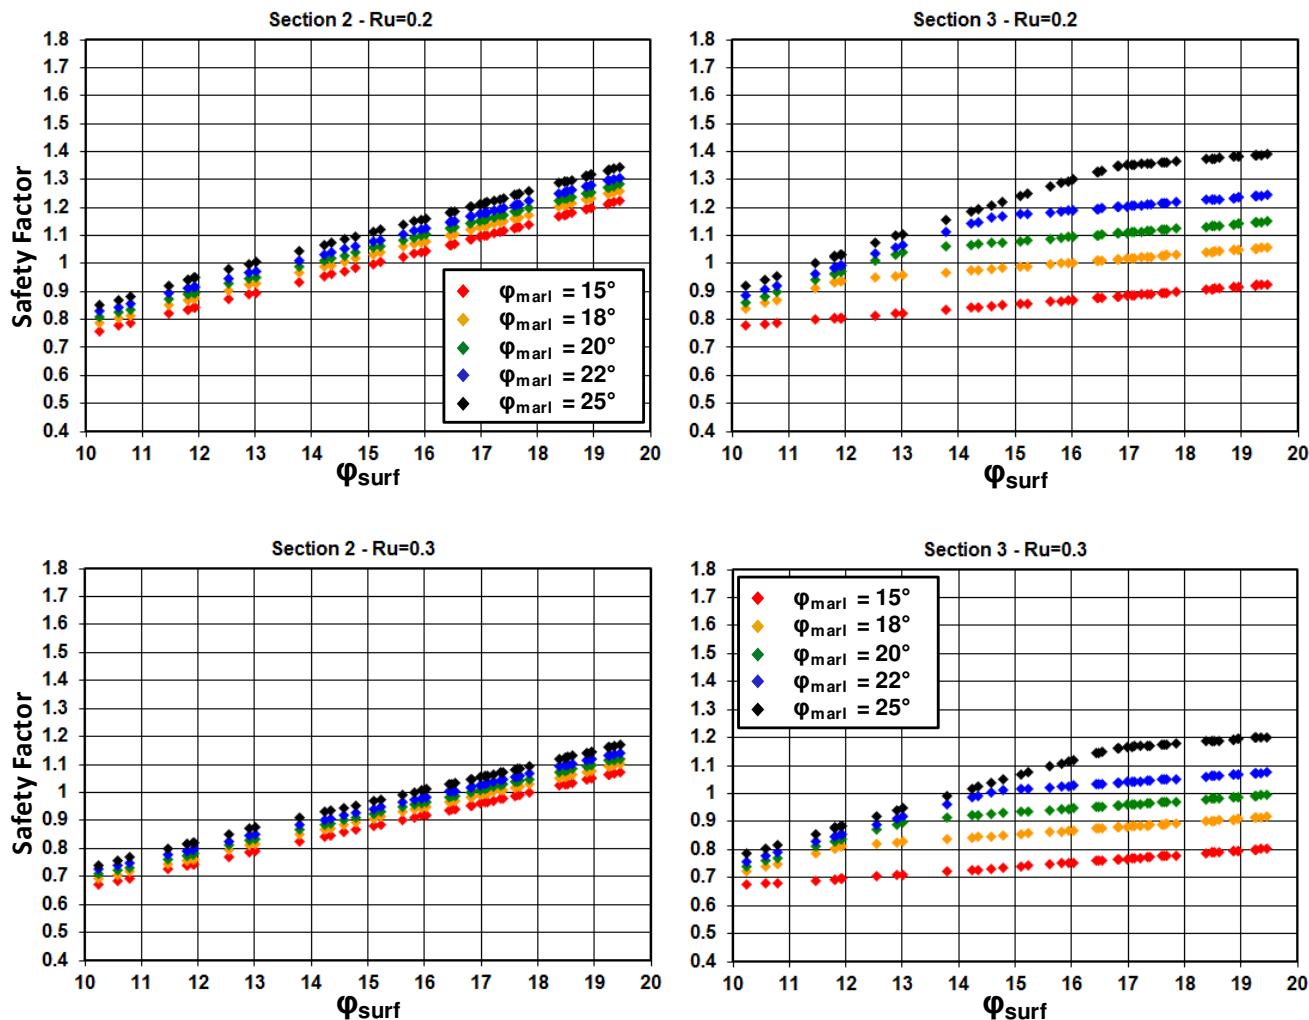
6. Considering the value of $\varphi_{marl}=15^\circ$ marginal and not very possible, the sets of φ_{marl} - φ_{surf} values resulting for each case are presented in Table 3.

Figure 7. Variation of safety factor for different values of φ_{marl} and φ_{surf} for $R_u=0.2$ (up) and $R_u=0.3$ (down), as computed for Section 2 (left) and Section 3 (right)

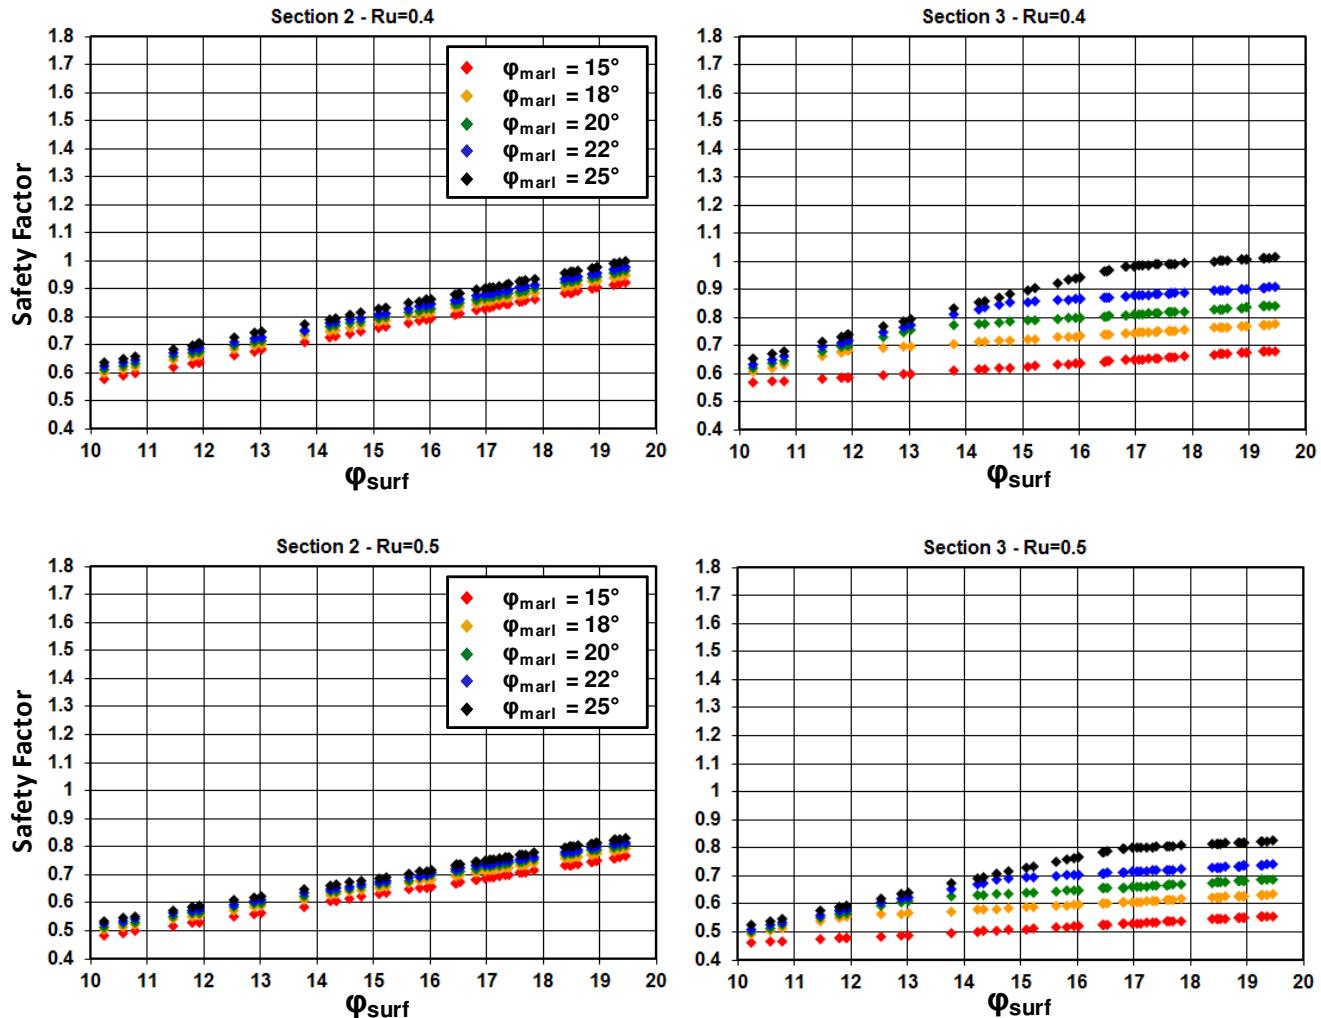
3. Values of the safety factor for values of the pore pressure ratio $R_u=0.4-0.5$ were generally well below unity for both analysis Sections (see Figure 8), especially for $\varphi_{surf} < 17^\circ-18^\circ$ and were not considered likely. Values of the safety factor for $\varphi_{surf} > 18^\circ$, given the nature of the specific surface and the fact that are assumed to refer to residual strength, were not considered reasonable.

Figure 8. Variation of safety factor for different values of φ_{marl} and φ_{surf} for R_u=0.4 (up) and R_u=0.5 (down), as computed for Section 2 (left) and Section 3 (right)

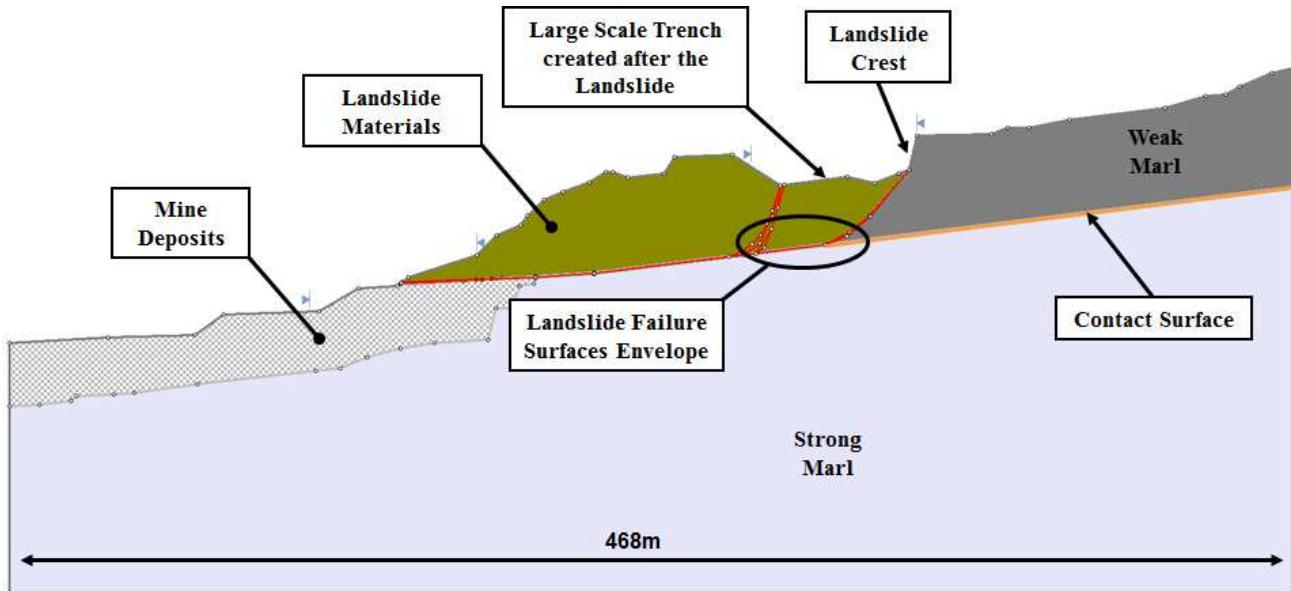
Figure 9. Analysis Section 2 after the landslide

The relevant analyses yielded results of the safety factor between 1.06 and 1.11, which were considered marginal, given the possible further deterioration of the shear strength of the materials involved in the slides, due to ongoing movements, especially during the rainy season in the area. Specifically, analyses of Section 2 resulted in a minimum value of the safety factor equal to 1.11, whereas the corresponding minimum value from Section 3 was 1.06. Analyses with free selection of surfaces by the software were not performed, as these would yield unrealistically low values of the safety factor (considerably <1), under the assumption that the total mass included in the landslide envelope had been downgraded to its residual strength (zero cohesion and low friction), which was not the case due to monolithic, undisturbed blocks existing within the slid mass. The fact that the resulting safety factor values were rational, i.e. marginally larger than unity, indicating a temporarily stable situation after a main landslide event, enhanced our confidence in the assumptions that were made.

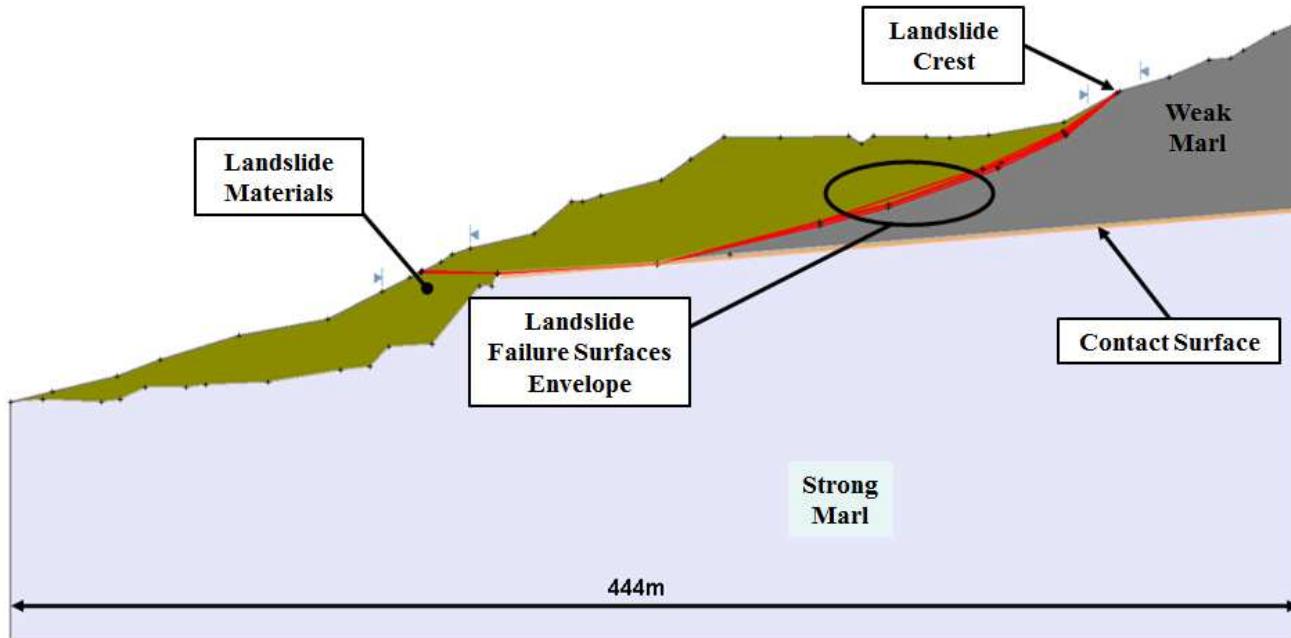
Figure 10. Analysis Section 3 after the landslide

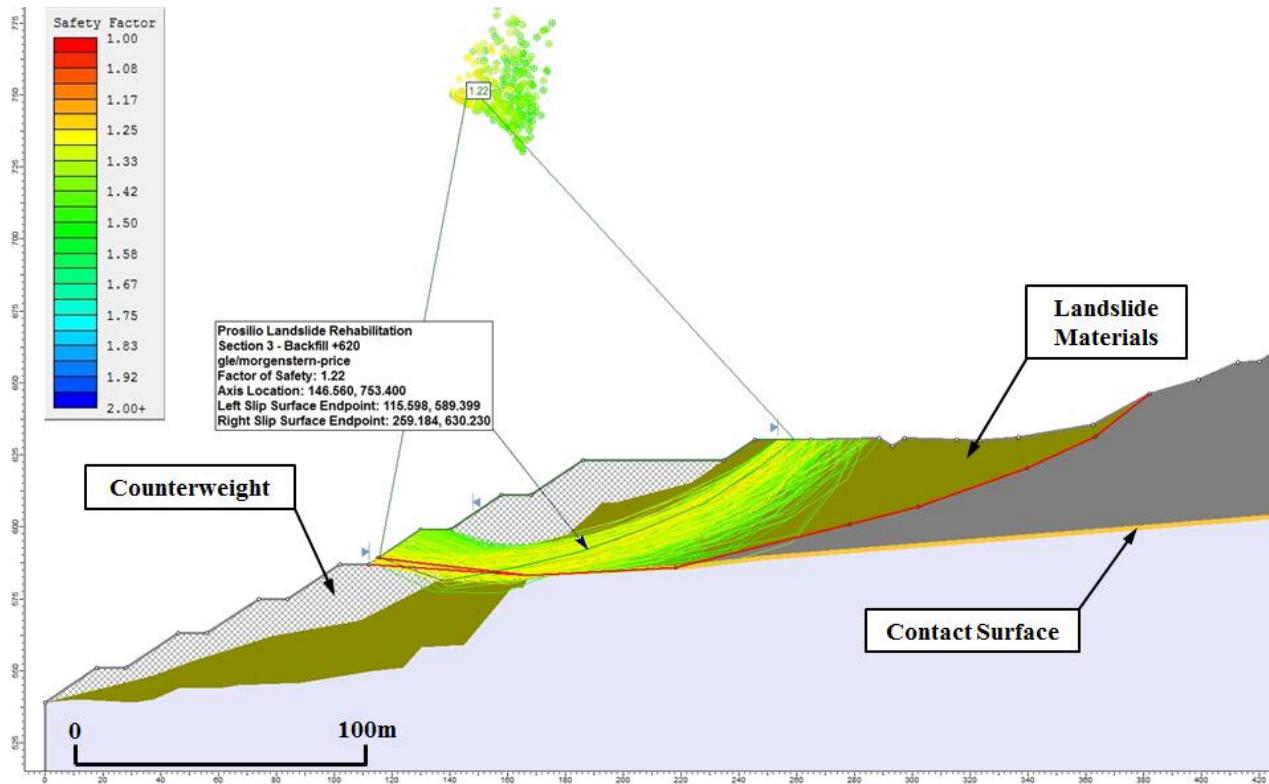
Figure 12. Analysis Results for Section 3 with backfill at the toe up to elevation +620 (F.S. = 1.22)

2. Placement of non commercial deposits at the toe of the landslide up to an elevation approximately 35 m above the contact surface between the upper weak and the underlying competent marl (~+620 m absolute elevation), did not significantly differentiate the safety factor. Specifically, considering the envelope of the landslide or surfaces along obvious large scale movements within the total landslide mass as potential failure surfaces, the computed values of the safety factor ranged between 1.56 and 1.70. Assuming that any failure surface within the total landslide envelope was possible, the safety factor ranged between 1.22 and 1.57. Therefore, it was shown that the additional placement up to the specific level was only to facilitate the landslide removal and exploitation procedures and was not necessary for the stabilization of the landslide. In fact, locally, due to the existing geometry and morphology of the landslide, this additional placement could somehow reduce the available safety factor, as part of the deposits would actually increase the sliding moment for certain potential failure surfaces (pose additional loading to the landslide - see Figure 12 above).
