A Large Scale Landslide in a Coal Mine in Marly Formations: Evaluation, Analysis and Rehabilitation

Submitted: 05 June 2015; Published: 16 December 2016

Reference: Prountzopoulos, G., Fortsakis, P., Marinos, V. and Marinos, P. (2016). *A Large Scale Landslide in a Coal Mine in Marly Formations: Evaluation, Analysis and Rehabilitation*. International Journal of Geoengineering Case histories, Vol.4, Issue 1, p.29-45. doi: 10.4417/IJGCH-04-01-03

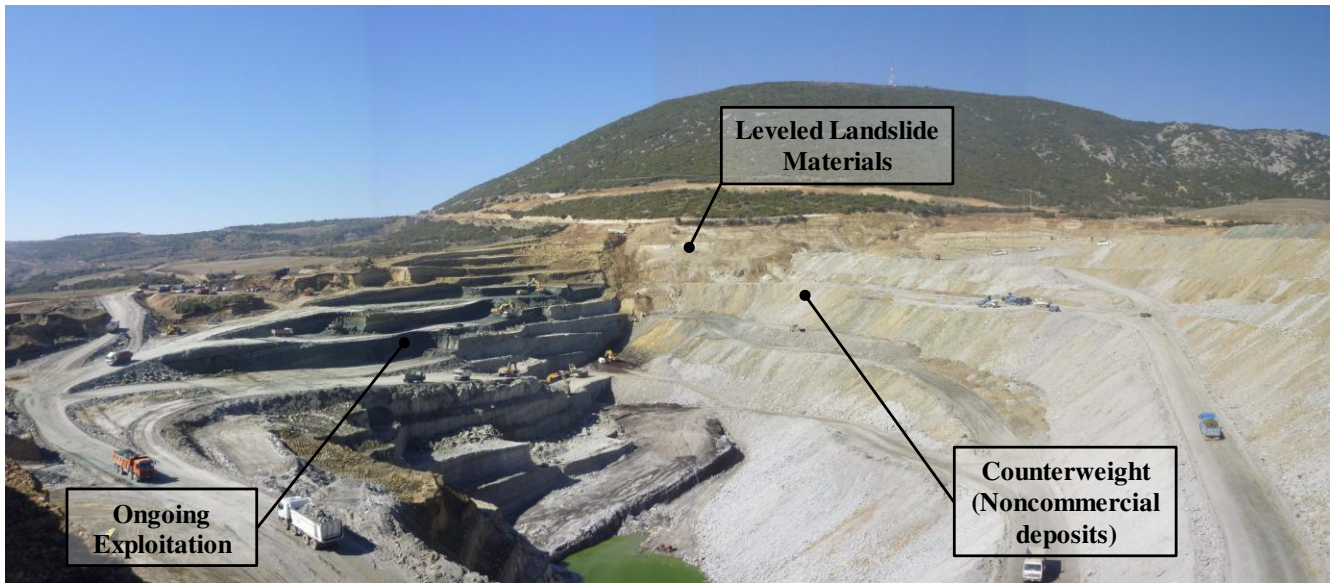
Figure 13. Aspect of the coal mine area after completion of counterweight construction and leveling works (March 2012).

The proposed rehabilitation scheme was successfully applied in order to stabilize the landslide before any intervention to its mass. The operation of the coal mine has continued without significant instability incidents ever since. The following figures show an aerial photo of the coal mine area and an aspect of the same from within the mine area, after completion of landslide counterweight construction and leveling of the landslide materials.

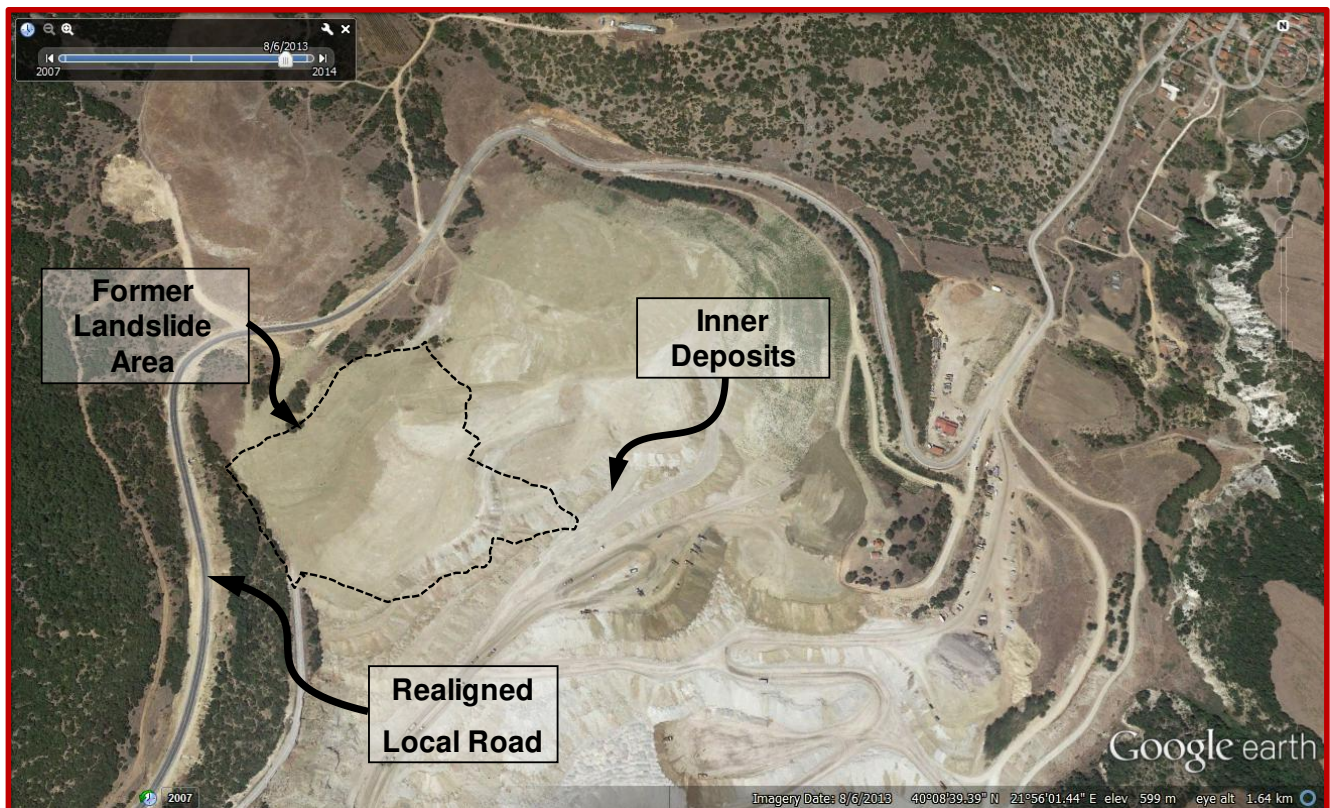
Figure 14. Aerial photo of the coal mine area after completion of counterweight construction and leveling works.
