# Remediation of The Pissouri Landslide in Cyprus

**ABSTRACT:** During the winter of 2001-2002, a landslide of 80.000 m<sup>3</sup> was activated and moved downslope at the Northeast outskirts of the Pissouri village in Cyprus (Limassol prefecture), displacing a section of a country road that was crossing the upper part of the sliding mass and destroying three newly built residences. This paper presents the geologic and hydrogeologic regime of the landslide and its implication on the landslide's mobilization. Geotechnical site investigation and post failure monitoring, in conjunction with slope stability back analysis formed the basis for the study of the slide and subsequently guided the remediation strategy. Various possible interventions to stabilize the slope and allow the safe reconstruction of the displaced road have been investigated and compared considering both economic and environmental criteria. The performance of the remediation measures has been studied in terms of stability safety, using numerical models previously calibrated via back analyses. Observations made during the execution of the stabilization works provided additional data verifying and supplementing the o

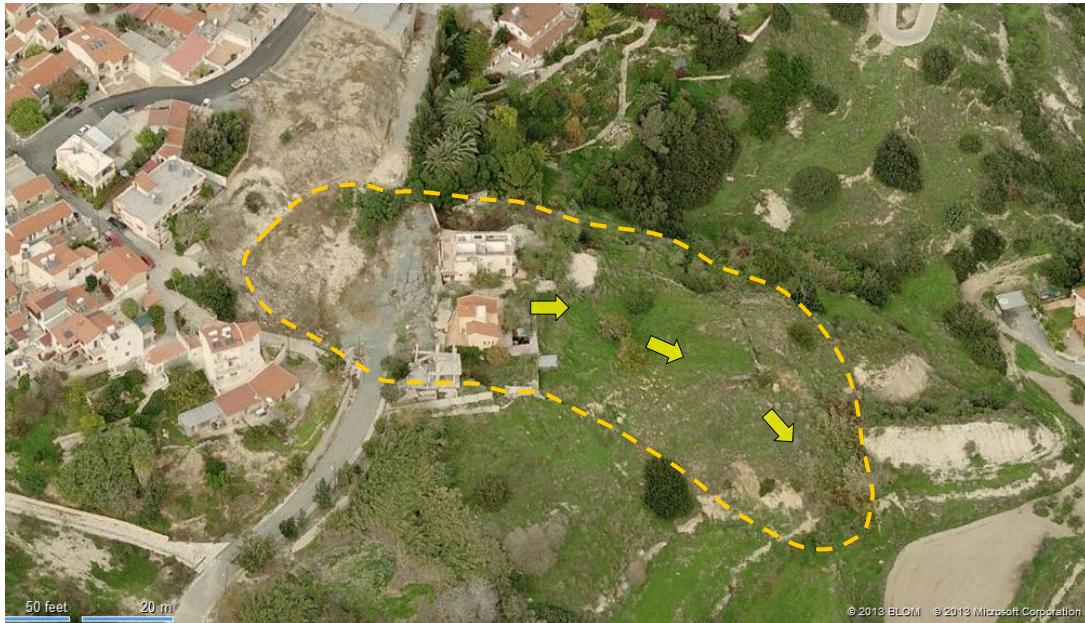
of the build-up area, approximately 80.000 m<sup>3</sup> of ground mobilized and moved 0.5 m to 1.0 m downslope. The landslide distorted a section of a country road which was crossing the upper part of the slide and three residential buildings built adjacent to it. It continued to move the following years, at low rates during the dry seasons and at an accelerating rate during the wet seasons. With an average movement rate of 3 cm per month the landslide displacement accumulated up to 3.00 m – 3.50 m during the next 10 years. The landslip was immediately followed by water springing at the toe of the sliding mass, and continued the following years to seasonally gush out water and mud, pinpointing the significance of groundwater seepage through the sliding mass to its mobilization. An aerial view of the landslide, the distorted road and the damaged buildings is presented in figure 1, which can also be seen on the photographs of figure 2.

Figure 1. Aerial view of the Pissouri landslide. Dashed line indicates the border of the sliding mass. Notice the distorted road and the damaged residential buildings resting on the sliding mass.

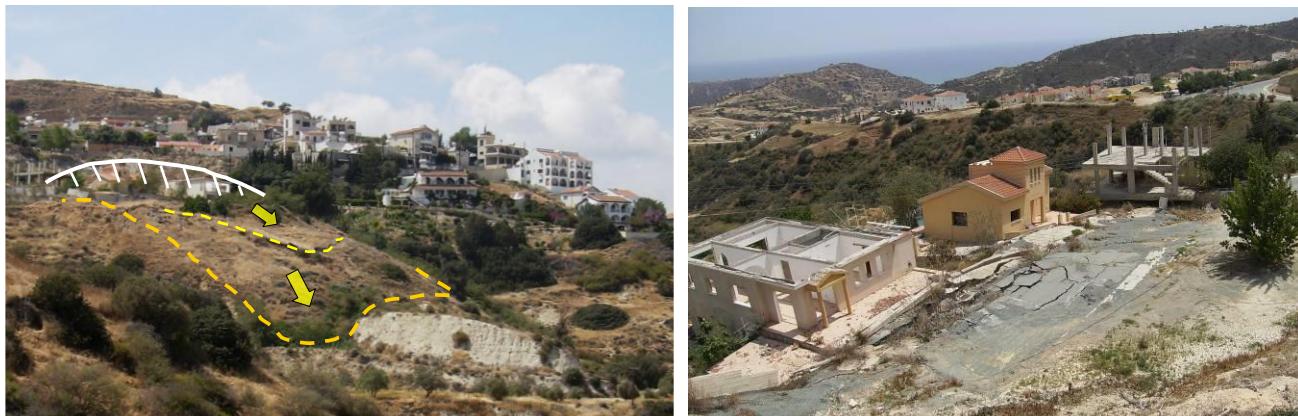
Figure 2. Left: Northward view of the Pissouri landslide. Dashed line marks the border of the sliding mass. Back scarp is also marked. Right: The distorted road and damaged buildings resting at the upper part of the sliding mass.

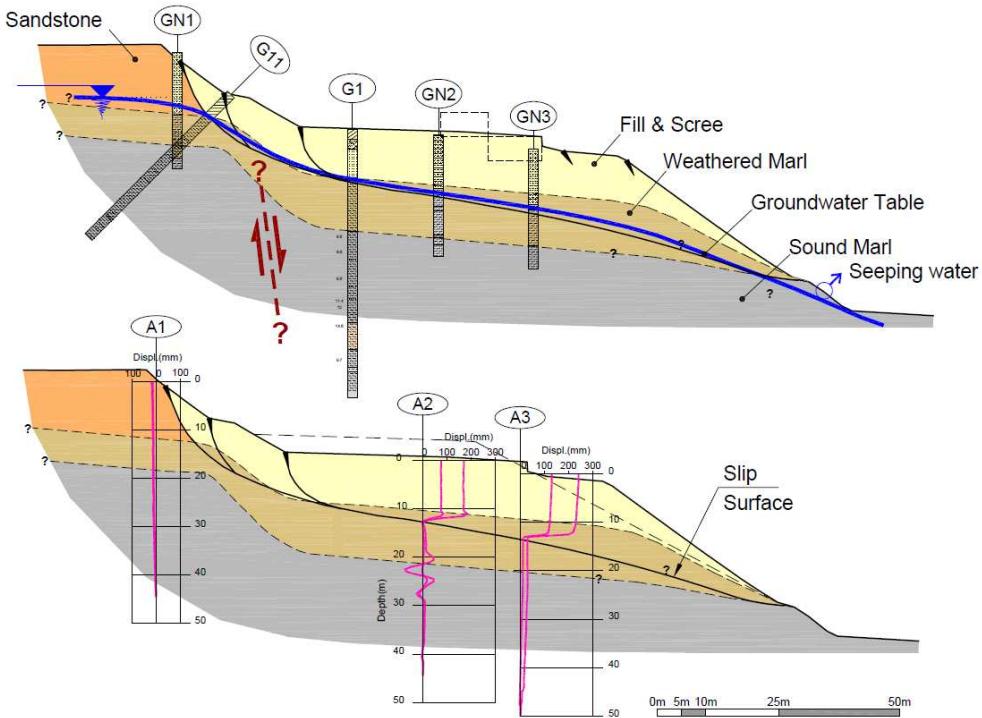
Figure 5. Geotechnical section along the sliding mass. Top: Exploratory boreholes Stratigraphy and ground water table  
Bottom: Inclinometer readings and location of slip surface.

The slip surface was located by combining the monitoring data from the two inclinometer tubes (A2 & A3) installed within the sliding mass and the careful mapping of slope breaks and cracks, visible on the ground (in some cases), on the cracked pavement of the distorted road, the houses and the paved ground around them. The third inclinometer tube which had been installed further upslope did not show signs of movement (as shown in figure 5) and allowed the identification of the back scarp of the slide with confidence.

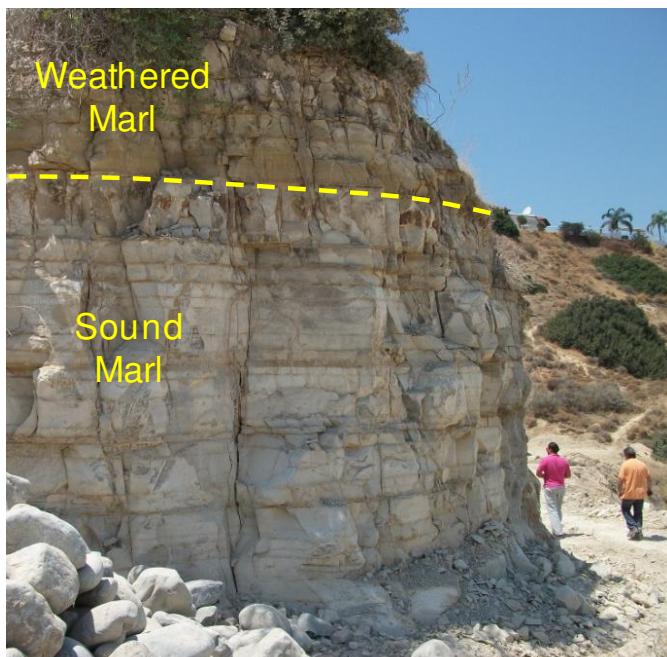
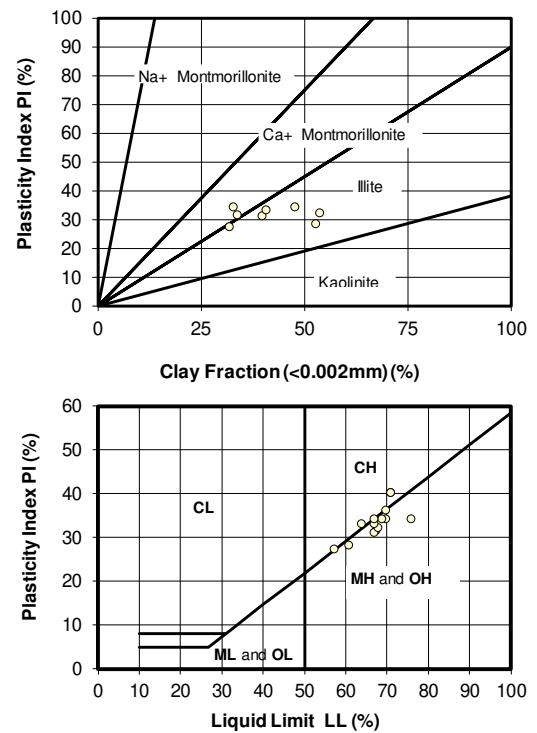
The bedrock is a low strength yellowish calcareous marlstone ( $UCS \approx 10$  MPa), fairly undisturbed, but marked by a medium to thick bedding (10 - 100 cm) dipping with a low angle to south-southeast. Stress relief lead to the development of sub-vertical joints and fissures and water circulation gradually resulted to the development of a capping weathered crust. Weathering is associated with oxidization and decalcification of the marlstone, the gradual increase in pore volume (further promoting seepage) and subsequent intact strength degradation to that of a stiff soil. In the landslide site the thickness of the weathered marl crust is 5 to 10 meters and the material was encountered in places disturbed and sheared by the landslide movement. The succession of sound and weathered marl is depicted on the photograph of Figure 6, where the weathered material is noted by the distinct brownish color and its intense fissility. Soil samples obtained from the weathered zone are classified as CH-MH with a plasticity index (PI) ranging from 20% to 35% and clay fraction (CF) between 30% and 60%. Natural water content of the weathered marl does not exceed 30% and the material is generally stiff with SPT values ranging from 25 blows/ft to refusal. Typical classification test results from this zone are also presented in Figure 6.

Figure 6. Left: Typical appearance of the bedded calcareous marl and the overlying weathered crust.  
Right: Typical soil classification test results performed on samples retrieved from the weathered marl zone.

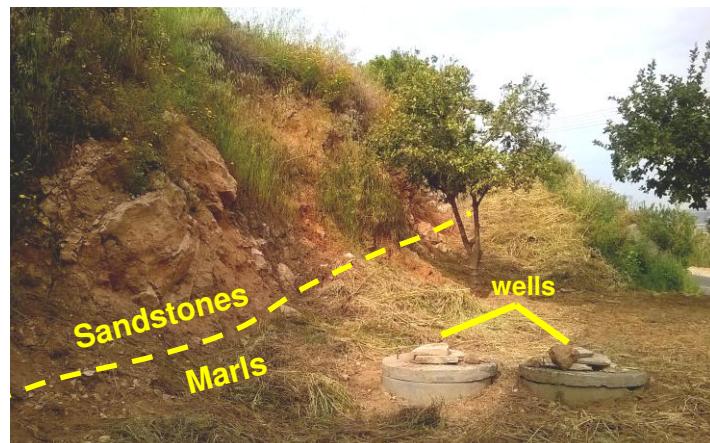
Figure 11. Wells collecting groundwater springing out freely in the sandstone-marl contact area were located a few hundred meters south of the landslide area.

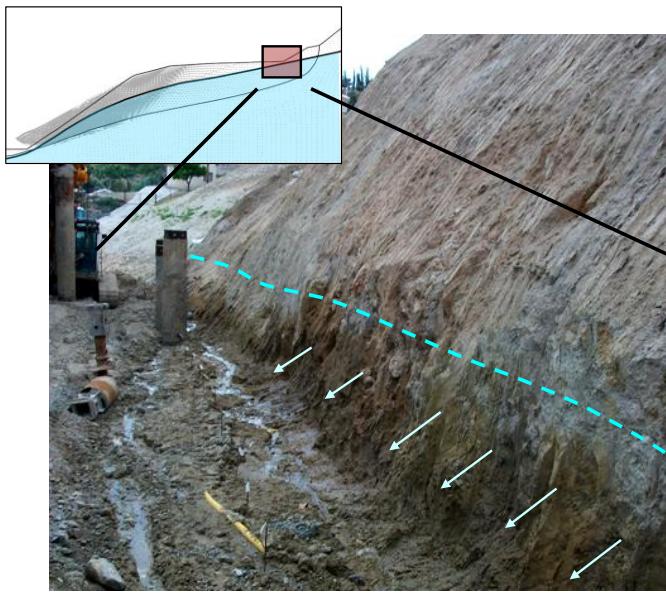
Figure 20. Water seeping out of the marl at the landslide back scarp
