A High Rock Cut Stabilization in Muscat City, Oman

Tahir M. Hayat, Vice President, Geotechnical and Geonvironmental Engineering Division, NESPAK, Lahore, Pakistan; email: tmhayat786@yahoo.com

Reference: Hayat, T.M., Bhatti, T.J. and Goldsmith, R. (2017). *A High Rock Cut Stabilization in Muscat City, Oman*.

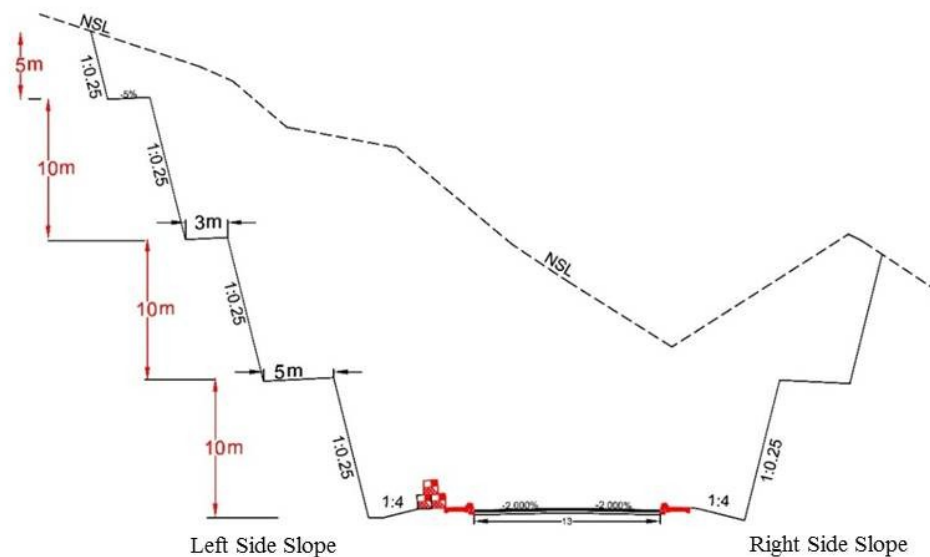
The maximum height of the rock slope in these cuts reaches 50 m with a cut slope of 1V:0.25H (76°) and 3 m wide benches at every 10 m height interval. A typical section of box cut at RD 0+420 m is shown in Figure 2. The initial design included slope protection measures such as short length rock bolts and reinforced shotcrete.

Figure 2. Slope and roadway configuration at station RD 0+420 m in Box Cut#1.

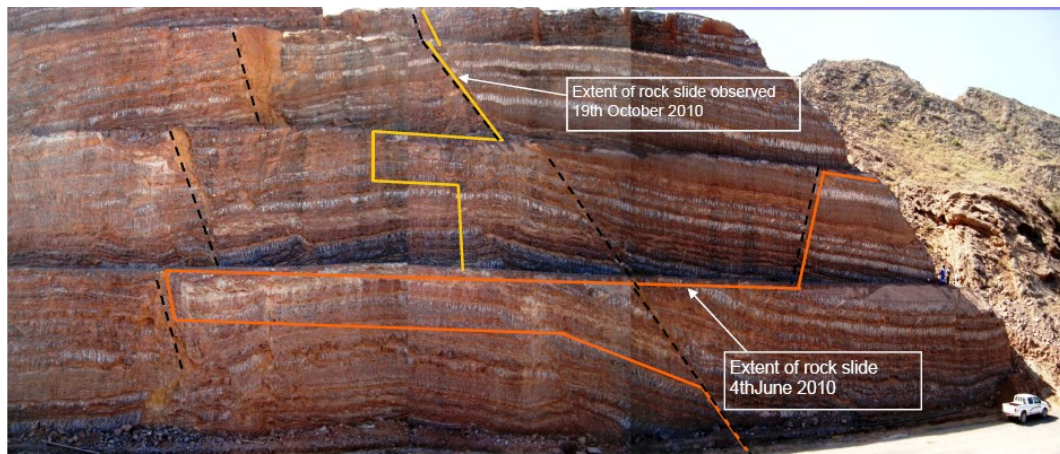
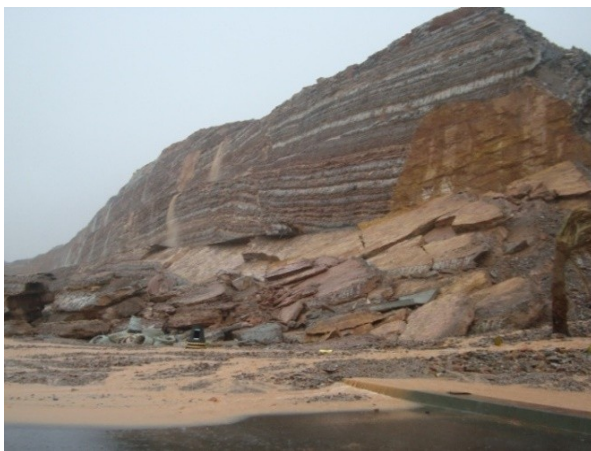
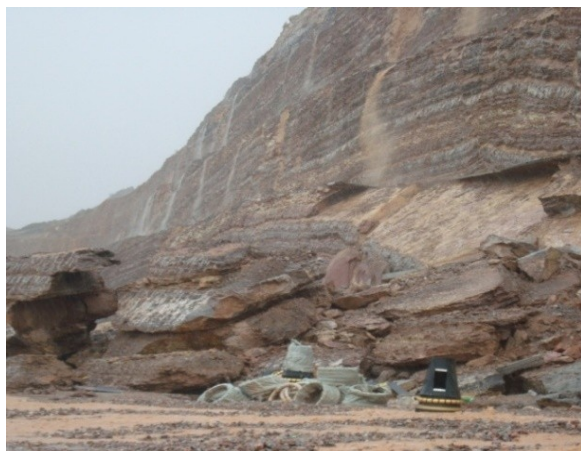
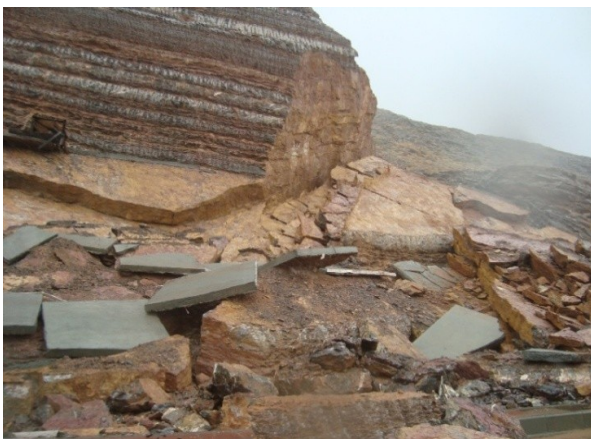
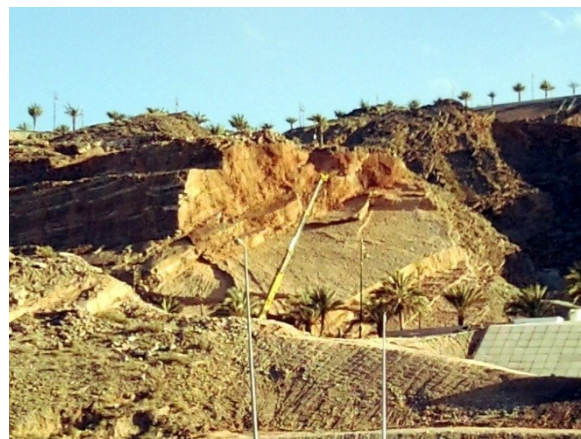
This rainfall caused a rock slide on the left side of the Box Cut # 1, from RD 0+380 m to 0+480 m. This section constituted the farthest edge of the cutting. On this side of Box Cut #1, a small wadi (valley) is located behind the slope. This was used as a channel for diverting the storm water from the catchment areas behind the slope. This wadi has steep gradient and was unlined at the time of slope failure.

Photographs taken just after the rain storm showed that the failure had occurred initially as a single event. Failure occurred along a 40° dipping bed in the lowest slope, which extended to the inner edge of the first berm and a near vertical joint forming the release plane. The photographs taken at that time also showed a large amount of water transported debris coming out from the above mentioned wadi adjacent to the failed area. Water was also noticed cascading over the crest of the main rock cut.

With the passage of time, the extent of the initial failure grew in size as more and more rock mass adjacent to the initial failure area failed progressively. Within a couple of weeks of the initial event, the failure grew to the top of the 35 m high cut, extending about 20 m along the crest and reaching as far as a steep joint with a strike of about 260° (N100 deg W), and dip of more than 70°. The total volume of failure was estimated at 800 m³ (Figure 4).

From site observations, it was concluded that the failure initiated along a laminated bed of argillaceous rock layers, which had the least shearing resistance of all the rock mass at the site. The failure undermined the slopes above it and caused their failure, which progressed in the weeks ahead of the initial event.

The main triggering factor was the increase in water pressure associated with the rainfall event. The Box Cut # 1 slope at the farthest end was exposed to weather on three sides; the front cut face, the edge face and behind in the wadi (valley). It is likely that the water in the wadi overflowed and infiltrated the loose jointed and bedded rock mass. It is also likely that the small solution channels formed conduits for water that entered the formation, contributing to the failure. Although the rock mass appeared visibly stable in the area after a few weeks, there were other bedding / joints in the area that could cause further instability in the future, especially under wet conditions.

Figure 4. Top photo provides an overall view of the slope face prior to sliding and the extent of two episodes of sliding on June 4th and October 11th 2010. The lower frames, except the lower right corner view, show sliding during Cyclone Phet, while the lower right corner view shows the resulting slope face after the final collapse on October 11th 2010. The sliding along the bedding and a vertical joint, a free release plane along the overspilled wadi, is an obvious reason of sliding during cyclone Phet.

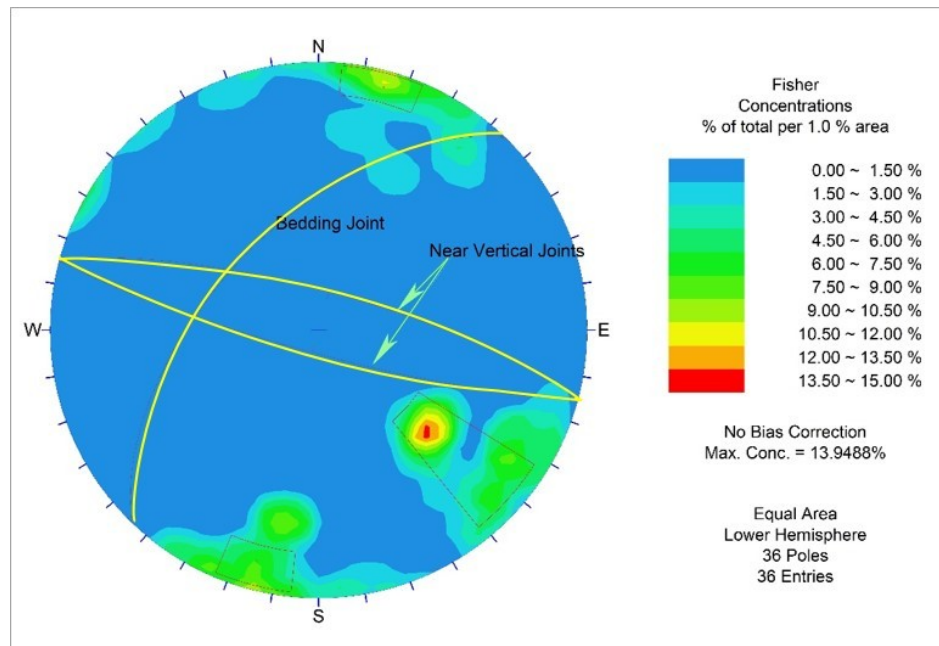
In Box Cut #1, from approximately RD 0+220 to 0+500 m, the interlayering of the beds is quite prominent and dips at 30° to 45° daylighting out of the face and within +/- 20° of the face orientation. In addition to the bedding, there are joints and faults that are steeply dipping at 70° to 90° and strike NE-SW or SSW. These joints have high persistence over all cut benches to the full 40 m height. Some of these features are faulted with noticeable displacements. Figure 5 shows the pole plot of the joints and great circles drawn through the centre of poles concentration by visual examination.

Figure 5. Stereoplot of the discontinuities representing the left slope in Box Cut 1.

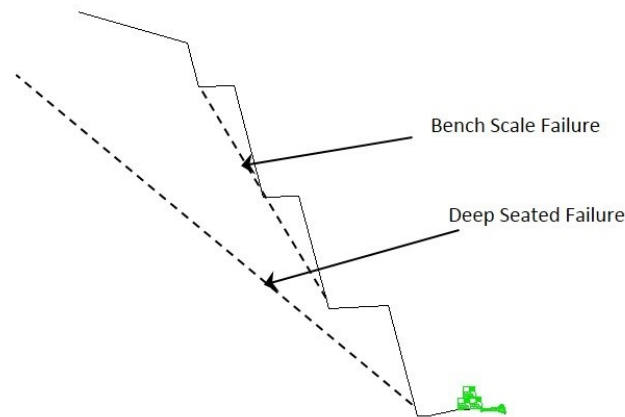
The orientation of bedding planes along various berms showed appreciable variation in the dip inclination. However, previous failures and site observations led to the conclusion that the most likely inclination of the failure plane was 40° . Also smaller scale failures involving one or two benches and larger global scale failures with deep seated planes were both possible. Based on the above, the following expected failure planes were considered in the re-assessment of slope stability:

Figure 8. Illustration of relatively small scale and multiple bench (deep) failures planes assumed in stability analysis of Left Face Slope at Km 0+400 m.

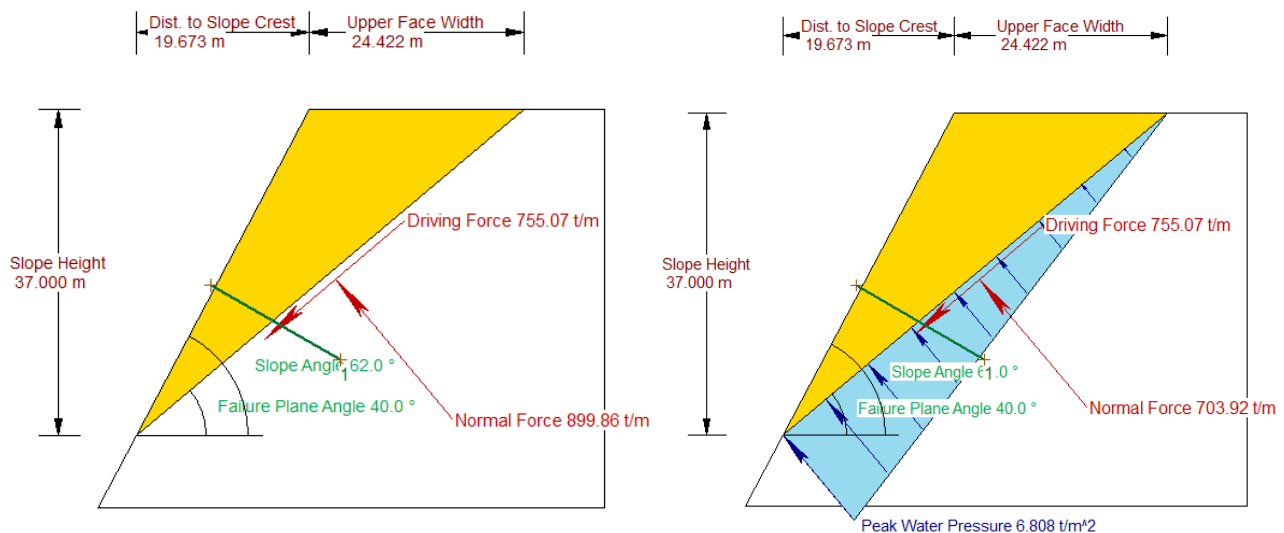
Figure 9. The driving and resisting forces against the calculated FOS 1.12 and 1.01 for dry and wet slope (15 m water head) respectively.

In analyses, the peak water pressure at the toe was applied in view of adopting a conservative approach as the mid-height water pressure gives slightly higher FOS under similar static water head and material strength conditions. Figure 9 above gives a graphical representation of applied water pressure along the sliding plane.

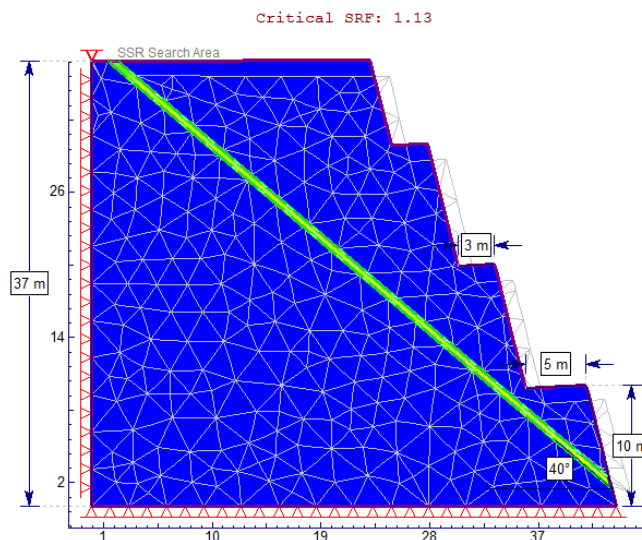
From the table above, it is can be observed that the Factors of Safety from the three approaches used are in general agreement. Figure 10 below shows the exaggerated deformed FE mesh of the upper sliding block for the $SRF = 1.2$ (In Dry Condition) for which no FEA convergence occurred.

Figure 10. Deformed mesh for the $SRF = 1.2$ (in dry conditions) for which no FEA convergence occurs. The maximum SRF for which the FEA satisfies the state of equilibrium is 1.13.

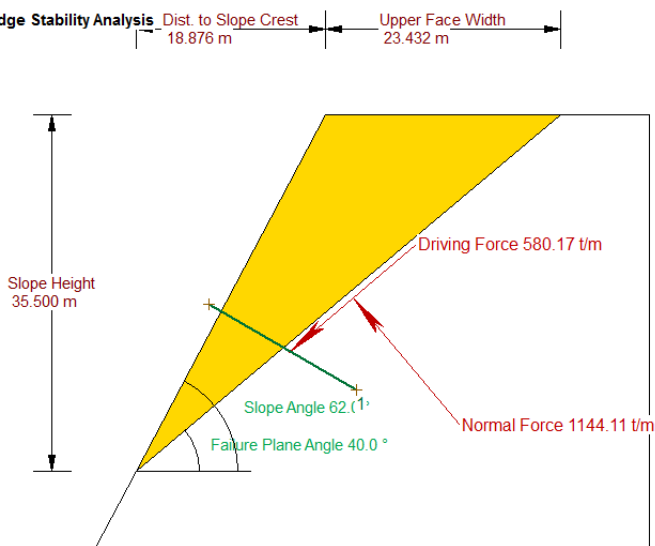
Factor of Safety	1.61
Driving Force	580.17t/m
Resisting Force	934.56t/m
Wedge Weight	1081.37t/m
Wedge Volume	415.91m ³ /m
Shear Strength	934.56t/m ²
Normal Force	1144.11t/m
Plane Waviness	0.0°
Active Bolt Force	336.00t
Active Bolt Angle	330.0°
Passive Bolt Force	0.00t
Passive Bolt Angle	0.0°

Figure 11. Factor of Safety (FOS) in dry condition with 3360 KN/m external force applied through designed cable anchors.

After several trials using different applied normal stresses on the failure plane, seven strand anchors of 1200 KN working load at 2.5 x 2.5 m grid (3400 KN/m) for a 35 m high slope were selected. The results of factor of safety using the 1200 KN anchors on the deep sliding planes are presented in Figures 11 to 14 and are summarized in Table 3.

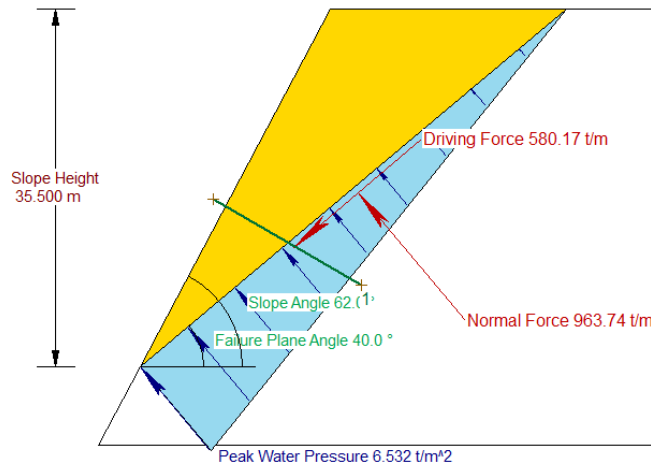
Factor of Safety	1.48
Driving Force	580.17t/m
Resisting Force	856.88t/m
Wedge Weight	1081.37t/m
Wedge Volume	415.91m ³ /m
Shear Strength	856.88t/m ²
Normal Force	963.74t/m
Plane Waviness	0.0°
Active Bolt Force	336.00t
Active Bolt Angle	330.0°
Passive Bolt Force	0.00t
Passive Bolt Angle	0.0°
Water Force on Failure Plane	180.38t/m

Figure 12. Factor of Safety (FOS) in wet condition under 15 m water head and 3360 KN/m external force applied through designed cable anchors.

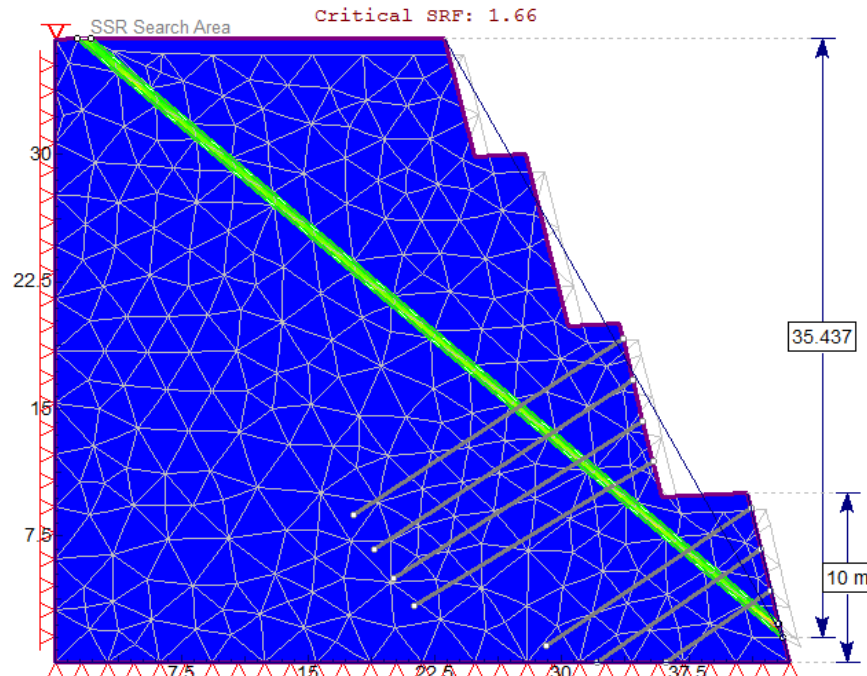
Figure 13. Deformed Mesh for the SRF =1.72 (in dry conditions) for which no FEA convergence occurred. The critical SRF for which the FEA satisfied the condition of equilibrium with 7 strand anchors of 1200 KN (2.5 x 2.5 m grid) is 1.66 as shown.

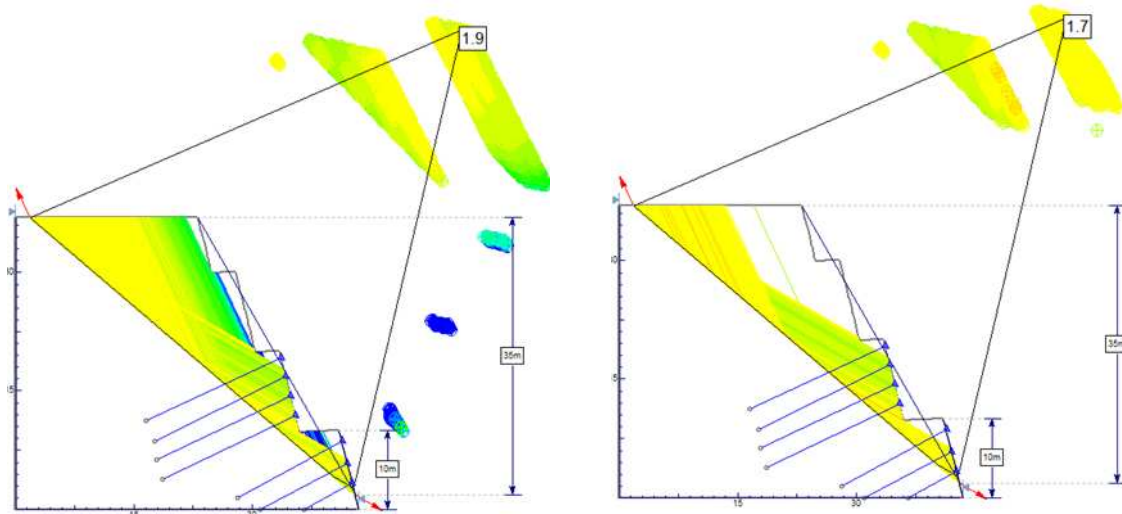
Figure 14. FOS with 7 x 1200 KN anchors in dry condition using Bishop (left) and Morgenstern-Price (right) methods.

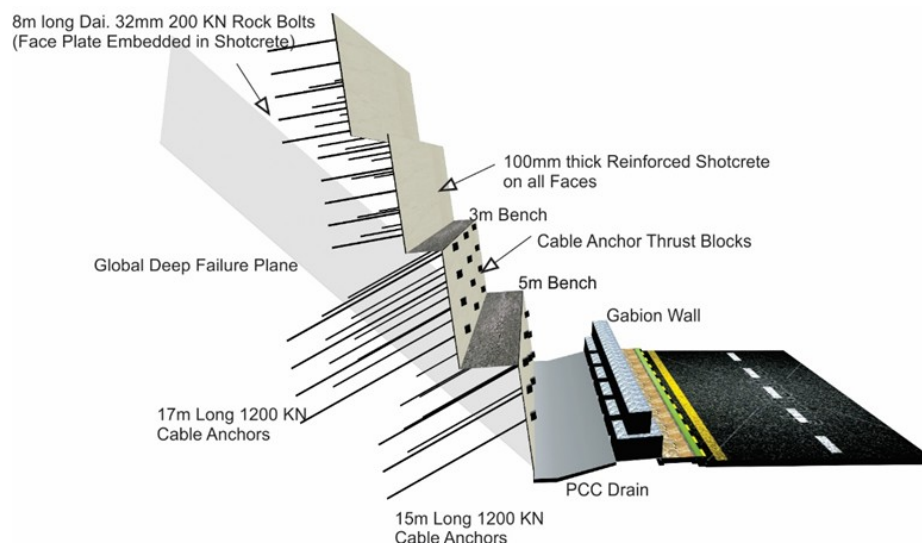
It was therefore concluded that the ends of box cut #1 were most vulnerable as at these locations large and deep seated failures were kinematically possible, whereas in the middle of these slopes, only shallower failures would be possible, the unstable wedges being confined at both ends. It was therefore decided to reinforce only the terminus of the 500 m long vulnerable slope with 1200 KN cable anchors. Other intermediate and cut faces above the cable anchored slopes were, however, reinforced with 200 KN rock bolts to control the comparatively smaller scale failures. The rock bolt heads were tensioned on steel plates resting on epoxy cement base. For long term durability, the steel plates were embedded in the shotcrete. The anchor heads of high capacity cable anchors were installed on specially constructed reinforced concrete anchor blocks. A typical arrangement of the reinforcement pattern at cut slope ends is shown in Figure 15.

Figure 15. 3D Conceptual arrangement of reinforcing elements at both the 20 m terminus of 500 m long left slope of Box Cut #1.

The arrangement of stabilization measures shown in Fig. 15 were implemented and are performing satisfactorily for the last six years.
