A High Rock Cut Stabilization in Muscat City, Oman

ABSTRACT: A large road box cut was constructed in hilly terrain of Muscat city, Oman, in an area underlain by the geologically complex Sahtan and Mahil formations comprising of limestone, dolomite, sandstone and siltstone with interbedded soft calcareous mudstone. The rockmass contains a large number of small scale faults, shear zones, minor folds and solution cavities. The maximum height of the cut was 50 m with slope angle of 1V:0.25H, and intermediate benches generally 3 m wide. To control vibrations in the urban neighborhood located nearby and avoid damage to the rockmass, a very cautious and time consuming excavation approach was adopted using rock breakers. The excavation work was completed in 2010. Oman has a hyper-arid environment with scarce rainfall for many months. However, occasionally the area is hit by intense rainstorms. During Cyclone Phet and accompanying rains in June 2010, part of the cut slope failed with a downslope movement of about 800 m³ of massive rock. This necessitated a post-excavation re-evaluation of the cut slope, which culminated in design modifications, and construction of long term slope stabiliza

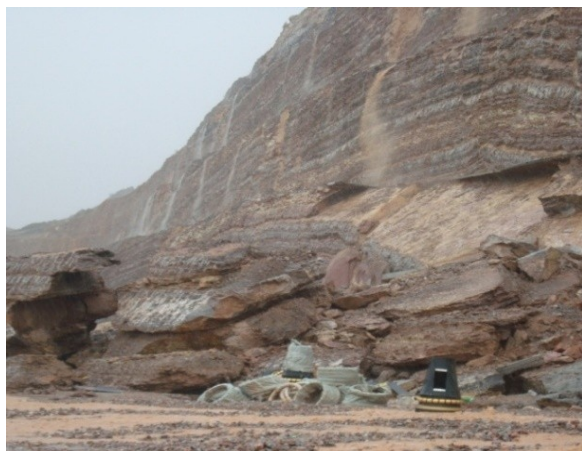
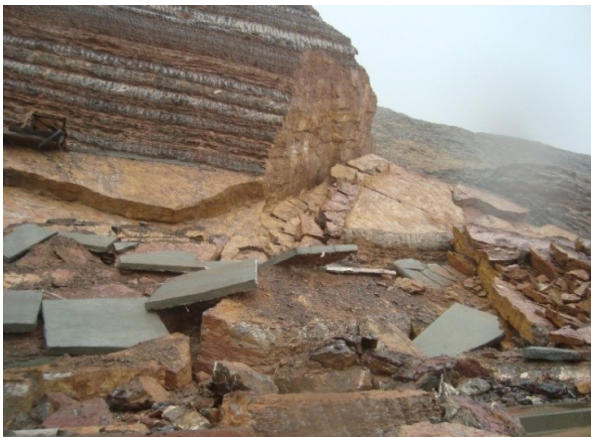
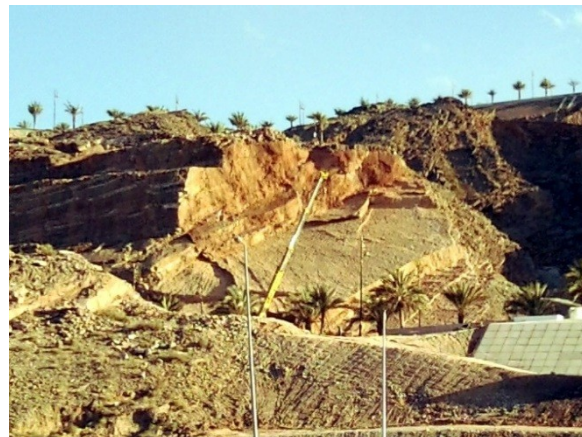
This rainfall caused a rock slide on the left side of the Box Cut # 1, from RD 0+380 m to 0+480 m. This section constituted the farthest edge of the cutting. On this side of Box Cut #1, a small wadi (valley) is located behind the slope. This was used as a channel for diverting the storm water from the catchment areas behind the slope. This wadi has steep gradient and was unlined at the time of slope failure.

Photographs taken just after the rain storm showed that the failure had occurred initially as a single event. Failure occurred along a 40° dipping bed in the lowest slope, which extended to the inner edge of the first berm and a near vertical joint forming the release plane. The photographs taken at that time also showed a large amount of water transported debris coming out from the above mentioned wadi adjacent to the failed area. Water was also noticed cascading over the crest of the main rock cut.

With the passage of time, the extent of the initial failure grew in size as more and more rock mass adjacent to the initial failure area failed progressively. Within a couple of weeks of the initial event, the failure grew to the top of the 35 m high cut, extending about 20 m along the crest and reaching as far as a steep joint with a strike of about 260° (N100 deg W), and dip of more than 70°. The total volume of failure was estimated at 800 m³ (Figure 4).

From site observations, it was concluded that the failure initiated along a laminated bed of argillaceous rock layers, which had the least shearing resistance of all the rock mass at the site. The failure undermined the slopes above it and caused their failure, which progressed in the weeks ahead of the initial event.

The main triggering factor was the increase in water pressure associated with the rainfall event. The Box Cut # 1 slope at the farthest end was exposed to weather on three sides; the front cut face, the edge face and behind in the wadi (valley). It is likely that the water in the wadi overflowed and infiltrated the loose jointed and bedded rock mass. It is also likely that the small solution channels formed conduits for water that entered the formation, contributing to the failure. Although the rock mass appeared visibly stable in the area after a few weeks, there were other bedding / joints in the area that could cause further instability in the future, especially under wet conditions.

Figure 4. Top photo provides an overall view of the slope face prior to sliding and the extent of two episodes of sliding on June 4th and October 11th 2010. The lower frames, except the lower right corner view, show sliding during Cyclone Phet, while the lower right corner view shows the resulting slope face after the final collapse on October 11th 2010. The sliding along the bedding and a vertical joint, a free release plane along the overspilled wadi, is an obvious reason of sliding during cyclone Phet.

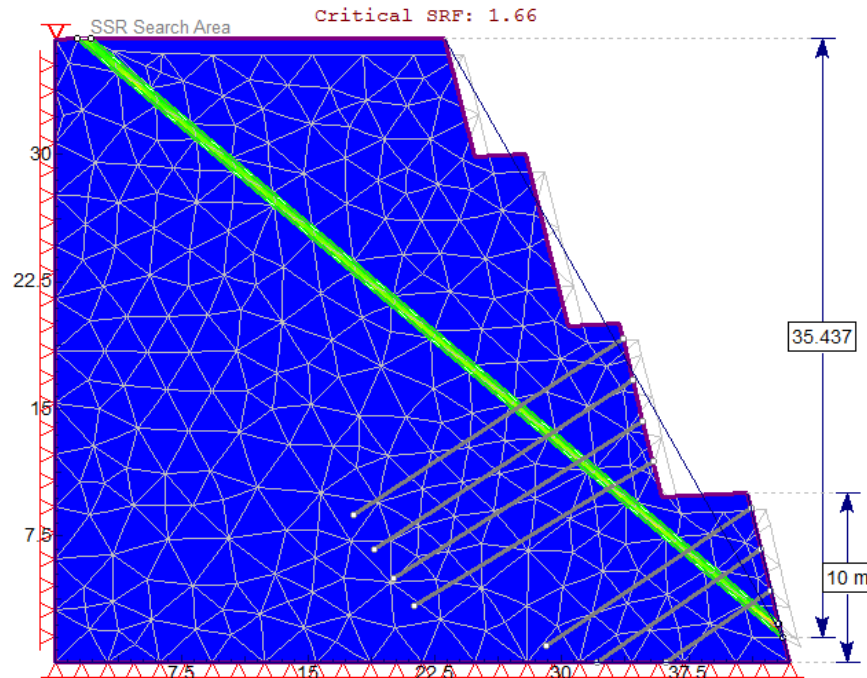
Figure 13. Deformed Mesh for the SRF = 1.72 (in dry conditions) for which no FEA convergence occurred. The critical SRF for which the FEA satisfied the condition of equilibrium with 7 strand anchors of 1200 KN (2.5 x 2.5 m grid) is 1.66 as shown.

After several trials using different applied normal stresses on the failure plane, seven strand anchors of 1200 KN working load at 2.5 x 2.5 m grid (3400 KN/m) for a 35 m high slope were selected. The results of factor of safety using the 1200 KN anchors on the deep sliding planes are presented in Figures 11 to 14 and are summarized in Table 3.
