A High Rock Cut Stabilization in Muscat City, Oman

Reference: Hayat, T.M., Bhatti, T.J. and Goldsmith, R. (2017). *A High Rock Cut Stabilization in Muscat City, Oman*.

International Journal of Geoengineering Case histories, <http://casehistories.geoengineer.org>, Vol.4, Issue 2, p.96-112.

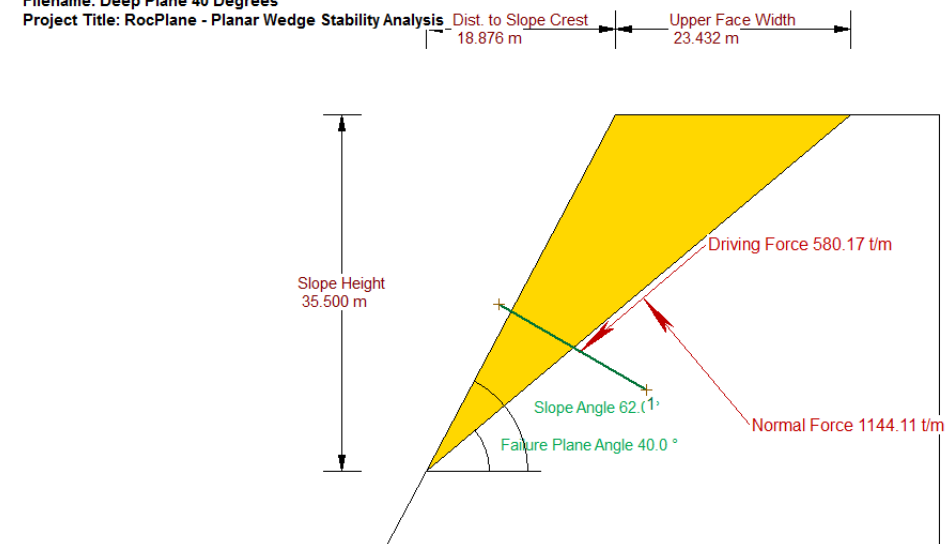
Figure 11. Factor of Safety (FOS) in dry condition with 3360 KN/m external force applied through designed cable anchors.

After several trials using different applied normal stresses on the failure plane, seven strand anchors of 1200 KN working load at 2.5 x 2.5 m grid (3400 KN/m) for a 35 m high slope were selected. The results of factor of safety using the 1200 KN anchors on the deep sliding planes are presented in Figures 11 to 14 and are summarized in Table 3.

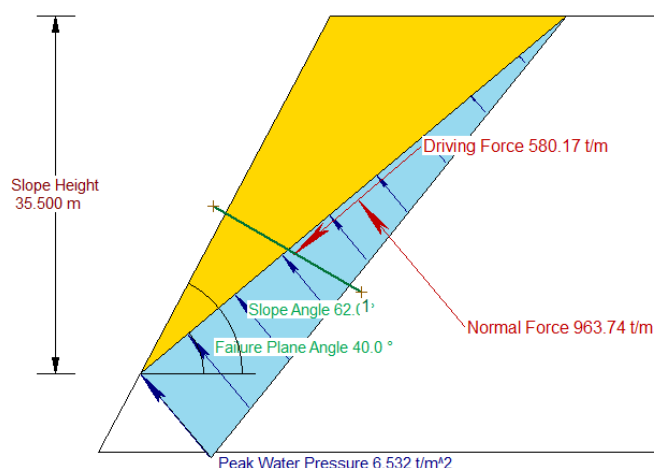
Factor of Safety	1.48
Driving Force	580.17t/m
Resisting Force	856.88t/m
Wedge Weight	1081.37t/m
Wedge Volume	415.91m³/m
Shear Strength	856.88t/m²
Normal Force	963.74t/m
Plane Waviness	0.0°
Active Bolt Force	336.00t
Active Bolt Angle	330.0°
Passive Bolt Force	0.00t
Passive Bolt Angle	0.0°
Water Force on Failure Plane	180.38t/m

Figure 12. Factor of Safety (FOS) in wet condition under 15 m water head and 3360 KN/m external force applied through designed cable anchors.

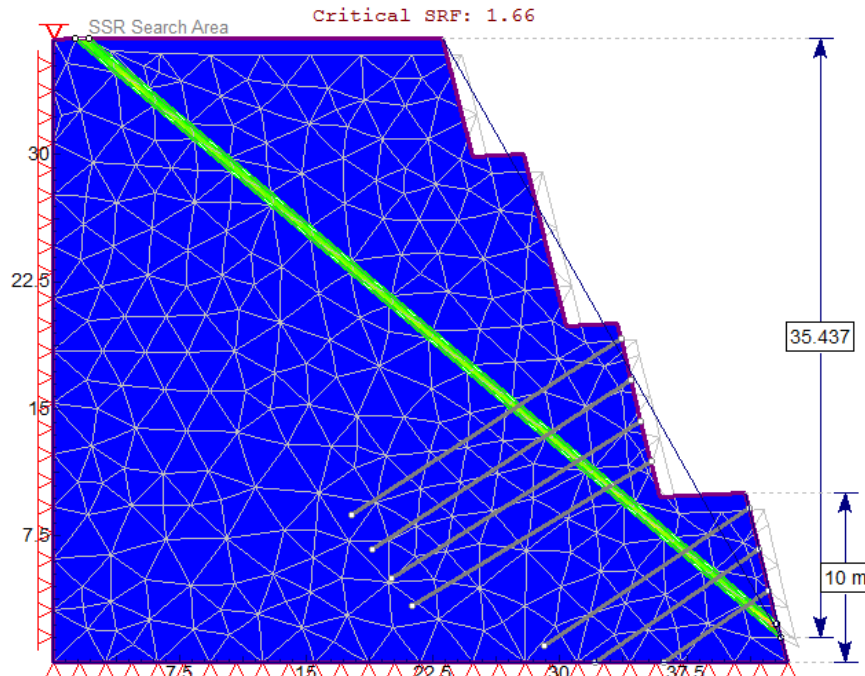
Figure 13. Deformed Mesh for the SRF =1.72 (in dry conditions) for which no FEA convergence occurred. The critical SRF for which the FEA satisfied the condition of equilibrium with 7 strand anchors of 1200 KN (2.5 x 2.5 m grid) is 1.66 as shown.

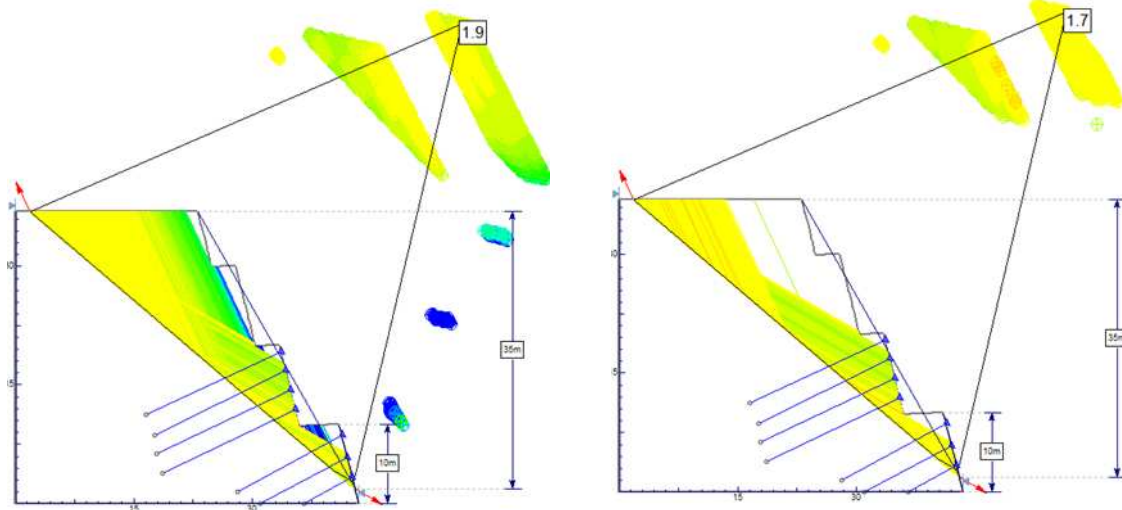
Figure 14. FOS with 7 x 1200 KN anchors in dry condition using Bishop (left) and Morgenstern-Price (right) methods.
