A High Rock Cut Stabilization in Muscat City, Oman

Reference: Hayat, T.M., Bhatti, T.J. and Goldsmith, R. (2017). *A High Rock Cut Stabilization in Muscat City, Oman*.

International Journal of Geoengineering Case histories, <http://casehistories.geoengineer.org>, Vol.4, Issue 2, p.96-112.

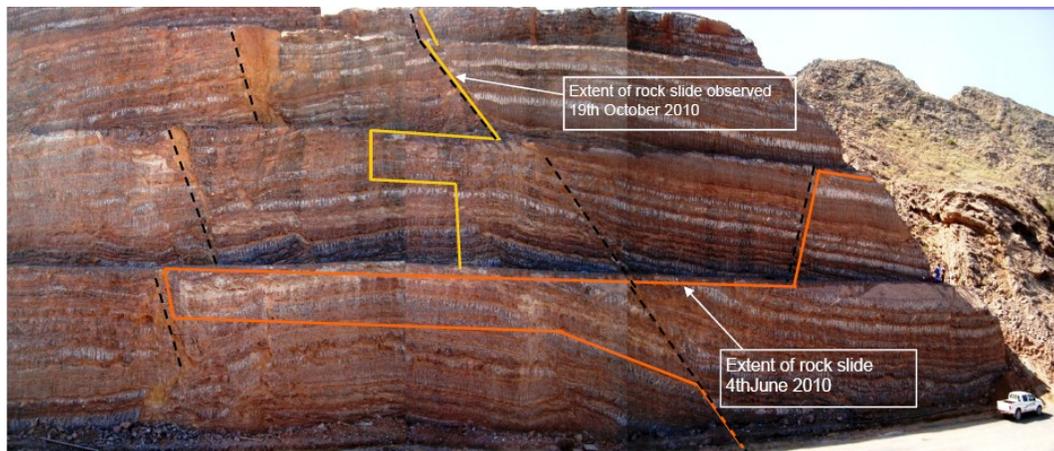
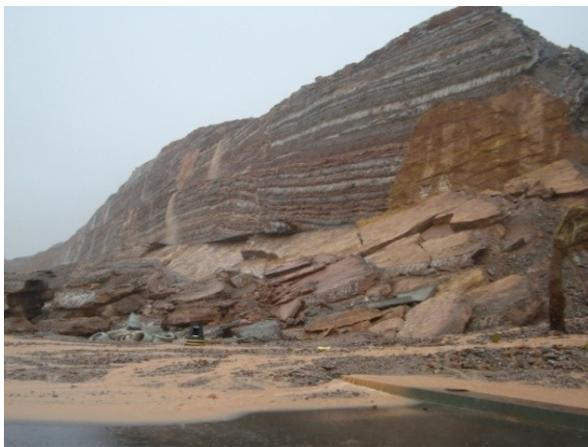
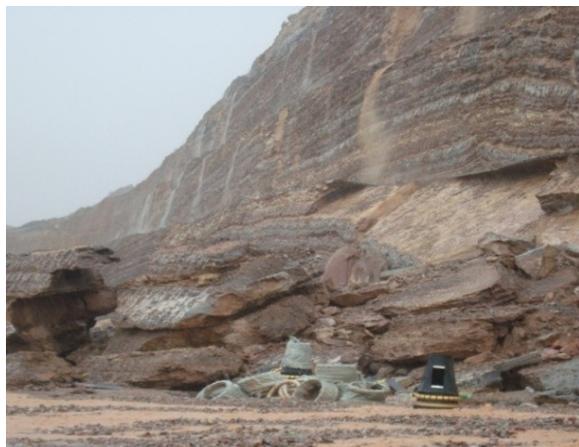
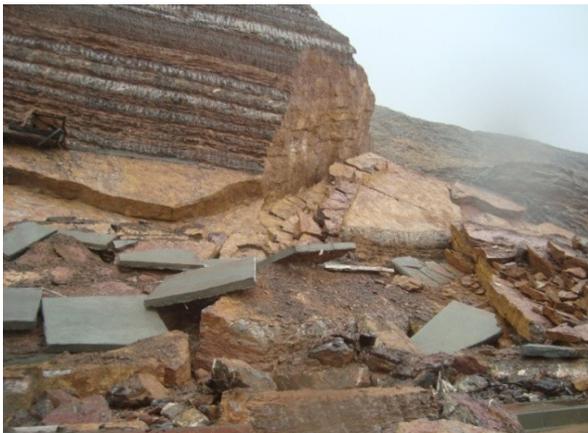
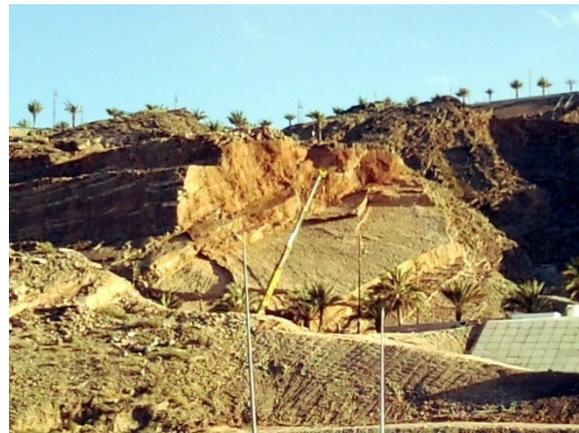
Photographs taken just after the rain storm showed that the failure had occurred initially as a single event. Failure occurred along a 40° dipping bed in the lowest slope, which extended to the inner edge of the first berm and a near vertical joint forming the release plane. The photographs taken at that time also showed a large amount of water transported debris coming out from the above mentioned wadi adjacent to the failed area. Water was also noticed cascading over the crest of the main rock cut.

With the passage of time, the extent of the initial failure grew in size as more and more rock mass adjacent to the initial failure area failed progressively. Within a couple of weeks of the initial event, the failure grew to the top of the 35 m high cut, extending about 20 m along the crest and reaching as far as a steep joint with a strike of about 260° (N100 deg W), and dip of more than 70°. The total volume of failure was estimated at 800 m³ (Figure 4).

From site observations, it was concluded that the failure initiated along a laminated bed of argillaceous rock layers, which had the least shearing resistance of all the rock mass at the site. The failure undermined the slopes above it and caused their failure, which progressed in the weeks ahead of the initial event.

The main triggering factor was the increase in water pressure associated with the rainfall event. The Box Cut # 1 slope at the farthest end was exposed to weather on three sides; the front cut face, the edge face and behind in the wadi (valley). It is likely that the water in the wadi overflowed and infiltrated the loose jointed and bedded rock mass. It is also likely that the small solution channels formed conduits for water that entered the formation, contributing to the failure. Although the rock mass appeared visibly stable in the area after a few weeks, there were other bedding / joints in the area that could cause further instability in the future, especially under wet conditions.

Figure 4. Top photo provides an overall view of the slope face prior to sliding and the extent of two episodes of sliding on June 4th and October 11th 2010. The lower frames, except the lower right corner view, show sliding during Cyclone Phet, while the lower right corner view shows the resulting slope face after the final collapse on October 11th 2010. The sliding along the bedding and a vertical joint, a free release plane along the overspilled wadi, is an obvious reason of sliding during cyclone Phet.

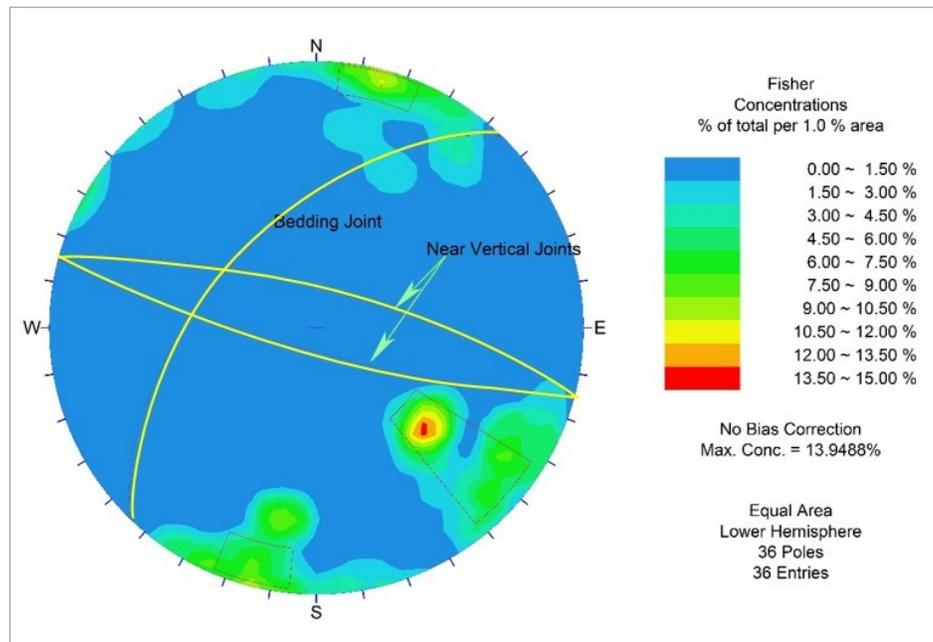
In Box Cut #1, from approximately RD 0+220 to 0+500 m, the interlayering of the beds is quite prominent and dips at 30° to 45° daylighting out of the face and within +/- 20° of the face orientation. In addition to the bedding, there are joints and faults that are steeply dipping at 70° to 90° and strike NE-SW or SSW. These joints have high persistence over all cut benches to the full 40 m height. Some of these features are faulted with noticeable displacements. Figure 5 shows the pole plot of the joints and great circles drawn through the centre of poles concentration by visual examination.

Figure 5. Stereoplot of the discontinuities representing the left slope in Box Cut 1.

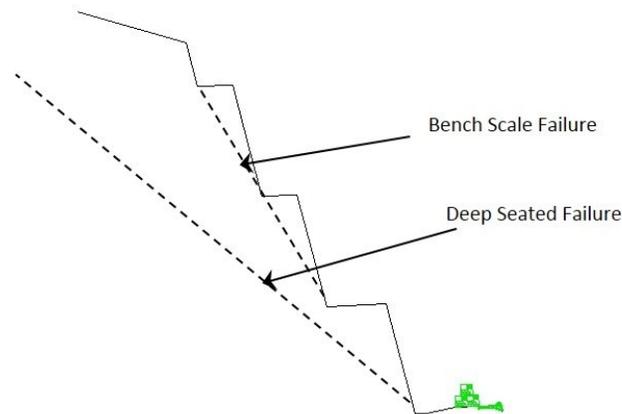
The orientation of bedding planes along various berms showed appreciable variation in the dip inclination. However, previous failures and site observations led to the conclusion that the most likely inclination of the failure plane was 40° . Also smaller scale failures involving one or two benches and larger global scale failures with deep seated planes were both possible. Based on the above, the following expected failure planes were considered in the re-assessment of slope stability:

Figure 8. Illustration of relatively small scale and multiple bench (deep) failures planes assumed in stability analysis of Left Face Slope at Km 0+400 m.

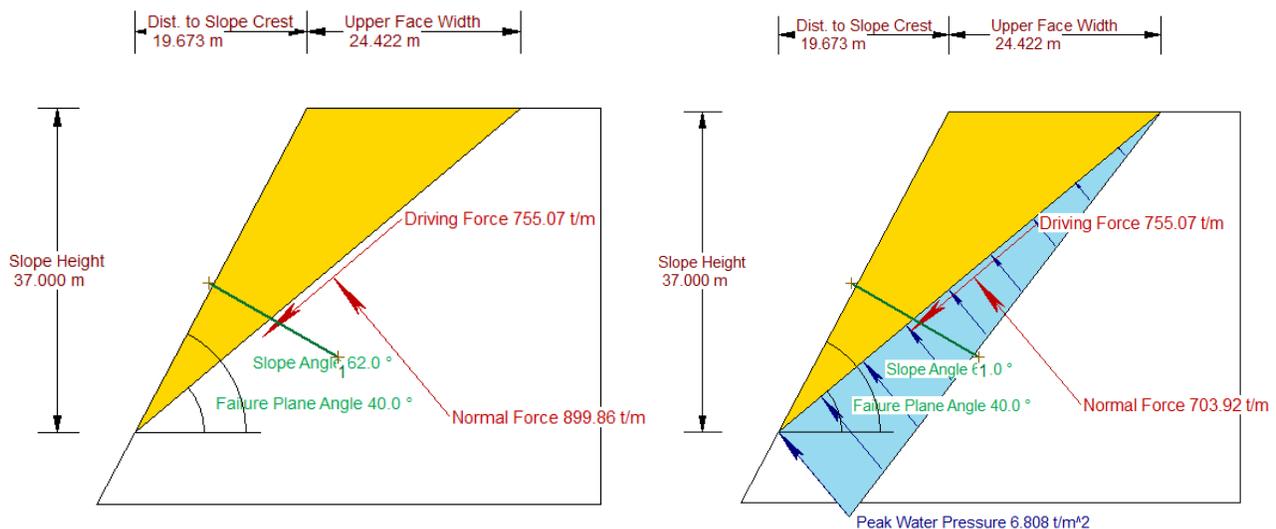
Figure 9. The driving and resisting forces against the calculated FOS 1.12 and 1.01 for dry and wet slope (15 m water head) respectively.

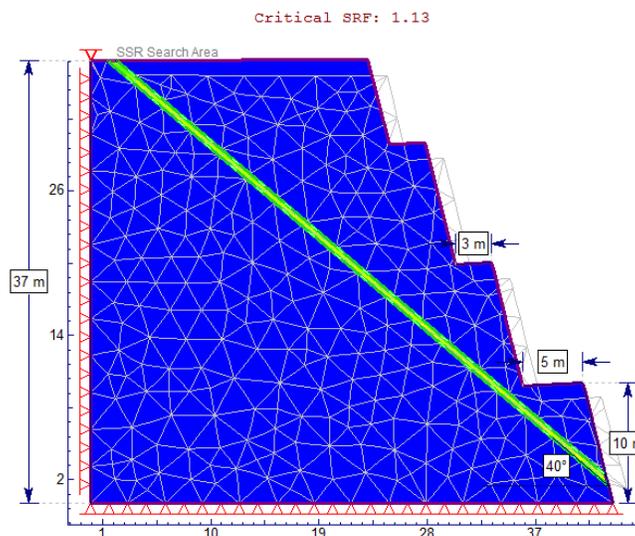
Figure 10. Deformed mesh for the $SRF = 1.2$ (in dry conditions) for which no FEA convergence occurs. The maximum SRF for which the FEA satisfies the state of equilibrium is 1.13.

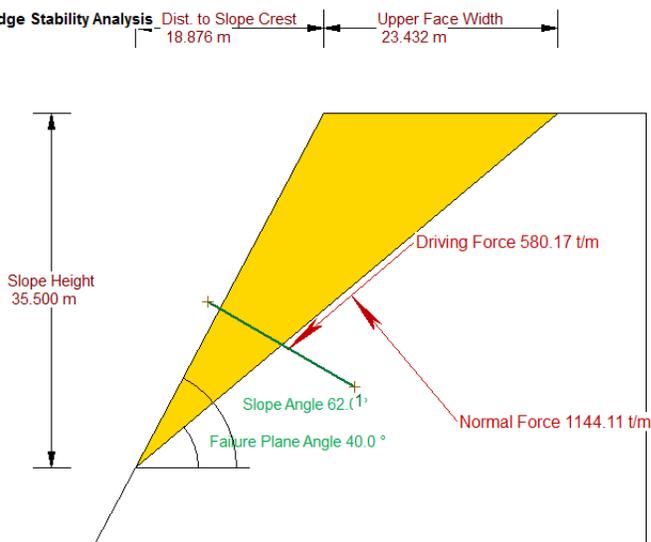
Factor of Safety	1.61
Driving Force	580.17t/m
Resisting Force	934.56t/m
Wedge Weight	1081.37t/m
Wedge Volume	415.91m ³ /m
Shear Strength	934.56t/m ²
Normal Force	1144.11t/m
Plane Waviness	0.0°
Active Bolt Force	336.00t
Active Bolt Angle	330.0°
Passive Bolt Force	0.00t
Passive Bolt Angle	0.0°

Figure 11. Factor of Safety (FOS) in dry condition with 3360 KN/m external force applied through designed cable anchors.

After several trials using different applied normal stresses on the failure plane, seven strand anchors of 1200 KN working load at 2.5 x 2.5 m grid (3400 KN/m) for a 35 m high slope were selected. The results of factor of safety using the 1200 KN anchors on the deep sliding planes are presented in Figures 11 to 14 and are summarized in Table 3.

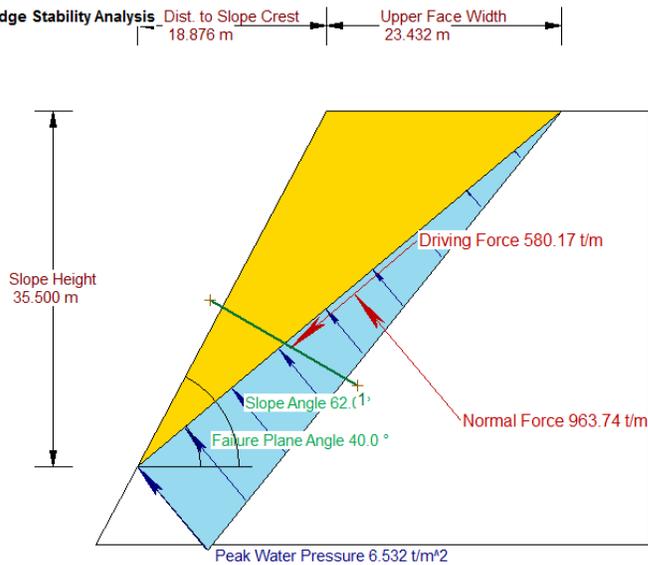
Factor of Safety	1.48
Driving Force	580.17t/m
Resisting Force	856.88t/m
Wedge Weight	1081.37t/m
Wedge Volume	415.91m ³ /m
Shear Strength	856.88t/m ²
Normal Force	963.74t/m
Plane Waviness	0.0°
Active Bolt Force	336.00t
Active Bolt Angle	330.0°
Passive Bolt Force	0.00t
Passive Bolt Angle	0.0°
Water Force on Failure Plane	180.38t/m

Figure 12. Factor of Safety (FOS) in wet condition under 15 m water head and 3360 KN/m external force applied through designed cable anchors.

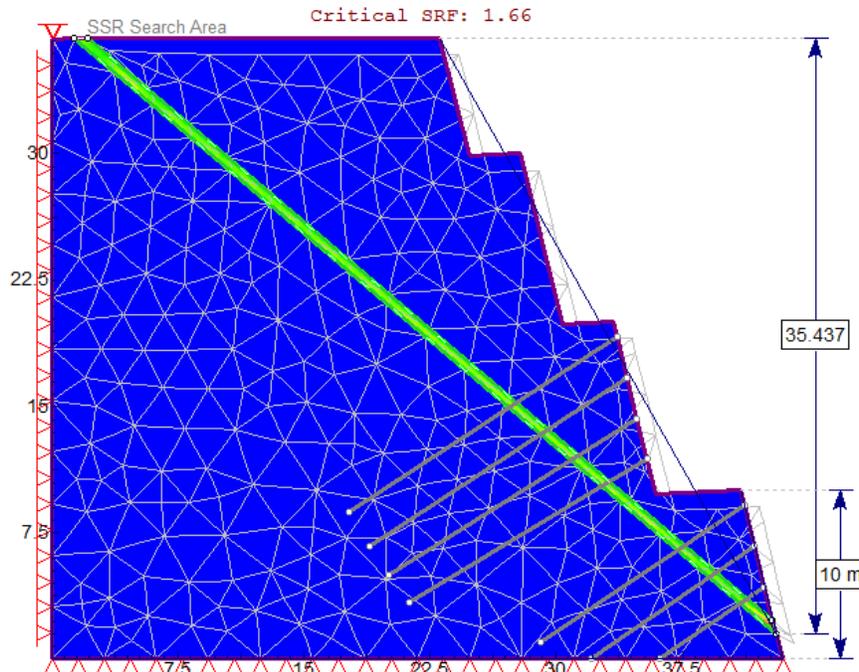
Figure 13. Deformed Mesh for the SRF =1.72 (in dry conditions) for which no FEA convergence occurred. The critical SRF for which the FEA satisfied the condition of equilibrium with 7 strand anchors of 1200 KN (2.5 x 2.5 m grid) is 1.66 as shown.

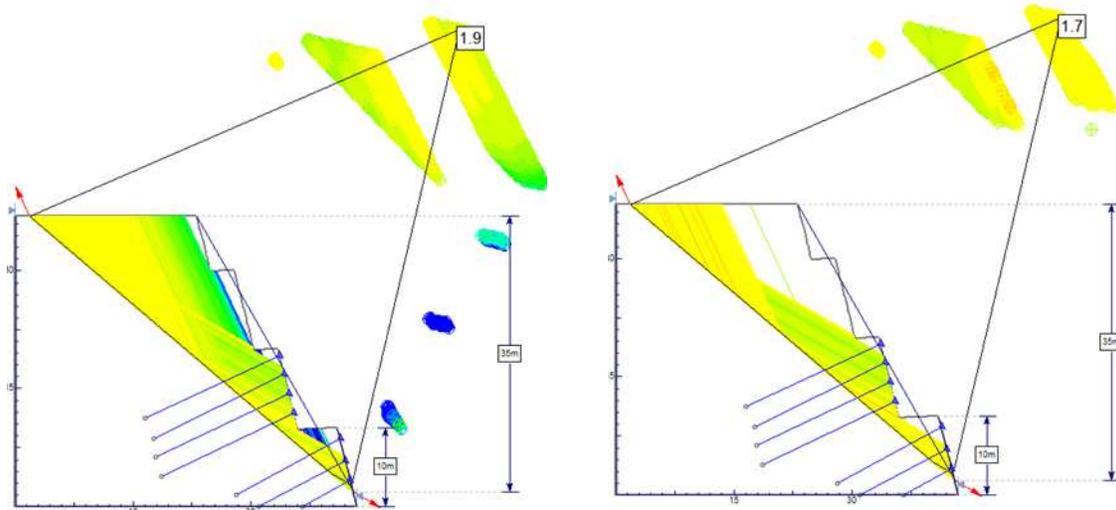
Figure 14. FOS with 7 x 1200 KN anchors in dry condition using Bishop (left) and Morgenstern-Price (right) methods.

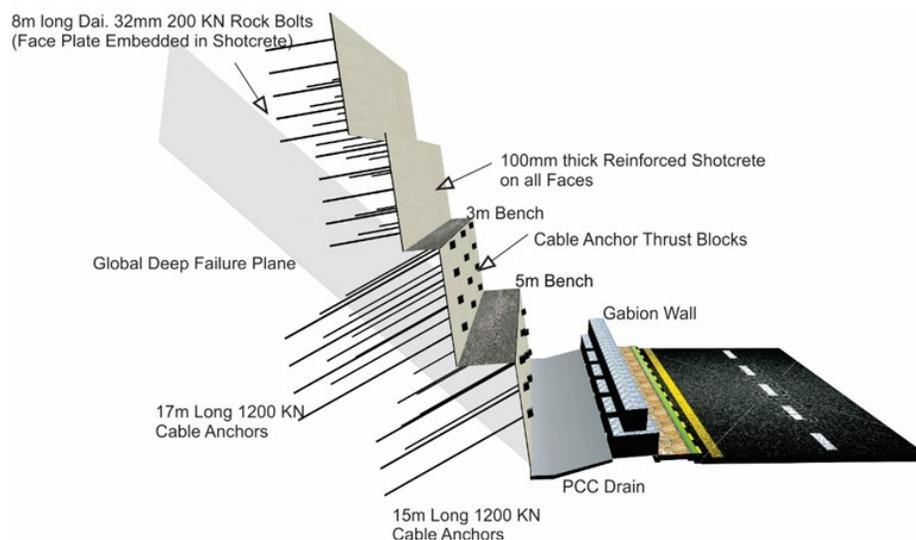
Figure 15. 3D Conceptual arrangement of reinforcing elements at both the 20 m terminus of 500 m long left slope of Box Cut #1.

It was therefore concluded that the ends of box cut #1 were most vulnerable as at these locations large and deep seated failures were kinematically possible, whereas in the middle of these slopes, only shallower failures would be possible, the unstable wedges being confined at both ends. It was therefore decided to reinforce only the terminus of the 500 m long vulnerable slope with 1200 KN cable anchors. Other intermediate and cut faces above the cable anchored slopes were, however, reinforced with 200 KN rock bolts to control the comparatively smaller scale failures. The rock bolt heads were tensioned on steel plates resting on epoxy cement base. For long term durability, the steel plates were embedded in the shotcrete. The anchor heads of high capacity cable anchors were installed on specially constructed reinforced concrete anchor blocks. A typical arrangement of the reinforcement pattern at cut slope ends is shown in Figure 15.

The arrangement of stabilization measures shown in Fig. 15 were implemented and are performing satisfactorily for the last six years.
