Geotechnical Damage Caused by the 2016 Kumamoto Earthquake, Japan

ABSTRACT: On the 16^{th} of April 2016, the Kumamoto earthquake $(M_w 7.0)$ hit the Central Kyushu Region, Japan, following a M_w 6.2 shock on the 14th of April. The earthquake sequences caused severe damage in Kumamoto Prefecture. This paper presents quick reconnaissance results focusing on geotechnical damage features, which were observed during field investigations immediately after, one, and two weeks after the main shock. The damage surveys were carried out in southern Kumamoto City, Mashiki Town, Aso Caldera area and their suburbs. In southern Kumamoto City, evidence of liquefaction was found at many locations, and some buildings and river levees suffered from significant settlement and deformation; damage to an embankment of Kyushu Highway also seemed to be the result of liquefaction. The majority of the damaged residential houses were found in Mashiki Town and its suburbs, which may be linked to intense earthquake motions associated with the seismic fault location. In Aso Caldera area, a number of moderate to large scale landslides and their significant impact to structures were observed. The greater part of

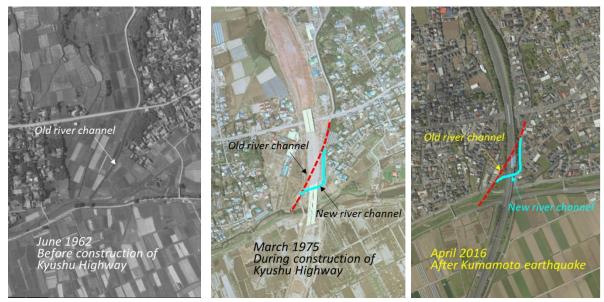
At site 6 in Fig. 3, a 50 m-long embankment on one side of Kyushu Highway, which connects Fukuoka to Kagoshima, suffered from significant damage (Fig. 10). The damage was caused by the earthquake on the 14th of April, in the form of subsidence and lateral flow. The highway was closed to traffic until the end of April, which disrupted emergency distributions in the affected areas. According to the land classification map (Fig. 7) and old aerial photos taken before the construction of the highway provided by GSI (2016) (Fig. 11), the exact location of the damaged embankment use to be a small river channel, which suggest that the process of liquefaction of saturated loose filled soil was the potential cause of damage to the embankment. In fact, the residential house near the damaged embankment suffered from large tilting as shown in Figure 10, indicating a bearing capacity lowering of foundation ground due to liquefaction.

Figure 11. Aerial photo of damaged highway embankment before and after the 2016 Kumamoto earthquake (Modified from GSI aerial photo).

Since the other side of the embankment survived the earthquake, as an emergency response, the number of driving lanes at the damaged embankment was temporary reduced to one in each direction, and only the one-lane reopened from the 29th of April. Due to the critical importance of the Kyushu Highway, however, careful investigation shall be conducted to thoroughly understand the cause of the damage observed and to propose effective countermeasures for the conclusive restoration of the embankment.

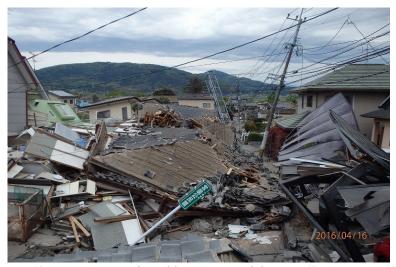
There were numerous building collapses in Mashiki Town. Fig. 13 shows the typical damage to the residential houses in the yellow-colored area in Fig. 12 (site 7). The residents in the affected area reported that a number of houses suffered from moderate to significant structural damage due to the earthquake on the 14th of April and then totally destroyed by the main shock on the 16th. It is also reported that the number of deaths in this area was fewer than expected from the damage shown in Fig. 13 because many affected residents had already fled their damaged house after the earthquake of the 14th (Fukuwa, 2016).

Figure 13. Damage to residential houses in Mashiki Town (Site 7 in Fig. 12) $(32^{\circ}47'16.38"N, 130^{\circ}48'58.47"E)$.

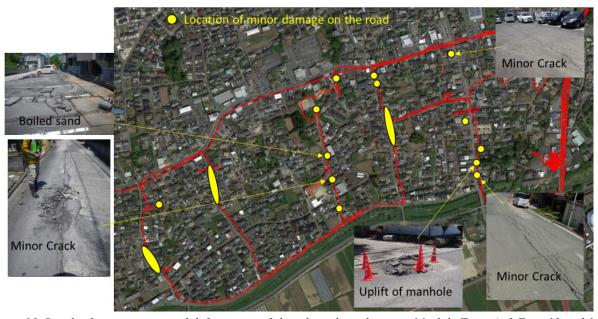
Figure 15 shows the result of the authors' quick survey. The spatial distribution of the collapsed houses was concentrated in the sloped area which consists of terrace and talus deposits, whereas ground deformation observed on the roads near the damaged houses was limited, therefore a large scale landslide might not have occurred. The cause of significant damage to the houses in this area was likely due to earthquake motion and the residual displacement of the entire sloped ground had an insignificant effect on the damaged houses. Although some houses were found to be damaged by ground deformation, as shown in Fig. 16 and 17 (sites 8 and 9), they were likely caused by localized failure of filled soil. On the other hand, the damage to the houses in the alluvial deposit area was limited whereas evidence of liquefaction was found frequently as shown in Fig. 15. It is inferred that the liquefied soil incidentally behaved like a seismic isolation system for the residential houses in this area.

Figure 15. Result of survey on ground deformation of sloped residential area in Mashiki Town (c.f. Figs. 12 and 14).

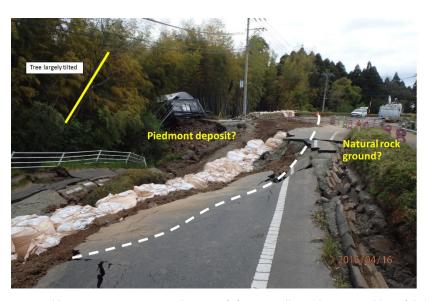
A section of Route 443 at site 10 in Fig. 12 was damaged by the earthquake on the 14th of April. The road on the left side in Fig. 18 failed and subsided by a maximum of about 2.0-2.5 m. The photo also shows the significantly tilted trees at the middle portion of the sliding mass. At the time of the survey on the 16th of April, two days after the occurrence of failure, large soil bags were placed on the exposed failure surface to prevent further damage. According to the landform classification map shown in Fig. 14, the failure was likely to have occurred in the talus deposit and the perimeter of the failure is likely to be the boundary between talus deposit and late Pleistocene volcanic rock.

Figure 18. Damage to Route 443 in Mashiki Town (Site 10 in Figs. 12 and 14) $(32^{\circ} 47'29.71"N, 130^{\circ} 49'17.58"E)$.

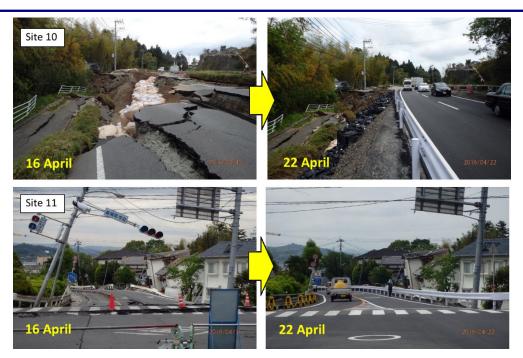
Approximately 150 m south of the above damaged site a differential settlement was observed (Photo 12b, site 11). According to the landform classification map in Fig. 14, it is indicated that the damaged site was recently constructed on the alluvial soil deposit. The damage, therefore, is attributed to strength reduction of foundation ground due to a process of liquefaction and/or that of the embankment, if the compaction work was inadequate. Immediately after the earthquake, emergency restoration work was rapidly conducted in the affected areas. As shown in Fig. 19, the restoration work for the damaged sites along Route 443 was completed a few days after the main shock.

Figure 19. Damages to Route 443 and their restoration for (a) site 10 and (b) site 11 (c.f. Figs. 12 and 14) (Site 10: 32° 47'29.71"N, 130° 49'17.58"E, Site 11: 32° 47'24.33"N, 130° 49'15.82"E).

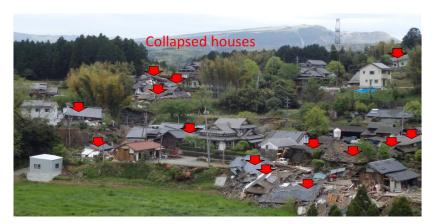
A number of residential houses along road No. 28 suffered from significant damage. As shown in Fig. 23, high collapse ratio of houses can be seen in the small village (site 15). In addition, modern bridges and a tunnel along road No. 28 suffered from serious damage. The girder of Ohkirihata Bridge moved about 1-1.5m and fell off its rubber bearings (Fig. 24, site 14). About 4 km north-east of Ohkirihata Bridge, Tawarayama tunnel suffered from a compressive axial failure and falling of lining concrete about 250 m from the tunnel portal (Fig. 25, site 16). The cause of compression of the tunnel was thought to be a surface fault movement in right lateral component, which was confirmed at the damaged location (Shirahama et al., 2016; Yoshimi, 2016). More information about the structural damages along road No. 28 due to the earthquake is reported in a separate report (Ikeda, et al., 2016).

Figure 23. Damage to residential houses in Ohkirihata area (site 15 in Fig. 12) (32°50'36.91"N, 130°55'43.16"E).

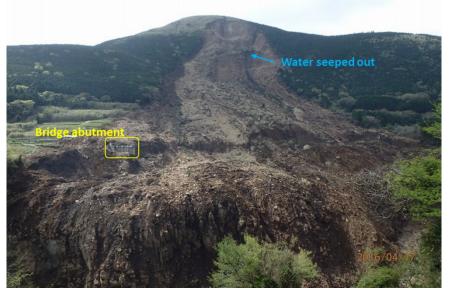
Figure 28 shows a shallow landslide near Aso Ohashi Bridge caused by the main shock on the 16th of April (site 17). The landslide had a height of about 300 m (measured from the road level to the scrap) with an inclination angle of about 50 degrees at the top and about 25 degrees at the middle and bottom of the slope. The debris was a mixture of middle Pleistocene volcanic soils and boulders (tuff breccia); Route 57 and JR Hohi Main Line (railway) was also covered by it. The debris travelled a distance exceeding 800 m and fell into the Kurokawa-River along with Aso Ohashi Bridge. Evidence of mud debris was found on the opposite side of the river which is thought to have travelled along the bridge before its collapse. For this reason, the cause of bridge failure is considered to be the impact force and/or weight of debris that flowed down from the landslide source. Moreover, in Figure 28, taken one day after the event, water seeped out from the failed surface, which may explain the reduction of shear strength of the slope ground due to increase in excess pore water pressure during the intense earthquake.

Figure 28. Landslide near Aso Ohashi Bridge (site 17 in Fig. 26). $(32^{\circ}53'0.02"N, 130^{\circ}59'22.80"E)$.

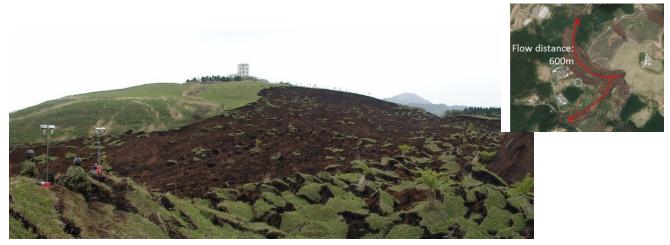
At site 18 in Fig. 26, a large scale landslide occurred at a volcanic hill (late Pleistocene) with a height in excess of 80 m from its base. The failure occurred on a relatively gentle slope with an angle of less than 10 degrees. The sliding of the slope towards the toe, however, was remarkable as shown in Figure 29. This failure killed five people who were in the house at the middle of the slope. A few hundred meters south of the above landslide another landslide occurred and caused severe damage to the residential houses as shown in Figure 30 (site 19). The length of the landslide was 70 m with an inclination angle of about 10 degrees. As the Kumamoto earthquake is an inland earthquake which caused severe damage in the mountain area, it is often compared with the 2004 Chetsu earthquake (M_w 6.6) which hit Niigata Prefecture, Japan, and caused a number of landslides (Toyota et al., 2006). Slope failures triggered by the Chuetsu earthquake occurred at a sedimentary rock interface, and the slope angle before the failure was about 20 degrees on average (Yamasaki, 2008), which is much steeper than the cases in the Aso mountain area in the Kumamoto earthquake. The debris of the landslides in Aso Caldera area was a mixture of volcanic ash, andsol, a highly porous dark-colored material comprising of volcanic ash mixed with organic matter, and pumice. As shown in Figure 30, alternating layers were seen at the surface of the scrap. The cause of failure and long-distance flow at the gentle slope is not identified yet, however, since the natural deposited pumice is known to have high crushability, the soil may have experienced significant strength reduction associated with particle breakage during the earthquake.

Figure 29. Large scale landslide in Aso Caldera area (site 18 in Fig. 26) (32° 53'5.47"N, 131° 00'10.56"E).

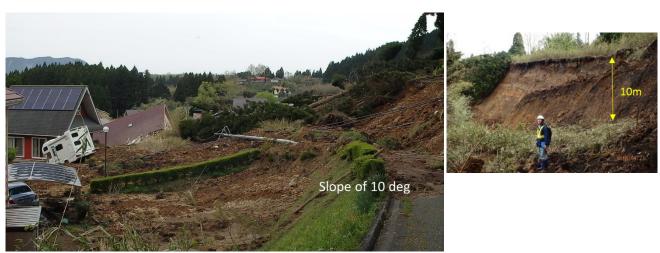
Figure 30. Landslide at gentle slope and its scrap (site 19 in Fig. 26) ($32^{\circ}52'29.42''N$, $131^{\circ}00'49.36''E$).

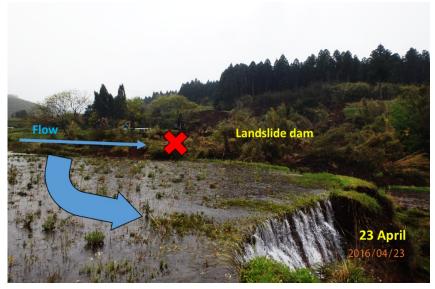
A slope failure was observed at site 20 in Fig. 26; the length of the failure was about 100 m. The debris blocked the road and a tributary of the Kurokawa River completely; the blocked tributary overflowed with water spreading into the surrounding paddy field (Figure 31). To avoid the potential risk of flooding to the downstream villages following the landslide dam breaching, the relevant authority had excavated a spillway to secure the safety of the dam. The excavation was likely finished within two weeks of the event.

Figure 31. Landslide dam formed by the earthquake and excavation work completed (site 20 in Fig. 26) $(32^{\circ}53'14.06"N, 130^{\circ}59'48.90"E)$.

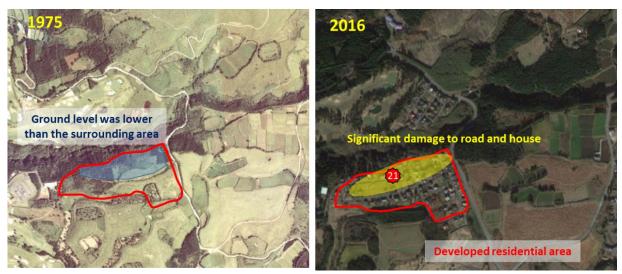
Figure 32 and 33 show damage of the road and house at site 21. Although this area reportedly survived the earthquake on the 14th of April, significant distortion of subsurface ground occurred during the main shock on the 16th of April. The spatial distribution of damage was severe at the northern part of the residential area. Figure 34 shows a comparison of aerial photos taken in 1975 and in 2016 (GSI, 2016), indicating that the damaged area use to be a paddy field but had subsequently been infilled during the construction of the housing estate. The filled soil in the damaged area is a local volcanic ash soil. Tanoue et al. (2005) reported that it is usually hard to construct a stable embankment from the ash deposited in the Central Kyushu area. It seems from Fig. 34 that the ground level of the northern part of the residential area was comparatively low in 1975, the filled soil might have been thicker for the northern side than the southern side. This might be why the earthquake-induced damage to the land was found to be severe in the northern side, however, structural damage to the residential houses in this area was negligible despite large ground deformation.

Figure 34. Aerial photo of damaged residential area in 1975 and after the 2016 Kumamoto earthquake (Modified from aerial photo of GSI, 2016).

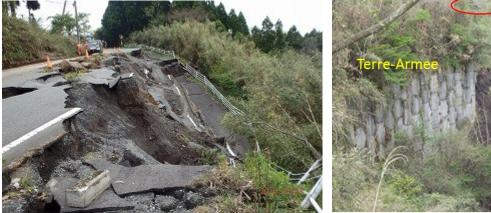
A 50 m-long embankment on prefectural road No. 149 (site 22 in Fig. 26) suffered from damage in the form of slope failure. Ground fissures and road pavement damage were also found there. This embankment (about 10-15 m high) was constructed along the small river by using a reinforced soil retaining wall technique (Terre-Armee), the wall was also damaged significantly as shown in Figure 35. Steel strip materials pulled out from the backfill soil were found on the failed slope surface. The reason for the failure of the reinforced soil retaining wall is not yet identified.

Figure 35. Damage to road embankment and reinforced retaining wall (Terre-Armee) (site 22 in Fig. 26) $(32^{\circ} 52'52.01"N, 131^{\circ} 00'14.84"E)$.

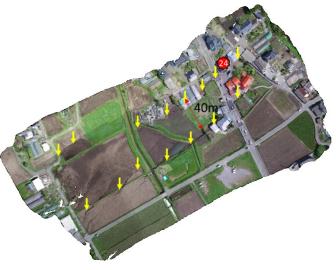
A trough-like depression was found at several locations in the basin of Aso Caldera. According to both the authors' site investigation and aerial photointerpretation of cracks on ground surface provided by the GSI (2016) and Kokusai Kogyo co. ltd (2016), the trough-like depression, with a maximum depth of about 1-1.5 m, was found to stretch several kilometers in length, the width of the depression was several tens of meters. At site 23, the ground depression caused damage to a residential house (Fig. 36). The damage due to the depression has also been harmful to agriculture in this area (Figure 37). The mechanism of the depression, however, is not yet identified. The residents in the affected area reported that the depression occurred immediately when the main shock occurred on the 16th of April. The fact indicates that the cause of the depression was probably not liquefaction. Refer to a separate report by Konagai et al. (2016) for further information about this feature.

Figure 37. Digital image obtained by UAV around the trough-like depression area (c.f. Fig. 26).
