Geotechnical Damage Caused by the 2016 Kumamoto Earthquake, Japan

ABSTRACT: On the 16th of April 2016, the Kumamoto earthquake (M_w 7.0) hit the Central Kyushu Region, Japan, following a M_w 6.2 shock on the 14th of April. The earthquake sequences caused severe damage in Kumamoto Prefecture. This paper presents quick reconnaissance results focusing on geotechnical damage features, which were observed during field investigations immediately after, one, and two weeks after the main shock. The damage surveys were carried out in southern Kumamoto City, Mashiki Town, Aso Caldera area and their suburbs. In southern Kumamoto City, evidence of liquefaction was found at many locations, and some buildings and river levees suffered from significant settlement and deformation; damage to an embankment of Kyushu Highway also seemed to be the result of liquefaction. The majority of the damaged residential houses were found in Mashiki Town and its suburbs, which may be linked to intense earthquake motions associated with the seismic fault location. In Aso Caldera area, a number of moderate to large scale landslides and their significant impact to structures were observed. The greater part of land

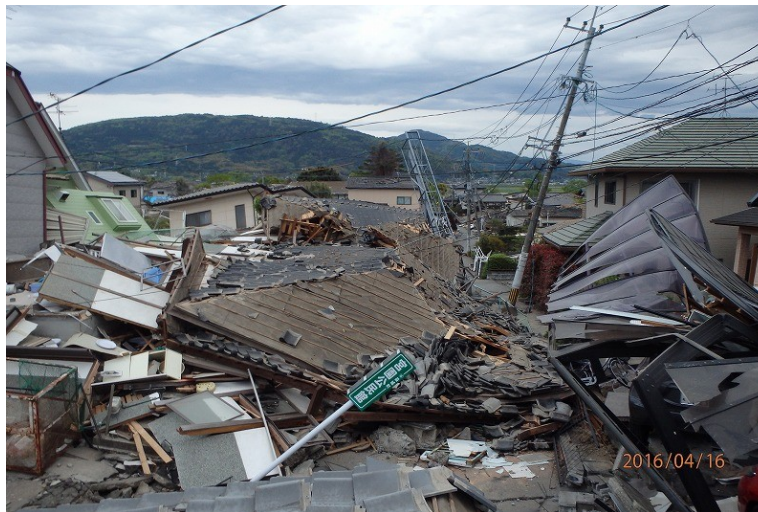
There were numerous building collapses in Mashiki Town. Fig. 13 shows the typical damage to the residential houses in the yellow-colored area in Fig. 12 (site 7). The residents in the affected area reported that a number of houses suffered from moderate to significant structural damage due to the earthquake on the 14th of April and then totally destroyed by the main shock on the 16th. It is also reported that the number of deaths in this area was fewer than expected from the damage shown in Fig. 13 because many affected residents had already fled their damaged house after the earthquake of the 14th (Fukuwa, 2016).

Figure 13. Damage to residential houses in Mashiki Town (Site 7 in Fig. 12)
($32^{\circ} 47'16.38''N$, $130^{\circ} 48'58.47''E$).

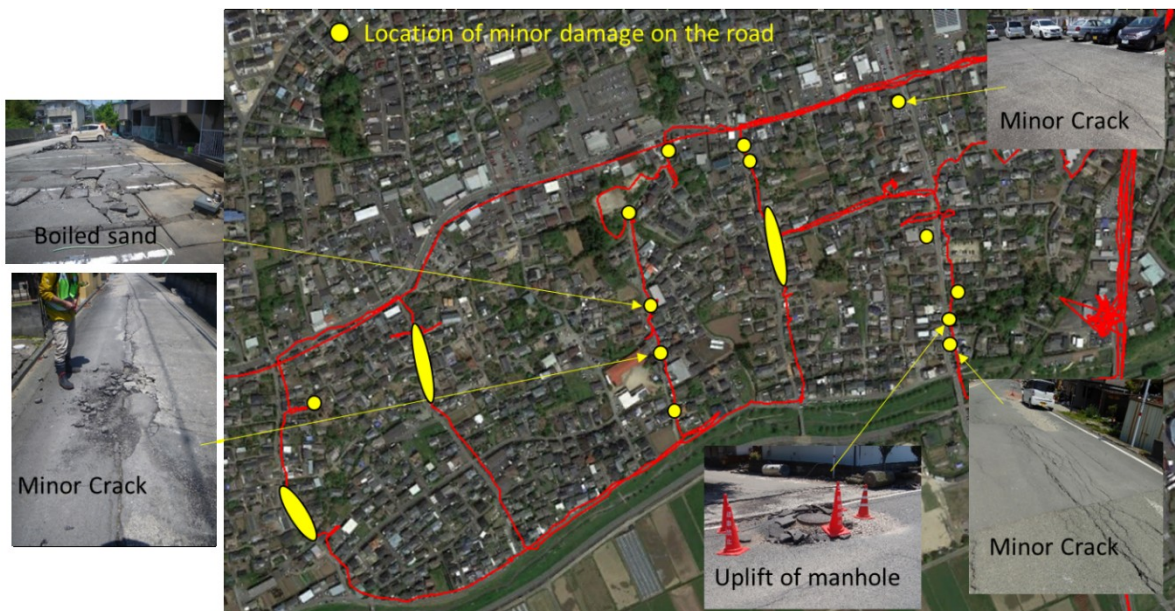
Figure 15 shows the result of the authors' quick survey. The spatial distribution of the collapsed houses was concentrated in the sloped area which consists of terrace and talus deposits, whereas ground deformation observed on the roads near the damaged houses was limited, therefore a large scale landslide might not have occurred. The cause of significant damage to the houses in this area was likely due to earthquake motion and the residual displacement of the entire sloped ground had an insignificant effect on the damaged houses. Although some houses were found to be damaged by ground deformation, as shown in Fig. 16 and 17 (sites 8 and 9), they were likely caused by localized failure of filled soil. On the other hand, the damage to the houses in the alluvial deposit area was limited whereas evidence of liquefaction was found frequently as shown in Fig. 15. It is inferred that the liquefied soil incidentally behaved like a seismic isolation system for the residential houses in this area.

Figure 15. Result of survey on ground deformation of sloped residential area in Mashiki Town (c.f. Figs. 12 and 14).

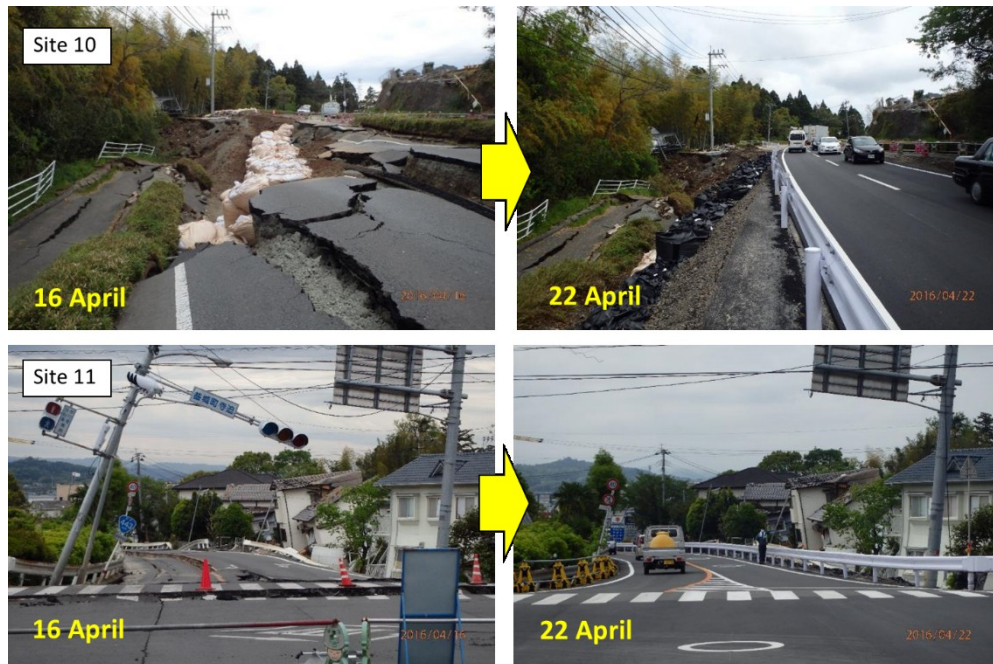
Approximately 150 m south of the above damaged site a differential settlement was observed (Photo 12b, site 11). According to the landform classification map in Fig. 14, it is indicated that the damaged site was recently constructed on the alluvial soil deposit. The damage, therefore, is attributed to strength reduction of foundation ground due to a process of liquefaction and/or that of the embankment, if the compaction work was inadequate. Immediately after the earthquake, emergency restoration work was rapidly conducted in the affected areas. As shown in Fig. 19, the restoration work for the damaged sites along Route 443 was completed a few days after the main shock.

Figure 19. Damages to Route 443 and their restoration for (a) site 10 and (b) site 11 (c.f. Figs. 12 and 14) (Site 10: $32^{\circ}47'29.71''N$, $130^{\circ}49'17.58''E$, Site 11: $32^{\circ}47'24.33''N$, $130^{\circ}49'15.82''E$).

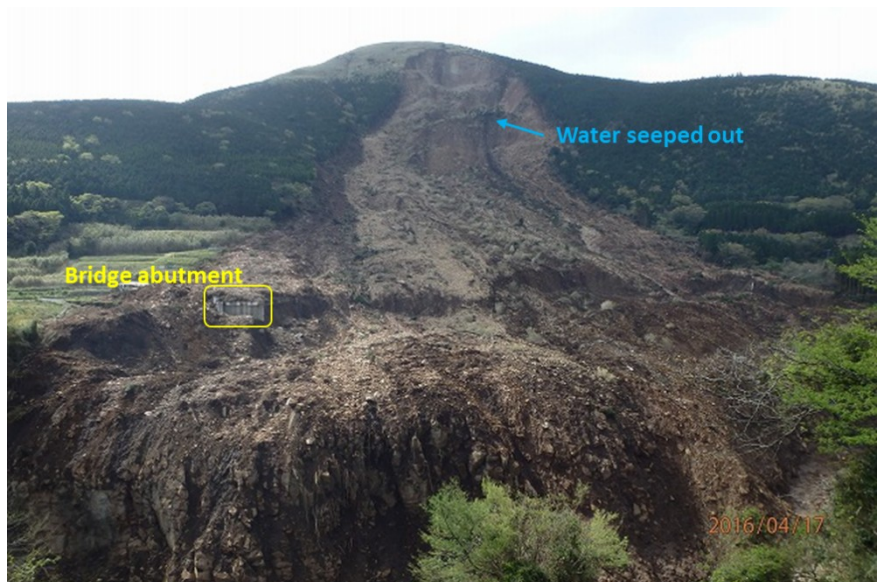
Figure 28 shows a shallow landslide near Aso Ohashi Bridge caused by the main shock on the 16th of April (site 17). The landslide had a height of about 300 m (measured from the road level to the scrap) with an inclination angle of about 50 degrees at the top and about 25 degrees at the middle and bottom of the slope. The debris was a mixture of middle Pleistocene volcanic soils and boulders (tuff breccia); Route 57 and JR Hohi Main Line (railway) was also covered by it. The debris travelled a distance exceeding 800 m and fell into the Kurokawa-River along with Aso Ohashi Bridge. Evidence of mud debris was found on the opposite side of the river which is thought to have travelled along the bridge before its collapse. For this reason, the cause of bridge failure is considered to be the impact force and/or weight of debris that flowed down from the landslide source. Moreover, in Figure 28, taken one day after the event, water seeped out from the failed surface, which may explain the reduction of shear strength of the slope ground due to increase in excess pore water pressure during the intense earthquake.

Figure 28. Landslide near Aso Ohashi Bridge (site 17 in Fig. 26).
(32° 53'0.02"N, 130° 59'22.80"E).

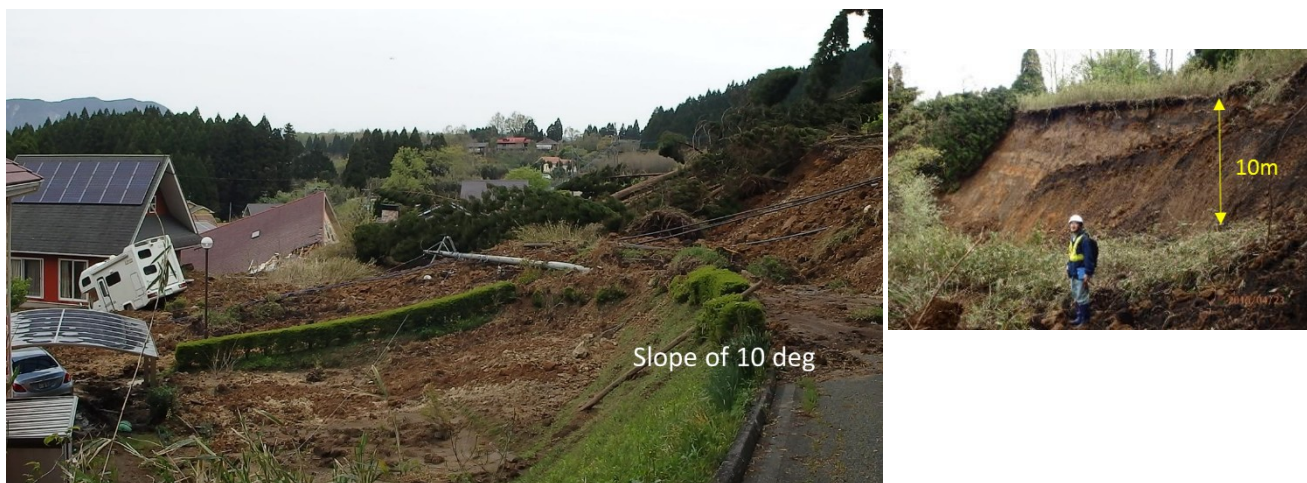
Figure 30. Landslide at gentle slope and its scrap (site 19 in Fig. 26) ($32^{\circ} 52'29.42''N$, $131^{\circ} 00'49.36''E$).

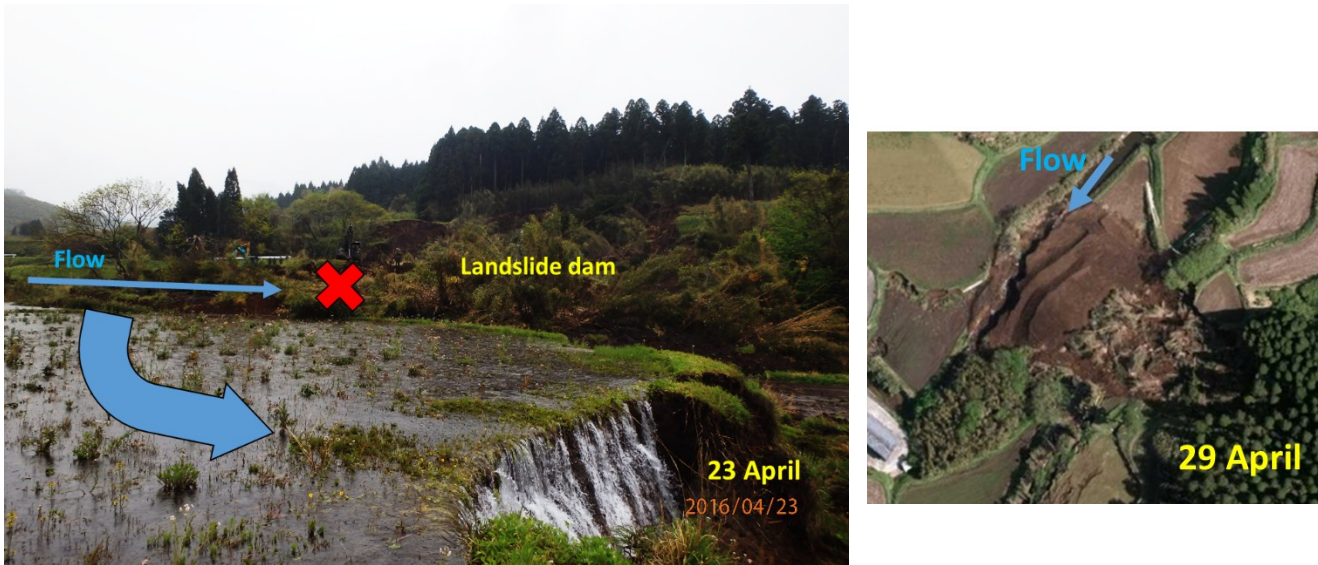
A slope failure was observed at site 20 in Fig. 26; the length of the failure was about 100 m. The debris blocked the road and a tributary of the Kurokawa River completely; the blocked tributary overflowed with water spreading into the surrounding paddy field (Figure 31). To avoid the potential risk of flooding to the downstream villages following the landslide dam breaching, the relevant authority had excavated a spillway to secure the safety of the dam. The excavation was likely finished within two weeks of the event.

Figure 31. Landslide dam formed by the earthquake and excavation work completed (site 20 in Fig. 26) ($32^{\circ} 53'14.06''N$, $130^{\circ} 59'48.90''E$).

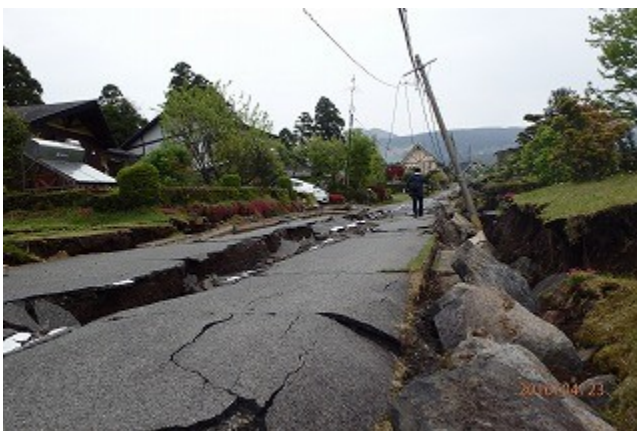
Figure 32 and 33 show damage of the road and house at site 21. Although this area reportedly survived the earthquake on the 14th of April, significant distortion of subsurface ground occurred during the main shock on the 16th of April. The spatial distribution of damage was severe at the northern part of the residential area. Figure 34 shows a comparison of aerial photos taken in 1975 and in 2016 (GSI, 2016), indicating that the damaged area used to be a paddy field but had subsequently been infilled during the construction of the housing estate. The filled soil in the damaged area is a local volcanic ash soil. Tanoue et al. (2005) reported that it is usually hard to construct a stable embankment from the ash deposited in the Central Kyushu area. It seems from Fig. 34 that the ground level of the northern part of the residential area was comparatively low in 1975, the filled soil might have been thicker for the northern side than the southern side. This might be why the earthquake-induced damage to the land was found to be severe in the northern side, however, structural damage to the residential houses in this area was negligible despite large ground deformation.

Figure 32. Damage to the road in residential area developed by filling (Site 21 in Fig. 26) ($32^{\circ} 52'43.89''N$, $130^{\circ} 59'58.89''E$).

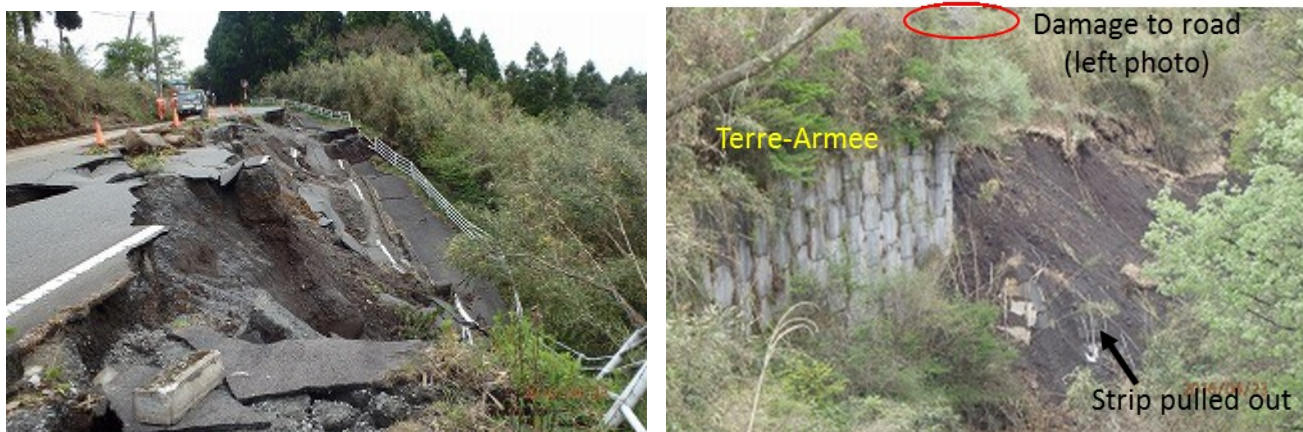
A 50 m-long embankment on prefectural road No. 149 (site 22 in Fig. 26) suffered from damage in the form of slope failure. Ground fissures and road pavement damage were also found there. This embankment (about 10-15 m high) was constructed along the small river by using a reinforced soil retaining wall technique (Terre-Armee), the wall was also damaged significantly as shown in Figure 35. Steel strip materials pulled out from the backfill soil were found on the failed slope surface. The reason for the failure of the reinforced soil retaining wall is not yet identified.

Figure 35. Damage to road embankment and reinforced retaining wall (Terre-Armee) (site 22 in Fig. 26) ($32^{\circ} 52'52.01''N$, $131^{\circ} 00'14.84''E$).
