# Geotechnical Damage Caused by the 2016 Kumamoto Earthquake, Japan

**ABSTRACT:** On the 16<sup>th</sup> of April 2016, the Kumamoto earthquake ( $M_w$  7.0) hit the Central Kyushu Region, Japan, following a  $M_w$  6.2 shock on the 14<sup>th</sup> of April. The earthquake sequences caused severe damage in Kumamoto Prefecture. This paper presents quick reconnaissance results focusing on geotechnical damage features, which were observed during field investigations immediately after, one, and two weeks after the main shock. The damage surveys were carried out in southern Kumamoto City, Mashiki Town, Aso Caldera area and their suburbs. In southern Kumamoto City, evidence of liquefaction was found at many locations, and some buildings and river levees suffered from significant settlement and deformation; damage to an embankment of Kyushu Highway also seemed to be the result of liquefaction. The majority of the damaged residential houses were found in Mashiki Town and its suburbs, which may be linked to intense earthquake motions associated with the seismic fault location. In Aso Caldera area, a number of moderate to large scale landslides and their significant impact to structures wer

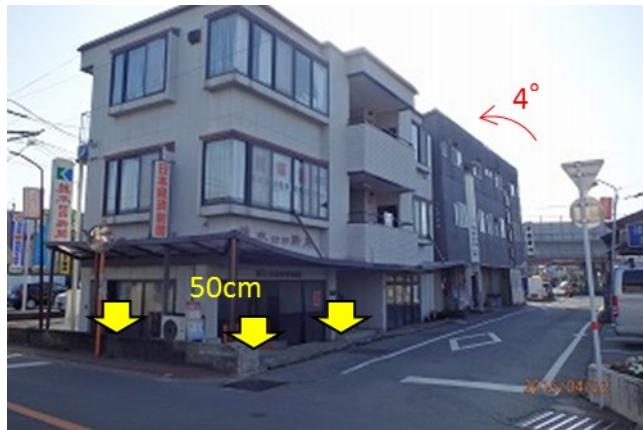
Figure 4 shows the liquefaction-induced damage to buildings in Karikusa district (site 1). The building suffered from significant settlement of about 50 cm. The adjacent building also suffered from a tilting of about four degrees. Similar damage to residential houses was observed in Majima district (Figure 5, site 2) which is a reclaimed land along the river. In addition, liquefaction as evidenced by sand boils present in Kumamoto Port, however, the liquefaction-induced damage to major facilities was not reported. As a whole impression of liquefaction during the Kumamoto earthquake, the number of damaged buildings and facilities was much fewer than in the Kanto region during the 2011 Off Pacific Coast of Tohoku Earthquake (Yasuda et al., 2012; Towhata et al., 2014).

Figure 4. Liquefaction-induced damage to buildings in Karikusa district (Site 1 in Fig. 3) ( $32^{\circ} 45'35.70"N, 130^{\circ} 40'59.76"E$ ).

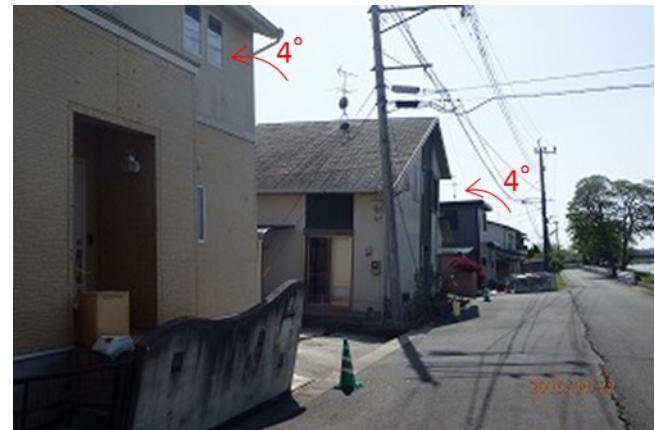
Figure 5. Liquefaction-induced damage to residential houses in Majima district (Site 2 in Fig. 3) ( $32^{\circ} 45'52.69"N, 130^{\circ} 46'7.49"E$ ).

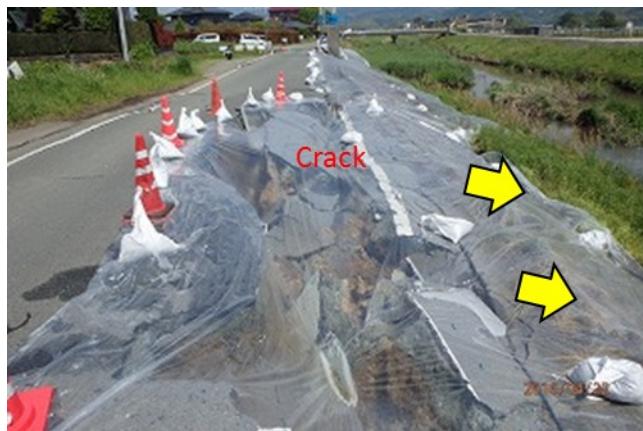
Figure 6 shows the typical liquefaction-induced damage to a river levee (site 3). Large settlement and lateral deformation was found at the levee along Akitsugawa-River. According to a landform classification map for flood control, provided by Geospatial Information Authority of Japan (GSI) shown in Fig. 7, the damaged levee is located at the old river channel, which suggests that a shallow soft deposit liquefied, inducing lateral spreading toward the river. Kyushu Regional Development Bureau of MLIT (2016) reported damage of variable severity to the levees of the Midorikawa-River and Shirakawa-River. They identified a total of 171 sites, however, their emergency restoration was almost completed as of middle of May. The settlement of levees, for example, caused a large gap between the embankment and bridge girders leading to a transportation problem (Figure 8, site 4). As of the end of April, such problems have occurred at many locations, however, they have been temporally solved by the installation of a filled slope (Figure 9, site 5). Although the locations of liquefaction are widespread in Kumamoto City (Wakamatsu et al., 2016), there have been no official report of serious liquefaction-induced damage; there are neither collapse of buildings nor washout of levees due to liquefaction.

Figure 6. Liquefaction-induced damage to levee along Akitsukawa-River (Site 3 in Figs. 3 and 7) ( $32^{\circ} 46'43.56"N, 130^{\circ} 47'40.27"E$ ).

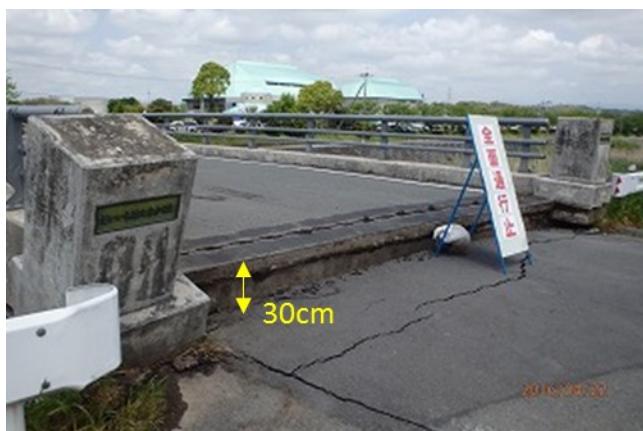
Figure 8. A large gap at bridge girder due to settlement of embankment (Site 4 in Fig. 3) ( $32^{\circ} 47'2.15"N, 130^{\circ} 49'17.70"E$ ).

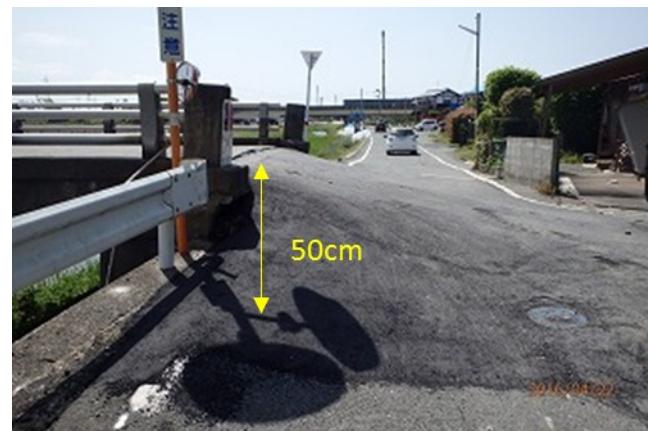
Figure 9. Temporary restoration work (filled slope) for settlement of levee (Site 5 in Figs. 3 and 7) ( $32^{\circ} 46'44.47"N, 130^{\circ} 47'45.43"E$ ).

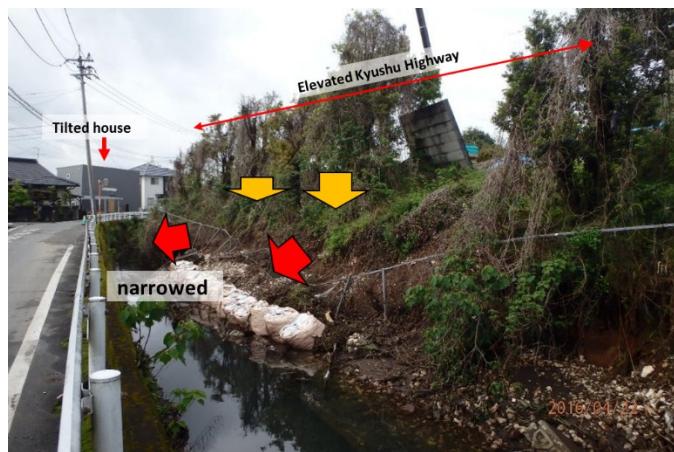
At site 6 in Fig. 3, a 50 m-long embankment on one side of Kyushu Highway, which connects Fukuoka to Kagoshima, suffered from significant damage (Fig. 10). The damage was caused by the earthquake on the 14<sup>th</sup> of April, in the form of subsidence and lateral flow. The highway was closed to traffic until the end of April, which disrupted emergency distributions in the affected areas. According to the land classification map (Fig. 7) and old aerial photos taken before the construction of the highway provided by GSI (2016) (Fig. 11), the exact location of the damaged embankment used to be a small river channel, which suggest that the process of liquefaction of saturated loose filled soil was the potential cause of damage to the embankment. In fact, the residential house near the damaged embankment suffered from large tilting as shown in Figure 10, indicating a bearing capacity lowering of foundation ground due to liquefaction.

Figure 10. Damage to Kyushu Highway embankment (Site 6 in Figs. 3 and 7) ( $32^{\circ} 46'46.80"N, 130^{\circ} 47'39.40"E$ ).

Since the other side of the embankment survived the earthquake, as an emergency response, the number of driving lanes at the damaged embankment was temporarily reduced to one in each direction, and only the one-lane reopened from the 29<sup>th</sup> of April. Due to the critical importance of the Kyushu Highway, however, careful investigation shall be conducted to thoroughly understand the cause of the damage observed and to propose effective countermeasures for the conclusive restoration of the embankment.

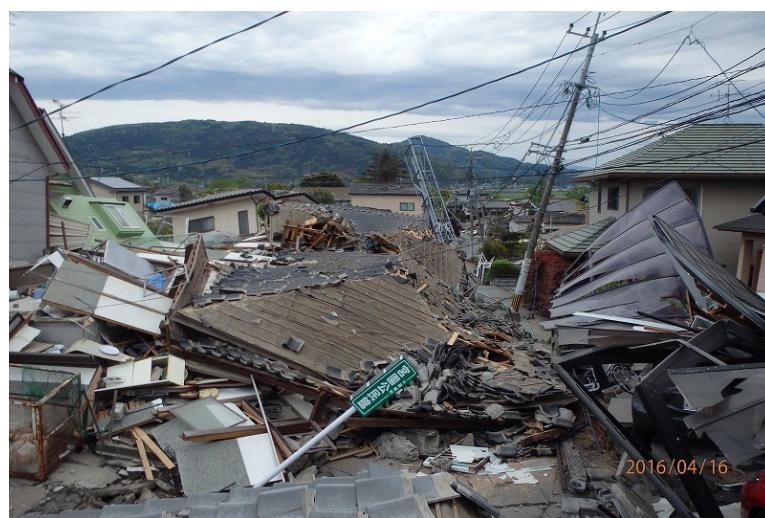
There were numerous building collapses in Mashiki Town. Fig. 13 shows the typical damage to the residential houses in the yellow-colored area in Fig. 12 (site 7). The residents in the affected area reported that a number of houses suffered from moderate to significant structural damage due to the earthquake on the 14<sup>th</sup> of April and then totally destroyed by the main shock on the 16<sup>th</sup>. It is also reported that the number of deaths in this area was fewer than expected from the damage shown in Fig. 13 because many affected residents had already fled their damaged house after the earthquake of the 14<sup>th</sup> (Fukuwa, 2016).

Figure 13. Damage to residential houses in Mashiki Town (Site 7 in Fig. 12)  
(32° 47'16.38"N, 130° 48'58.47"E).

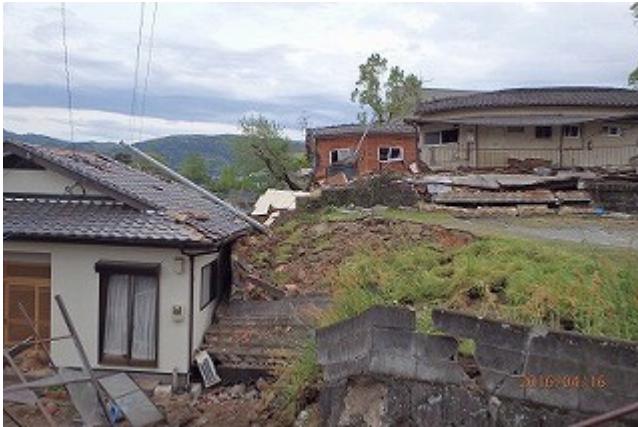
Figure 16. Ground displacement-induced damage to a residential house (Site 8 in Fig. 12) ( $32^{\circ} 47'24.96"N, 130^{\circ} 49'12.75"E$ ).

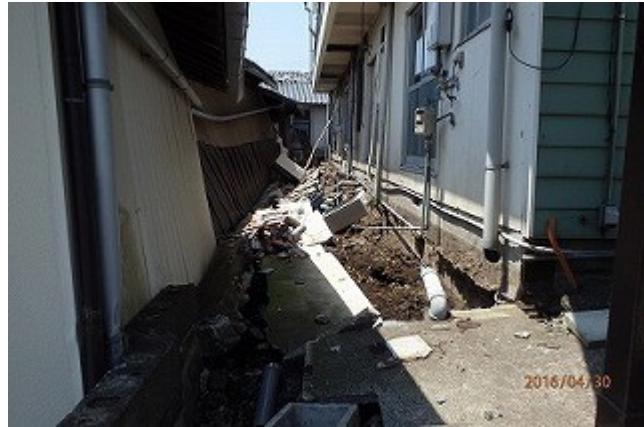
Figure 17. Ground displacement-induced damage to a residential house (Site 9 in Fig. 12) ( $32^{\circ} 47'14.48"N, 130^{\circ} 48'41.06"E$ ).

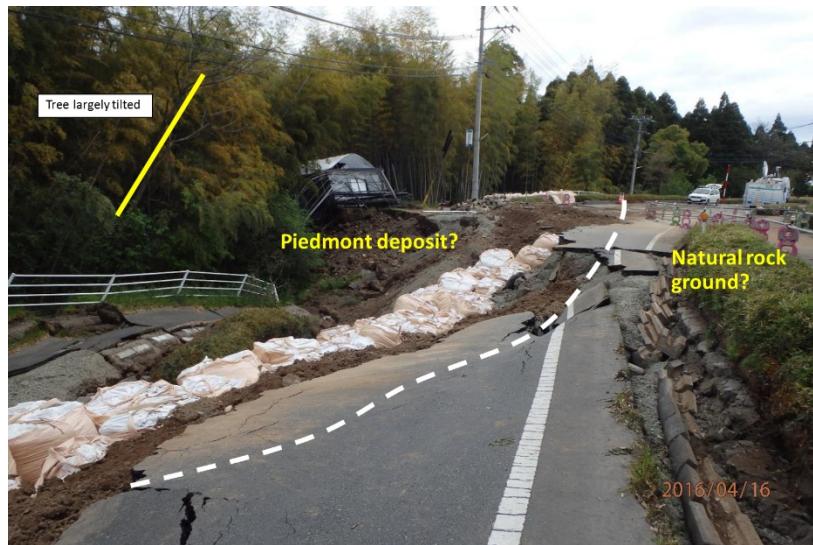
A section of Route 443 at site 10 in Fig. 12 was damaged by the earthquake on the 14<sup>th</sup> of April. The road on the left side in Fig. 18 failed and subsided by a maximum of about 2.0-2.5 m. The photo also shows the significantly tilted trees at the middle portion of the sliding mass. At the time of the survey on the 16<sup>th</sup> of April, two days after the occurrence of failure, large soil bags were placed on the exposed failure surface to prevent further damage. According to the landform classification map shown in Fig. 14, the failure was likely to have occurred in the talus deposit and the perimeter of the failure is likely to be the boundary between talus deposit and late Pleistocene volcanic rock.

Figure 18. Damage to Route 443 in Mashiki Town (Site 10 in Figs. 12 and 14) ( $32^{\circ} 47'29.71"N, 130^{\circ} 49'17.58"E$ ).

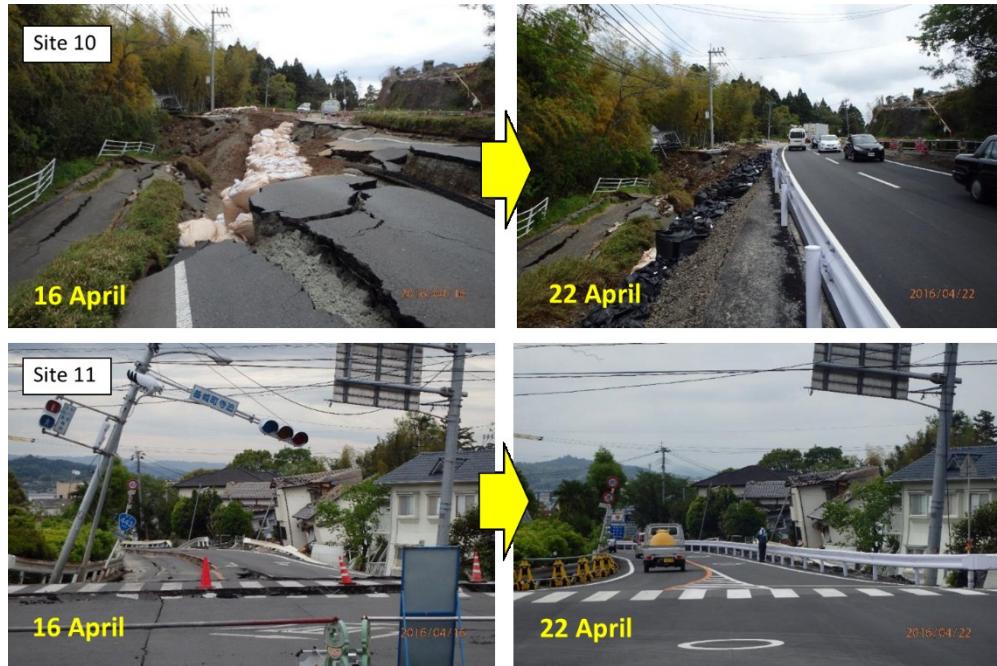
Approximately 150 m south of the above damaged site a differential settlement was observed (Photo 12b, site 11). According to the landform classification map in Fig. 14, it is indicated that the damaged site was recently constructed on the alluvial soil deposit. The damage, therefore, is attributed to strength reduction of foundation ground due to a process of liquefaction and/or that of the embankment, if the compaction work was inadequate. Immediately after the earthquake, emergency restoration work was rapidly conducted in the affected areas. As shown in Fig. 19, the restoration work for the damaged sites along Route 443 was completed a few days after the main shock.

Figure 19. Damages to Route 443 and their restoration for (a) site 10 and (b) site 11 (c.f. Figs. 12 and 14) (Site 10:  $32^{\circ}47'29.71''N$ ,  $130^{\circ}49'17.58''E$ , Site 11:  $32^{\circ}47'24.33''N$ ,  $130^{\circ}49'15.82''E$ ).

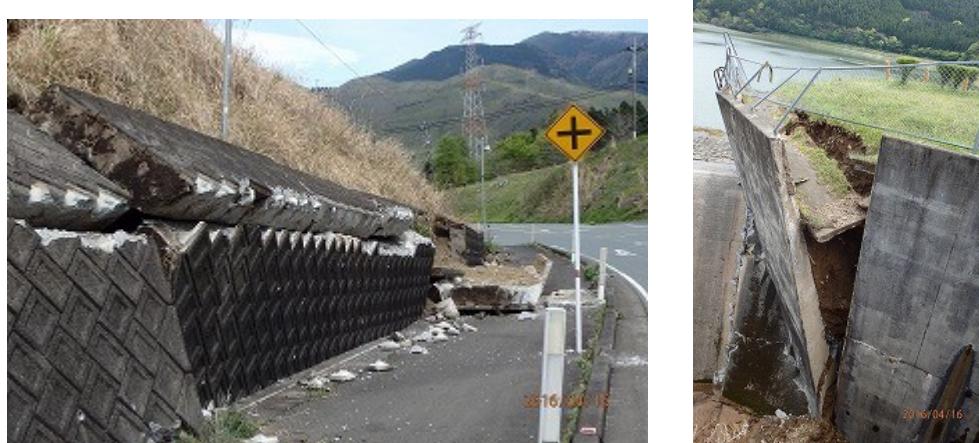
Mashiki and the surrounding areas were close to the seismic fault and suffered from a variety of geotechnical and structural damage due to the earthquakes. Damage to gravity-type and cantilever-type retaining walls (2-3 m high) was found at several locations due to surface manifestation of fault rupture. The retaining wall and dam spillway retaining wall at site 12 in Fig. 12 were structurally damaged as a result of the fault movement (Fig. 20).

Figure 20. Damage to retaining wall and spillway retaining wall (site 12 in Fig. 12) ( $32^{\circ}50'29.22''N$ ,  $130^{\circ}55'55.83''E$ ).

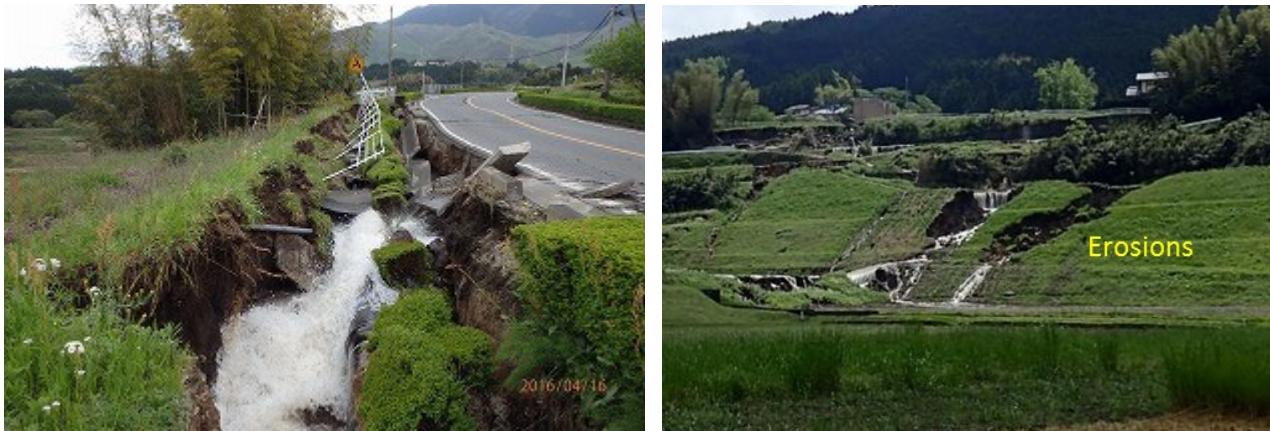
Along the prefectural road No. 28 a section built upon an embankment suffered from major cracks, settlement and outward deformation as shown in Fig. 21 (site 13). The deformation of the embankment caused damage to a water pipeline followed by a water leak which resulted in significant erosion of the embankment. A large slope failure was observed at site 14; the length of the slope failure was about 130 m. The surface of the slope has been protected by a shotcrete with a thickness of 5-10 cm. The fallen boulders and debris which consist of late Pleistocene volcanic rocks (rhyolite and dacite) blocked the road completely (Fig. 22).

Figure 21. Damage to road embankment along prefectural road No. 28 (site 13 in Fig. 12) ( $32^{\circ}50'36.63''N$ ,  $130^{\circ}55'24.48''E$ ).

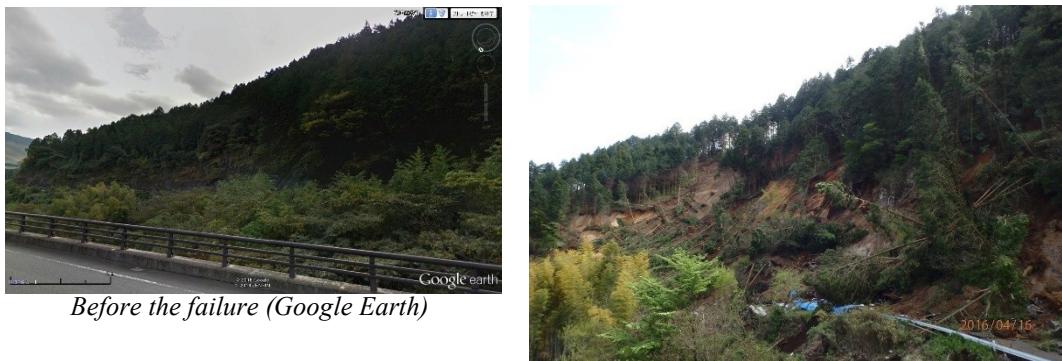
Figure 22. Slope failure along prefectural road No. 28 (site 14 in Fig. 12) ( $32^{\circ}50'32.96''N$ ,  $130^{\circ}55'40.65''E$ ).

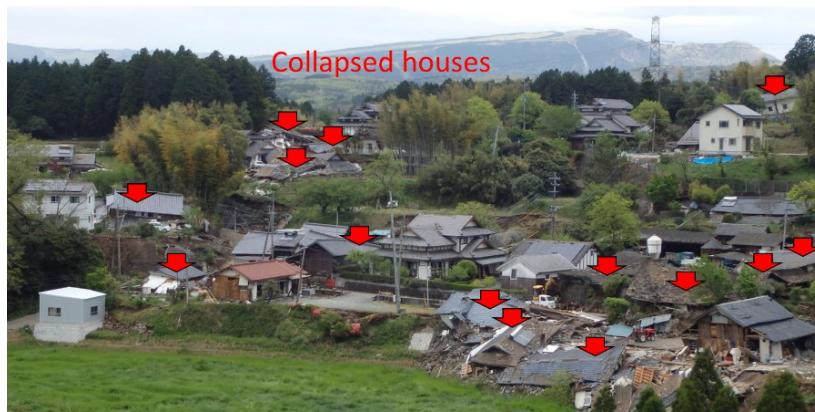
A number of residential houses along road No. 28 suffered from significant damage. As shown in Fig. 23, high collapse ratio of houses can be seen in the small village (site 15). In addition, modern bridges and a tunnel along road No. 28 suffered from serious damage. The girder of Ohkirihiata Bridge moved about 1-1.5m and fell off its rubber bearings (Fig. 24, site 14). About 4 km north-east of Ohkirihiata Bridge, Tawarayama tunnel suffered from a compressive axial failure and falling of lining concrete about 250 m from the tunnel portal (Fig. 25, site 16). The cause of compression of the tunnel was thought to be a surface fault movement in right lateral component, which was confirmed at the damaged location (Shirahama et al., 2016; Yoshimi, 2016). More information about the structural damages along road No. 28 due to the earthquake is reported in a separate report (Ikeda, et al., 2016).

Figure 23. Damage to residential houses in Ohkirihiata area (site 15 in Fig. 12) ( $32^{\circ}50'36.91''N$ ,  $130^{\circ}55'43.16''E$ ).

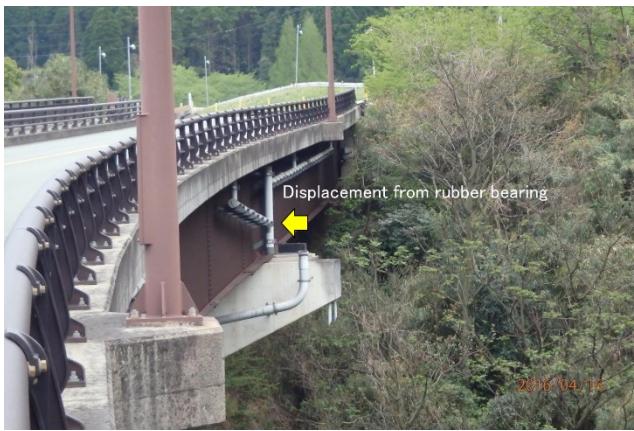
Figure 24. The girder of Ohkiri-hata Bridge moved about 1-1.5m (Site 14 in Fig. 12) (32° 50'32.63"N, 130° 55'43.10"E).

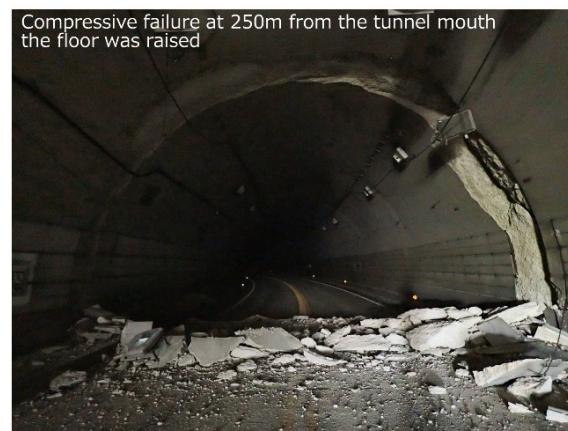
Figure 25. Tawarayama tunnel suffered from axial compression failure (Site 16 in Fig. 12) (32° 51'35.68"N, 130° 58'6.86"E).

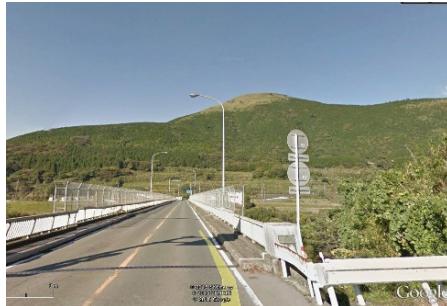
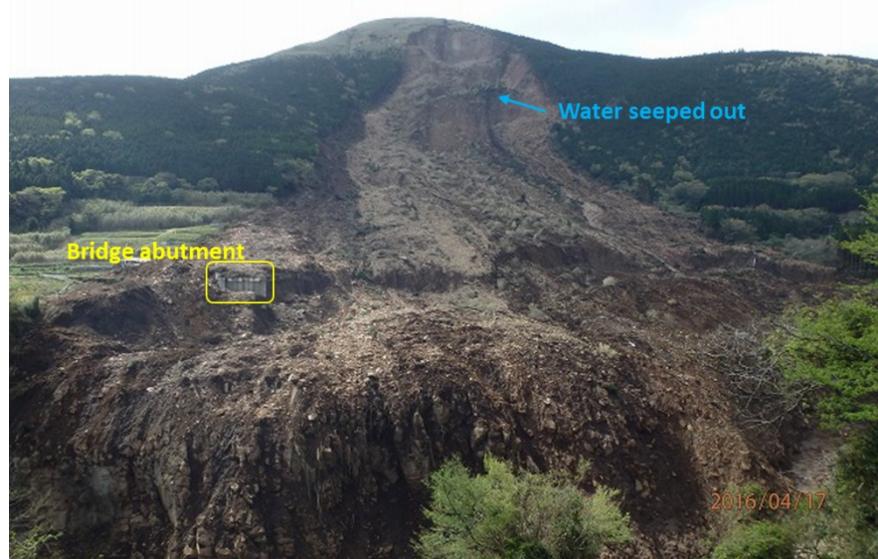
Figure 28 shows a shallow landslide near Aso Ohashi Bridge caused by the main shock on the 16<sup>th</sup> of April (site 17). The landslide had a height of about 300 m (measured from the road level to the scrap) with an inclination angle of about 50 degrees at the top and about 25 degrees at the middle and bottom of the slope. The debris was a mixture of middle Pleistocene volcanic soils and boulders (tuff breccia); Route 57 and JR Hohi Main Line (railway) was also covered by it. The debris travelled a distance exceeding 800 m and fell into the Kurokawa-River along with Aso Ohashi Bridge. Evidence of mud debris was found on the opposite side of the river which is thought to have travelled along the bridge before its collapse. For this reason, the cause of bridge failure is considered to be the impact force and/or weight of debris that flowed down from the landslide source. Moreover, in Figure 28, taken one day after the event, water seeped out from the failed surface, which may explain the reduction of shear strength of the slope ground due to increase in excess pore water pressure during the intense earthquake.

Figure 28. Landslide near Aso Ohashi Bridge (site 17 in Fig. 26).  
(32° 53' 0.02"N, 130° 59' 22.80"E).

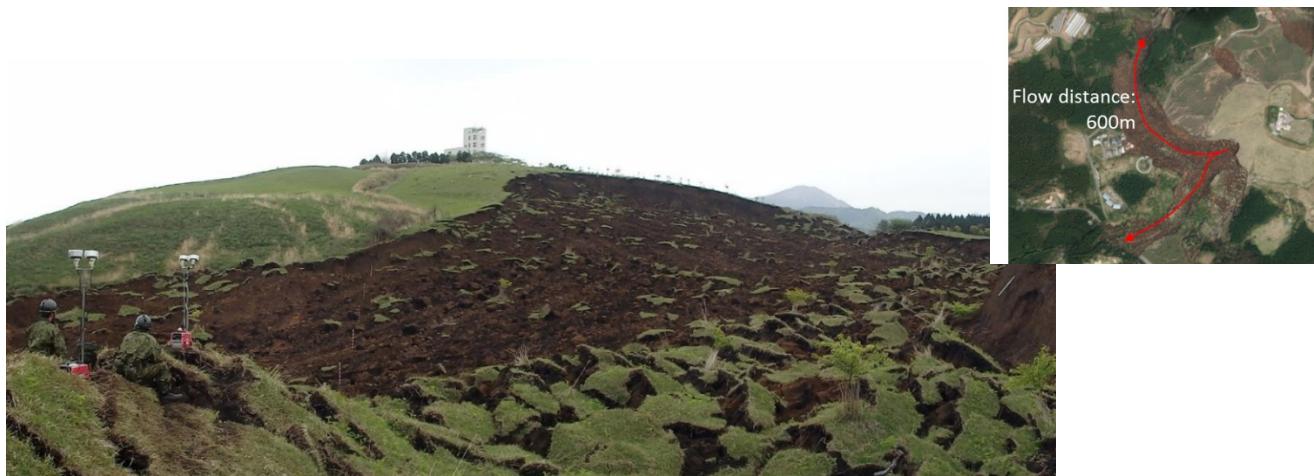
At site 18 in Fig. 26, a large scale landslide occurred at a volcanic hill (late Pleistocene) with a height in excess of 80 m from its base. The failure occurred on a relatively gentle slope with an angle of less than 10 degrees. The sliding of the slope towards the toe, however, was remarkable as shown in Figure 29. This failure killed five people who were in the house at the middle of the slope. A few hundred meters south of the above landslide another landslide occurred and caused severe damage to the residential houses as shown in Figure 30 (site 19). The length of the landslide was 70 m with an inclination angle of about 10 degrees. As the Kumamoto earthquake is an inland earthquake which caused severe damage in the mountain area, it is often compared with the 2004 Chetsu earthquake ( $M_w$  6.6) which hit Niigata Prefecture, Japan, and caused a number of landslides (Toyota et al., 2006). Slope failures triggered by the Chuetsu earthquake occurred at a sedimentary rock interface, and the slope angle before the failure was about 20 degrees on average (Yamasaki, 2008), which is much steeper than the cases in the Aso mountain area in the Kumamoto earthquake. The debris of the landslides in Aso Caldera area was a mixture of volcanic ash, andsol, a highly porous dark-colored material comprising of volcanic ash mixed with organic matter, and pumice. As shown in Figure 30, alternating layers were seen at the surface of the scrap. The cause of failure and long-distance flow at the gentle slope is not identified yet, however, since the natural deposited pumice is known to have high crushability, the soil may have experienced significant strength reduction associated with particle breakage during the earthquake.

Figure 29. Large scale landslide in Aso Caldera area (site 18 in Fig. 26) ( $32^{\circ} 53'5.47"N, 131^{\circ} 00'10.56"E$ ).

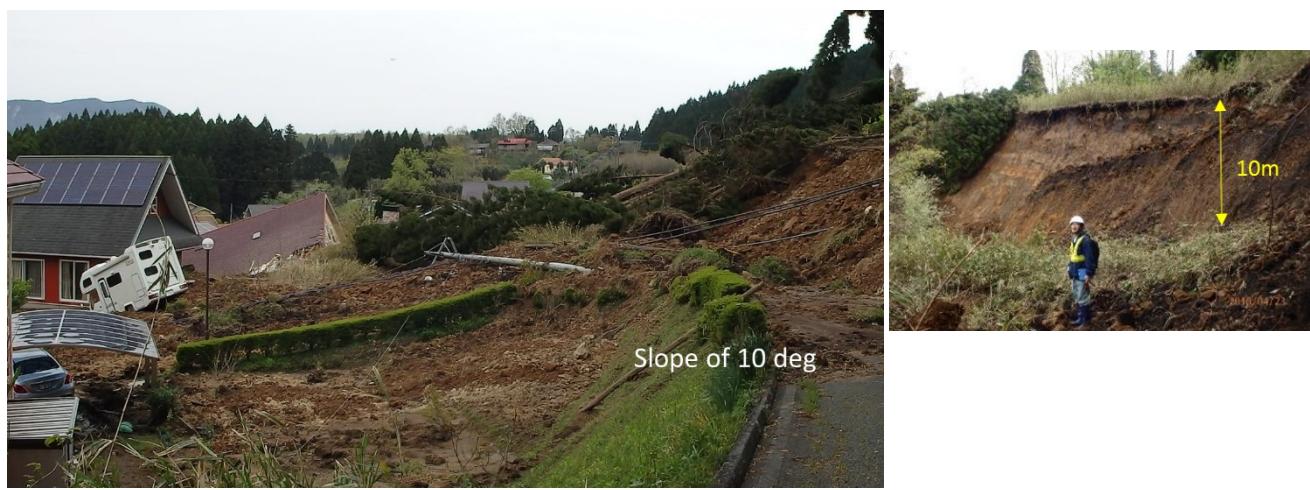
Figure 30. Landslide at gentle slope and its scrap (site 19 in Fig. 26) ( $32^{\circ} 52'29.42"N, 131^{\circ} 00'49.36"E$ ).

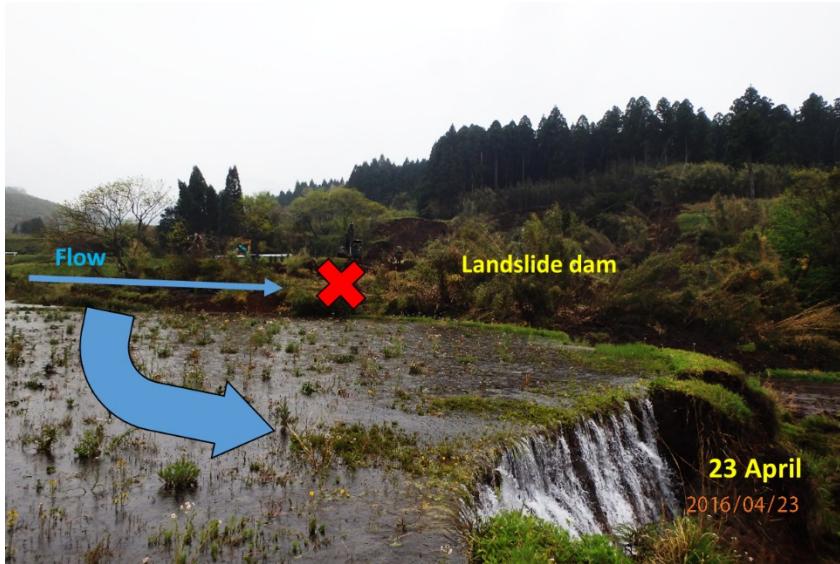
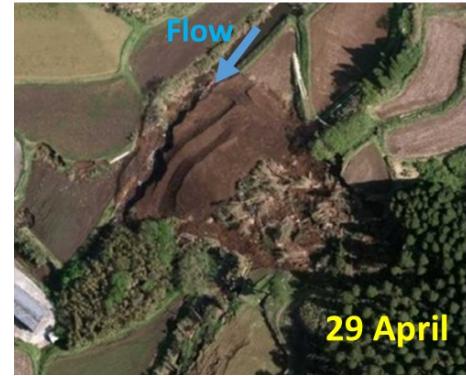
A slope failure was observed at site 20 in Fig. 26; the length of the failure was about 100 m. The debris blocked the road and a tributary of the Kurokawa River completely; the blocked tributary overflowed with water spreading into the surrounding paddy field (Figure 31). To avoid the potential risk of flooding to the downstream villages following the landslide dam breaching, the relevant authority had excavated a spillway to secure the safety of the dam. The excavation was likely finished within two weeks of the event.

Figure 31. Landslide dam formed by the earthquake and excavation work completed (site 20 in Fig. 26)  
 $(32^{\circ} 53'14.06"N, 130^{\circ} 59'48.90"E)$ .

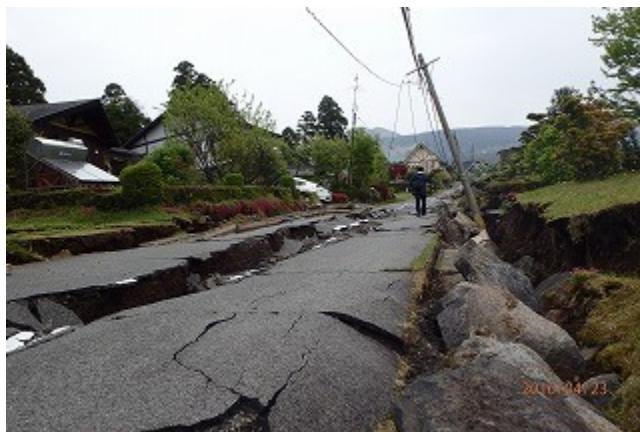
Figure 32 and 33 show damage of the road and house at site 21. Although this area reportedly survived the earthquake on the 14<sup>th</sup> of April, significant distortion of subsurface ground occurred during the main shock on the 16<sup>th</sup> of April. The spatial distribution of damage was severe at the northern part of the residential area. Figure 34 shows a comparison of aerial photos taken in 1975 and in 2016 (GSI, 2016), indicating that the damaged area used to be a paddy field but had subsequently been infilled during the construction of the housing estate. The filled soil in the damaged area is a local volcanic ash soil. Tanoue et al. (2005) reported that it is usually hard to construct a stable embankment from the ash deposited in the Central Kyushu area. It seems from Fig. 34 that the ground level of the northern part of the residential area was comparatively low in 1975, the filled soil might have been thicker for the northern side than the southern side. This might be why the earthquake-induced damage to the land was found to be severe in the northern side, however, structural damage to the residential houses in this area was negligible despite large ground deformation.

Figure 32. Damage to the road in residential area developed by filling (Site 21 in Fig. 26)  
 $(32^{\circ} 52'43.89"N, 130^{\circ} 59'58.89"E)$ .

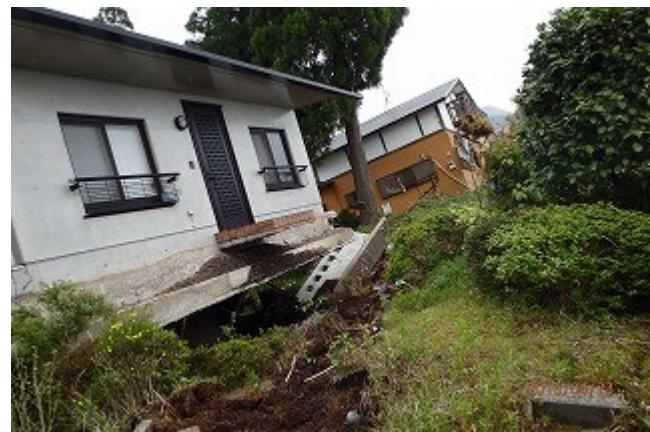
Figure 33. Damage to the house in residential area developed by filling (Site 21 in Fig. 26)  
 $(32^{\circ} 52'45.06"N, 131^{\circ} 00'1.44"E)$ .

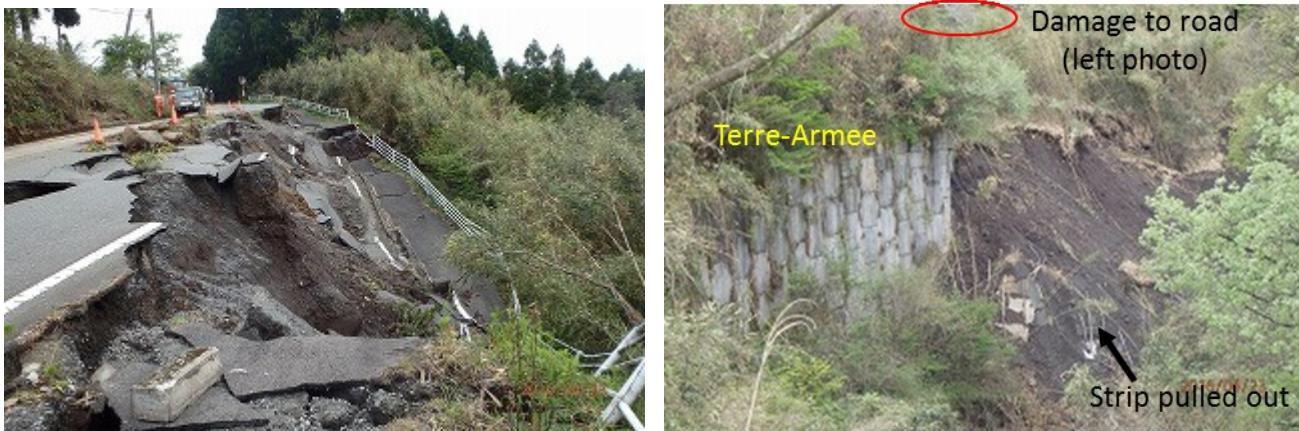
A 50 m-long embankment on prefectural road No. 149 (site 22 in Fig. 26) suffered from damage in the form of slope failure. Ground fissures and road pavement damage were also found there. This embankment (about 10-15 m high) was constructed along the small river by using a reinforced soil retaining wall technique (Terre-Armee), the wall was also damaged significantly as shown in Figure 35. Steel strip materials pulled out from the backfill soil were found on the failed slope surface. The reason for the failure of the reinforced soil retaining wall is not yet identified.

Figure 35. Damage to road embankment and reinforced retaining wall (Terre-Armee) (site 22 in Fig. 26) ( $32^{\circ} 52'52.01''N$ ,  $131^{\circ} 00'14.84''E$ ).

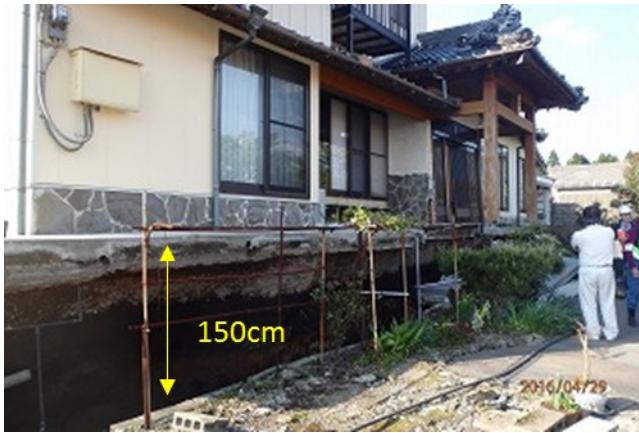
A trough-like depression was found at several locations in the basin of Aso Caldera. According to both the authors' site investigation and aerial photointerpretation of cracks on ground surface provided by the GSI (2016) and Kokusai Kogyo co. ltd (2016), the trough-like depression, with a maximum depth of about 1-1.5 m, was found to stretch several kilometers in length, the width of the depression was several tens of meters. At site 23, the ground depression caused damage to a residential house (Fig. 36). The damage due to the depression has also been harmful to agriculture in this area (Figure 37). The mechanism of the depression, however, is not yet identified. The residents in the affected area reported that the depression occurred immediately when the main shock occurred on the 16<sup>th</sup> of April. The fact indicates that the cause of the depression was probably not liquefaction. Refer to a separate report by Konagai et al. (2016) for further information about this feature.

Figure 36. Ground depression-induced damage to the residential house (Site 23 in Fig. 26) ( $32^{\circ} 57'23.84"N, 131^{\circ} 2'12.31"E$ ).
