Geotechnical Damage Caused by the 2016 Kumamoto Earthquake, Japan

ABSTRACT: On the 16th of April 2016, the Kumamoto earthquake (M_w 7.0) hit the Central Kyushu Region, Japan, following a M_w 6.2 shock on the 14th of April. The earthquake sequences caused severe damage in Kumamoto Prefecture. This paper presents quick reconnaissance results focusing on geotechnical damage features, which were observed during field investigations immediately after, one, and two weeks after the main shock. The damage surveys were carried out in southern Kumamoto City, Mashiki Town, Aso Caldera area and their suburbs. In southern Kumamoto City, evidence of liquefaction was found at many locations, and some buildings and river levees suffered from significant settlement and deformation; damage to an embankment of Kyushu Highway also seemed to be the result of liquefaction. The majority of the damaged residential houses were found in Mashiki Town and its suburbs, which may be linked to intense earthquake motions associated with the seismic fault location. In Aso Caldera area, a number of moderate to large scale landslides and their significant impact to structures were observed. The greater part of land

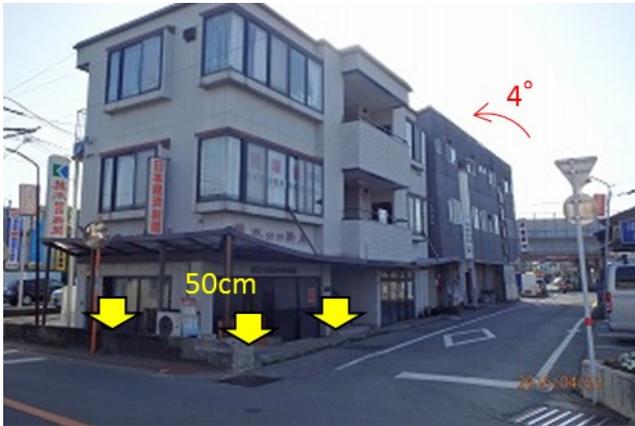
Figure 4 shows the liquefaction-induced damage to buildings in Karikusa district (site 1). The building suffered from significant settlement of about 50 cm. The adjacent building also suffered from a tilting of about four degrees. Similar damage to residential houses was observed in Majima district (Figure 5, site 2) which is a reclaimed land along the river. In addition, liquefaction as evidenced by sand boils present in Kumamoto Port, however, the liquefaction-induced damage to major facilities was not reported. As a whole impression of liquefaction during the Kumamoto earthquake, the number of damaged buildings and facilities was much fewer than in the Kanto region during the 2011 Off Pacific Coast of Tohoku Earthquake (Yasuda et al., 2012; Towhata et al., 2014).

Figure 4. Liquefaction-induced damage to buildings in Karikusa district (Site 1 in Fig. 3) ($32^{\circ} 45'35.70''N$, $130^{\circ} 40'59.76''E$).

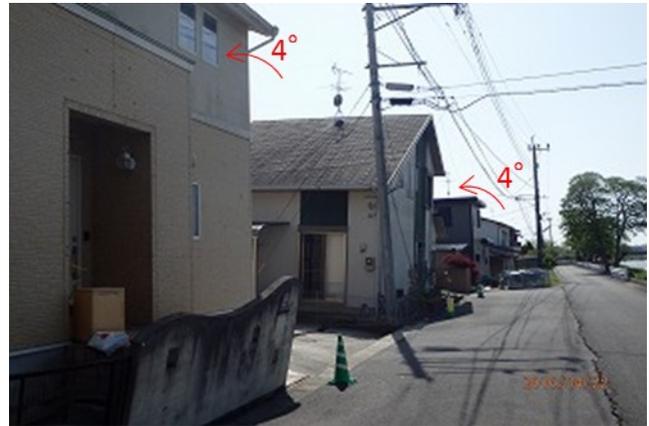
Figure 5. Liquefaction-induced damage to residential houses in Majima district (Site 2 in Fig. 3) ($32^{\circ} 45'52.69''N$, $130^{\circ} 46'7.49''E$).

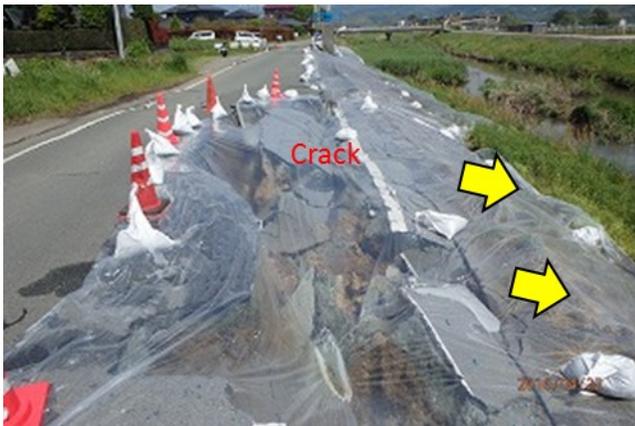
Figure 6 shows the typical liquefaction-induced damage to a river levee (site 3). Large settlement and lateral deformation was found at the levee along Akitsukawa-River. According to a landform classification map for flood control, provided by Geospatial Information Authority of Japan (GSI) shown in Fig. 7, the damaged levee is located at the old river channel, which suggests that a shallow soft deposit liquefied, inducing lateral spreading toward the river. Kyushu Regional Development Bureau of MLIT (2016) reported damage of variable severity to the levees of the Midorikawa-River and Shirakawa-River. They identified a total of 171 sites, however, their emergency restoration was almost completed as of middle of May. The settlement of levees, for example, caused a large gap between the embankment and bridge girders leading to a transportation problem (Figure 8, site 4). As of the end of April, such problems have occurred at many locations, however, they have been temporally solved by the installation of a filled slope (Figure 9, site 5). Although the locations of liquefaction are widespread in Kumamoto City (Wakamatsu et al., 2016), there have been no official report of serious liquefaction-induced damage; there are neither collapse of buildings nor washout of levees due to liquefaction.

Figure 6. Liquefaction-induced damage to levee along Akitsukawa-River (Site 3 in Figs. 3 and 7) ($32^{\circ} 46'43.56''N$, $130^{\circ} 47'40.27''E$).

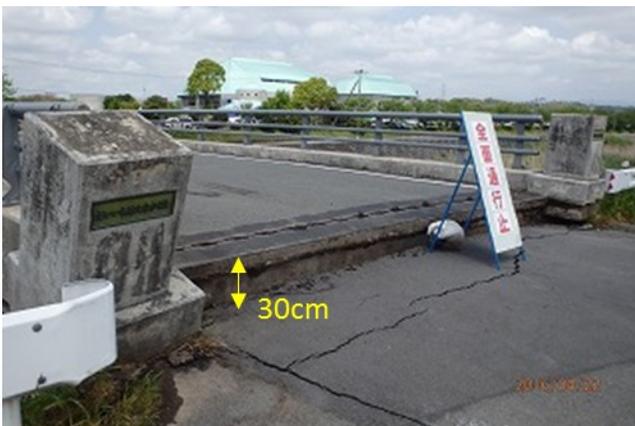
Figure 8. A large gap at bridge girder due to settlement of embankment (Site 4 in Fig. 3) ($32^{\circ} 47'2.15''N$, $130^{\circ} 49'17.70''E$).

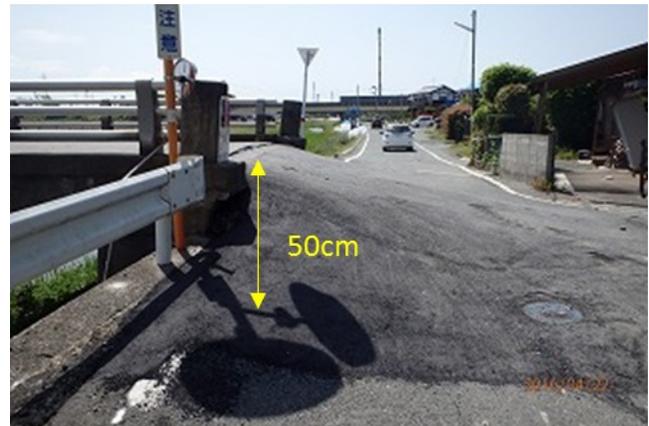
Figure 9. Temporary restoration work (filled slope) for settlement of levee (Site 5 in Figs. 3 and 7) ($32^{\circ} 46'44.47''N$, $130^{\circ} 47'45.43''E$).

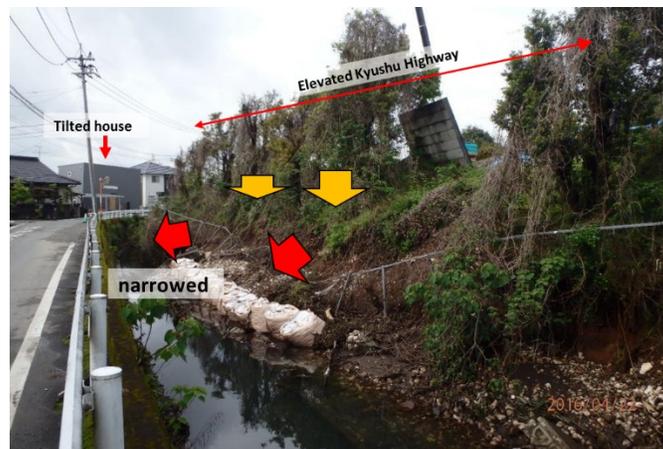
At site 6 in Fig. 3, a 50 m-long embankment on one side of Kyushu Highway, which connects Fukuoka to Kagoshima, suffered from significant damage (Fig. 10). The damage was caused by the earthquake on the 14th of April, in the form of subsidence and lateral flow. The highway was closed to traffic until the end of April, which disrupted emergency distributions in the affected areas. According to the land classification map (Fig. 7) and old aerial photos taken before the construction of the highway provided by GSI (2016) (Fig. 11), the exact location of the damaged embankment used to be a small river channel, which suggests that the process of liquefaction of saturated loose filled soil was the potential cause of damage to the embankment. In fact, the residential house near the damaged embankment suffered from large tilting as shown in Figure 10, indicating a bearing capacity lowering of foundation ground due to liquefaction.

Figure 10. Damage to Kyushu Highway embankment (Site 6 in Figs. 3 and 7) ($32^{\circ} 46'46.80''N$, $130^{\circ} 47'39.40''E$).

Since the other side of the embankment survived the earthquake, as an emergency response, the number of driving lanes at the damaged embankment was temporarily reduced to one in each direction, and only the one-lane reopened from the 29th of April. Due to the critical importance of the Kyushu Highway, however, careful investigation shall be conducted to thoroughly understand the cause of the damage observed and to propose effective countermeasures for the conclusive restoration of the embankment.

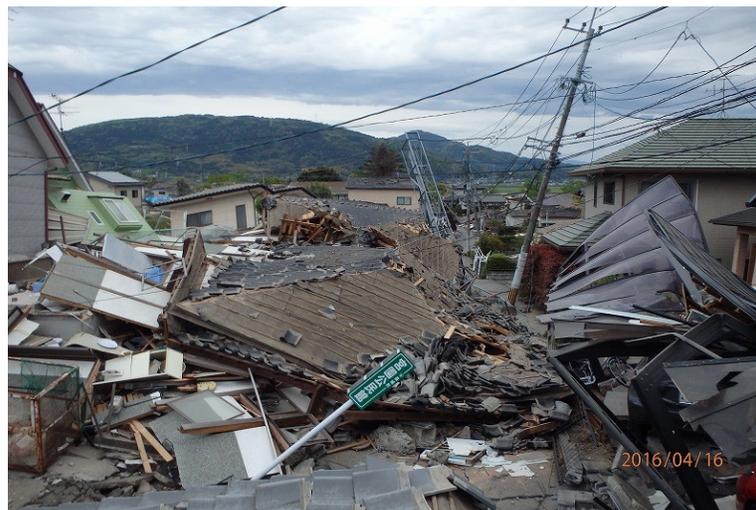
There were numerous building collapses in Mashiki Town. Fig. 13 shows the typical damage to the residential houses in the yellow-colored area in Fig. 12 (site 7). The residents in the affected area reported that a number of houses suffered from moderate to significant structural damage due to the earthquake on the 14th of April and then totally destroyed by the main shock on the 16th. It is also reported that the number of deaths in this area was fewer than expected from the damage shown in Fig. 13 because many affected residents had already fled their damaged house after the earthquake of the 14th (Fukuwa, 2016).

Figure 13. Damage to residential houses in Mashiki Town (Site 7 in Fig. 12)
($32^{\circ} 47'16.38''N$, $130^{\circ} 48'58.47''E$).

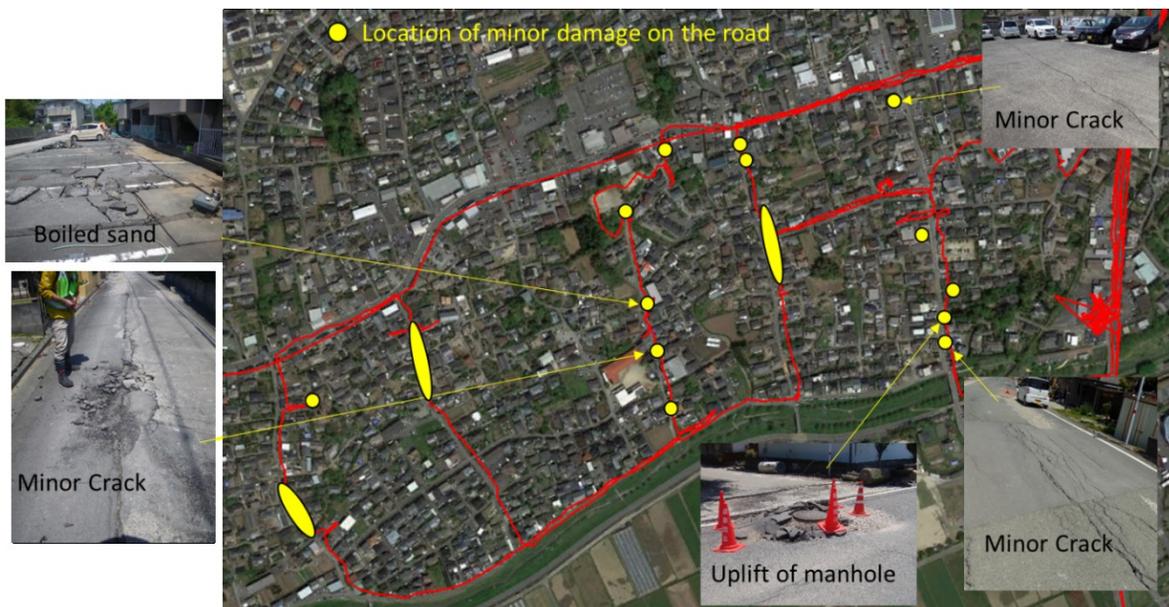
Figure 15 shows the result of the authors' quick survey. The spatial distribution of the collapsed houses was concentrated in the sloped area which consists of terrace and talus deposits, whereas ground deformation observed on the roads near the damaged houses was limited, therefore a large scale landslide might not have occurred. The cause of significant damage to the houses in this area was likely due to earthquake motion and the residual displacement of the entire sloped ground had an insignificant effect on the damaged houses. Although some houses were found to be damaged by ground deformation, as shown in Fig. 16 and 17 (sites 8 and 9), they were likely caused by localized failure of filled soil. On the other hand, the damage to the houses in the alluvial deposit area was limited whereas evidence of liquefaction was found frequently as shown in Fig. 15. It is inferred that the liquefied soil incidentally behaved like a seismic isolation system for the residential houses in this area.

Figure 15. Result of survey on ground deformation of sloped residential area in Mashiki Town (c.f. Figs. 12 and 14).

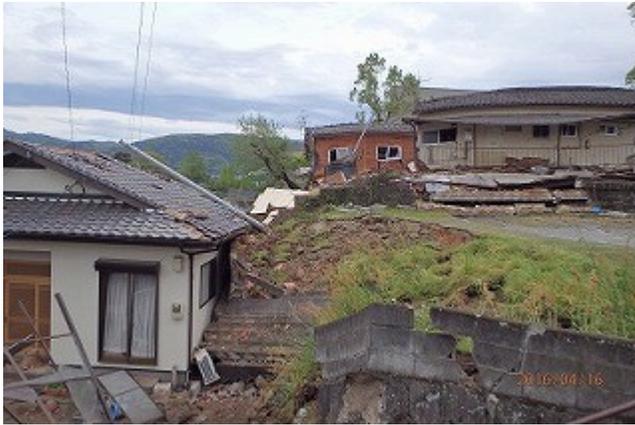
Figure 16. Ground displacement-induced damage to a residential house (Site 8 in Fig. 12) ($32^{\circ} 47'24.96''N$, $130^{\circ} 49'12.75''E$).

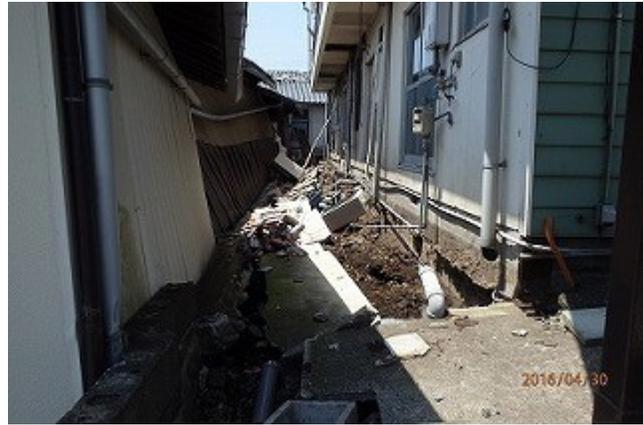
Figure 17. Ground displacement-induced damage to a residential house (Site 9 in Fig. 12) ($32^{\circ} 47'14.48''N$, $130^{\circ} 48'41.06''E$).

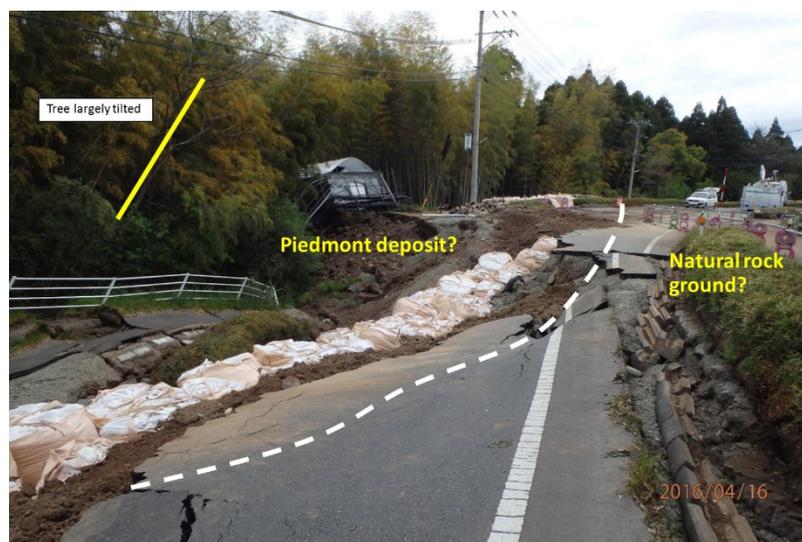
A section of Route 443 at site 10 in Fig. 12 was damaged by the earthquake on the 14th of April. The road on the left side in Fig. 18 failed and subsided by a maximum of about 2.0-2.5 m. The photo also shows the significantly tilted trees at the middle portion of the sliding mass. At the time of the survey on the 16th of April, two days after the occurrence of failure, large soil bags were placed on the exposed failure surface to prevent further damage. According to the landform classification map shown in Fig. 14, the failure was likely to have occurred in the talus deposit and the perimeter of the failure is likely to be the boundary between talus deposit and late Pleistocene volcanic rock.

Figure 18. Damage to Route 443 in Mashiki Town (Site 10 in Figs. 12 and 14) ($32^{\circ} 47'29.71''N$, $130^{\circ} 49'17.58''E$).

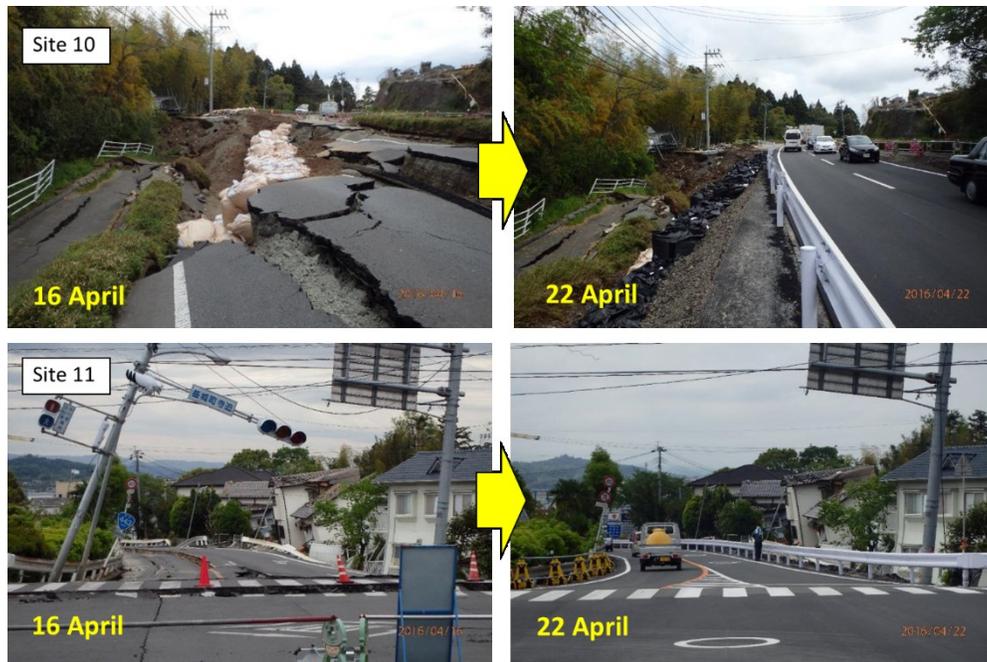
Approximately 150 m south of the above damaged site a differential settlement was observed (Photo 12b, site 11). According to the landform classification map in Fig. 14, it is indicated that the damaged site was recently constructed on the alluvial soil deposit. The damage, therefore, is attributed to strength reduction of foundation ground due to a process of liquefaction and/or that of the embankment, if the compaction work was inadequate. Immediately after the earthquake, emergency restoration work was rapidly conducted in the affected areas. As shown in Fig. 19, the restoration work for the damaged sites along Route 443 was completed a few days after the main shock.

Figure 19. Damages to Route 443 and their restoration for (a) site 10 and (b) site 11 (c.f. Figs. 12 and 14) (Site 10: $32^{\circ}47'29.71''N$, $130^{\circ}49'17.58''E$, Site 11: $32^{\circ}47'24.33''N$, $130^{\circ}49'15.82''E$).

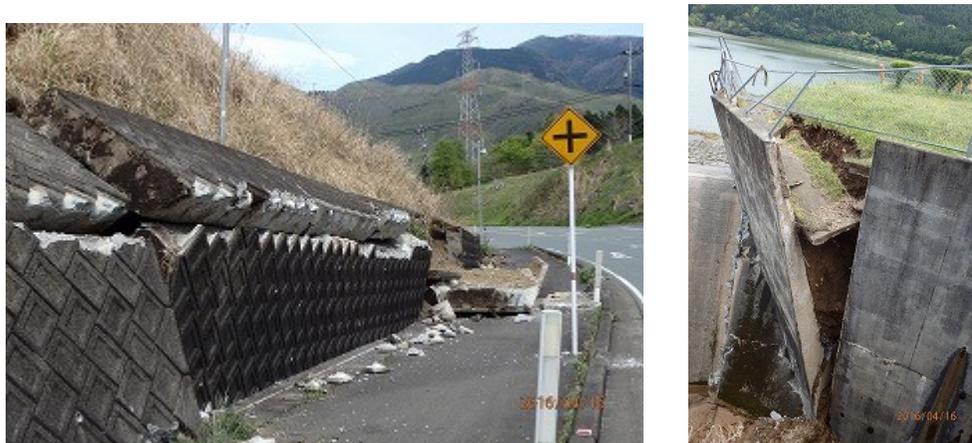
Mashiki and the surrounding areas were close to the seismic fault and suffered from a variety of geotechnical and structural damage due to the earthquakes. Damage to gravity-type and cantilever-type retaining walls (2-3 m high) was found at several locations due to surface manifestation of fault rupture. The retaining wall and dam spillway retaining wall at site 12 in Fig. 12 were structurally damaged as a result of the fault movement (Fig. 20).

Figure 20. Damage to retaining wall and spillway retaining wall (site 12 in Fig. 12) ($32^{\circ}50'29.22''N$, $130^{\circ}55'55.83''E$).

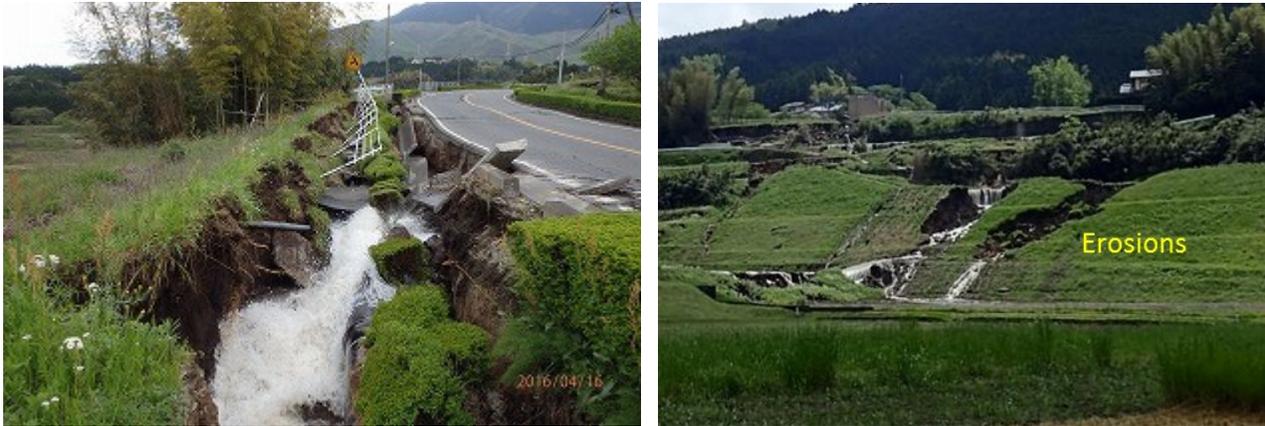
Along the prefectural road No. 28 a section built upon an embankment suffered from major cracks, settlement and outward deformation as shown in Fig. 21 (site 13). The deformation of the embankment caused damage to a water pipeline followed by a water leak which resulted in significant erosion of the embankment. A large slope failure was observed at site 14; the length of the slope failure was about 130 m. The surface of the slope has been protected by a shotcrete with a thickness of 5-10 cm. The fallen boulders and debris which consist of late Pleistocene volcanic rocks (rhyolite and dacite) blocked the road completely (Fig. 22).

Figure 21. Damage to road embankment along prefectural road No. 28 (site 13 in Fig. 12) ($32^{\circ}50'36.63''N$, $130^{\circ}55'24.48''E$).

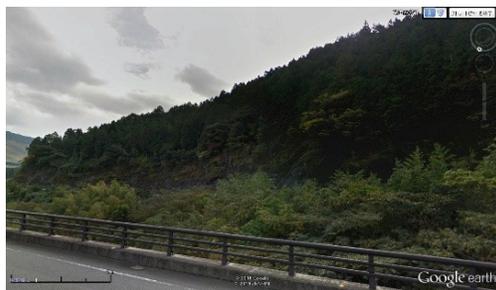
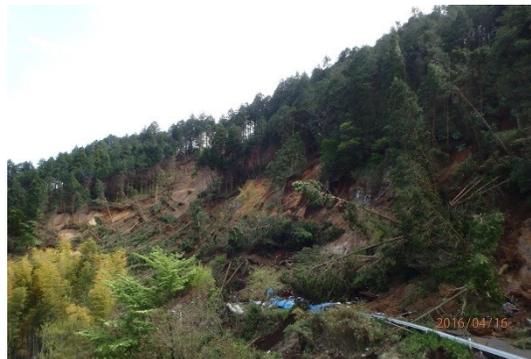
Figure 22. Slope failure along prefectural road No. 28 (site 14 in Fig. 12) ($32^{\circ}50'32.96''N$, $130^{\circ}55'40.65''E$).

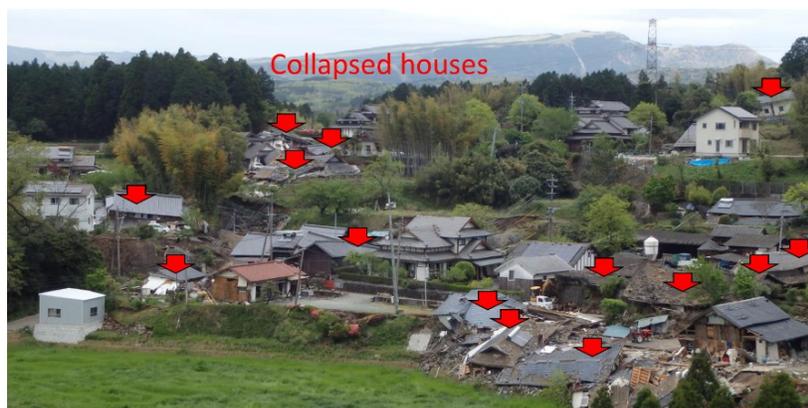
A number of residential houses along road No. 28 suffered from significant damage. As shown in Fig. 23, high collapse ratio of houses can be seen in the small village (site 15). In addition, modern bridges and a tunnel along road No. 28 suffered from serious damage. The girder of Ohkiri-hata Bridge moved about 1-1.5m and fell off its rubber bearings (Fig. 24, site 14). About 4 km north-east of Ohkiri-hata Bridge, Tawarayama tunnel suffered from a compressive axial failure and falling of lining concrete about 250 m from the tunnel portal (Fig. 25, site 16). The cause of compression of the tunnel was thought to be a surface fault movement in right lateral component, which was confirmed at the damaged location (Shirahama et al., 2016; Yoshimi, 2016). More information about the structural damages along road No. 28 due to the earthquake is reported in a separate report (Ikeda, et al., 2016).

Figure 23. Damage to residential houses in Ohkiri-hata area (site 15 in Fig. 12) ($32^{\circ}50'36.91''N$, $130^{\circ}55'43.16''E$).

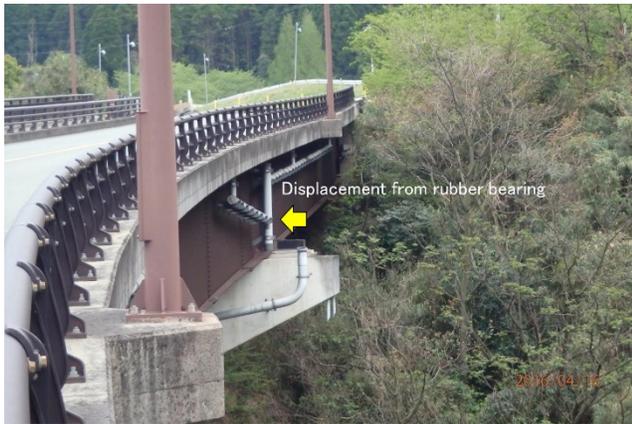
Figure 24. The girder of Ohkirihata Bridge moved about 1-1.5m (Site 14 in Fig. 12) ($32^{\circ} 50'32.63''N$, $130^{\circ} 55'43.10''E$).

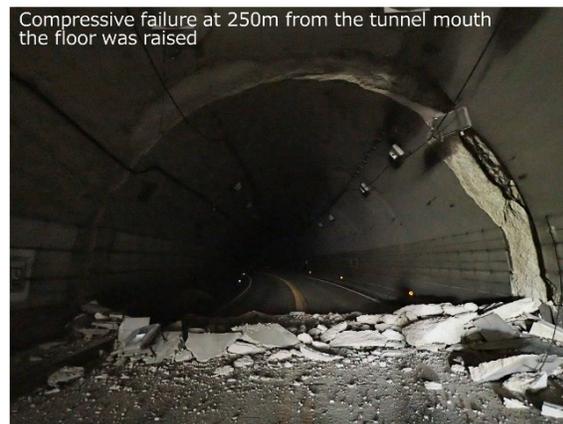
Figure 25. Tawarayama tunnel suffered from axial compression failure (Site 16 in Fig. 12) ($32^{\circ} 51'35.68''N$, $130^{\circ} 58'6.86''E$).

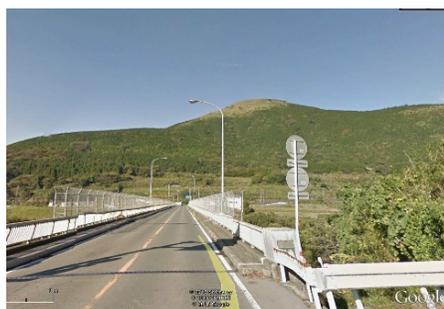
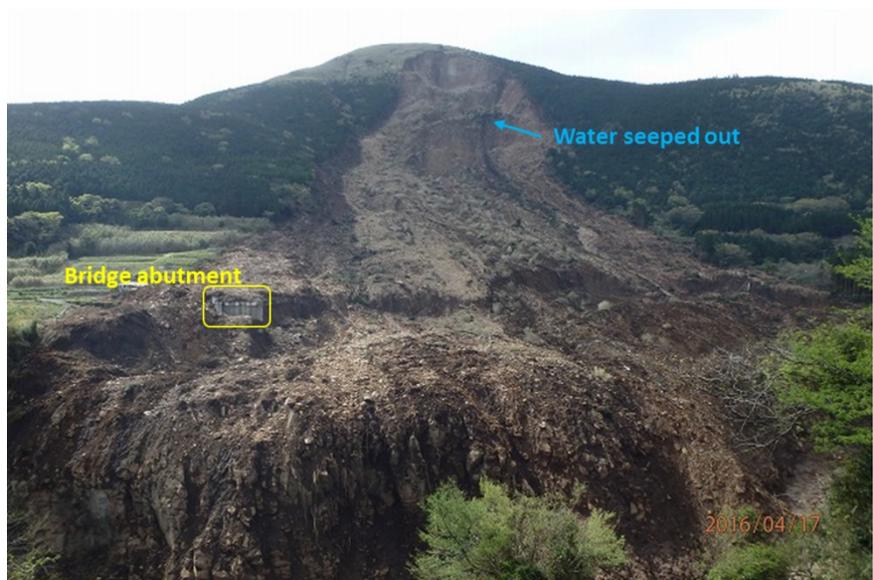
Figure 28 shows a shallow landslide near Aso Ohashi Bridge caused by the main shock on the 16th of April (site 17). The landslide had a height of about 300 m (measured from the road level to the scrap) with an inclination angle of about 50 degrees at the top and about 25 degrees at the middle and bottom of the slope. The debris was a mixture of middle Pleistocene volcanic soils and boulders (tuff breccia); Route 57 and JR Hohi Main Line (railway) was also covered by it. The debris travelled a distance exceeding 800 m and fell into the Kurokawa-River along with Aso Ohashi Bridge. Evidence of mud debris was found on the opposite side of the river which is thought to have travelled along the bridge before its collapse. For this reason, the cause of bridge failure is considered to be the impact force and/or weight of debris that flowed down from the landslide source. Moreover, in Figure 28, taken one day after the event, water seeped out from the failed surface, which may explain the reduction of shear strength of the slope ground due to increase in excess pore water pressure during the intense earthquake.

Figure 28. Landslide near Aso Ohashi Bridge (site 17 in Fig. 26).
(32° 53'0.02"N, 130° 59'22.80"E).

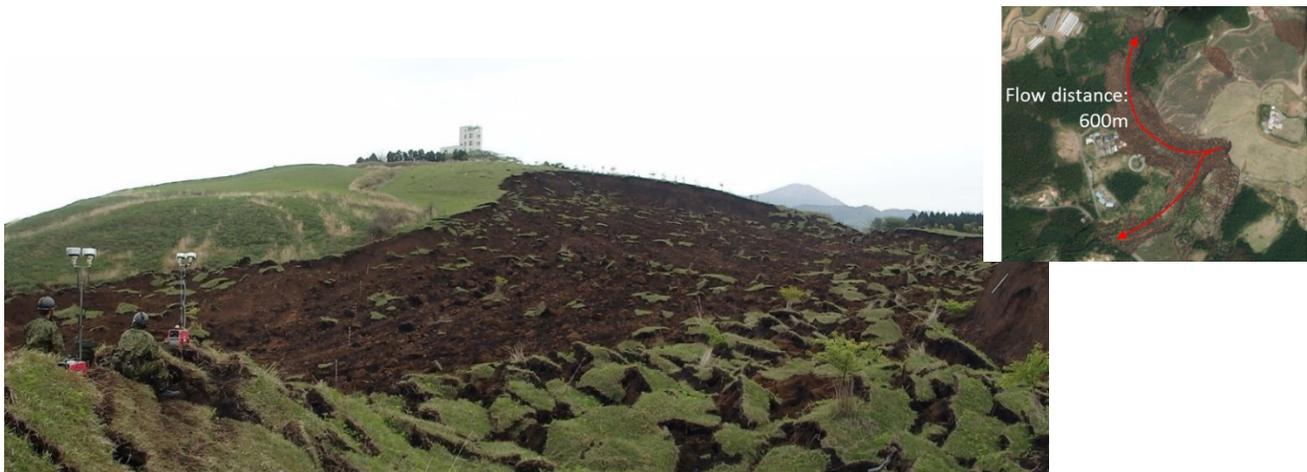
At site 18 in Fig. 26, a large scale landslide occurred at a volcanic hill (late Pleistocene) with a height in excess of 80 m from its base. The failure occurred on a relatively gentle slope with an angle of less than 10 degrees. The sliding of the slope towards the toe, however, was remarkable as shown in Figure 29. This failure killed five people who were in the house at the middle of the slope. A few hundred meters south of the above landslide another landslide occurred and caused severe damage to the residential houses as shown in Figure 30 (site 19). The length of the landslide was 70 m with an inclination angle of about 10 degrees. As the Kumamoto earthquake is an inland earthquake which caused severe damage in the mountain area, it is often compared with the 2004 Chuetsu earthquake (M_w 6.6) which hit Niigata Prefecture, Japan, and caused a number of landslides (Toyota et al., 2006). Slope failures triggered by the Chuetsu earthquake occurred at a sedimentary rock interface, and the slope angle before the failure was about 20 degrees on average (Yamasaki, 2008), which is much steeper than the cases in the Aso mountain area in the Kumamoto earthquake. The debris of the landslides in Aso Caldera area was a mixture of volcanic ash, andsol, a highly porous dark-colored material comprising of volcanic ash mixed with organic matter, and pumice. As shown in Figure 30, alternating layers were seen at the surface of the scrap. The cause of failure and long-distance flow at the gentle slope is not identified yet, however, since the natural deposited pumice is known to have high crushability, the soil may have experienced significant strength reduction associated with particle breakage during the earthquake.

Figure 29. Large scale landslide in Aso Caldera area (site 18 in Fig. 26) ($32^{\circ} 53'5.47''N$, $131^{\circ} 00'10.56''E$).

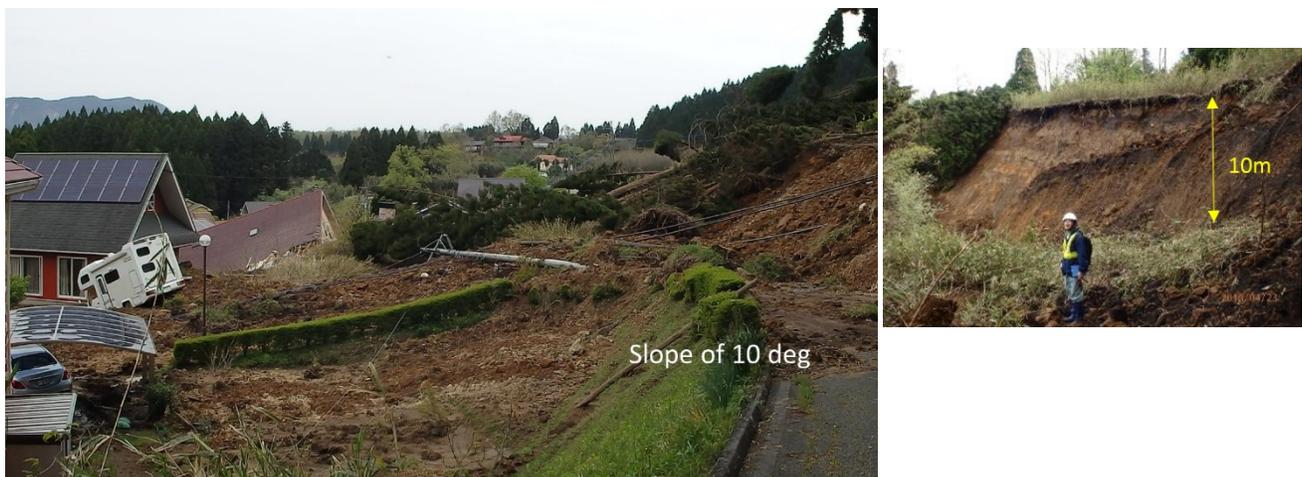
Figure 30. Landslide at gentle slope and its scrap (site 19 in Fig. 26) ($32^{\circ} 52'29.42''N$, $131^{\circ} 00'49.36''E$).

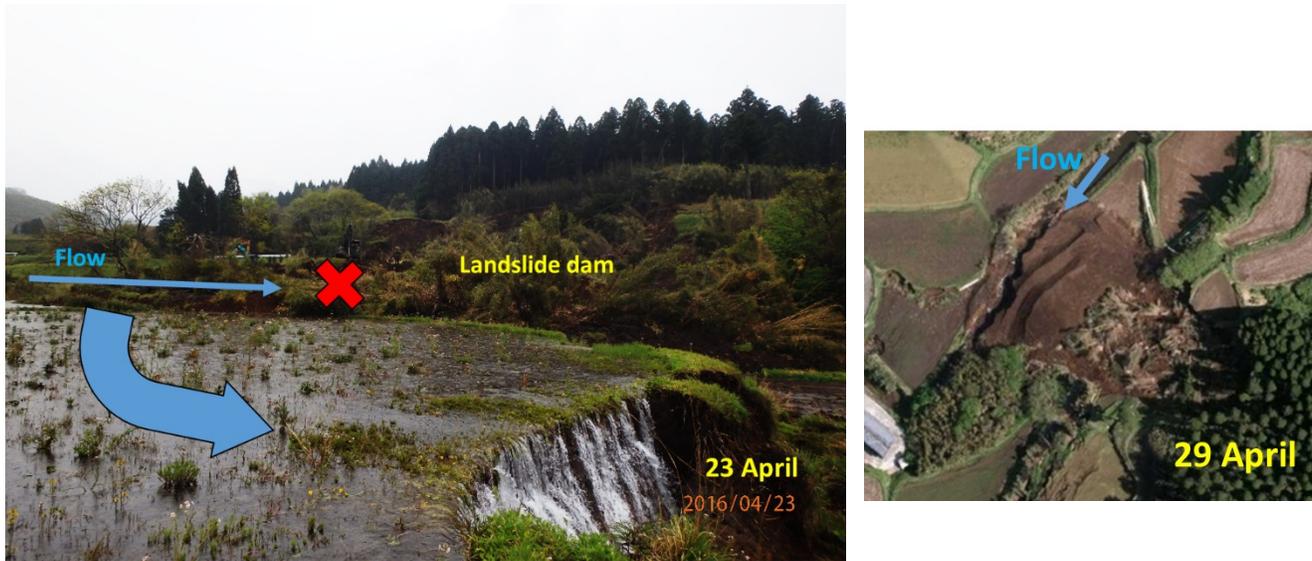
A slope failure was observed at site 20 in Fig. 26; the length of the failure was about 100 m. The debris blocked the road and a tributary of the Kurokawa River completely; the blocked tributary overflowed with water spreading into the surrounding paddy field (Figure 31). To avoid the potential risk of flooding to the downstream villages following the landslide dam breaching, the relevant authority had excavated a spillway to secure the safety of the dam. The excavation was likely finished within two weeks of the event.

Figure 31. Landslide dam formed by the earthquake and excavation work completed (site 20 in Fig. 26) ($32^{\circ} 53'14.06''N$, $130^{\circ} 59'48.90''E$).

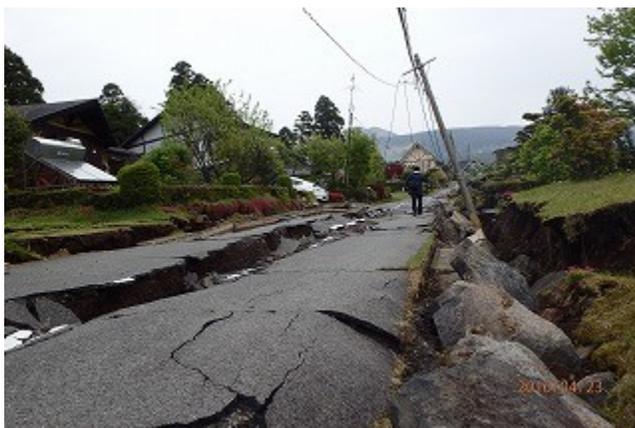
Figure 32 and 33 show damage of the road and house at site 21. Although this area reportedly survived the earthquake on the 14th of April, significant distortion of subsurface ground occurred during the main shock on the 16th of April. The spatial distribution of damage was severe at the northern part of the residential area. Figure 34 shows a comparison of aerial photos taken in 1975 and in 2016 (GSI, 2016), indicating that the damaged area used to be a paddy field but had subsequently been infilled during the construction of the housing estate. The filled soil in the damaged area is a local volcanic ash soil. Tanoue et al. (2005) reported that it is usually hard to construct a stable embankment from the ash deposited in the Central Kyushu area. It seems from Fig. 34 that the ground level of the northern part of the residential area was comparatively low in 1975, the filled soil might have been thicker for the northern side than the southern side. This might be why the earthquake-induced damage to the land was found to be severe in the northern side, however, structural damage to the residential houses in this area was negligible despite large ground deformation.

Figure 32. Damage to the road in residential area developed by filling (Site 21 in Fig. 26) ($32^{\circ} 52'43.89''N$, $130^{\circ} 59'58.89''E$).

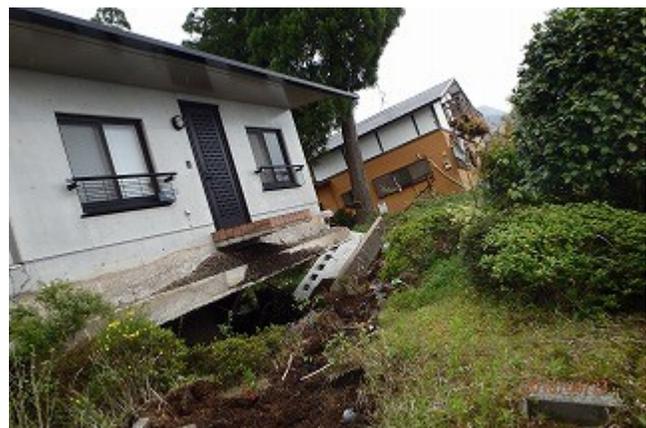
Figure 33. Damage to the house in residential area developed by filling (Site 21 in Fig. 26) ($32^{\circ} 52'45.06''N$, $131^{\circ} 00'1.44''E$).

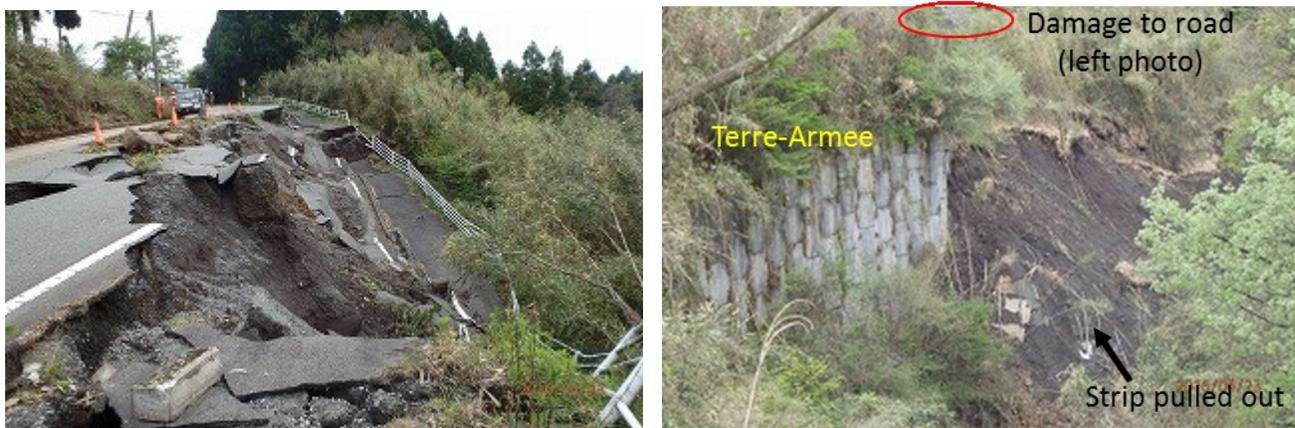
A 50 m-long embankment on prefectural road No. 149 (site 22 in Fig. 26) suffered from damage in the form of slope failure. Ground fissures and road pavement damage were also found there. This embankment (about 10-15 m high) was constructed along the small river by using a reinforced soil retaining wall technique (Terre-Armee), the wall was also damaged significantly as shown in Figure 35. Steel strip materials pulled out from the backfill soil were found on the failed slope surface. The reason for the failure of the reinforced soil retaining wall is not yet identified.

Figure 35. Damage to road embankment and reinforced retaining wall (Terre-Armee) (site 22 in Fig. 26) ($32^{\circ} 52'52.01''N$, $131^{\circ} 00'14.84''E$).

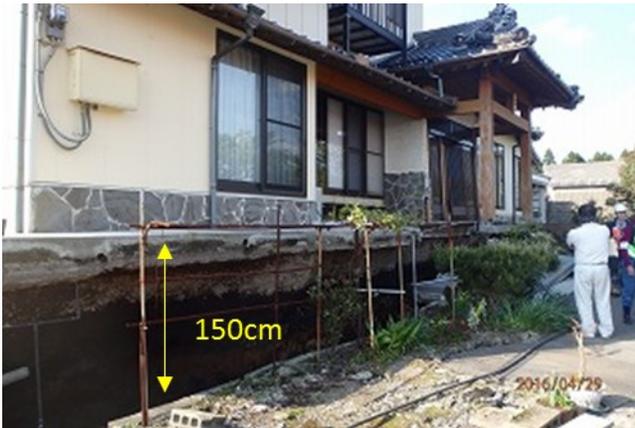
A trough-like depression was found at several locations in the basin of Aso Caldera. According to both the authors' site investigation and aerial photointerpretation of cracks on ground surface provided by the GSI (2016) and Kokusai Kogyo co. Ltd (2016), the trough-like depression, with a maximum depth of about 1-1.5 m, was found to stretch several kilometers in length, the width of the depression was several tens of meters. At site 23, the ground depression caused damage to a residential house (Fig. 36). The damage due to the depression has also been harmful to agriculture in this area (Figure 37). The mechanism of the depression, however, is not yet identified. The residents in the affected area reported that the depression occurred immediately when the main shock occurred on the 16th of April. The fact indicates that the cause of the depression was probably not liquefaction. Refer to a separate report by Konagai et al. (2016) for further information about this feature.

Figure 36. Ground depression-induced damage to the residential house (Site 23 in Fig. 26) ($32^{\circ} 57'23.84''N$, $131^{\circ} 2'12.31''E$).
