Geotechnical Damage Caused by the 2016 Kumamoto Earthquake, Japan

Takashi Kiyota, Associate Professor, Institute of Industrial Science, University of Tokyo, Tokyo, Japan; email: kiyota@iis.u-tokyo.ac.jp

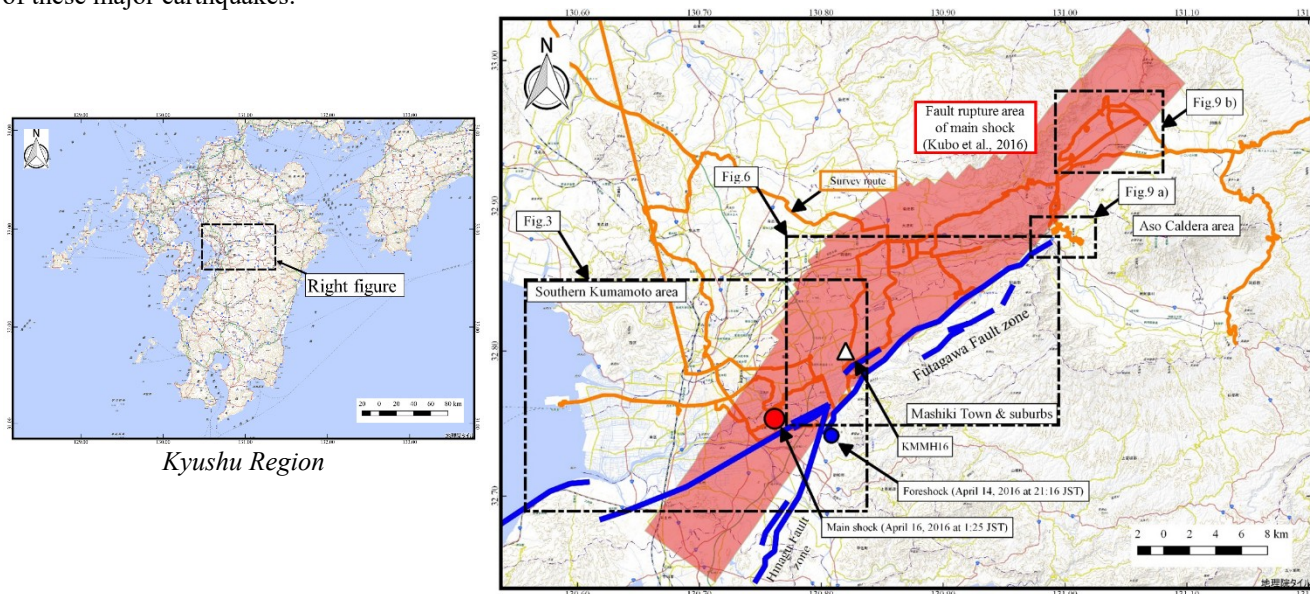
Figure 1. Location of the epicenters of earthquakes, earthquake faults and survey route.

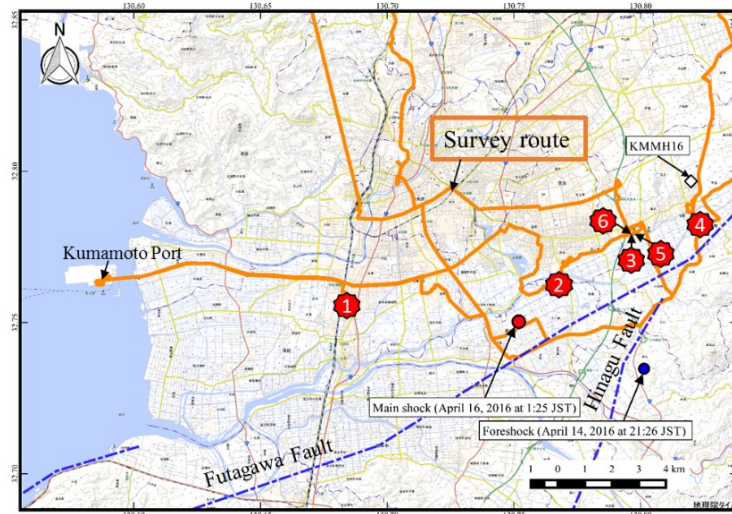
Figure 3. Survey route and locations of investigation sites in southern Kumamoto City (modified from Google map).

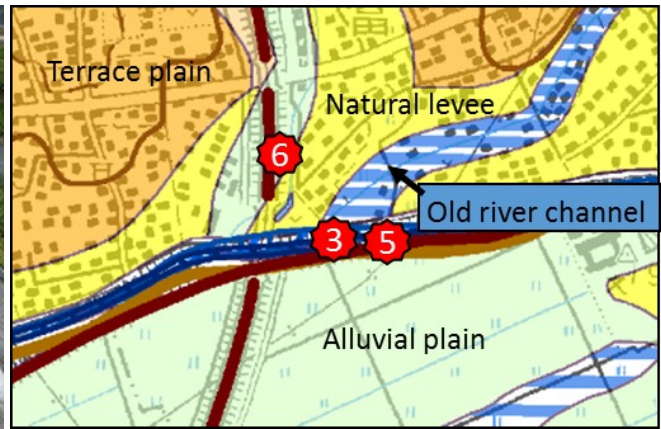
Figure 7. Landform classification map and location of the damaged sites (Modified from GSI's map).

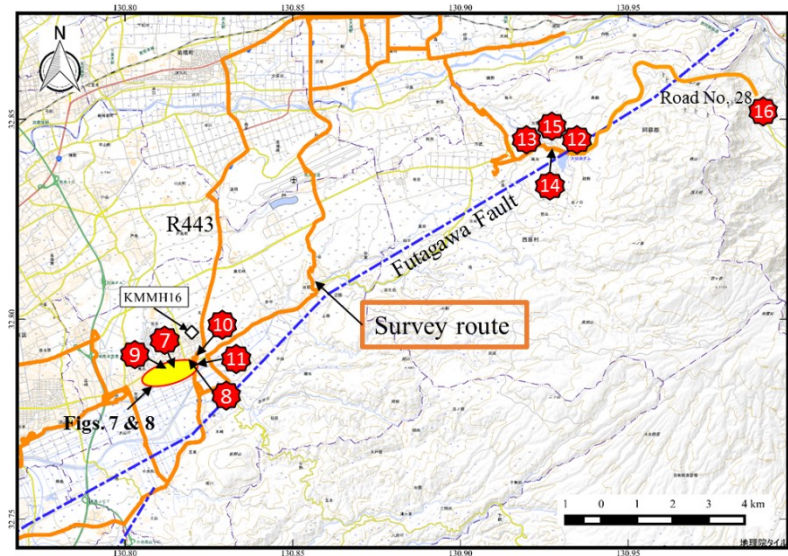
Figure 12. Survey route and locations of investigation sites in Mashiki Town and suburb area.

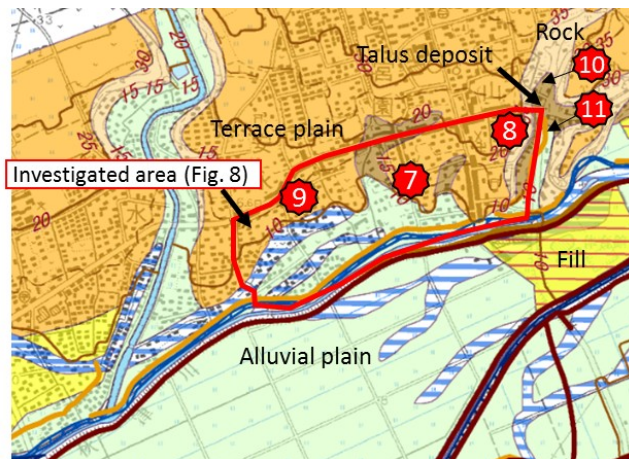
Figure 14. Landform classification map around the survey area in Mashiki Town (Modified from GSI's map, c.f. Fig. 12).

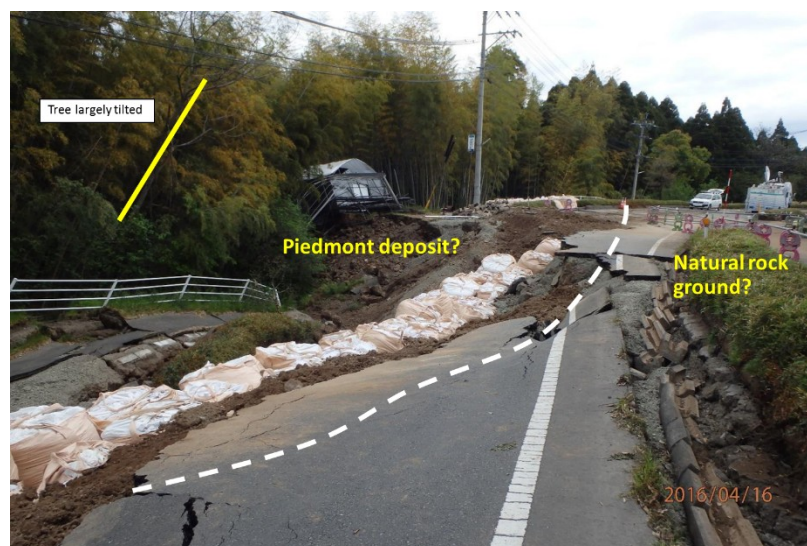
Figure 18. Damage to Route 443 in Mashiki Town (Site 10 in Figs. 12 and 14) ($32^{\circ} 47'29.71''N$, $130^{\circ} 49'17.58''E$).

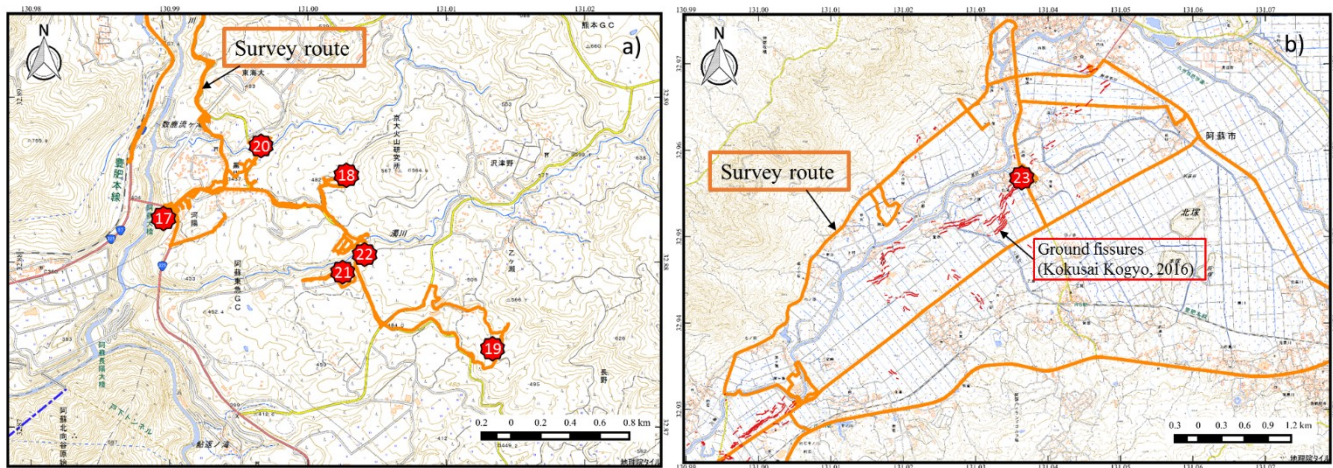
Figure 26. Survey route and locations of investigation sites in Aso Caldera area.

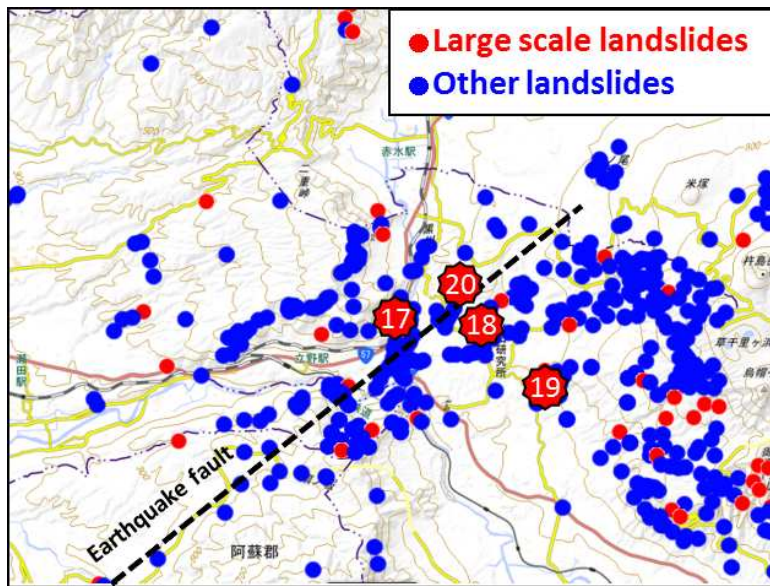
Figure 27. Positional relationship between fault and landslides in and around Aso Caldera area (Modified from landslide map of GSI, 2016).

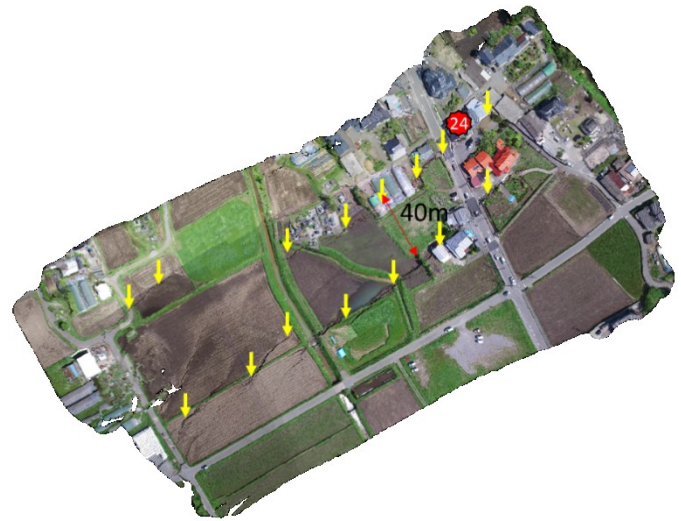
Figure 37. Digital image obtained by UAV around the trough-like depression area (c.f. Fig. 26).
