# Geotechnical Damage Caused by the 2016 Kumamoto Earthquake, Japan

Reference: Kiyota, T., Ikeda, T., Konagai, K. and Shiga, M. (2017). *Geotechnical Damage Caused by the 2016 Kumamoto Earthquake, Japan*. International Journal of Geoengineering Case histories, <http://casehistories.geoengineer.org>, Vol.4, Issue 2, p.78-95. doi: 10.4417/IJGCH-04-02-01

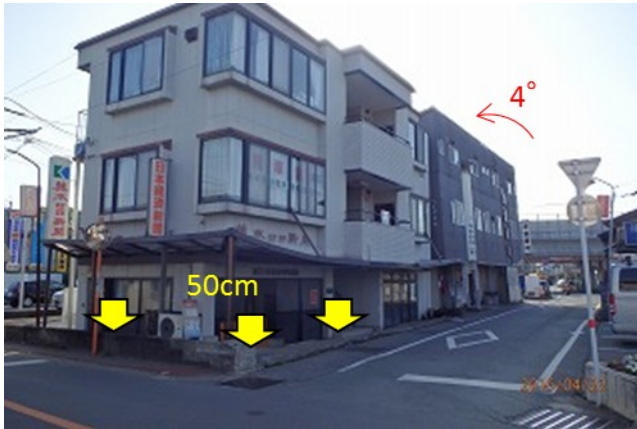
Figure 4 shows the liquefaction-induced damage to buildings in Karikusa district (site 1). The building suffered from significant settlement of about 50 cm. The adjacent building also suffered from a tilting of about four degrees. Similar damage to residential houses was observed in Majima district (Figure 5, site 2) which is a reclaimed land along the river. In addition, liquefaction as evidenced by sand boils present in Kumamoto Port, however, the liquefaction-induced damage to major facilities was not reported. As a whole impression of liquefaction during the Kumamoto earthquake, the number of damaged buildings and facilities was much fewer than in the Kanto region during the 2011 Off Pacific Coast of Tohoku Earthquake (Yasuda et al., 2012; Towhata et al., 2014).

Figure 4. Liquefaction-induced damage to buildings in Karikusa district (Site 1 in Fig. 3) ( $32^{\circ}45'35.70''N$ ,  $130^{\circ}40'59.76''E$ ).

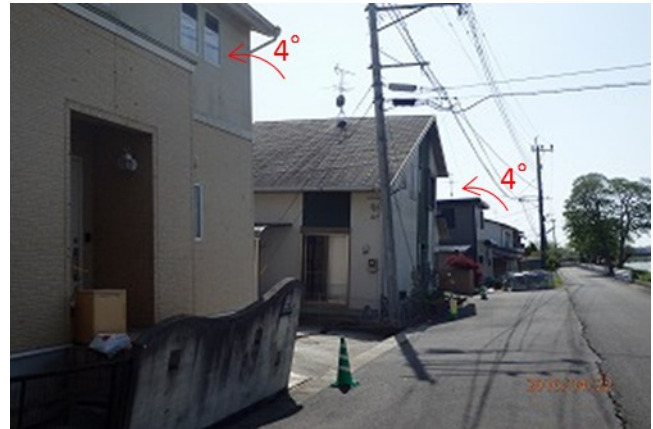
Figure 5. Liquefaction-induced damage to residential houses in Majima district (Site 2 in Fig. 3) ( $32^{\circ}45'52.69''N$ ,  $130^{\circ}46'7.49''E$ ).

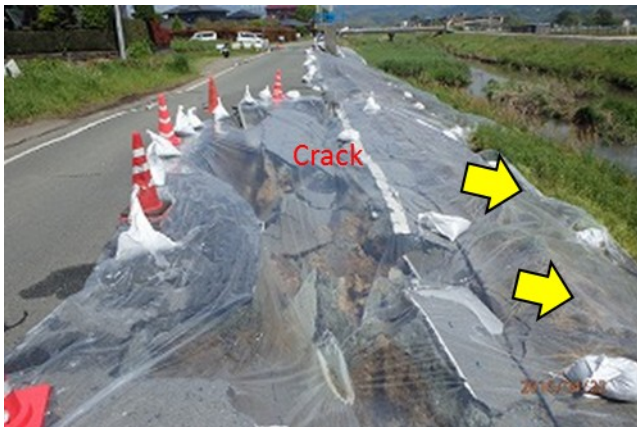
Figure 6 shows the typical liquefaction-induced damage to a river levee (site 3). Large settlement and lateral deformation was found at the levee along Akitsukawa-River. According to a landform classification map for flood control, provided by Geospatial Information Authority of Japan (GSI) shown in Fig. 7, the damaged levee is located at the old river channel, which suggests that a shallow soft deposit liquefied, inducing lateral spreading toward the river. Kyushu Regional Development Bureau of MLIT (2016) reported damage of variable severity to the levees of the Midorikawa-River and Shirakawa-River. They identified a total of 171 sites, however, their emergency restoration was almost completed as of middle of May. The settlement of levees, for example, caused a large gap between the embankment and bridge girders leading to a transportation problem (Figure 8, site 4). As of the end of April, such problems have occurred at many locations, however, they have been temporally solved by the installation of a filled slope (Figure 9, site 5). Although the locations of liquefaction are widespread in Kumamoto City (Wakamatsu et al., 2016), there have been no official report of serious liquefaction-induced damage; there are neither collapse of buildings nor washout of levees due to liquefaction.

Figure 6. Liquefaction-induced damage to levee along Akitsukawa-River (Site 3 in Figs. 3 and 7) ( $32^{\circ}46'43.56''N$ ,  $130^{\circ}47'40.27''E$ ).

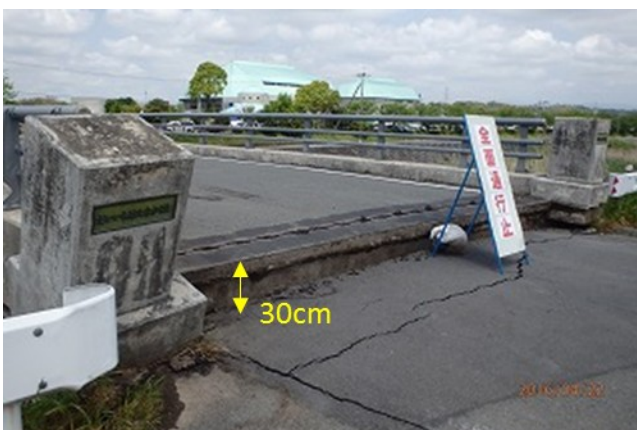
Figure 8. A large gap at bridge girder due to settlement of embankment (Site 4 in Fig. 3) ( $32^{\circ}47'2.15''N$ ,  $130^{\circ}49'17.70''E$ ).

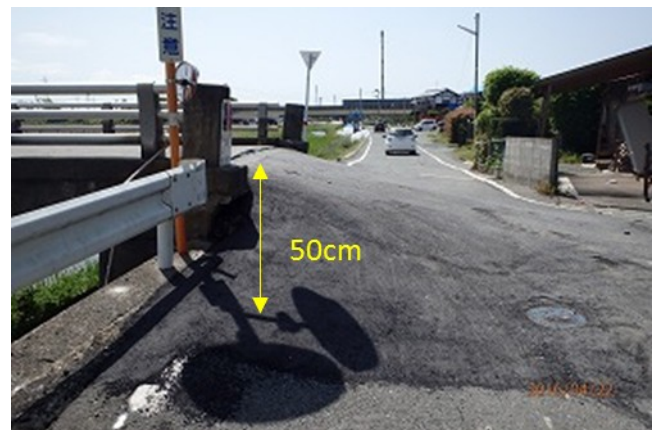
Figure 9. Temporary restoration work (filled slope) for settlement of levee (Site 5 in Figs. 3 and 7) ( $32^{\circ}46'44.47''N$ ,  $130^{\circ}47'45.43''E$ ).

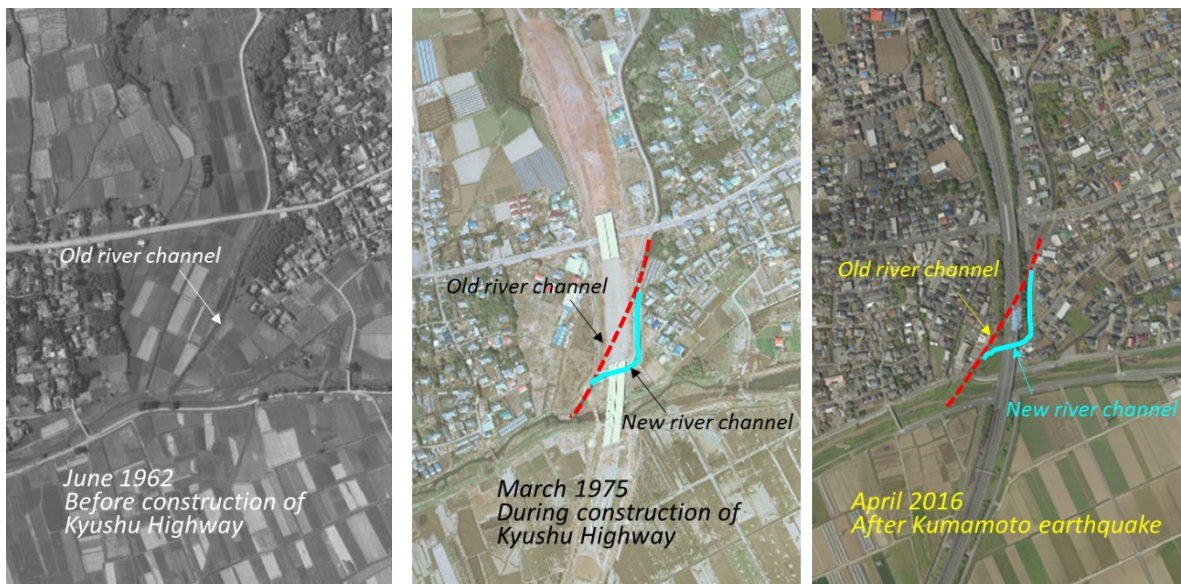
Figure 11. Aerial photo of damaged highway embankment before and after the 2016 Kumamoto earthquake (Modified from GSI aerial photo).

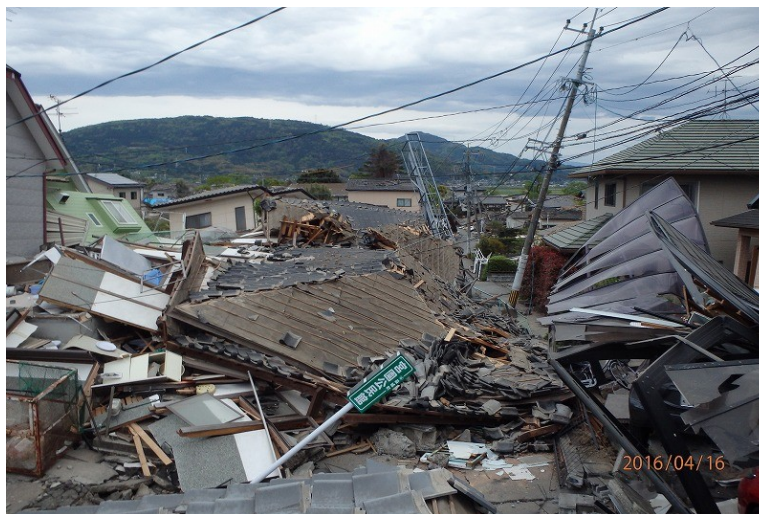
There were numerous building collapses in Mashiki Town. Fig. 13 shows the typical damage to the residential houses in the yellow-colored area in Fig. 12 (site 7). The residents in the affected area reported that a number of houses suffered from moderate to significant structural damage due to the earthquake on the 14<sup>th</sup> of April and then totally destroyed by the main shock on the 16<sup>th</sup>. It is also reported that the number of deaths in this area was fewer than expected from the damage shown in Fig. 13 because many affected residents had already fled their damaged house after the earthquake of the 14<sup>th</sup> (Fukuwa, 2016).

Figure 13. Damage to residential houses in Mashiki Town (Site 7 in Fig. 12)  
(32° 47'16.38"N, 130° 48'58.47"E).

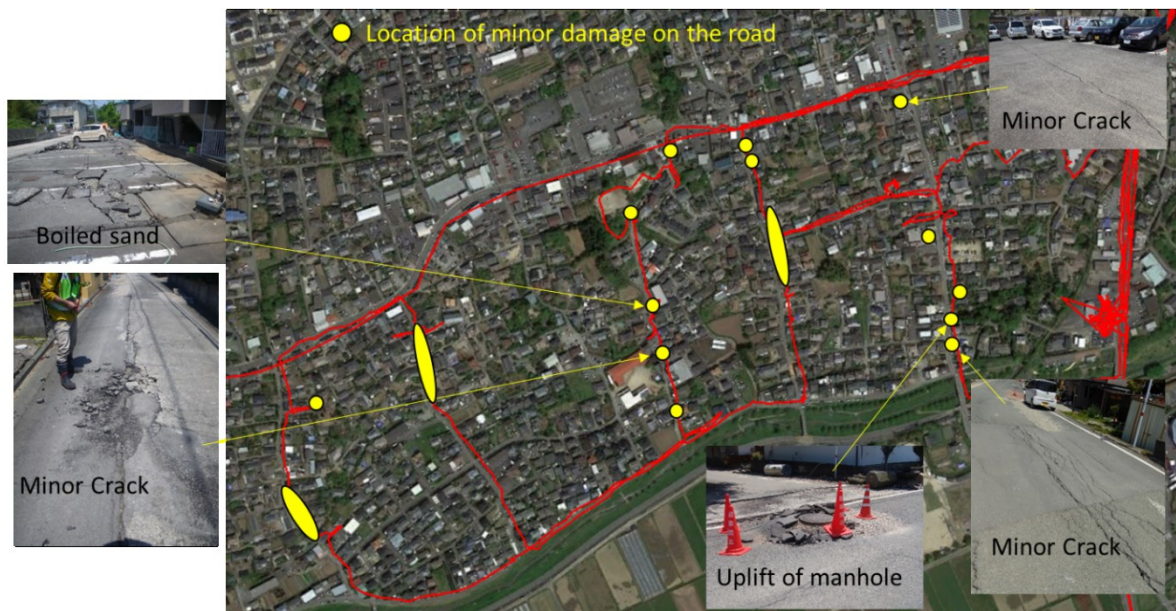
Figure 15 shows the result of the authors' quick survey. The spatial distribution of the collapsed houses was concentrated in the sloped area which consists of terrace and talus deposits, whereas ground deformation observed on the roads near the damaged houses was limited, therefore a large scale landslide might not have occurred. The cause of significant damage to the houses in this area was likely due to earthquake motion and the residual displacement of the entire sloped ground had an insignificant effect on the damaged houses. Although some houses were found to be damaged by ground deformation, as shown in Fig. 16 and 17 (sites 8 and 9), they were likely caused by localized failure of filled soil. On the other hand, the damage to the houses in the alluvial deposit area was limited whereas evidence of liquefaction was found frequently as shown in Fig. 15. It is inferred that the liquefied soil incidentally behaved like a seismic isolation system for the residential houses in this area.

Figure 15. Result of survey on ground deformation of sloped residential area in Mashiki Town (c.f. Figs. 12 and 14).

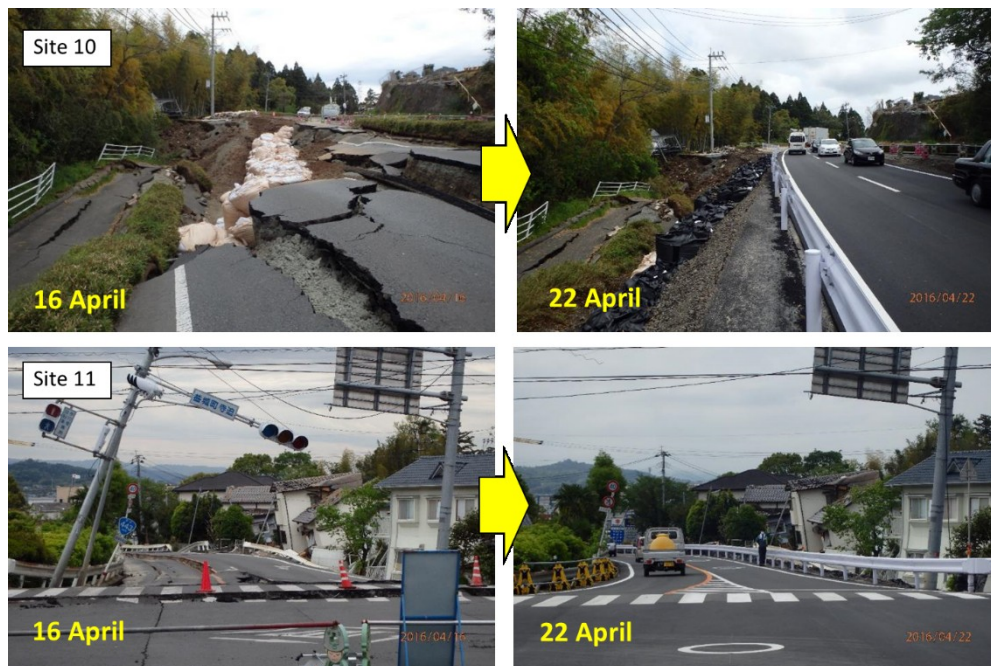
Approximately 150 m south of the above damaged site a differential settlement was observed (Photo 12b, site 11). According to the landform classification map in Fig. 14, it is indicated that the damaged site was recently constructed on the alluvial soil deposit. The damage, therefore, is attributed to strength reduction of foundation ground due to a process of liquefaction and/or that of the embankment, if the compaction work was inadequate. Immediately after the earthquake, emergency restoration work was rapidly conducted in the affected areas. As shown in Fig. 19, the restoration work for the damaged sites along Route 443 was completed a few days after the main shock.

Figure 19. Damages to Route 443 and their restoration for (a) site 10 and (b) site 11 (c.f. Figs. 12 and 14)  
(Site 10:  $32^{\circ}47'29.71''N$ ,  $130^{\circ}49'17.58''E$ , Site 11:  $32^{\circ}47'24.33''N$ ,  $130^{\circ}49'15.82''E$ ).

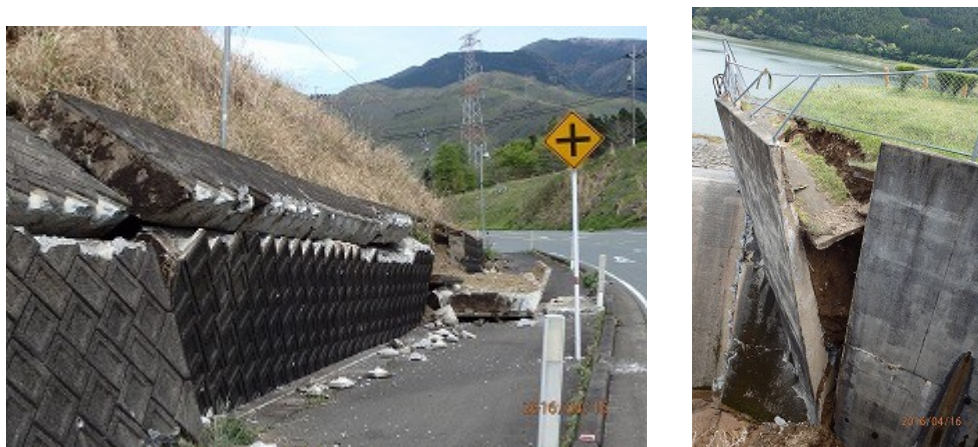
Mashiki and the surrounding areas were close to the seismic fault and suffered from a variety of geotechnical and structural damage due to the earthquakes. Damage to gravity-type and cantilever-type retaining walls (2-3 m high) was found at several locations due to surface manifestation of fault rupture. The retaining wall and dam spillway retaining wall at site 12 in Fig. 12 were structurally damaged as a result of the fault movement (Fig. 20).

Figure 20. Damage to retaining wall and spillway retaining wall (site 12 in Fig. 12)  
( $32^{\circ}50'29.22''N$ ,  $130^{\circ}55'55.83''E$ ).

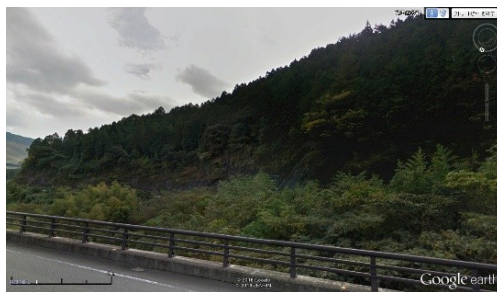
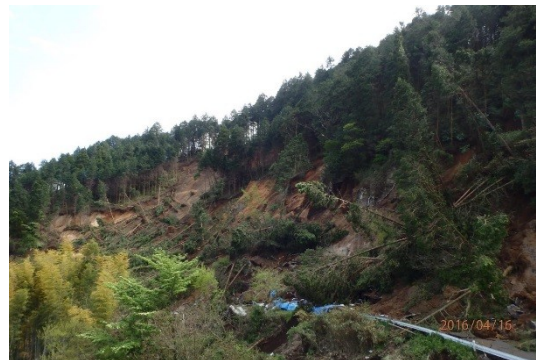
Figure 22. Slope failure along prefectural road No. 28 (site 14 in Fig. 12) ( $32^{\circ}50'32.96''N$ ,  $130^{\circ}55'40.65''E$ ).

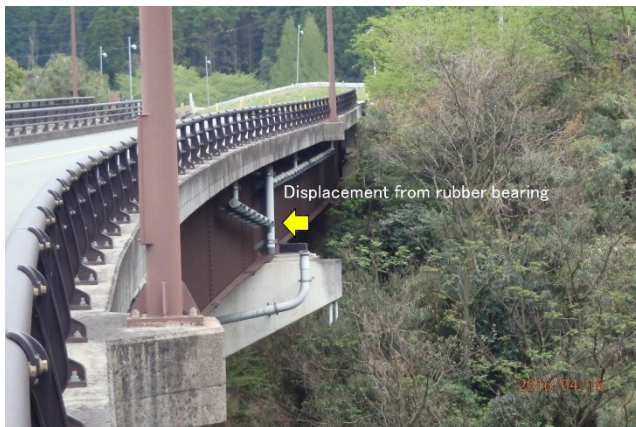
Figure 24. The girder of Ohkiri-hata Bridge moved about 1-1.5m (Site 14 in Fig. 12) ( $32^{\circ} 50'32.63''N$ ,  $130^{\circ} 55'43.10''E$ ).

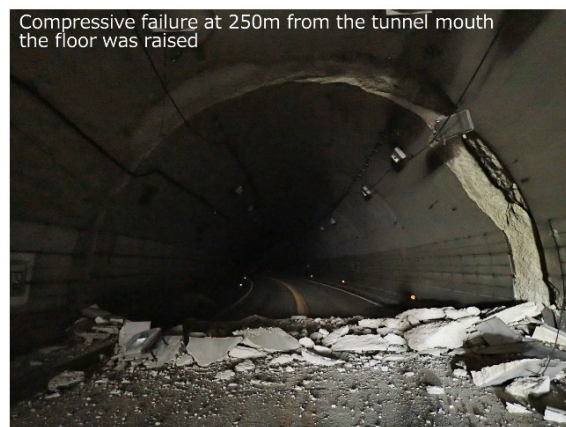
Figure 25. Tawarayama tunnel suffered from axial compression failure (Site 16 in Fig. 12) ( $32^{\circ} 51'35.68''N$ ,  $130^{\circ} 58'6.86''E$ ).

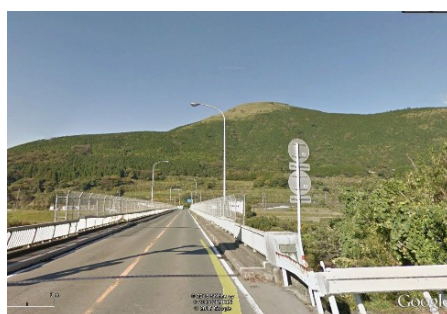
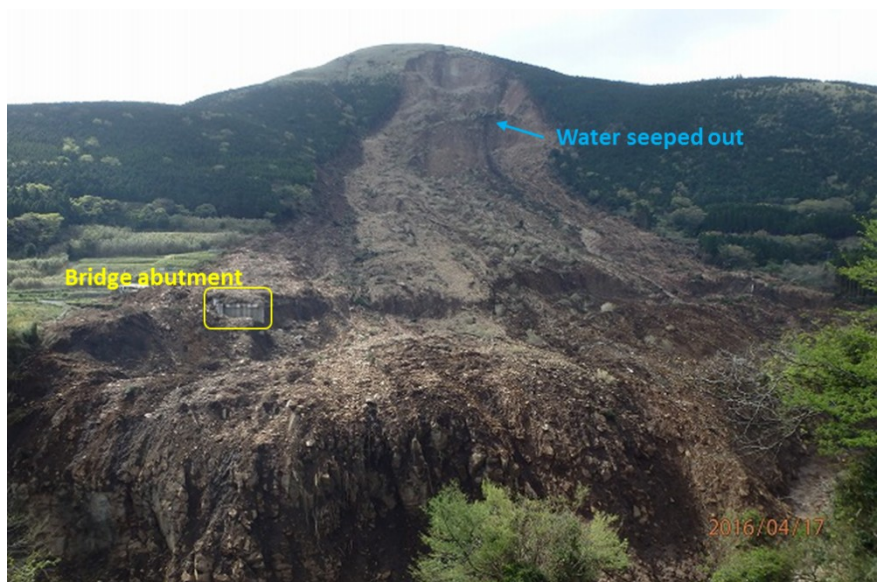
Figure 28 shows a shallow landslide near Aso Ohashi Bridge caused by the main shock on the 16<sup>th</sup> of April (site 17). The landslide had a height of about 300 m (measured from the road level to the scrap) with an inclination angle of about 50 degrees at the top and about 25 degrees at the middle and bottom of the slope. The debris was a mixture of middle Pleistocene volcanic soils and boulders (tuff breccia); Route 57 and JR Hohi Main Line (railway) was also covered by it. The debris travelled a distance exceeding 800 m and fell into the Kurokawa-River along with Aso Ohashi Bridge. Evidence of mud debris was found on the opposite side of the river which is thought to have travelled along the bridge before its collapse. For this reason, the cause of bridge failure is considered to be the impact force and/or weight of debris that flowed down from the landslide source. Moreover, in Figure 28, taken one day after the event, water seeped out from the failed surface, which may explain the reduction of shear strength of the slope ground due to increase in excess pore water pressure during the intense earthquake.

Figure 28. Landslide near Aso Ohashi Bridge (site 17 in Fig. 26).  
(32° 53'0.02"N, 130° 59'22.80"E).

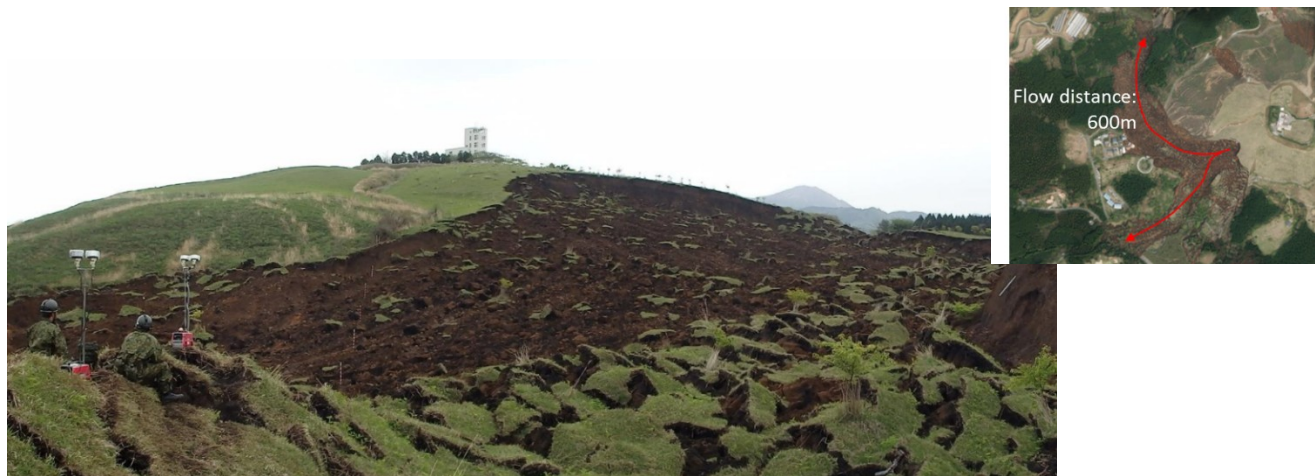
At site 18 in Fig. 26, a large scale landslide occurred at a volcanic hill (late Pleistocene) with a height in excess of 80 m from its base. The failure occurred on a relatively gentle slope with an angle of less than 10 degrees. The sliding of the slope towards the toe, however, was remarkable as shown in Figure 29. This failure killed five people who were in the house at the middle of the slope. A few hundred meters south of the above landslide another landslide occurred and caused severe damage to the residential houses as shown in Figure 30 (site 19). The length of the landslide was 70 m with an inclination angle of about 10 degrees. As the Kumamoto earthquake is an inland earthquake which caused severe damage in the mountain area, it is often compared with the 2004 Chuetsu earthquake ( $M_w$  6.6) which hit Niigata Prefecture, Japan, and caused a number of landslides (Toyota et al., 2006). Slope failures triggered by the Chuetsu earthquake occurred at a sedimentary rock interface, and the slope angle before the failure was about 20 degrees on average (Yamasaki, 2008), which is much steeper than the cases in the Aso mountain area in the Kumamoto earthquake. The debris of the landslides in Aso Caldera area was a mixture of volcanic ash, andsol, a highly porous dark-colored material comprising of volcanic ash mixed with organic matter, and pumice. As shown in Figure 30, alternating layers were seen at the surface of the scrap. The cause of failure and long-distance flow at the gentle slope is not identified yet, however, since the natural deposited pumice is known to have high crushability, the soil may have experienced significant strength reduction associated with particle breakage during the earthquake.

Figure 29. Large scale landslide in Aso Caldera area (site 18 in Fig. 26) ( $32^{\circ} 53'5.47''N$ ,  $131^{\circ} 00'10.56''E$ ).

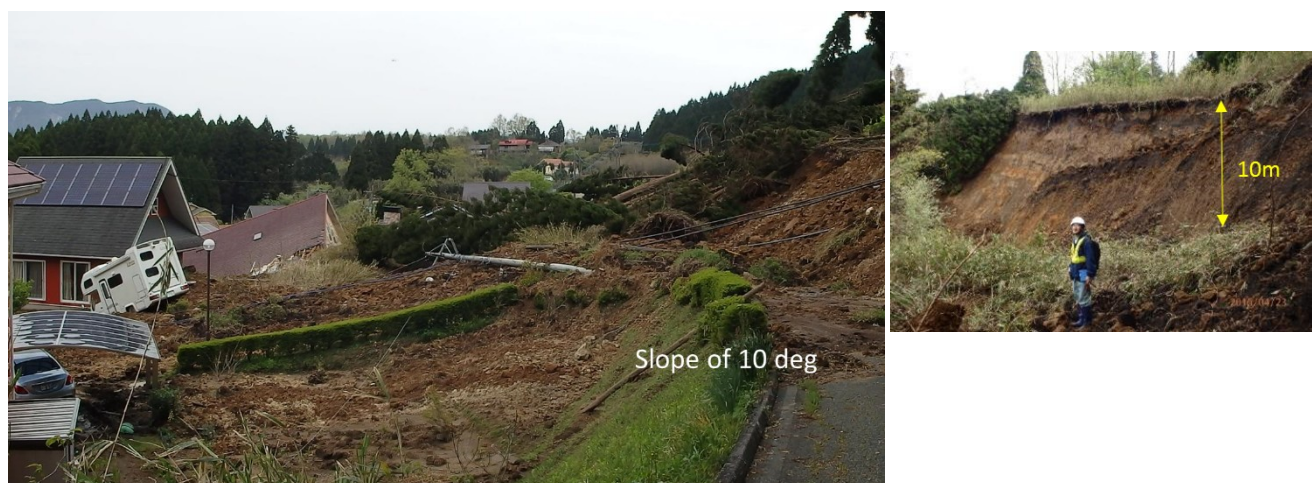
Figure 30. Landslide at gentle slope and its scrap (site 19 in Fig. 26) ( $32^{\circ} 52'29.42''N$ ,  $131^{\circ} 00'49.36''E$ ).

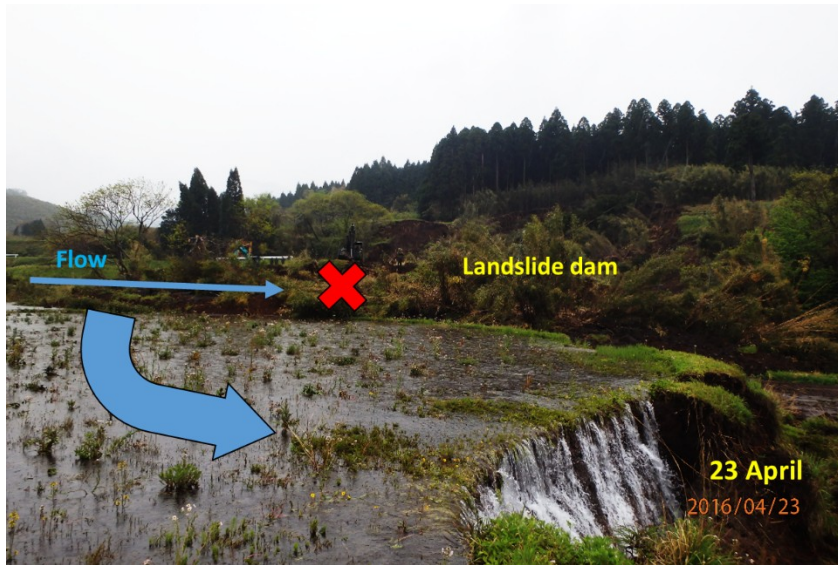
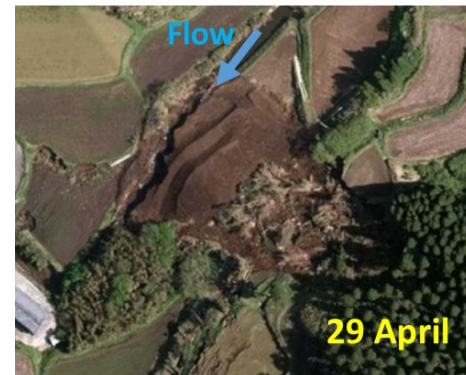
A slope failure was observed at site 20 in Fig. 26; the length of the failure was about 100 m. The debris blocked the road and a tributary of the Kurokawa River completely; the blocked tributary overflowed with water spreading into the surrounding paddy field (Figure 31). To avoid the potential risk of flooding to the downstream villages following the landslide dam breaching, the relevant authority had excavated a spillway to secure the safety of the dam. The excavation was likely finished within two weeks of the event.

Figure 31. Landslide dam formed by the earthquake and excavation work completed (site 20 in Fig. 26) ( $32^{\circ} 53'14.06''N$ ,  $130^{\circ} 59'48.90''E$ ).

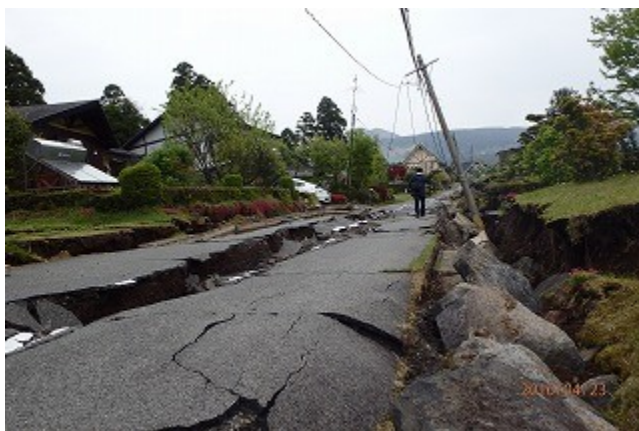
Figure 32 and 33 show damage to the road and house at site 21. Although this area reportedly survived the earthquake on the 14<sup>th</sup> of April, significant distortion of subsurface ground occurred during the main shock on the 16<sup>th</sup> of April. The spatial distribution of damage was severe at the northern part of the residential area. Figure 34 shows a comparison of aerial photos taken in 1975 and in 2016 (GSI, 2016), indicating that the damaged area used to be a paddy field but had subsequently been infilled during the construction of the housing estate. The filled soil in the damaged area is a local volcanic ash soil. Tanoue et al. (2005) reported that it is usually hard to construct a stable embankment from the ash deposited in the Central Kyushu area. It seems from Fig. 34 that the ground level of the northern part of the residential area was comparatively low in 1975, the filled soil might have been thicker for the northern side than the southern side. This might be why the earthquake-induced damage to the land was found to be severe in the northern side, however, structural damage to the residential houses in this area was negligible despite large ground deformation.

Figure 32. Damage to the road in residential area developed by filling (Site 21 in Fig. 26) ( $32^{\circ} 52'43.89''N$ ,  $130^{\circ} 59'58.89''E$ ).

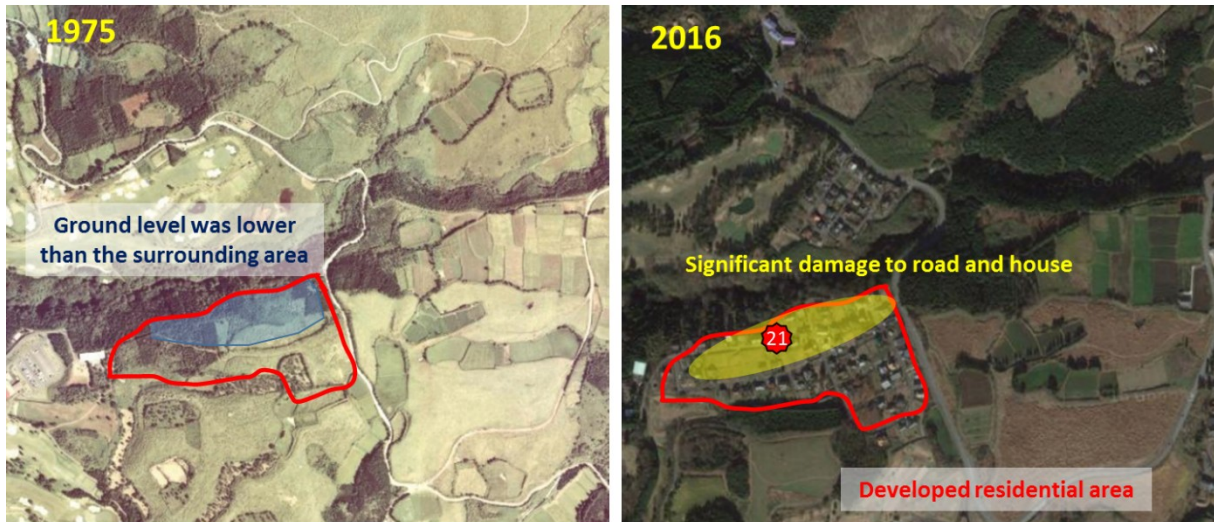
Figure 34. Aerial photo of damaged residential area in 1975 and after the 2016 Kumamoto earthquake (Modified from aerial photo of GSI, 2016).

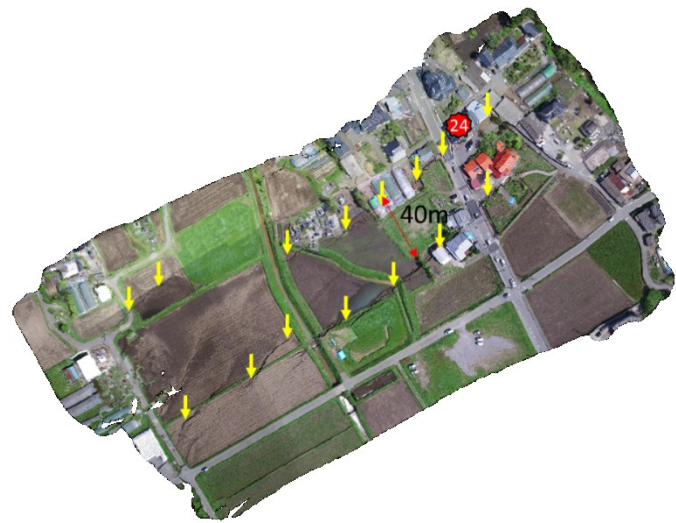
Figure 37. Digital image obtained by UAV around the trough-like depression area (c.f. Fig. 26).
