Uplift of an Underground Tank in Northern Malabar Region, India

ABSTRACT: *An underground reinforced concrete tank was constructed for a project in the southwest region of India. The tank was 90 m x 35 m in plan and 7.3 m deep resting on partly filled-up and partly native soil. During the peak monsoon, a sudden uplifting of the base slab by about 300 mm and subsequent failure of the foundation raft and a partition wall was observed. Laboratory testing was executed and hydrogeological survey was carried out using ground penetrating radar, seismic refraction and infiltrometer testing, and an analytical study was carried out to identify the root cause of the tank uplifting. Based on this study, it was observed that the uplifting and structural failure was essentially due to the peculiar land terrain and soil properties and the development of excess hydraulic head below the bottom of the tank. After considering different options, the rectification measures were carried out by provision of dewatering wells along the tank periphery to release the excess hydrostatic pressure and stabilize the foundation raft. The structural repair of the top of the foundation raft and partition wall was

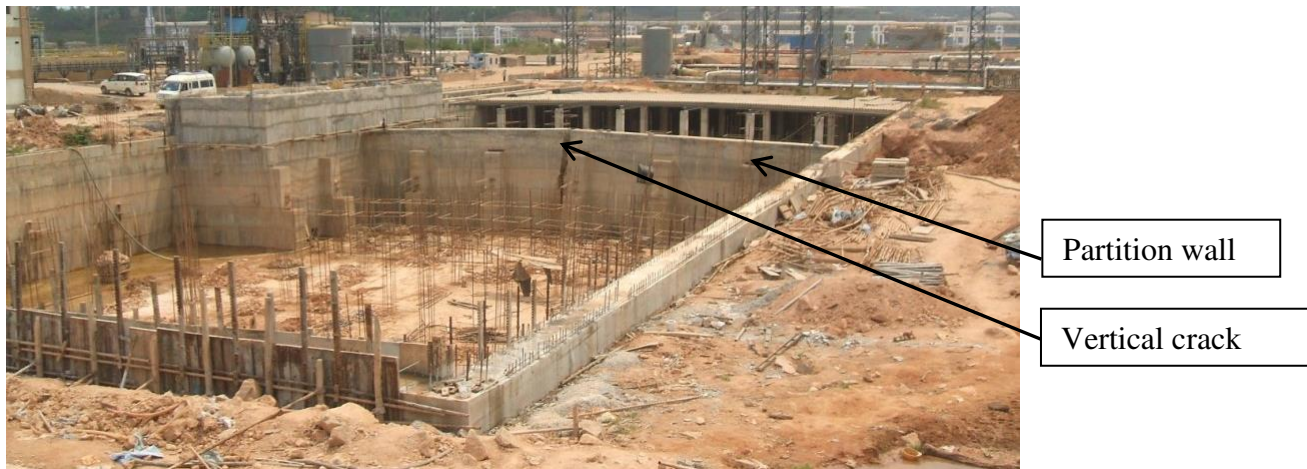
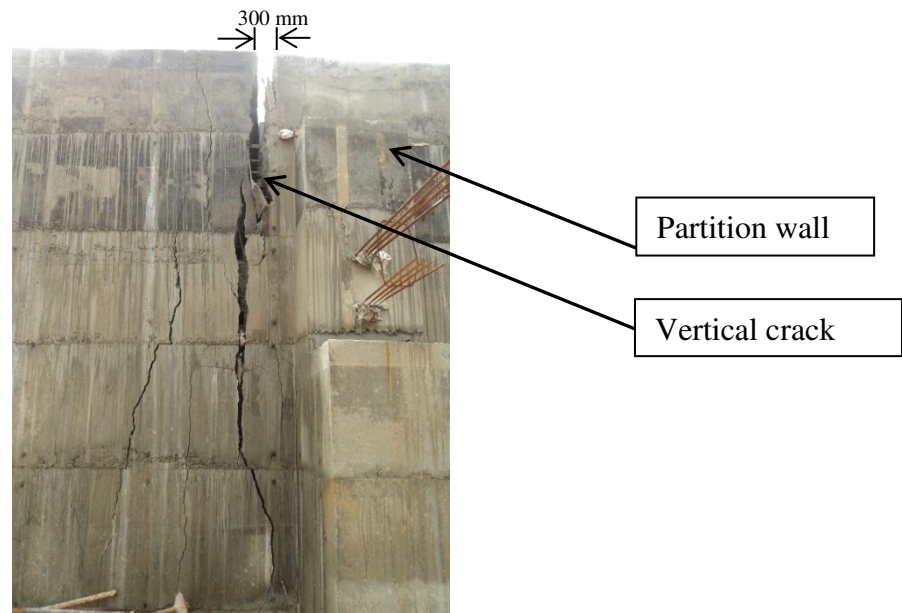
Figure 2. Uplifting and cracking of tank partition wall.

Fig 2 indicates the curved and cracked partition wall due to the tank uplifting. Several other cracks were observed along the height of the partition wall on either side of the middle 300 mm wide crack, with the crack width decreasing away from the center. Based on daily measurements taken on top of the partition wall after the failure, the uplifting of bottom slab and the crack width of partition wall was observed to be increasing at a rate of 30 mm per day. The cracks, which were observed on top of the foundation raft inside the tank, had maximum width of 12 mm. The seepage of groundwater inside the tank was not observed through these cracks. Thus, the depth of cracks was limited only to the top portion and not penetrating the entire thickness of the foundation raft.

As the crack width in the partition wall was increasing at a rate of 30 mm per day, it was necessary to take immediate corrective measures to stop the cracks from further widening. It was therefore suggested to drill boreholes of 200 mm diameter up to 8 m depth (as the depth of tank is 7.3 m) around the tank periphery so as to reduce the water pressure acting on the bottom of foundation raft by allowing the water under pressure to get released through these boreholes. However, due to the heavy rains, the contractor could not position the drilling equipment near the tank to drill the boreholes. Considering the practical delays in carrying out the borehole activity, another suggested option was to fill the tank with water up to approximately 5.5 m height which would generate additional weight within the tank, to counter the upward buoyant force of groundwater. Thus the accumulated water within the surrounding area was diverted inside the tank. As soon as the tank started filling with water, the settlement of the tank started taking place due to the weight of water. It took more than a month to fill the tank with water up to a height of 5.50 m after which the tank was observed to be completely settled to its original position and the crack width in the partition wall was reduced to 25 mm from 300 mm.

The structural rectification of damaged partition wall was carried out by demolishing the damaged portion, providing new reinforcement, applying epoxy bonding coating on old concrete and reconstructing the demolished portion of the wall.

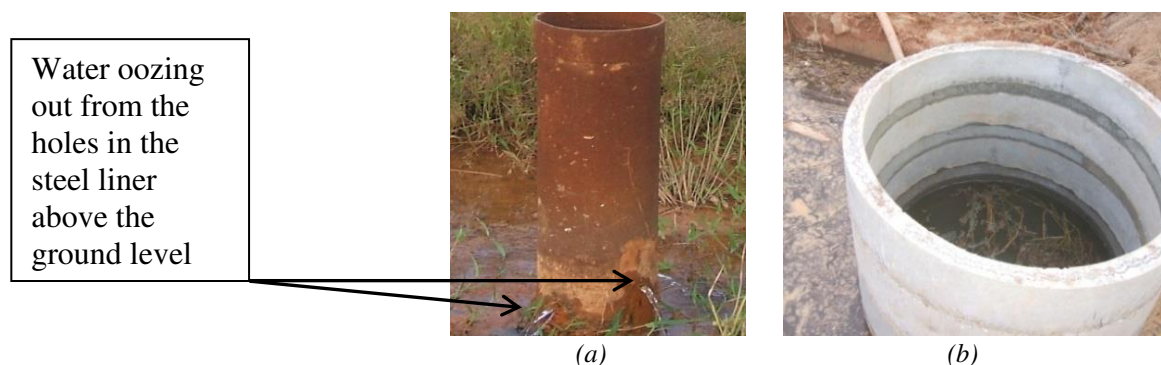
In the meantime, when the tank filling was ongoing and the rainfall intensity reduced, the boreholes with steel liner were drilled along the tank periphery and a 1.2 m diameter and 4 m deep ring well was also dug near the tank. The groundwater was observed to be coming out from the perforations in steel liner above the ground level due to high hydraulic head (Fig. 3a). The water level in an open well was also observed to be at the ground level (Fig. 3b).

Figure 3. Groundwater level in (a) borehole with steel liner and (b) ring well

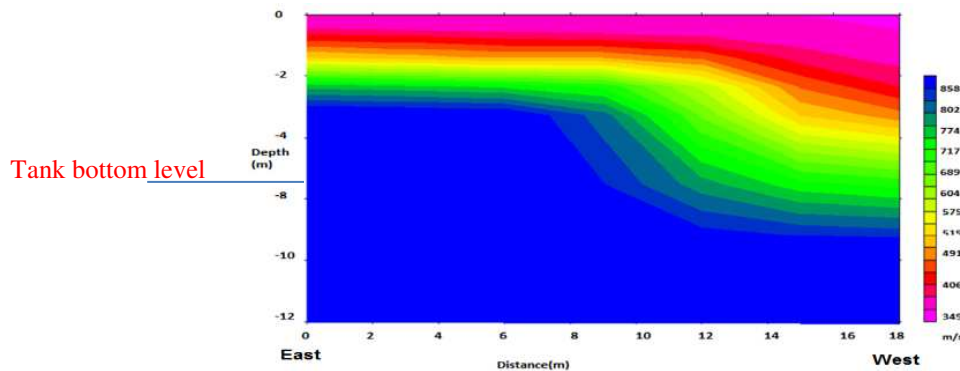
The seismic refraction survey data was used to classify the soil using correlations between typical velocities, type of formations and the density as suggested by Bourbie et al. (1987). Based on this classification, the top layer consists of clayey soil, which is moderately compacted up to a depth of 1.5 m with P-wave velocity of 349 m/s. It is followed by a layer of clay and gravel with a thickness of 1.5 m, having a velocity range from 377 m/s to 482 m/s and a layer of sandy silt strata up to 10 m with a thickness of about 7.5 m and a seismic velocity range from 491 m/s to 858 m/s, as shown in Fig. 6.

Figure 6. The soil strata profile obtained from SR2 data conducted on the south side of the tank near the closed water well (see Fig. 5 for survey location with respect to the tank).

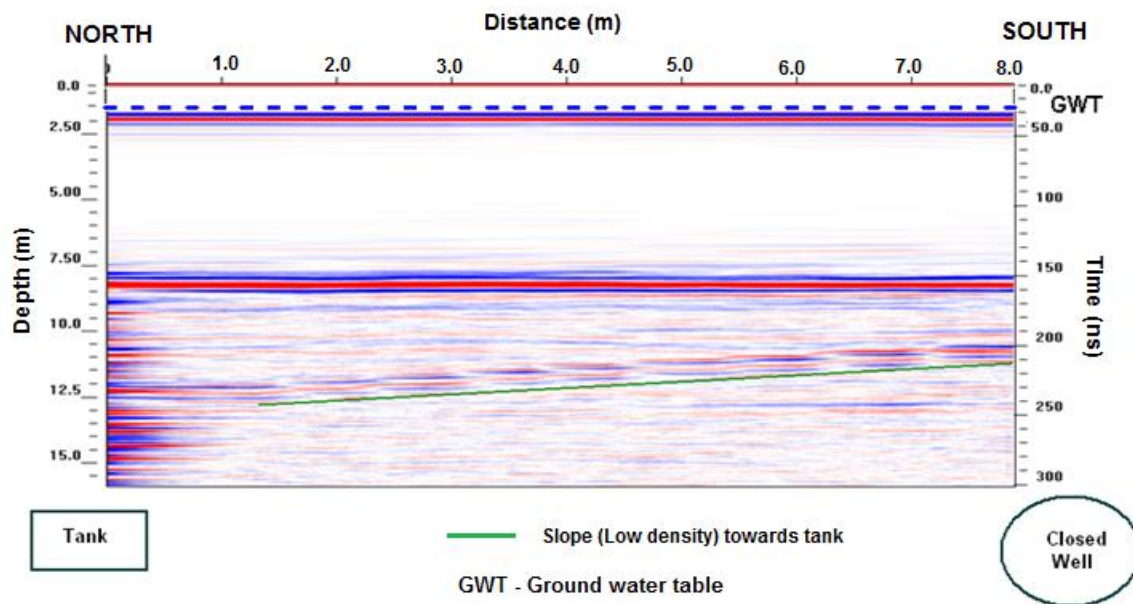
Close to the side wall of the tank, the discontinuous sloping feature towards the tank at depths of 11 m to 12.5 m below existing ground level (EGL) was observed. The observed sloping feature was identified as water channel with the direction of flow from closed water well (south direction) towards the tank (north direction) as highlighted by the green line in Fig. 7.

Figure 7. GPR2 profile collected using 200 MHZ antenna outside the tank along North - South direction by placing the antenna inside the floating body. This profile is located between the tank and closed water well i.e., close to the wall of tank. (see Fig. 5 for survey location with respect to the tank).

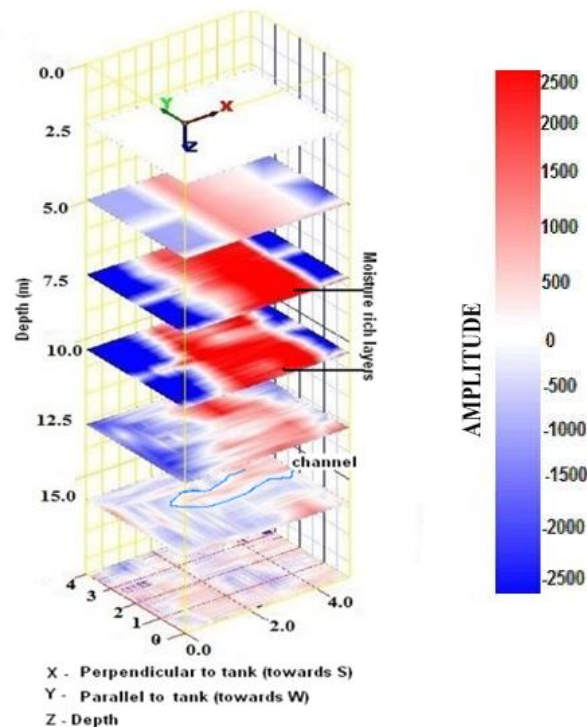
3D data near the tank clearly indicates the clay rich strata at the depth of 2.5 m below ground level and the moisture is more concentrated at the depth of 7.5 m to 10 m from ground level (see Fig. 10). This visualization assisted in confirming the presence of water channels between the well and the tank.

Figure 10. 3D view of the grid from GPR2 near the tank, data collected with 2 m interval at X axis and 1 m interval at Y axis. X is the direction perpendicular to the tank; Y is direction parallel to the tank and Z is the depth of penetration of the GPR2 antenna, i.e., 20 m.
