Uplift of an Underground Tank in Northern Malabar Region, India

ABSTRACT: An underground reinforced concrete tank was constructed for a project in the southwest region of India. The tank was 90 m x 35 m in plan and 7.3 m deep resting on partly filled-up and partly native soil. During the peak monsoon, a sudden uplifting of the base slab by about 300 mm and subsequent failure of the foundation raft and a partition wall was observed. Laboratory testing was executed and hydrogeological survey was carried out using ground penetrating radar, seismic refraction and infiltrometer testing, and an analytical study was carried out to identify the root cause of the tank uplifting. Based on this study, it was observed that the uplifting and structural failure was essentially due to the peculiar land terrain and soil properties and the development of excess hydraulic head below the bottom of the tank. After considering different options, the rectification measures were carried out by provision of dewatering wells along the tank periphery to release the excess hydrostatic pressure and stabilize the foundation raft. The structural repair of the top of the foundation raft and partition wall was c

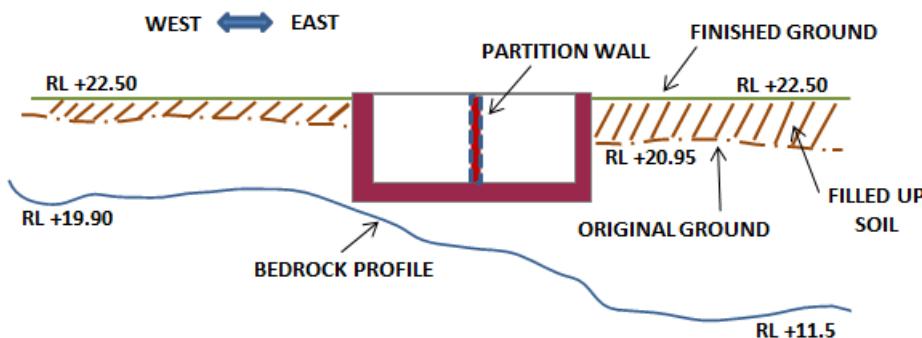
The overall topography of the project site was sloping from west towards the east. The profile of bedrock was also dipping down from west towards the east as shown with varying reduced levels (RL) in Fig. 1 along with the relative location of the tank.

Figure 1. Topographic features near the tank.

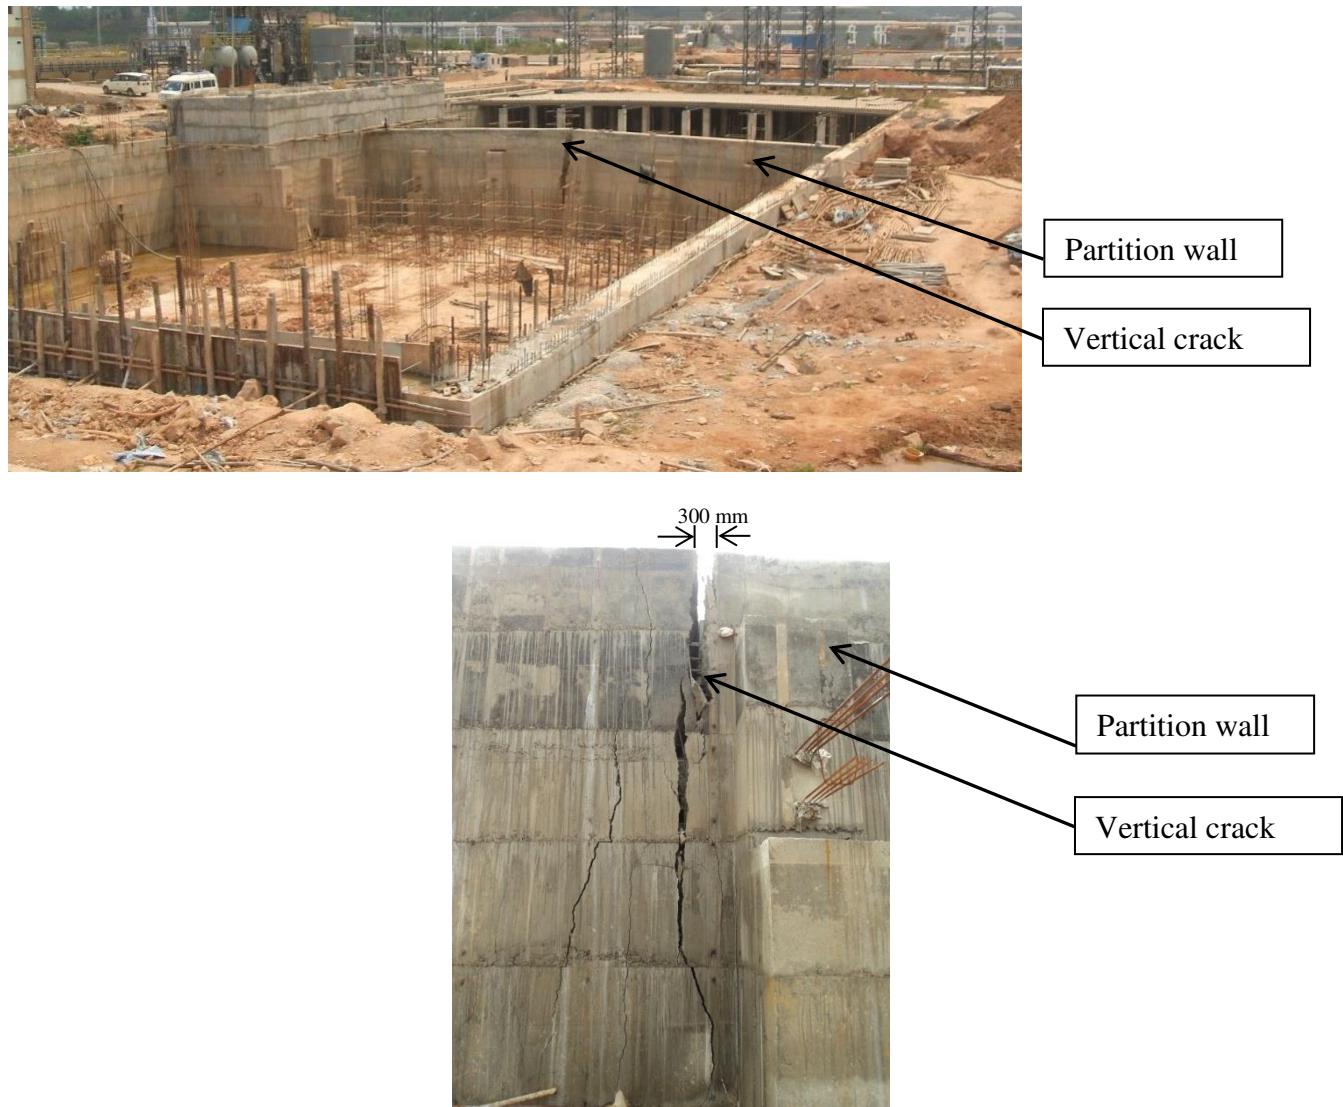
Fig 2 indicates the curved and cracked partition wall due to the tank uplifting. Several other cracks were observed along the height of the partition wall on either side of the middle 300 mm wide crack, with the crack width decreasing away from the center. Based on daily measurements taken on top of the partition wall after the failure, the uplifting of bottom slab and the crack width of partition wall was observed to be increasing at a rate of 30 mm per day. The cracks, which were observed on top of the foundation raft inside the tank, had maximum width of 12 mm. The seepage of groundwater inside the tank was not observed through these cracks. Thus, the depth of cracks was limited only to the top portion and not penetrating the entire thickness of the foundation raft.

Figure 2. Uplifting and cracking of tank partition wall.

As the crack width in the partition wall was increasing at a rate of 30 mm per day, it was necessary to take immediate corrective measures to stop the cracks from further widening. It was therefore suggested to drill boreholes of 200 mm diameter up to 8 m depth (as the depth of tank is 7.3 m) around the tank periphery so as to reduce the water pressure acting on the bottom of foundation raft by allowing the water under pressure to get released through these boreholes. However, due to the heavy rains, the contractor could not position the drilling equipment near the tank to drill the boreholes. Considering the practical delays in carrying out the borehole activity, another suggested option was to fill the tank with water up to approximately 5.5 m height which would generate additional weight within the tank, to counter the upward buoyant force of groundwater. Thus the accumulated water within the surrounding area was diverted inside the tank. As soon as the tank started filling with water, the settlement of the tank started taking place due to the weight of water. It took more than a month to fill the tank with water up to a height of 5.50 m after which the tank was observed to be completely settled to its original position and the crack width in the partition wall was reduced to 25 mm from 300 mm.

The structural rectification of damaged partition wall was carried out by demolishing the damaged portion, providing new reinforcement, applying epoxy bonding coating on old concrete and reconstructing the demolished portion of the wall.

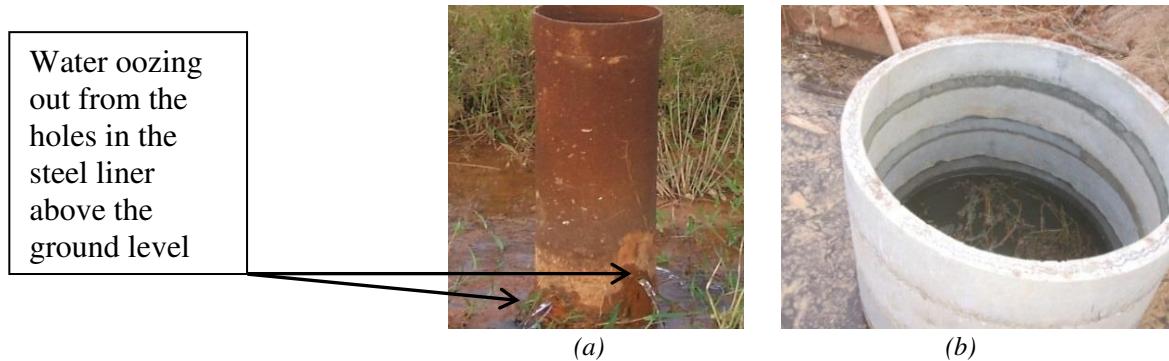
In the meantime, when the tank filling was ongoing and the rainfall intensity reduced, the boreholes with steel liner were drilled along the tank periphery and a 1.2 m diameter and 4 m deep ring well was also dug near the tank. The groundwater was observed to be coming out from the perforations in steel liner above the ground level due to high hydraulic head (Fig. 3a). The water level in an open well was also observed to be at the ground level (Fig. 3b).

Figure 3. Groundwater level in (a) borehole with steel liner and (b) ring well

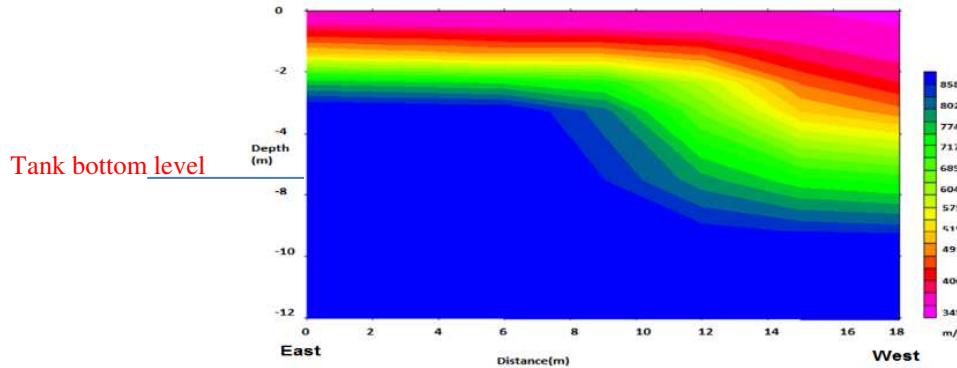
The seismic refraction survey data was used to classify the soil using correlations between typical velocities, type of formations and the density as suggested by Bourbie et al. (1987). Based on this classification, the top layer consists of clayey soil, which is moderately compacted up to a depth of 1.5 m with P-wave velocity of 349 m/s. It is followed by a layer of clay and gravel with a thickness of 1.5 m, having a velocity range from 377 m/s to 482 m/s and a layer of sandy silt strata up to 10 m with a thickness of about 7.5 m and a seismic velocity range from 491 m/s to 858 m/s, as shown in Fig. 6.

Figure 6. The soil strata profile obtained from SR2 data conducted on the south side of the tank near the closed water well (see Fig. 5 for survey location with respect to the tank).

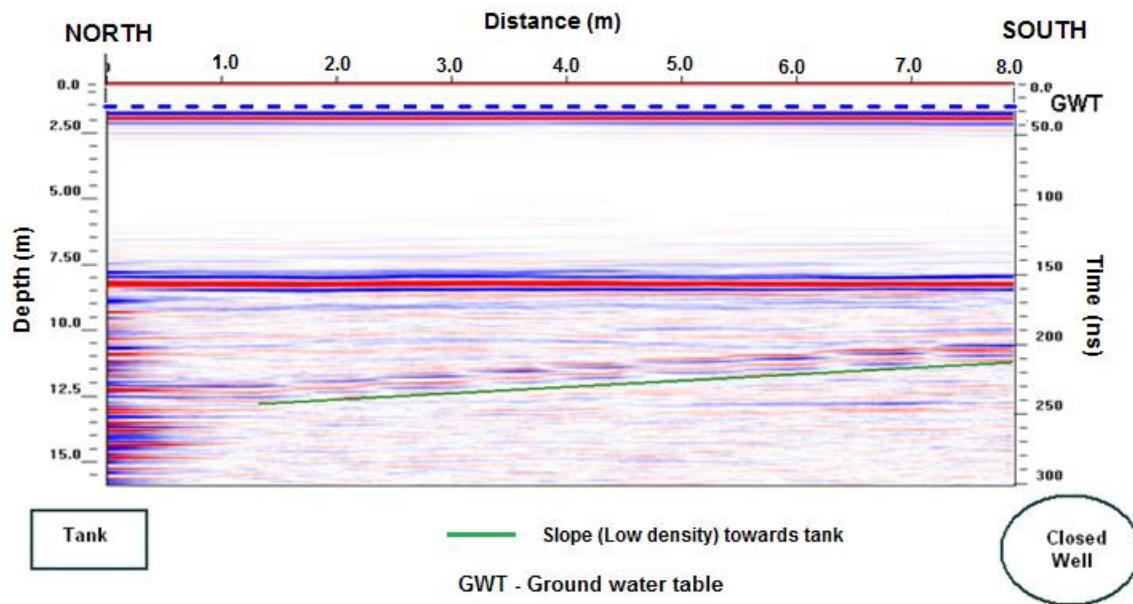
Close to the side wall of the tank, the discontinuous sloping feature towards the tank at depths of 11 m to 12.5 m below existing ground level (EGL) was observed. The observed sloping feature was identified as water channel with the direction of flow from closed water well (south direction) towards the tank (north direction) as highlighted by the green line in Fig. 7.

Figure 7. GPR2 profile collected using 200 MHZ antenna outside the tank along North - South direction by placing the antenna inside the floating body. This profile is located between the tank and closed water well i.e., close to the wall of tank. (see Fig. 5 for survey location with respect to the tank).

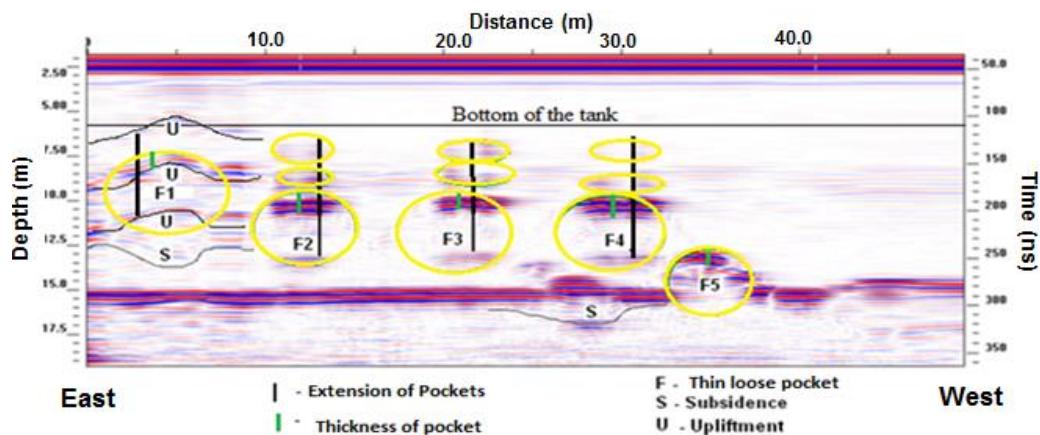
A phase inversion occurred at the concrete and void interface as indicated by a negative amplitude preceding a positive amplitude (see Fig. 8, 9 and 10). The amplitude of the GPR data is represented by red, blue and white colors. Red coloured areas represent a positive reflection and blue coloured areas represent a negative reflection while white areas represent distinct reflected areas, typically indicative of a dielectric uniformity within a given medium.

Loose pockets in the substrata were observed along the East-West direction beneath the tank bottom. The horizontal length of loose pockets below the bottom of the tank (F1 to F5) are observed to be varying between 0.5 m to 5.5 m at different locations. (see Fig. 7). The vertical thicknesses of the loose pockets are approximately 0.5 m each.

Figure 7. GPR3 profile collected using a 200 MHZ antenna inside the tank along East - West direction by placing antenna inside the floating body.

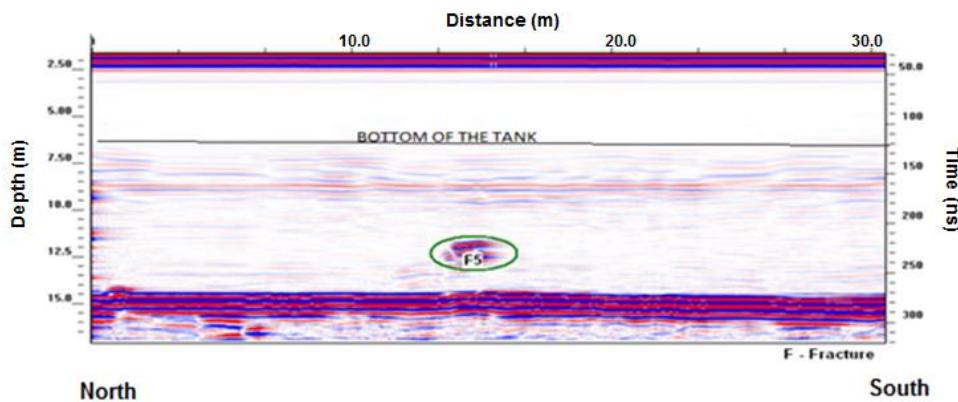
Fracture F5 is visible at the depth of 12.5 m in the profile along North-South direction (shown in Fig. 9). High amplitude reflections at 7.5 m depth are interpreted as rock formations and very high amplitude thick reflections encountered at depth of 14.5 m are interpreted as hard bedrock.

Figure 9. GPR4 profile collected using a 200 MHZ antenna inside the tank along North - South direction by placing antenna inside the floating body.

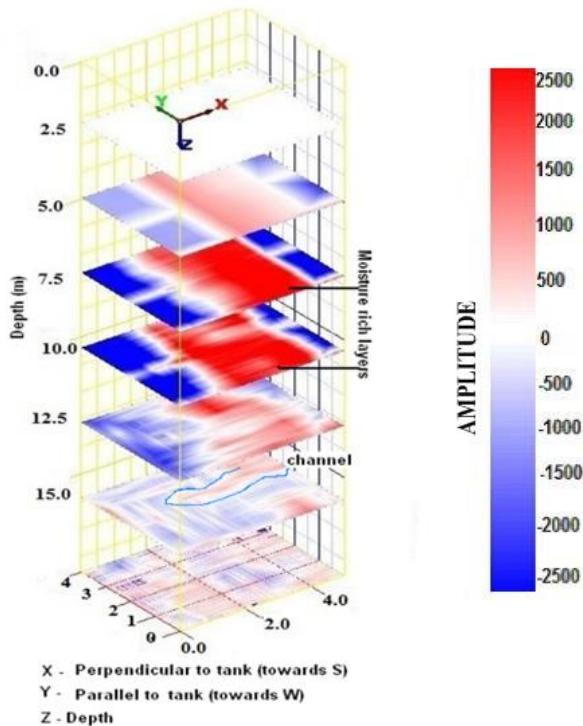
3D data near the tank clearly indicates the clay rich strata at the depth of 2.5 m below ground level and the moisture is more concentrated at the depth of 7.5 m to 10 m from ground level (see Fig. 10). This visualization assisted in confirming the presence of water channels between the well and the tank.

Figure 10. 3D view of the grid from GPR2 near the tank, data collected with 2 m interval at X axis and 1 m interval at Y axis. X is the direction perpendicular to the tank; Y is direction parallel to the tank and Z is the depth of penetration of the GPR2 antenna, i.e., 20 m.
