Uplift of an Underground Tank in Northern Malabar Region, India

ABSTRACT: An underground reinforced concrete tank was constructed for a project in the southwest region of India. The tank was 90 m x 35 m in plan and 7.3 m deep resting on partly filled-up and partly native soil. During the peak monsoon, a sudden uplifting of the base slab by about 300 mm and subsequent failure of the foundation raft and a partition wall was observed. Laboratory testing was executed and hydrogeological survey was carried out using ground penetrating radar, seismic refraction and infiltrometer testing, and an analytical study was carried out to identify the root cause of the tank uplifting. Based on this study, it was observed that the uplifting and structural failure was essentially due to the peculiar land terrain and soil properties and the development of excess hydraulic head below the bottom of the tank. After considering different options, the rectification measures were carried out by provision of dewatering wells along the tank periphery to release the excess hydrostatic pressure and stabilize the foundation raft. The structural repair of the top of the foundation raft and partition wall was c

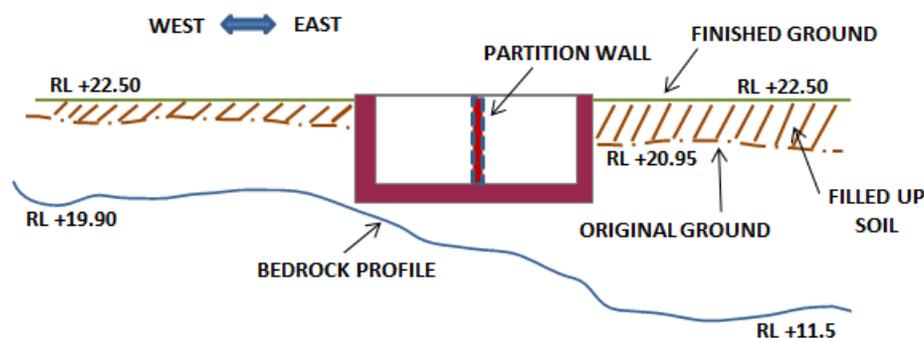
The overall topography of the project site was sloping from west towards the east. The profile of bedrock was also dipping down from west towards the east as shown with varying reduced levels (RL) in Fig. 1 along with the relative location of the tank.

Figure 1. Topographic features near the tank.

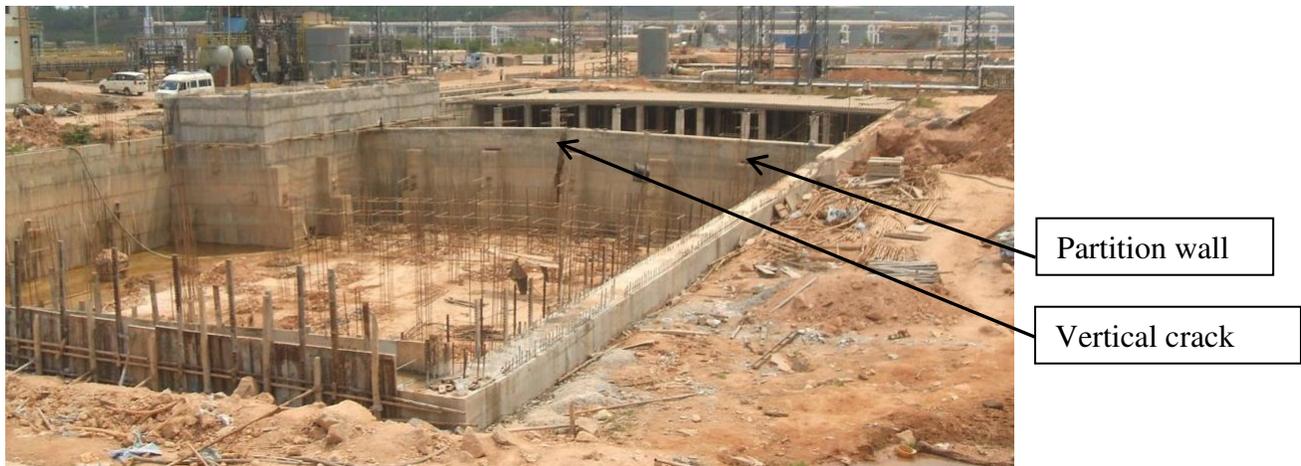
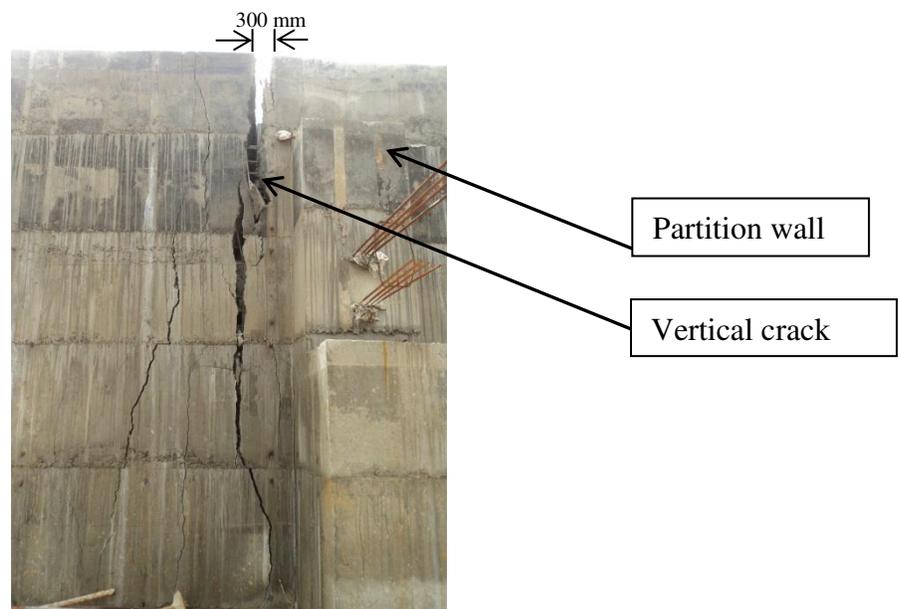
In the southern part of India, the monsoon is at its peak in the months of June & July every year. In mid-June of 2013, the foundation raft of the tank suddenly got uplifted by approximately 300 mm at the center. The review of past rainfall data revealed higher rainfall intensity in June 2013 compared to rainfall in the previous three years as shown in Table 2. During the failure of the tank, the 0.9 m thick reinforced cement concrete (RCC) partition wall inside the tank got cracked in tension at the center due to the uplifting and bending of the foundation raft. However, no uplifting was noticed at the four edges of the tank. Thus, the tank took an inverse saucer shape due to the uplifting at the center.

Fig 2 indicates the curved and cracked partition wall due to the tank uplifting. Several other cracks were observed along the height of the partition wall on either side of the middle 300 mm wide crack, with the crack width decreasing away from the center. Based on daily measurements taken on top of the partition wall after the failure, the uplifting of bottom slab and the crack width of partition wall was observed to be increasing at a rate of 30 mm per day. The cracks, which were observed on top of the foundation raft inside the tank, had maximum width of 12 mm. The seepage of groundwater inside the tank was not observed through these cracks. Thus, the depth of cracks was limited only to the top portion and not penetrating the entire thickness of the foundation raft.

Figure 2. Uplifting and cracking of tank partition wall.

As the crack width in the partition wall was increasing at a rate of 30 mm per day, it was necessary to take immediate corrective measures to stop the cracks from further widening. It was therefore suggested to drill boreholes of 200 mm diameter up to 8 m depth (as the depth of tank is 7.3 m) around the tank periphery so as to reduce the water pressure acting on the bottom of foundation raft by allowing the water under pressure to get released through these boreholes. However, due to the heavy rains, the contractor could not position the drilling equipment near the tank to drill the boreholes. Considering the practical delays in carrying out the borehole activity, another suggested option was to fill the tank with water up to approximately 5.5 m height which would generate additional weight within the tank, to counter the upward buoyant force of groundwater. Thus the accumulated water within the surrounding area was diverted inside the tank. As soon as the tank started filling with water, the settlement of the tank started taking place due to the weight of water. It took more than a month to fill the tank with water up to a height of 5.50 m after which the tank was observed to be completely settled to its original position and the crack width in the partition wall was reduced to 25 mm from 300 mm.

The structural rectification of damaged partition wall was carried out by demolishing the damaged portion, providing new reinforcement, applying epoxy bonding coating on old concrete and reconstructing the demolished portion of the wall.

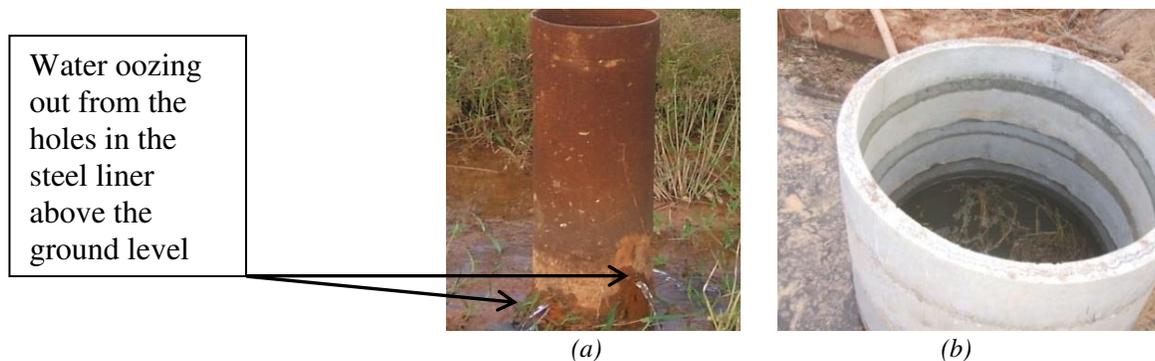
In the meantime, when the tank filling was ongoing and the rainfall intensity reduced, the boreholes with steel liner were drilled along the tank periphery and a 1.2 m diameter and 4 m deep ring well was also dug near the tank. The groundwater was observed to be coming out from the perforations in steel liner above the ground level due to high hydraulic head (Fig. 3a). The water level in an open well was also observed to be at the ground level (Fig. 3b).

Figure 3. Groundwater level in (a) borehole with steel liner and (b) ring well

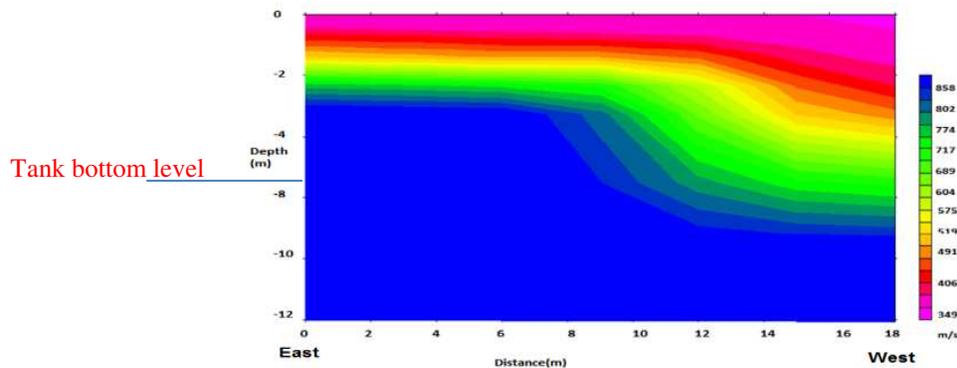
The seismic refraction survey data was used to classify the soil using correlations between typical velocities, type of formations and the density as suggested by Bourbie et al. (1987). Based on this classification, the top layer consists of clayey soil, which is moderately compacted up to a depth of 1.5 m with P-wave velocity of 349 m/s. It is followed by a layer of clay and gravel with a thickness of 1.5 m, having a velocity range from 377 m/s to 482 m/s and a layer of sandy silt strata up to 10 m with a thickness of about 7.5 m and a seismic velocity range from 491 m/s to 858 m/s, as shown in Fig. 6.

Figure 6. The soil strata profile obtained from SR2 data conducted on the south side of the tank near the closed water well (see Fig. 5 for survey location with respect to the tank).

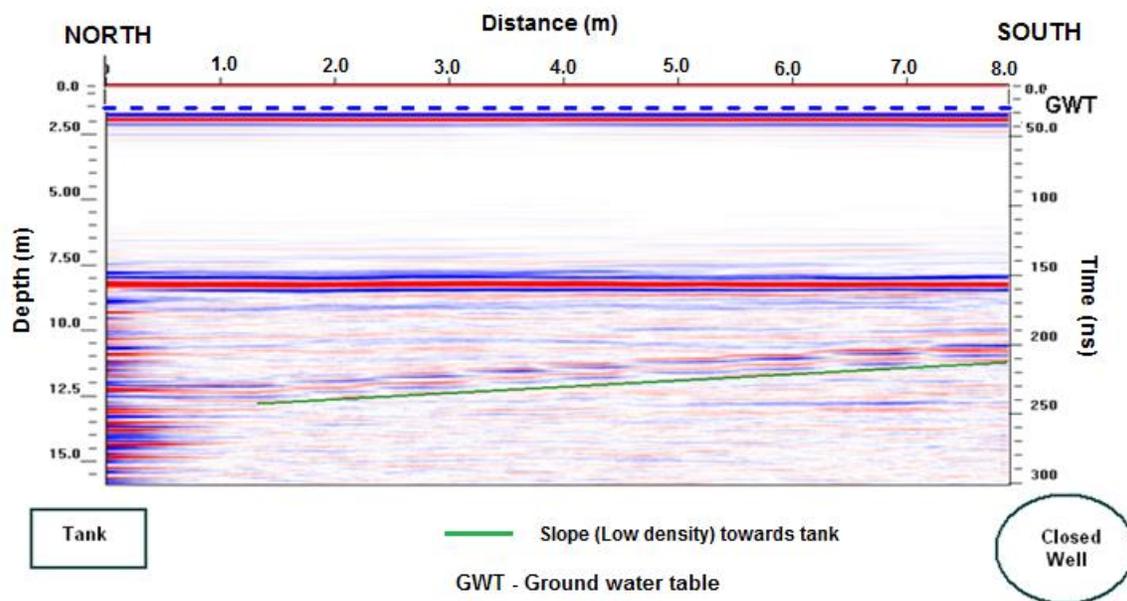
Close to the side wall of the tank, the discontinuous sloping feature towards the tank at depths of 11 m to 12.5 m below existing ground level (EGL) was observed. The observed sloping feature was identified as water channel with the direction of flow from closed water well (south direction) towards the tank (north direction) as highlighted by the green line in Fig. 7.

Figure 7. GPR2 profile collected using 200 MHZ antenna outside the tank along North - South direction by placing the antenna inside the floating body. This profile is located between the tank and closed water well i.e., close to the wall of tank. (see Fig. 5 for survey location with respect to the tank).

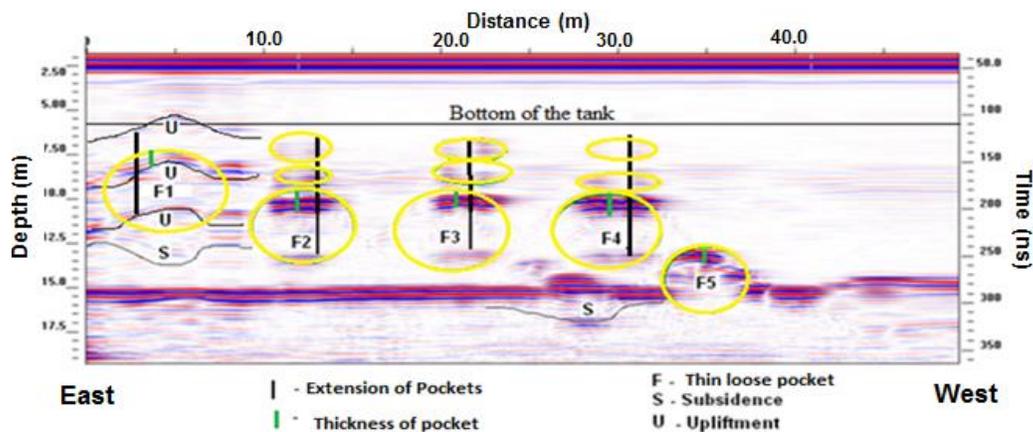
A phase inversion occurred at the concrete and void interface as indicated by a negative amplitude preceding a positive amplitude (see Fig. 8, 9 and 10). The amplitude of the GPR data is represented by red, blue and white colors. Red coloured areas represent a positive reflection and blue coloured areas represent a negative reflection while white areas represent distinct reflected areas, typically indicative of a dielectric uniformity within a given medium.

Loose pockets in the substrata were observed along the East-West direction beneath the tank bottom. The horizontal length of loose pockets below the bottom of the tank (F1 to F5) are observed to be varying between 0.5 m to 5.5 m at different locations. (see Fig. 7). The vertical thicknesses of the loose pockets are approximately 0.5 m each.

Figure 7. GPR3 profile collected using a 200 MHZ antenna inside the tank along East - West direction by placing antenna inside the floating body.

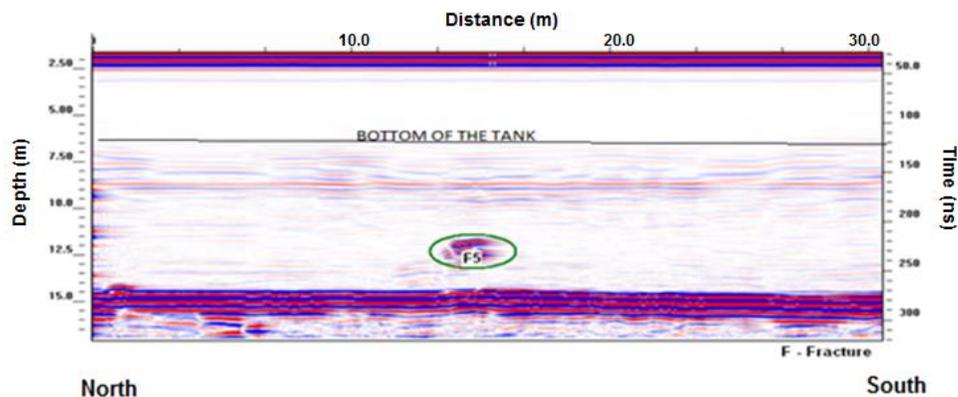
Fracture F5 is visible at the depth of 12.5 m in the profile along North-South direction (shown in Fig. 9). High amplitude reflections at 7.5 m depth are interpreted as rock formations and very high amplitude thick reflections encountered at depth of 14.5 m are interpreted as hard bedrock.

Figure 9. GPR4 profile collected using a 200 MHZ antenna inside the tank along North - South direction by placing antenna inside the floating body.

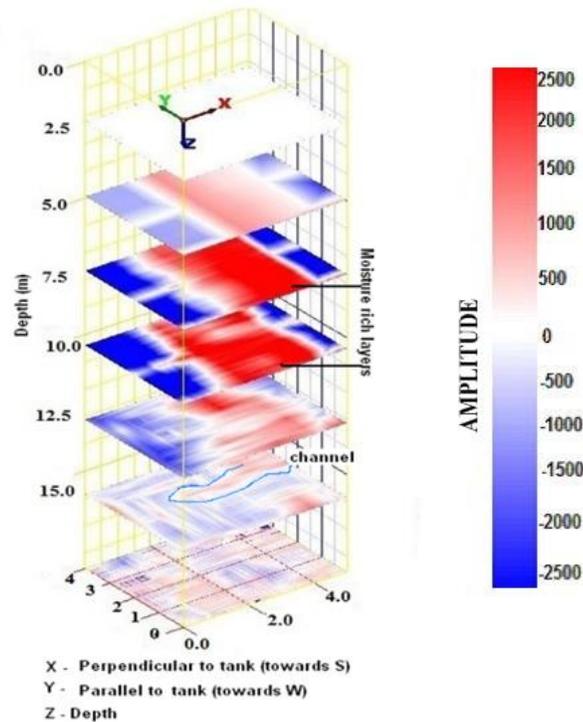
3D data near the tank clearly indicates the clay rich strata at the depth of 2.5 m below ground level and the moisture is more concentrated at the depth of 7.5 m to 10 m from ground level (see Fig. 10). This visualization assisted in confirming the presence of water channels between the well and the tank.

Figure 10. 3D view of the grid from GPR2 near the tank, data collected with 2 m interval at X axis and 1 m interval at Y axis. X is the direction perpendicular to the tank; Y is direction parallel to the tank and Z is the depth of penetration of the GPR2 antenna, i.e., 20 m.
