# Uplift of an Underground Tank in Northern Malabar Region, India

ABSTRACT: An underground reinforced concrete tank was constructed for a project in the southwest region of India. The tank was 90 m x 35 m in plan and 7.3 m deep resting on partly filled-up and partly native soil. During the peak monsoon, a sudden uplifting of the base slab by about 300 mm and subsequent failure of the foundation raft and a partition wall was observed. Laboratory testing was executed and hydrogeological survey was carried out using ground penetrating radar, seismic refraction and infiltrometer testing, and an analytical study was carried out to identify the root cause of the tank uplifting. Based on this study, it was observed that the uplifting and structural failure was essentially due to the peculiar land terrain and soil properties and the development of excess hydraulic head below the bottom of the tank. After considering different options, the rectification measures were carried out by provision of dewatering wells along the tank periphery to release the excess hydrostatic pressure and stabilize the foundation raft. The structural repair of the top of the foundation raft and partition wall was

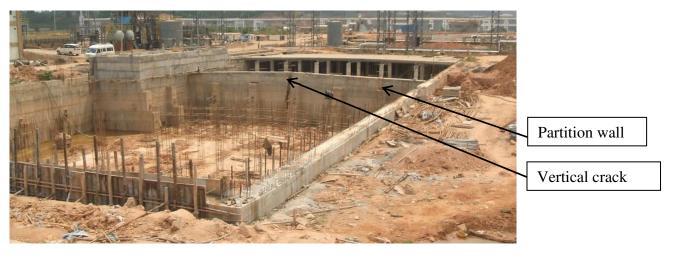
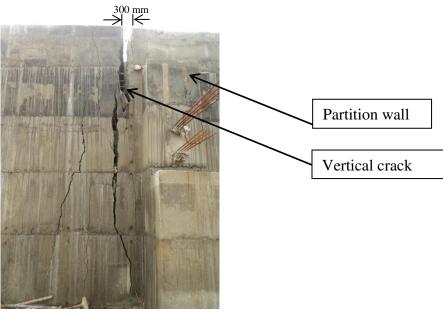
Figure 2. Uplifting and cracking of tank partition wall.

In the southern part of India, the monsoon is at its peak in the months of June & July every year. In mid-June of 2013, the foundation raft of the tank suddenly got uplifted by approximately 300 mm at the center. The review of past rainfall data revealed higher rainfall intensity in June 2013 compared to rainfall in the previous three years as shown in Table 2. During the failure of the tank, the 0.9 m thick reinforced cement concrete (RCC) partition wall inside the tank got cracked in tension at the center due to the uplifting and bending of the foundation raft. However, no uplifting was noticed at the four edges of the tank. Thus, the tank took an inverse saucer shape due to the uplifting at the center.

Fig 2 indicates the curved and cracked partition wall due to the tank uplifting. Several other cracks were observed along the height of the partition wall on either side of the middle 300 mm wide crack, with the crack width decreasing away from the center. Based on daily measurements taken on top of the partition wall after the failure, the uplifting of bottom slab and the crack width of partition wall was observed to be increasing at a rate of 30 mm per day. The cracks, which were observed on top of the foundation raft inside the tank, had maximum width of 12 mm. The seepage of groundwater inside the tank was not observed through these cracks. Thus, the depth of cracks was limited only to the top portion and not penetrating the entire thickness of the foundation raft.

As the crack width in the partition wall was increasing at a rate of 30 mm per day, it was necessary to take immediate corrective measures to stop the cracks from further widening. It was therefore suggested to drill boreholes of 200 mm diameter up to 8 m depth (as the depth of tank is 7.3 m) around the tank periphery so as to reduce the water pressure acting on the bottom of foundation raft by allowing the water under pressure to get released through these boreholes. However, due to the heavy rains, the contractor could not position the drilling equipment near the tank to drill the boreholes. Considering the practical delays in carrying out the borehole activity, another suggested option was to fill the tank with water up to approximately 5.5 m height which would generate additional weight within the tank, to counter the upward buoyant force of groundwater. Thus the accumulated water within the surrounding area was diverted inside the tank. As soon as the tank started filling with water, the settlement of the tank started taking place due to the weight of water. It took more than a month to fill the tank with water up to a height of 5.50 m after which the tank was observed to be completely settled to its original position and the crack width in the partition wall was reduced to 25 mm from 300 mm.

The structural rectification of damaged partition wall was carried out by demolishing the damaged portion, providing new reinforcement, applying epoxy bonding coating on old concrete and reconstructing the demolished portion of the wall.

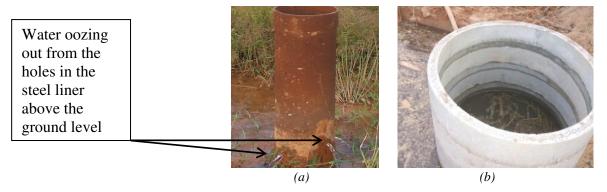
Figure 3. Groundwater level in (a) borehole with steel liner and (b) ring well

In the meantime, when the tank filling was ongoing and the rainfall intensity reduced, the boreholes with steel liner were drilled along the tank periphery and a 1.2 m diameter and 4 m deep ring well was also dug near the tank. The groundwater was observed to be coming out from the perforations in steel liner above the ground level due to high hydraulic head (Fig. 3a). The water level in an open well was also observed to be at the ground level (Fig. 3b).

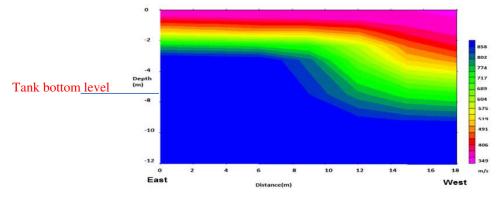
Figure 6. The soil strata profile obtained from SR2 data conducted on the south side of the tank near the closed water well (see Fig. 5 for survey location with respect to the tank).

The seismic refraction survey data was used to classify the soil using correlations between typical velocities, type of formations and the density as suggested by Bourbie et al. (1987). Based on this classification, the top layer consists of clayey soil, which is moderately compacted up to a depth of 1.5 m with P-wave velocity of 349 m/s. It is followed by a layer of clay and gravel with a thickness of 1.5 m, having a velocity range from 377 m/s to 482 m/s and a layer of sandy silt strata up to 10 m with a thickness of about 7.5 m and a seismic velocity range from 491 m/s to 858 m/s, as shown in Fig. 6.

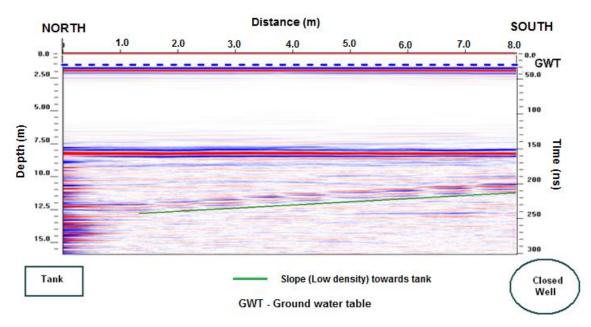
Close to the side wall of the tank, the discontinuous sloping feature towards the tank at depths of 11 m to 12.5 m below existing ground level (EGL) was observed. The observed sloping feature was identified as water channel with the direction of flow from closed water well (south direction) towards the tank (north direction) as highlighted by the green line in Fig. 7.

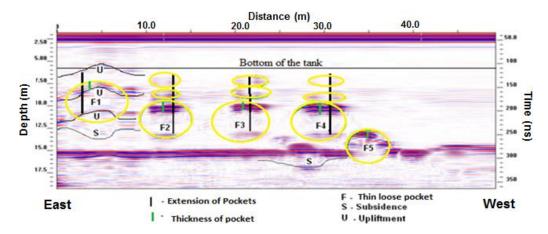
Figure 7. GPR3 profile collected using a 200 MHZ antenna inside the tank along East - West direction by placing antenna inside the floating body.

A phase inversion occurred at the concrete and void interface as indicated by a negative amplitude preceding a positive amplitude (see Fig. 8, 9 and 10). The amplitude of the GPR data is represented by red, blue and white colors. Red coloured areas represent a positive reflection and blue coloured areas represent a negative reflection while white areas represent distinct reflected areas, typically indicative of a dielectric uniformity within a given medium.

Loose pockets in the substrata were observed along the East-West direction beneath the tank bottom. The horizontal length of loose pockets below the bottom of the tank (F1 to F5) are observed to be varying between 0.5 m to 5.5 m at different locations. (see Fig. 7). The vertical thicknesses of the loose pockets are approximately 0.5 m each.

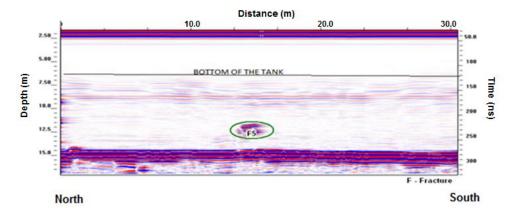
Figure 9. GPR4 profile collected using a 200 MHZ antenna inside the tank along North - South direction by placing antenna inside the floating body.

Fracture F5 is visible at the depth of 12.5 m in the profile along North-South direction (shown in Fig. 9). High amplitude reflections at 7.5 m depth are interpreted as rock formations and very high amplitude thick reflections encountered at depth of 14.5 m are interpreted as hard bedrock.

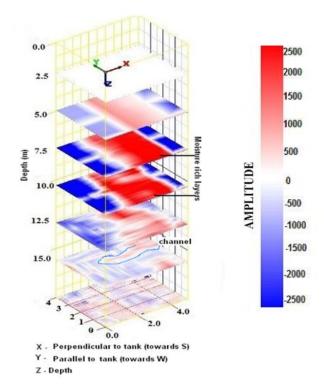
Figure 10. 3D view of the grid from GPR2 near the tank, data collected with 2 m interval at X axis and 1 m interval at Y axis. X is the direction perpendicular to the tank; Y is direction parallel to the tank and Z is the depth of penetration of the GPR2 antenna, i.e., 20 m.

3D data near the tank clearly indicates the clay rich strata at the depth of 2.5 m below ground level and the moisture is more concentrated at the depth of 7.5 m to 10 m from ground level (see Fig. 10). This visualization assisted in confirming the presence of water channels between the well and the tank.
