Uplift of an Underground Tank in Northern Malabar Region, India

ABSTRACT: An underground reinforced concrete tank was constructed for a project in the southwest region of India. The tank was 90 m x 35 m in plan and 7.3 m deep resting on partly filled-up and partly native soil. During the peak monsoon, a sudden uplifting of the base slab by about 300 mm and subsequent failure of the foundation raft and a partition wall was observed. Laboratory testing was executed and hydrogeological survey was carried out using ground penetrating radar, seismic refraction and infiltrometer testing, and an analytical study was carried out to identify the root cause of the tank uplifting. Based on this study, it was observed that the uplifting and structural failure was essentially due to the peculiar land terrain and soil properties and the development of excess hydraulic head below the bottom of the tank. After considering different options, the rectification measures were carried out by provision of dewatering wells along the tank periphery to release the excess hydrostatic pressure and stabilize the foundation raft. The structural repair of the top of the foundation raft and partition wall was c

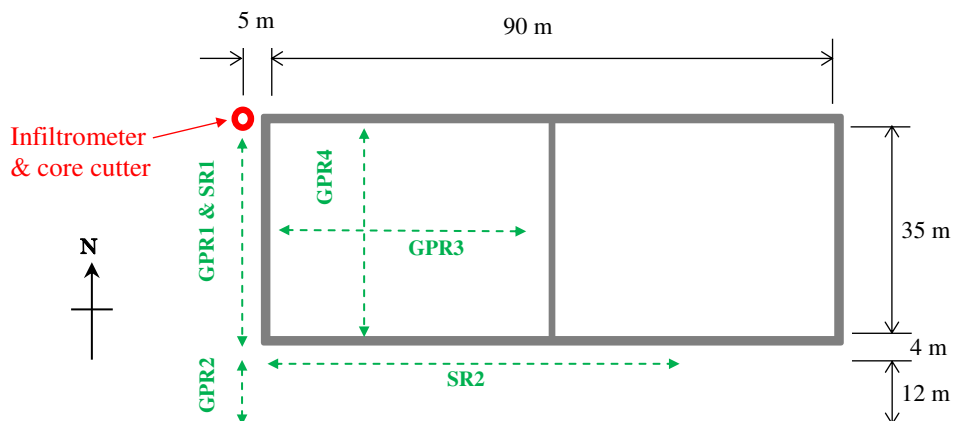
Figure 5. The schematic plan illustrating the location of GPR profiles, seismic refraction (SR) survey profiles and soil samples (see also Table 2).

The investigation was focused on the west and south periphery of the tank, where the ground was submerged. It shall also be noted that historically there was a perennial water well near the southwest corner of the tank which was filled up with soil and boulders during construction. The water from this well was used for household purposes by the local villagers. The concrete slab was also cast on top of this well during construction. The area on north and east of the tank was observed to be relatively dry.
