Lessons Learned from Dike Failures in Recent Decades

ABSTRACT: The paper describes five different dike failures that occurred in recent decades. The case histories were located on different rivers and involved different loading conditions. The observed failure mechanisms involved erosion and stability problems. The types of erosion observed were both internal erosion due to extreme groundwater flow and external erosion caused by the river flow and wave action. The case involving instability was caused by uplift, i.e., increased hydraulic head led to a sharp reduction in maximum shear strength between subsoil layers. Two cases demonstrate the importance of dike management and maintenance. Despite the variations in the loading conditions and failure mechanisms, all the cases show that the strength of a dike depends not only on the material used to build the dike but also on the strength of the subsoil.

Lessons Learned from Dike Failures in Recent Decades. International Journal of Geoengineering Case Histories, Vol.4, Issue 3, p.203-229. doi: 10.4417/IJGCH-04-03-04

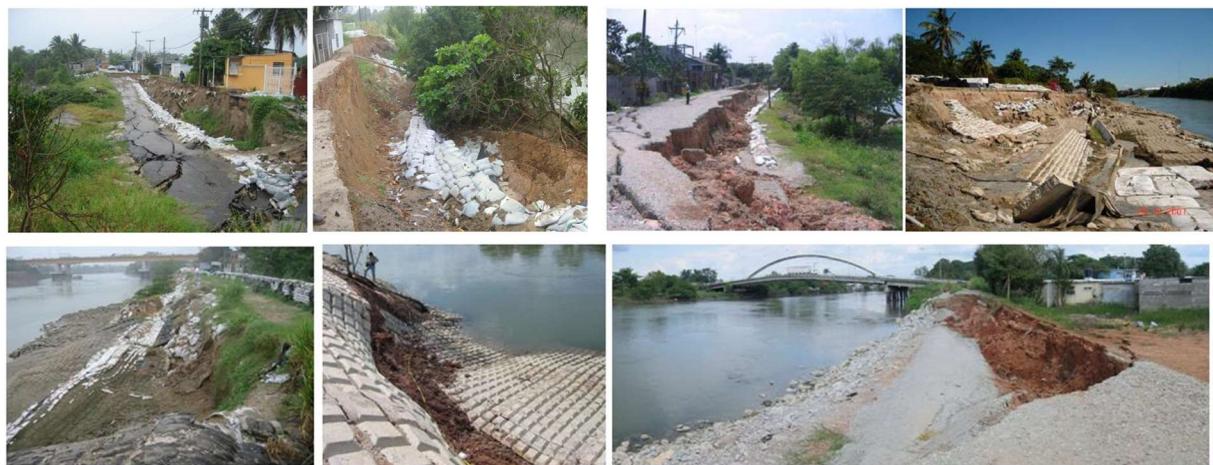
gradients generated by these fluctuations – and rain infiltration in the crests of the dikes (Figure 3). Auvinet et al. (2008) observed that problems in river banks commonly begin with erosion which, depending on the type of soil, can cause piping in some areas, possibly resulting in landslides (Figure 4). These eroded sections are generally protected with dikes consisting of clayey material. Elements that can better withstand erosion by river water are also used, examples being rock fill, systems with concrete bags (*bolsacreto* or *colchacreto*), breakwaters or sheet pile walls. River embankments may also fail when the weight of these structures exceeds the bearing capacity of the foundation soil (Figure 3). Generally, failure occurs in layers with low shear strength such as the highly compressible clays and peats which are found in unpredictable locations along the banks of the rivers in Villahermosa (Figure 1). It has also been found that factors such as scour of the riverbed and over-loading caused by the weight of additional protection such as sand bags result in dike instability. In addition, intense rainfall in the region can cause large and rapid variations in the levels of local rivers, lagoons and reservoirs.

Figure 3. Consequences of water drawdown in Tabasco State, Mexico

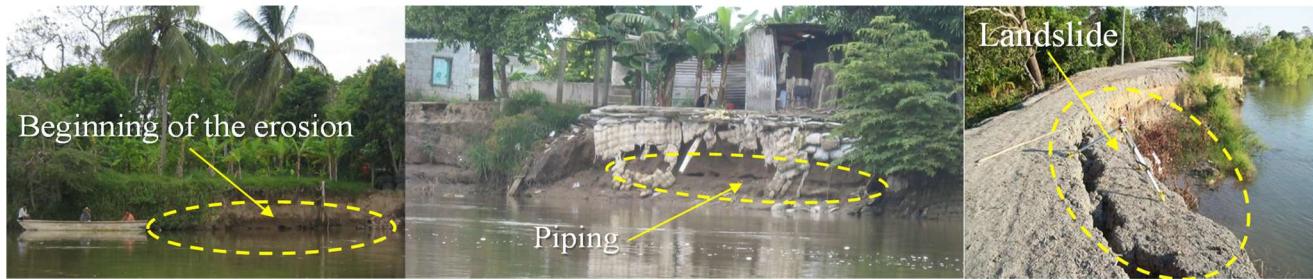
Figure 4. Evidence of instability in river banks and dikes induced by rapid drawdown in Villahermosa.

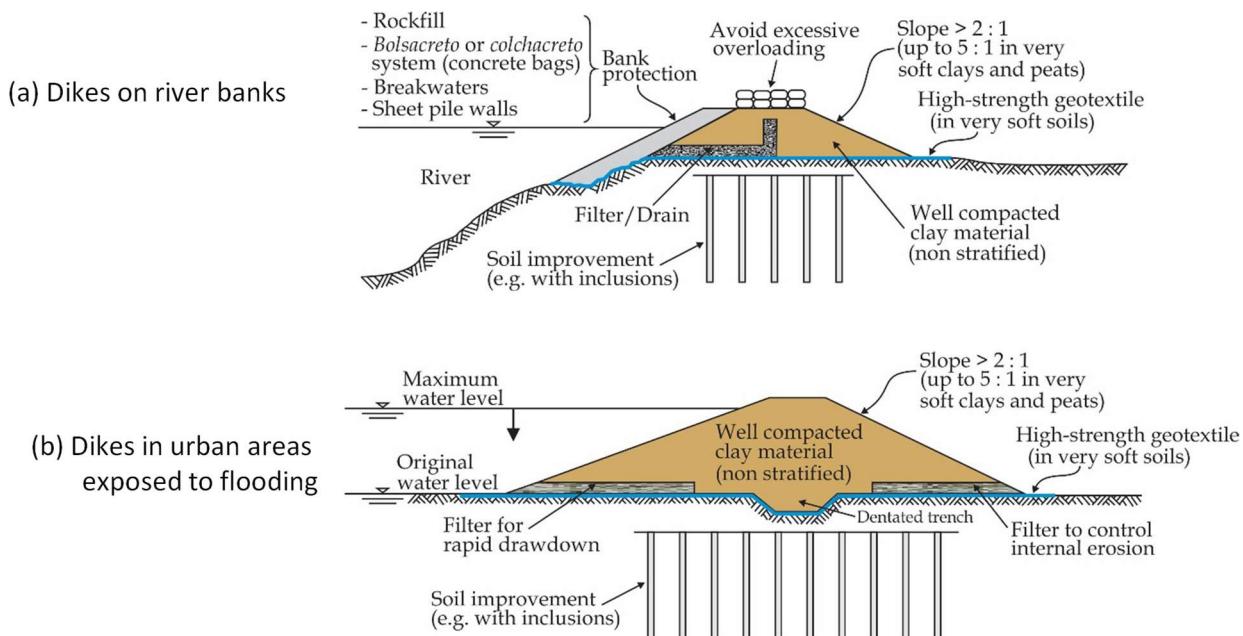
Figure 10. General recommendations to protect Tabasco dikes

This study focused on one of the main problems affecting the stability of Tabasco dikes: the water drawdown phenomenon caused by sudden changes in the levels of rivers, lagoons and reservoirs. Particular emphasis was placed on the study of exit hydraulic gradients at the toe of homogeneous and isotropic dikes. The effects of different parameters (drawdown rate, hydraulic conductivity and slope ratio) for the dikes were assessed in unsaturated, transient-state, flow analyses based on numerical modelling with the finite element method. Based on the results, it is concluded that analyses should consider the susceptibility to erosion of the material used to build the dike. However, analyses should also include measures – such as the installation of drains and filters – to reduce the hydraulic gradients and seepage forces generated inside the soil mass. The results of the analysis led to the practical recommendations shown in Figure 10, which should be taken into consideration for the protection of the Tabasco dikes.

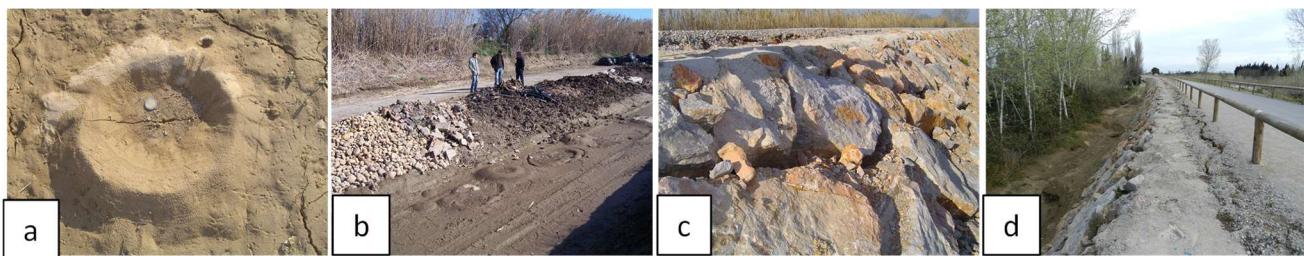
This was also a moderate event: about 800 m³/s at Rivesaltes. However, it lasted longer: 18 hours rather than the 12 hours in the November 2005 event. The dikes were loaded up to 1/2 to 2/3 of their height. CEMAGREF quickly conducted an inspection of a section of 500 m which had been identified in 1999 as being prone to sand boils. A recommendation had been made to install a drainage and seepage system on the landward side. Some of this work had been completed in 2000 with supervision from the managing authority at the time (an association of local authorities). During the winter of 2004-2005, the landward side of the dike was reinforced with concreted riprap to render it resilient to overtopping. During the 2006 event, a section of 130 m in the same location suffered damage caused by internal erosion in the form of sand boils (Figures 13a, b) and subsidence over a strip of up to 1-2 m wide in the protected plain close to the dike, including the maintenance track, and cracking of the concreted riprap (Figures 13c, d).

Figure 13. a) Sand boil (photo: Pierre Philippe, CEMAGREF), b) Multiple sand boils close to the maintenance track on the landward side of the dike (photo: Patrice Mériaux, CEMAGREF), c) Damage to the dike itself: cracks on the crest and in the riprap landside revetment (photo: Pierre Philippe, CEMAGREF), d) Damage to the dike itself: crack on the crest; this picture was taken in 2013 but similar damage occurred in 2006 (photo: Patrice Mériaux, Irstea).

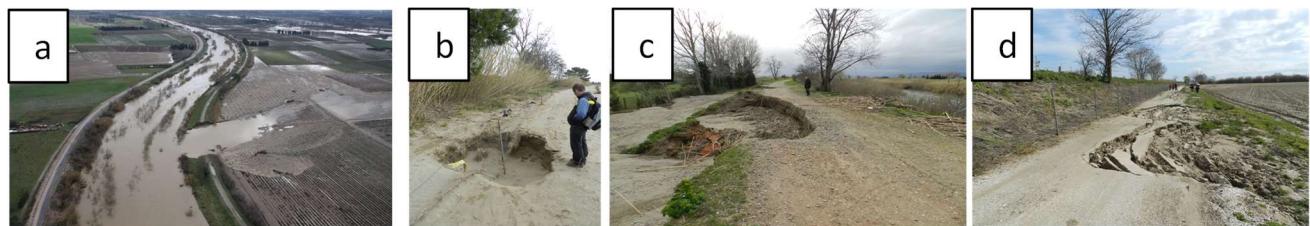
The discharge during this event is also estimated to have been approximately 1000 m³/s. There was a breach over a 75-m section in one of the areas prone to sand boils (Figure 14a). The dike itself was eroded, as well as its foundations down to the depth of the minor river bed. The exact cause of the breach is not known because there were no eyewitnesses close to the dike at the time of the breach initiation about 2 hours after the maximum discharge. The breach may have been caused by internal erosion in the dike or the foundation soils, with possible local overtopping following internal erosion and collapse. A large sinkhole was found close to the breach (Figure 14b). Significant additional damage was observed as a result of overflowing (Figure 14c), internal erosion and foundation instability (Figure 14d), as well as internal erosion in the dike itself at one location.

Figure 14. a) The March 2013 breach at the Pia location on the right of the river (photo: DREAL Languedoc-Roussillon), b) A sinkhole close to the breach (photo: Patrice Mériaux, Irstea), c) Damage caused by overflowing (photo: Patrice Mériaux, Irstea), d) Damage to a track on the landward side of the dike caused by under-seepage (photo: Patrice Mériaux, Irstea)

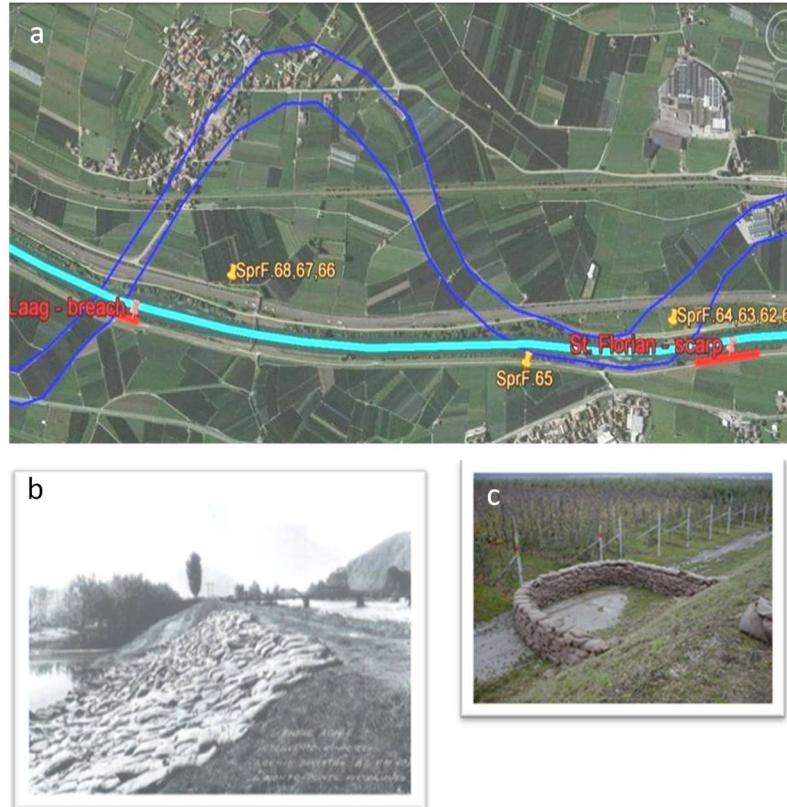
Evidence of water flowing through or underneath the embankment is provided in Figure 18b, c. Ponded backwater often accumulates during a flood event and springs form at the toe of the embankment on the landward side.

The original riverbed meandered through the Adige valley and was straightened at the end of the 19th century, as shown in Figure 18a, by constructing the current embankments. The ancient river bed is filled with material that is coarser than the surrounding clayey and silty deposits. At some places the current riverbed intersects the ancient river beds and locally the embankments are founded on the coarse-grained filling. As a result, the hydraulic conductivity of the embankment foundation at these intersections is relatively high and groundwater flows preferentially through these layers.

Figure 18. (a) Current and ancient river bed profiles and spring formation during the flood events in 1997 and 2000 (b) Backwater areas during the 1966 flood (c) Spring formation during the 1997 flood event

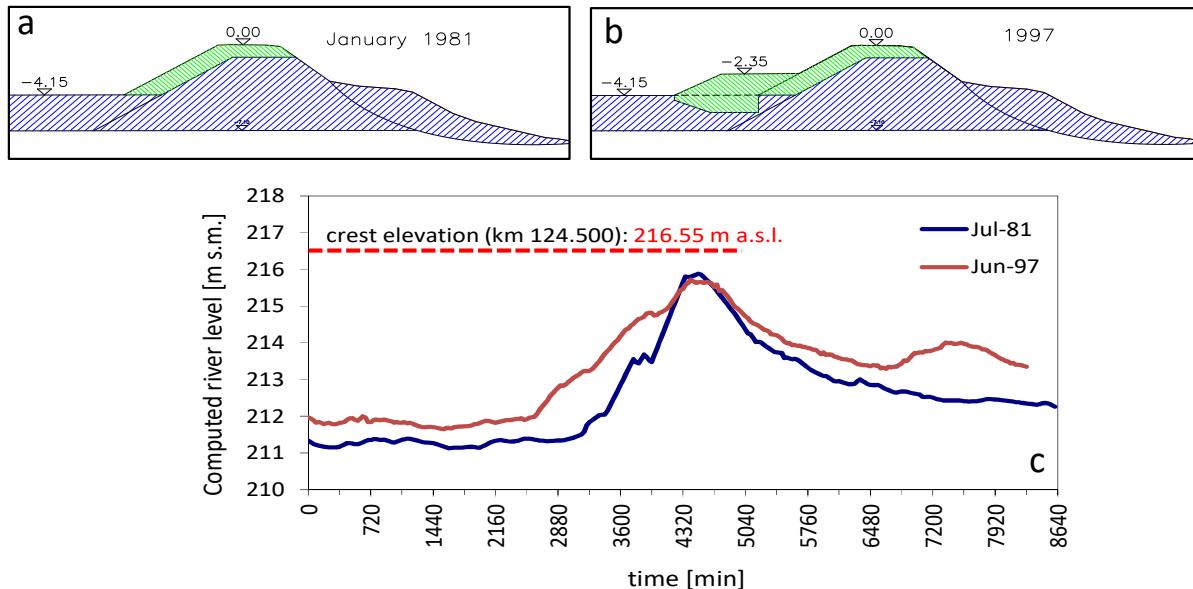
During the flood event in 1997, which was even more intense than the one in 1981 (Figure 19c) no collapse phenomena were observed in the segments that had experienced instability in 1981. This can be attributed to the construction of the berm and the increased stability on the landward side.

Figure 19. a) cross section during the flood event in 1981 b) remedial works consisting of a berm on the landward side, c) the river level during the flood events in 1981 and 1997 The elevation of the embankment crest is also reported as a reference.

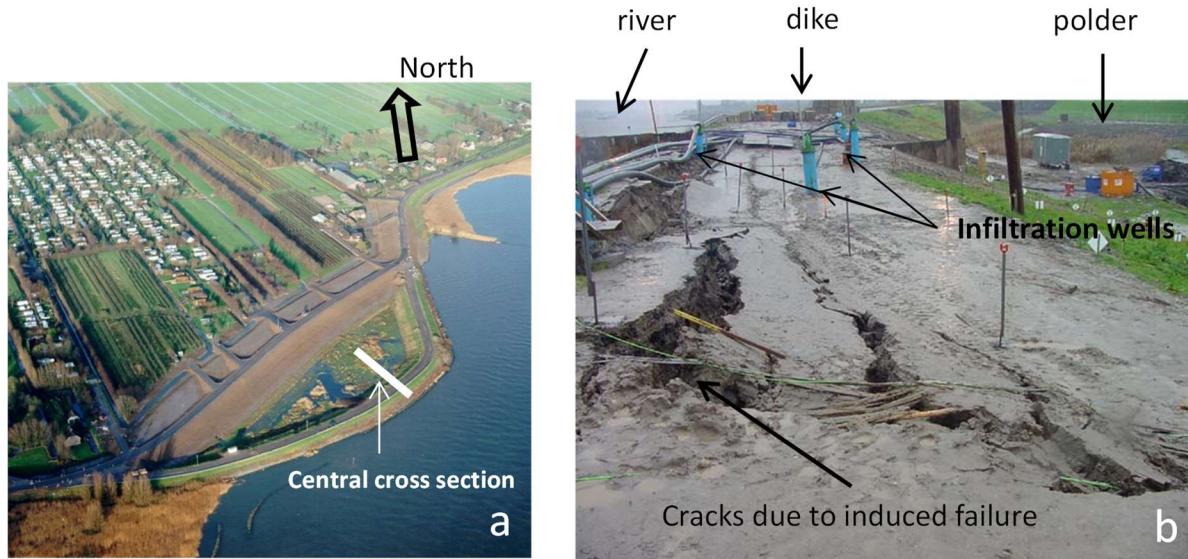
Figure 27. Test site, a; aerial photograph before testing, arrow indicates North direction, white line indicates the location of the central cross section shown by Figure 29, b; failed dike body after testing

The test began at 06.00 on 26 November 2000, $t = 0$ in the graphs below. Figure 32 shows the river level and the average head in the nine infiltration wells. Infiltration started at $t = 370$ min, 6 hours after the start of the test. Initially, the hydraulic head in the wells followed the fluctuations in the river level. It should be noted that the test site is close to the sea and that the tidal wave has a pronounced influence on the water level in front of the dike. Although drinking water was used for infiltration, the infiltration wells clogged up after 26 hours, $t = 1580$ min, reducing well capacity. Due to maintenance, required to regain the full pumping capacity, the hydraulic head was seen to fall between $t = 1580$ and 2260 min, a period of 11.3 hours (Figure 32). Maintenance was also needed between $t = 3090$ and 3308 min, a period of 3.6 hours. Failure was observed at $t = 3450$ min, approximately 2.5 days after the start of the test, in the form of large longitudinal cracks in the dike body accompanied by major subsoil deformation (see Figures 33 and 34). The difference in height at the location of the cracks increased to more than 1.0 m (Figure 27b).

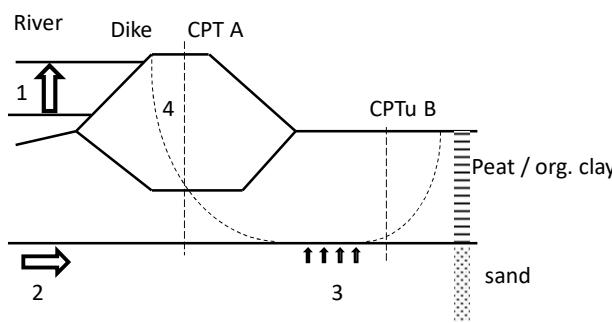
A typical failure mechanism for dikes in this area is loss of stability due to uplift of the soft soil layers at the toe. Figure 28 explains the failure mechanism. There is a hydraulic connection between the river and the Pleistocene sand layer. A rise in the river level (1) results in an increase in the hydraulic head in the Pleistocene sand layers (2) until the pore pressure equals the weight of the Holocene layers on top (3). The shear strength at the transition between the Holocene clay and peat layers on the one hand and the Pleistocene sand deposit on the other is drastically reduced, creating the conditions for a long, deep, slip plane (4). The uplift phenomenon is described in further detail by Cooling & Marsland (1953), Marsland (1961), Bauduin et al. (1989) and Van (2001). Observations of stability loss due to uplift are scarce and it was decided to study the uplift phenomenon at the Bergambacht test site.

Figure 28. Impression of the uplift failure mechanism, 1: river level rise, 2: hydraulic connection to sand layer, 3: pore pressure rise until uplift top layer, 4: failure plane.

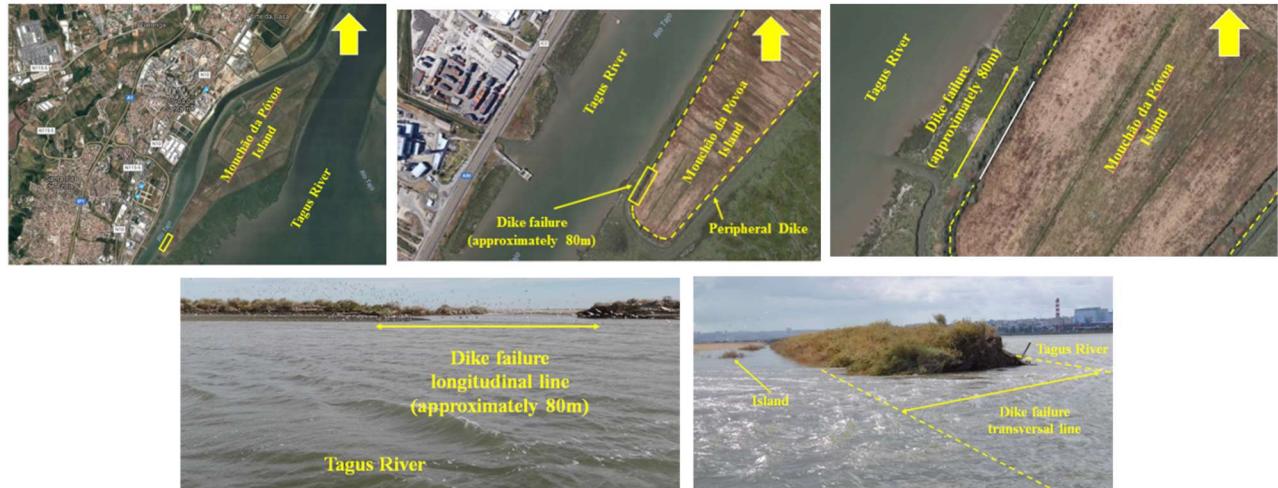
on an alluvium layer protected on the outer face by riprap (rock armour) revetment. The island has been used for agriculture for at least the last 80 years. Figure 38 provides views of the failure that occurred on March 2016.

Figure 38. Location and view of the dike failure.

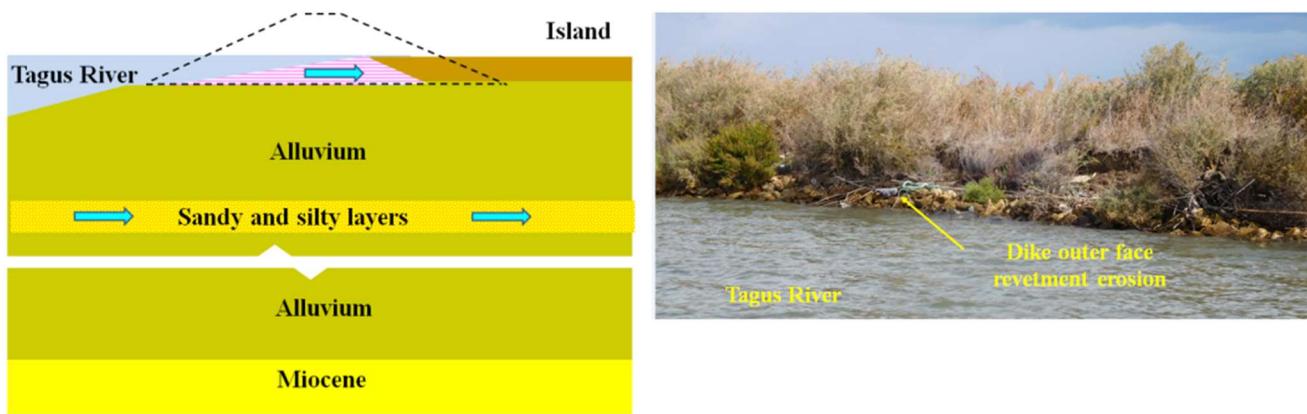
The main failure mechanism is related to the erosion of the clay fill due to water inflow and the mechanical action of the waves on the outer face of the dike. Failure originated with the erosion of the riprap revetment (Figure 39). The presence of a permeable sandy layer below the dike foundations also contributed to the failure mechanism. The actual dike failure began during the severe winter of 2015 - 2016 and involved a section with an overall length of approximately 30 m. When the failure occurred, the water level in the Tagus River was approximately Mean Sea Level, MSL, +4.20 m. In October 2016, the overall length of the dike failure line had increased to approximately 80 m.

Failure due to the clay fill erosion (Tagus river waves start to erode the rip rap revetment)

Figure 40. Dike failure due to the erosion of the clay fill, cross-section and view of the outer face.

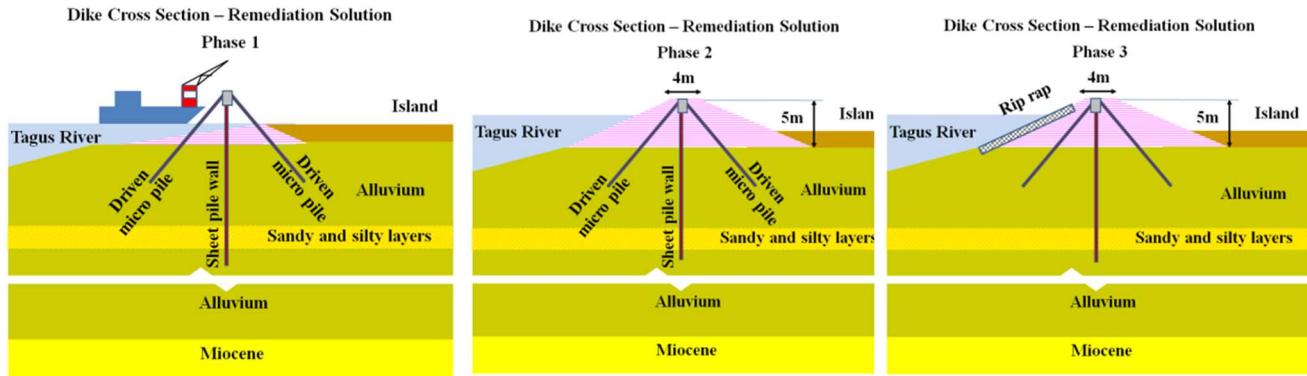
Figure 41. Dike remediation: main construction phases.

The proposed dike remediation solutions comprised the use of a driven sheet-pile wall braced by inclined driven steel micro-piles, all capped with a top and a central, reinforced, concrete beam. Those works are to be performed from a barge at high tide. The depth of the sheet pile walls will have to be enough to pass through the silty and sandy alluvial layers. A protection and stabilisation fill will be required on both the outer and inner sides of the sheet piling. On the outer face of the fill, a riprap protection revetment will be required to protect the fill from hydraulic erosion. Figure 41 illustrates the reconstruction works.
