Lessons Learned from Dike Failures in Recent Decades

ABSTRACT: *The paper describes five different dike failures that occurred in recent decades. The case histories were located on different rivers and involved different loading conditions. The observed failure mechanisms involved erosion and stability problems. The types of erosion observed were both internal erosion due to extreme groundwater flow and external erosion caused by the river flow and wave action. The case involving instability was caused by uplift, i.e., increased hydraulic head led to a sharp reduction in maximum shear strength between subsoil layers. Two cases demonstrate the importance of dike management and maintenance. Despite the variations in the loading conditions and failure mechanisms, all the cases show that the strength of a dike depends not only on the material used to build the dike but also on the strength of the subsoil.*

Lessons Learned from Dike Failures in Recent Decades. International Journal of Geoenvironment Case histories, Vol.4, Issue 3, p.203-229. doi: 10.4417/IJGCH-04-03-04

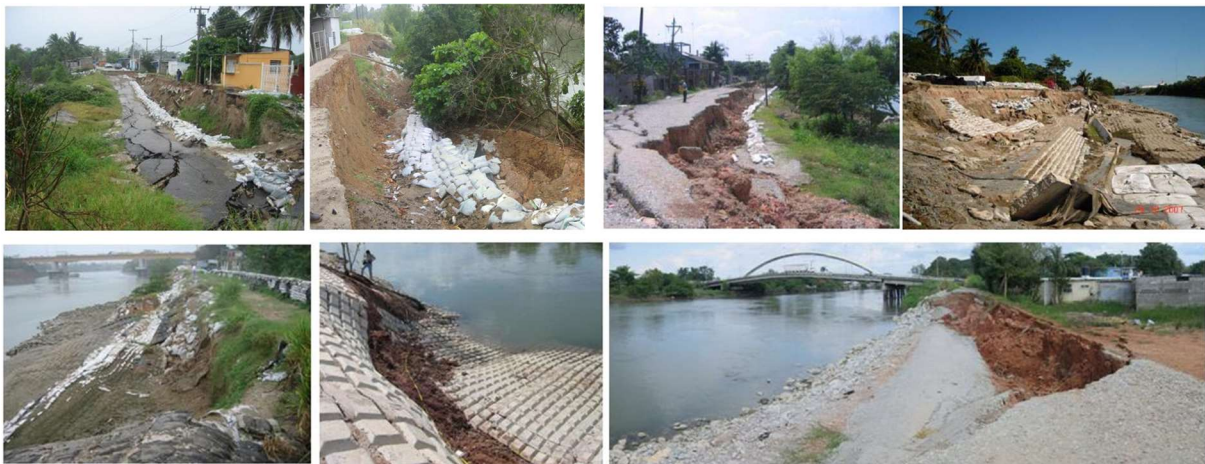
gradients generated by these fluctuations – and rain infiltration in the crests of the dikes (Figure 3). Auvinet et al. (2008) observed that problems in river banks commonly begin with erosion which, depending on the type of soil, can cause piping in some areas, possibly resulting in landslides (Figure 4). These eroded sections are generally protected with dikes consisting of clayey material. Elements that can better withstand erosion by river water are also used, examples being rock fill, systems with concrete bags (*bolsacreto* or *colchacreto*), breakwaters or sheet pile walls. River embankments may also fail when the weight of these structures exceeds the bearing capacity of the foundation soil (Figure 3). Generally, failure occurs in layers with low shear strength such as the highly compressible clays and peats which are found in unpredictable locations along the banks of the rivers in Villahermosa (Figure 1). It has also been found that factors such as scour of the riverbed and overloading caused by the weight of additional protection such as sand bags result in dike instability. In addition, intense rainfall in the region can cause large and rapid variations in the levels of local rivers, lagoons and reservoirs.

Figure 3. Consequences of water drawdown in Tabasco State, Mexico

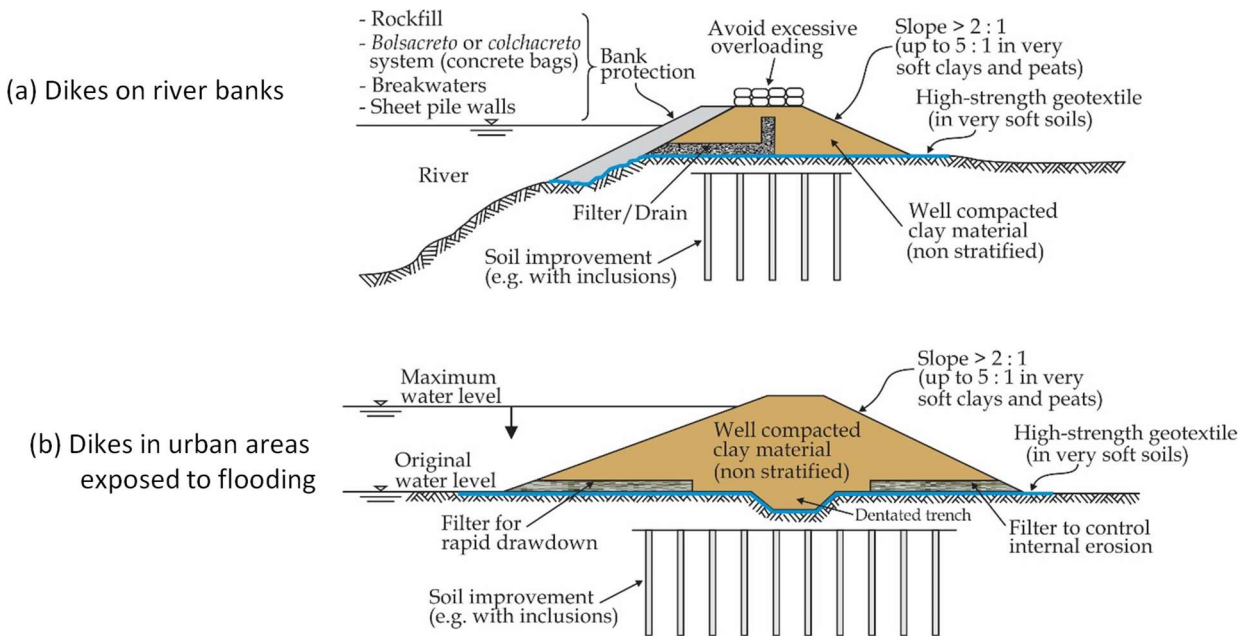
Figure 10. General recommendations to protect Tabasco dikes

This study focused on one of the main problems affecting the stability of Tabasco dikes: the water drawdown phenomenon caused by sudden changes in the levels of rivers, lagoons and reservoirs. Particular emphasis was placed on the study of exit hydraulic gradients at the toe of homogeneous and isotropic dikes. The effects of different parameters (drawdown rate, hydraulic conductivity and slope ratio) for the dikes were assessed in unsaturated, transient-state, flow analyses based on numerical modelling with the finite element method. Based on the results, it is concluded that analyses should consider the susceptibility to erosion of the material used to build the dike. However, analyses should also include measures – such as the installation of drains and filters – to reduce the hydraulic gradients and seepage forces generated inside the soil mass. The results of the analysis led to the practical recommendations shown in Figure 10, which should be taken into consideration for the protection of the Tabasco dikes.

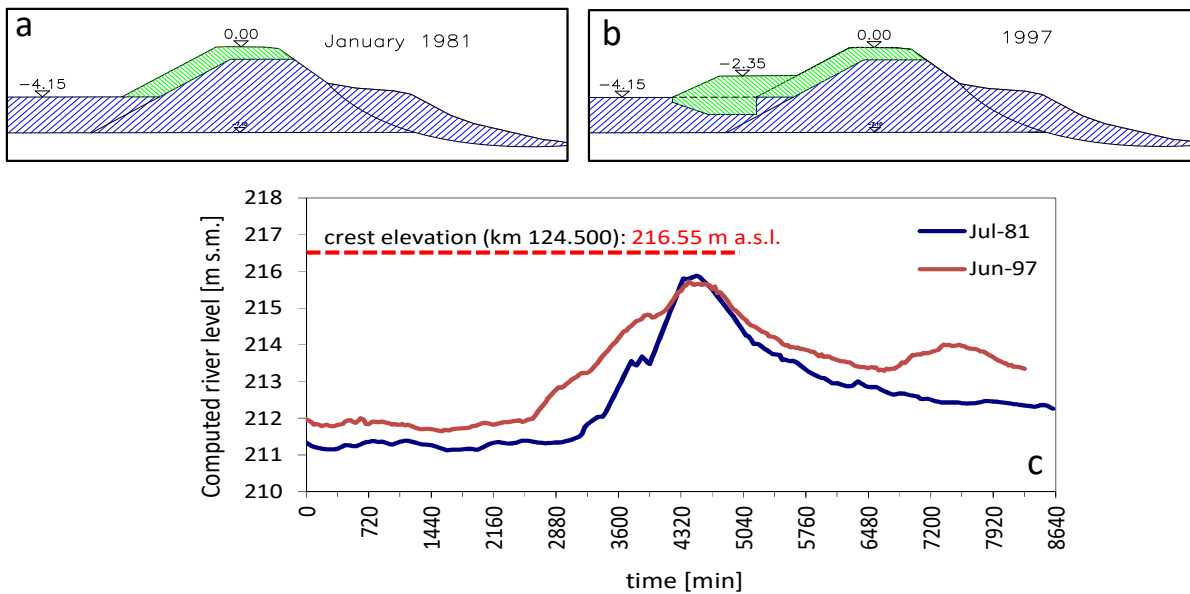
During the flood event in 1997, which was even more intense than the one in 1981 (Figure 19c) no collapse phenomena were observed in the segments that had experienced instability in 1981. This can be attributed to the construction of the berm and the increased stability on the landward side.

Figure 19. a) cross section during the flood event in 1981 b) remedial works consisting of a berm on the landward side, c) the river level during the flood events in 1981 and 1997 The elevation of the embankment crest is also reported as a reference.
