Lessons Learned from Dike Failures in Recent Decades

ABSTRACT: *The paper describes five different dike failures that occurred in recent decades. The case histories were located on different rivers and involved different loading conditions. The observed failure mechanisms involved erosion and stability problems. The types of erosion observed were both internal erosion due to extreme groundwater flow and external erosion caused by the river flow and wave action. The case involving instability was caused by uplift, i.e., increased hydraulic head led to a sharp reduction in maximum shear strength between subsoil layers. Two cases demonstrate the importance of dike management and maintenance. Despite the variations in the loading conditions and failure mechanisms, all the cases show that the strength of a dike depends not only on the material used to build the dike but also on the strength of the subsoil.*

Lessons Learned from Dike Failures in Recent Decades. International Journal of Geoenvironment Case histories, Vol.4, Issue 3, p.203-229. doi: 10.4417/IJGCH-04-03-04

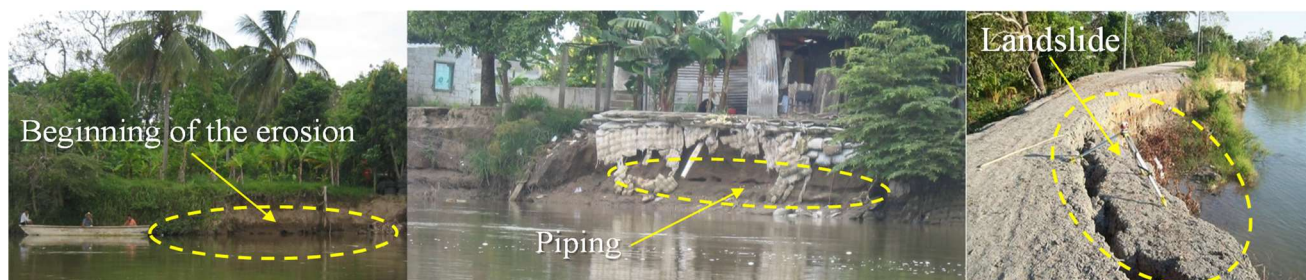
Sudden or rapid drawdown occurs when there is an unexpected drop in the outside water level that modifies the flow conditions in the structure without adequate time for drainage of the soil mass. Hydraulic gradients and seepage forces develop that, in extreme conditions, cause soil erosion problems that range from minor to severe, examples being piping or even the complete failure of the structure. In addition, rapid drawdown has a negative effect on slope stability and it may result in the

Figure 4. Evidence of instability in river banks and dikes induced by rapid drawdown in Villahermosa.

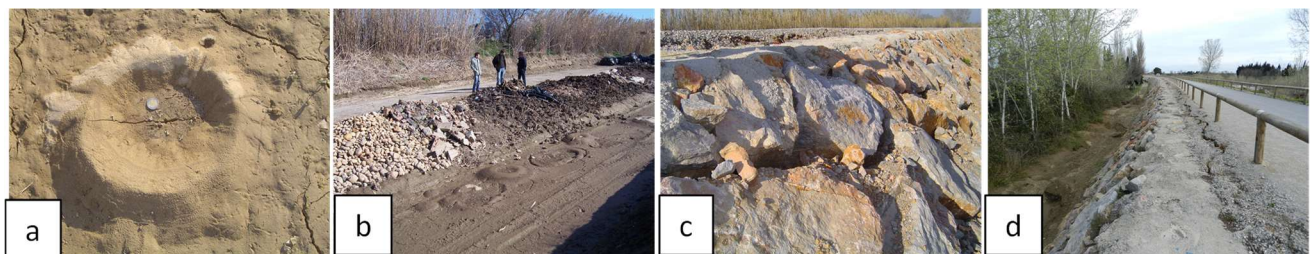
This was also a moderate event: about 800 m³/s at Rivesaltes. However, it lasted longer: 18 hours rather than the 12 hours in the November 2005 event. The dikes were loaded up to 1/2 to 2/3 of their height. CEMAGREF quickly conducted an inspection of a section of 500 m which had been identified in 1999 as being prone to sand boils. A recommendation had been made to install a drainage and seepage system on the landward side. Some of this work had been completed in 2000 with supervision from the managing authority at the time (an association of local authorities). During the winter of 2004-2005, the landward side of the dike was reinforced with concreted riprap to render it resilient to overtopping. During the 2006 event, a section of 130 m in the same location suffered damage caused by internal erosion in the form of sand boils (Figures 13a, b) and subsidence over a strip of up to 1-2 m wide in the protected plain close to the dike, including the maintenance track, and cracking of the concreted riprap (Figures 13c, d).

Figure 13. a) Sand boil (photo: Pierre Philippe, CEMAGREF), b) Multiple sand boils close to the maintenance track on the landward side of the dike (photo: Patrice Mériaux, CEMAGREF), c) Damage to the dike itself: cracks on the crest and in the riprap landside revetment (photo: Pierre Philippe, CEMAGREF), d) Damage to the dike itself: crack on the crest; this picture was taken in 2013 but similar damage occurred in 2006 (photo: Patrice Mériaux, Irstea).

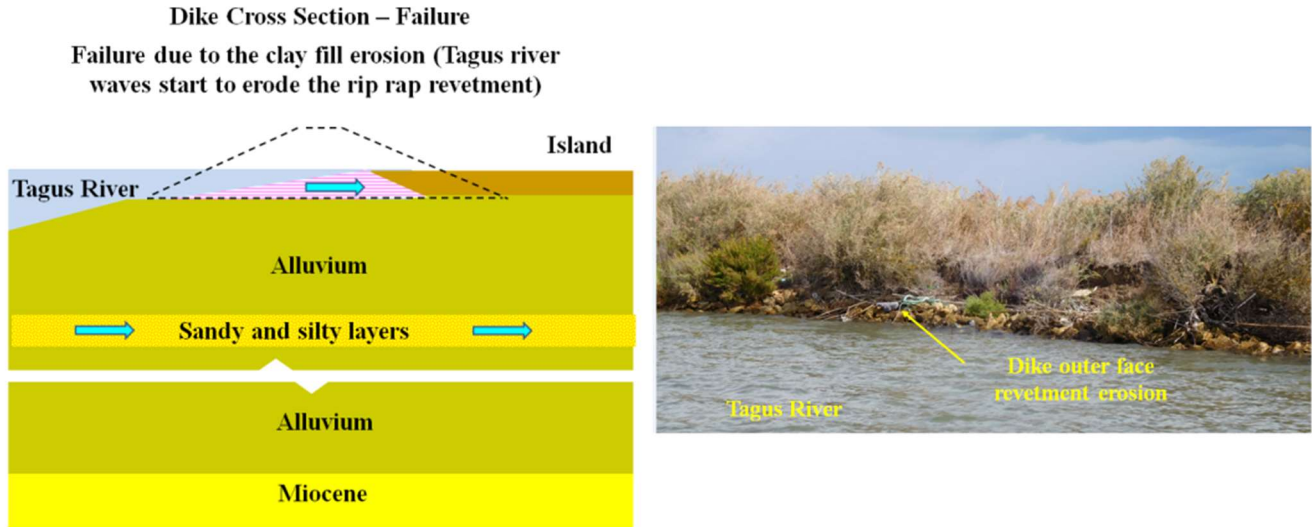
The main failure mechanism is related to the erosion of the clay fill due to water inflow and the mechanical action of the waves on the outer face of the dike. Failure originated with the erosion of the riprap revetment (Figure 39). The presence of a permeable sandy layer below the dike foundations also contributed to the failure mechanism. The actual dike failure began during the severe winter of 2015 - 2016 and involved a section with an overall length of approximately 30 m. When the failure occurred, the water level in the Tagus River was approximately Mean Sea Level, MSL, +4.20 m. In October 2016, the overall length of the dike failure line had increased to approximately 80 m.

Figure 40. Dike failure due to the erosion of the clay fill, cross-section and view of the outer face.

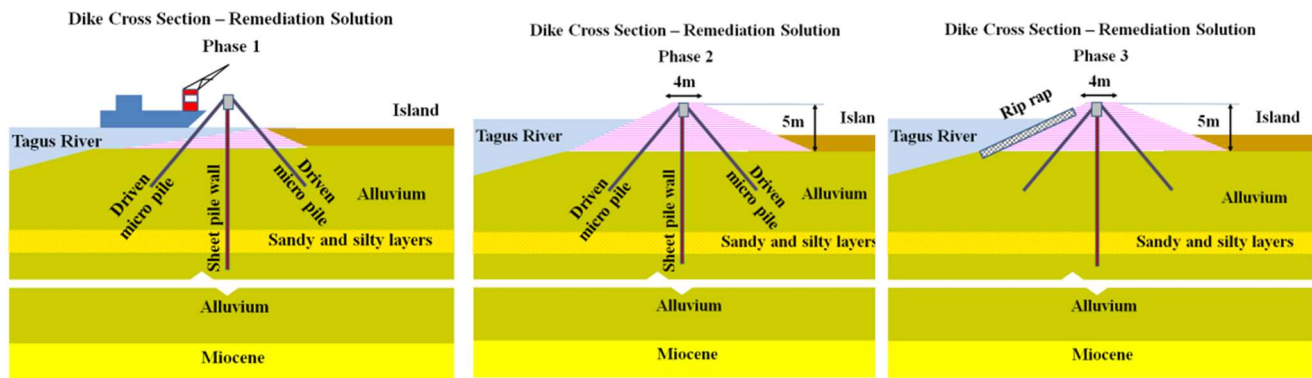
Figure 41. Dike remediation: main construction phases.

The proposed dike remediation solutions comprised the use of a driven sheet-pile wall braced by inclined driven steel micro-piles, all capped with a top and a central, reinforced, concrete beam. Those works are to be performed from a barge at high tide. The depth of the sheet pile walls will have to be enough to pass through the silty and sandy alluvial layers. A protection and stabilisation fill will be required on both the outer and inner sides of the sheet piling. On the outer face of the fill, a riprap protection revetment will be required to protect the fill from hydraulic erosion. Figure 41 illustrates the reconstruction works.
