Geotechnical Observations of Dams Failed During the 2015 Historic Flooding in South Carolina

ABSTRACT: *This paper presents a description of post-flood reconnaissance and geotechnical investigation of four earthen dams that were breached or damaged following an extreme flooding event in South Carolina in 2015. As a result of unprecedented rainfall and flooding that occurred during a five-day period at the beginning of October in 2015, a total of 51 earthen dams failed and nearly 200 were damaged. Many of these dams failed due to overtopping that led to a breach of the dam. Among the four dams investigated, full breach was observed at three dams; two of which were overtopped, and one was not. The fourth dam was not breached but was severely damaged. For each of these dams, the paper documents background information, pre-flood conditions, post-flood field observations and measurements, and laboratory testing results of collected soil samples. Impacts of vegetation on the dams and the effects of dam failure on critical infrastructure are also presented. The detailed descriptions and geotechnical investigations of the dam failures presented herein serve as case histories that can be u

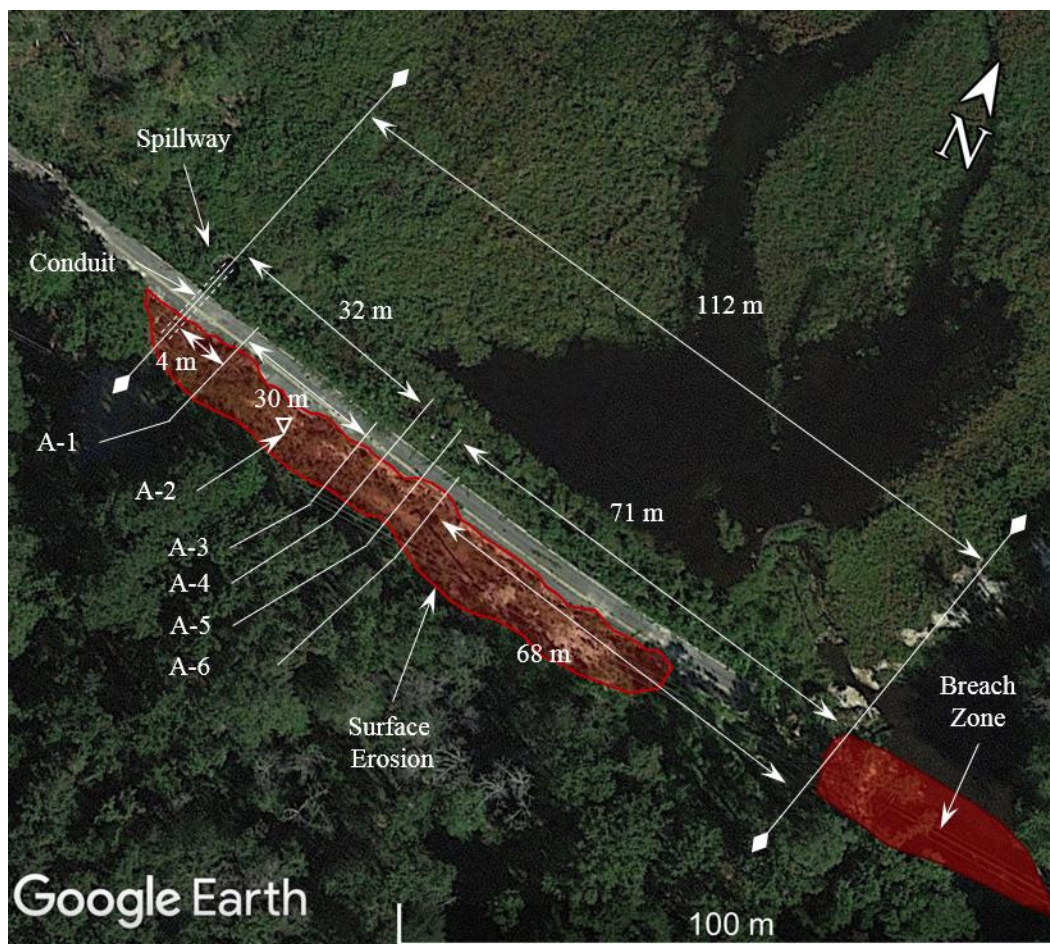
Figure 3. Location of spillway, surface erosion, breach, and sampling locations in Dam A (Google Earth, accessed on April 8, 2018).

The spillway structure of this dam is located on the west side of the dam and about 112 m from the breach zone, as shown in Figure 3. Sampling locations relative to the spillway and the breach zone are also presented in this figure. The spillway is a conduit made of a 1.2 m diameter concrete pipe, as shown in Figure 4a, with a maximum discharge capacity of approximately 17 m³/s (USACE 2016). The soil above the pipe on the downstream side was washed out, as shown in Figure 4b. It is unknown whether this structure worked as the primary spillway of the dam, or if an additional spillway structure existed before the breach.

Damage to this dam includes a complete breach and a large zone of surface erosion separate from the breach, as shown in Figure 3. The breach is located near to the east end of the dam. The breach extended approximately 50 m of the total 290 m length of the dam, and nearly 7,300 m³ of material, including soil and pavement, were washed out (see Figure 6). In the breach zone, several trees on the upstream side slope tipped over the road in the direction of water flow (see Figures 6 and 8), which provides some evidence of overtopping. In the surface erosion zone, the soil erosion along the downstream side slope extended over 60 m parallel to and 20 m perpendicular to the road, as shown in Figures 3, 5b and 7b. As shown in Figure 7a, part of the asphalt shoulder and roadway collapsed above the zone of surface erosion.

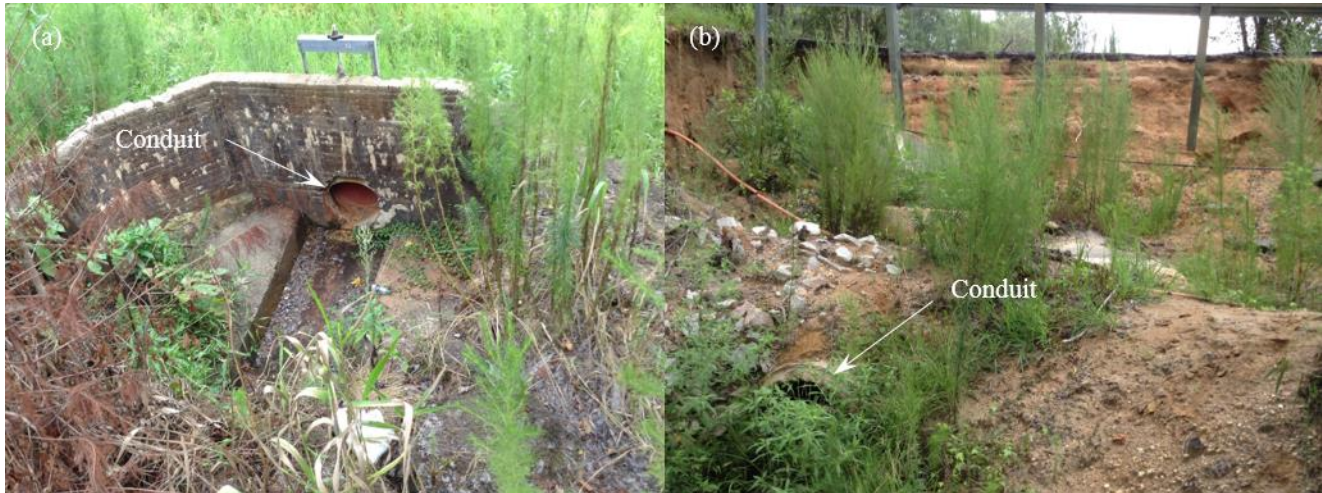
Figure 4. Spillway structure for Dam A: (a) conduit on upstream side (north view from SR-40-67), and (b) conduit and washed out soil above on downstream side (north view from downstream).

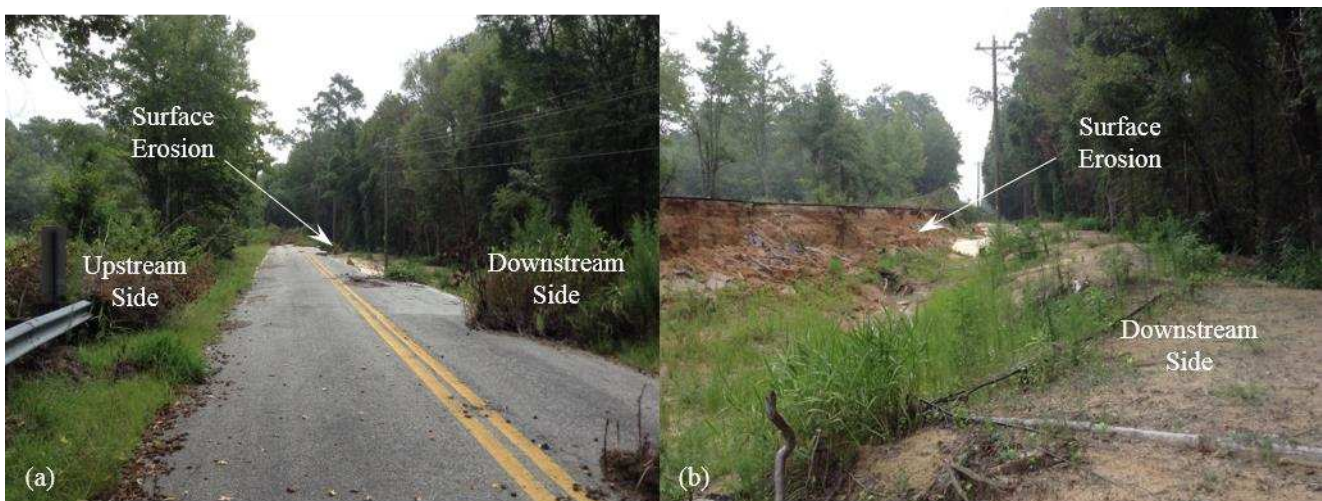
Vegetation was not present on the crest of Dam A where the road is located. However, there is vegetation on the edges of the crest adjacent to the road and on the upstream and downstream sides of the dam. Mature trees with heights of nearly 12 m were observed on the upstream side, parallel to the road and nearly 3 m away from the upstream shoulder (see Figure 5a). Trees on the downstream side have similar heights, but were found nearly 20 m away from the road (see Figure 5b). All of the mature trees appear to be part of the natural growth in the local ecosystem. It is unclear if the presence of vegetation influenced dam performance or contributed to its failure. In the area where soil was exposed on the downstream side slope (noted as surface erosion in Figure 5b), there were no trees present and no roots observed in the soil. Near the northeast section of the breach, several trees were found tipped over the road (see Figure 6), but no roots were observed in the soil.

Figure 5. Vegetation on Dam A: (a) vegetation upstream and downstream of the dam (east view from S-40-67), and (b) vegetation and surface erosion on the downstream side of the dam (east view from downstream).

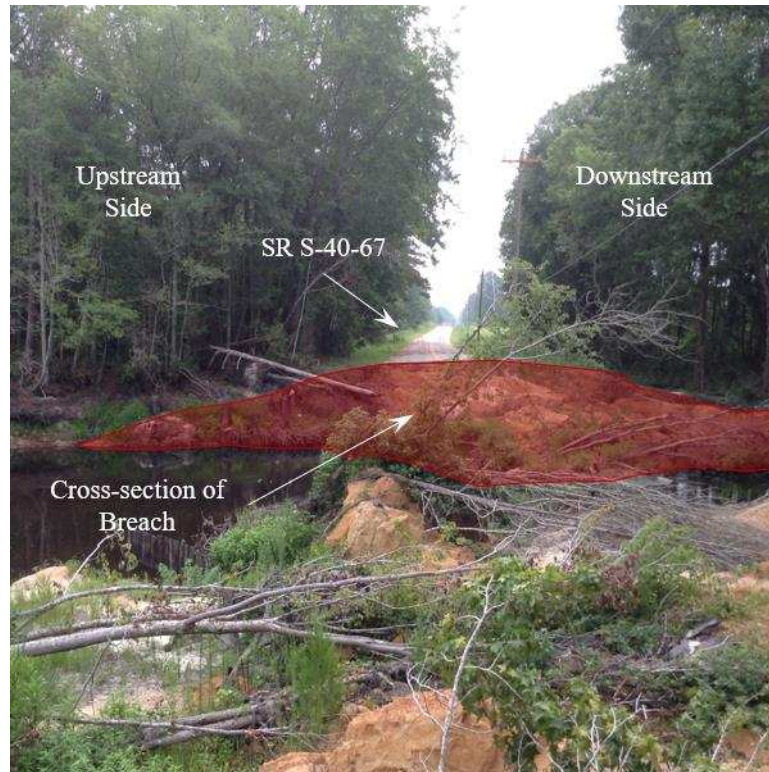
Figure 6. Cross-sectional area of breach in Dam A (east view from SR-40-67).

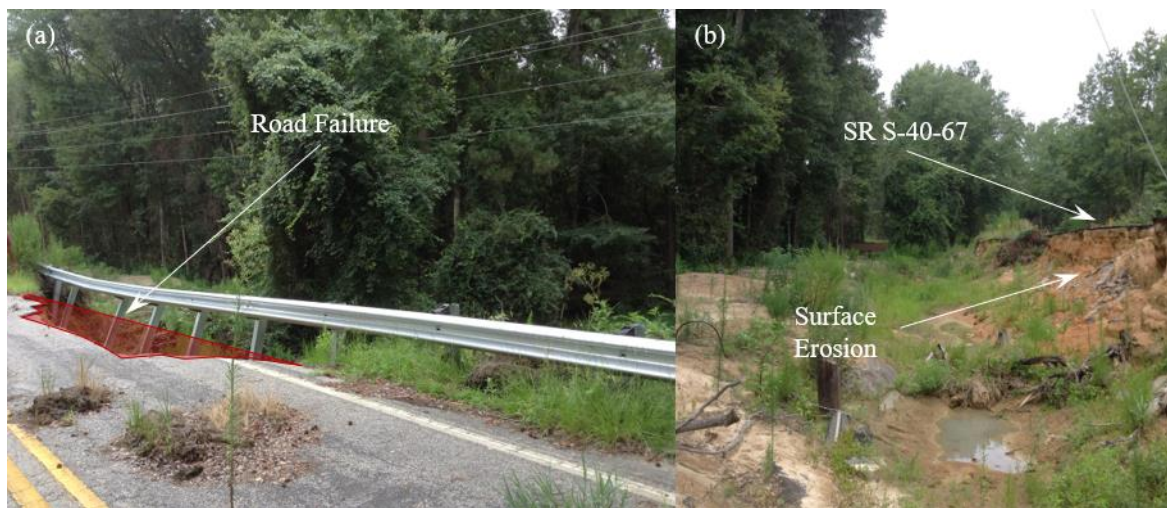
Figure 7. Failure of Dam A: (a) road failure of State Road S-40-67 (southeast view from S-40-67), and (b) surface erosion due to overtopping (west view from downstream).

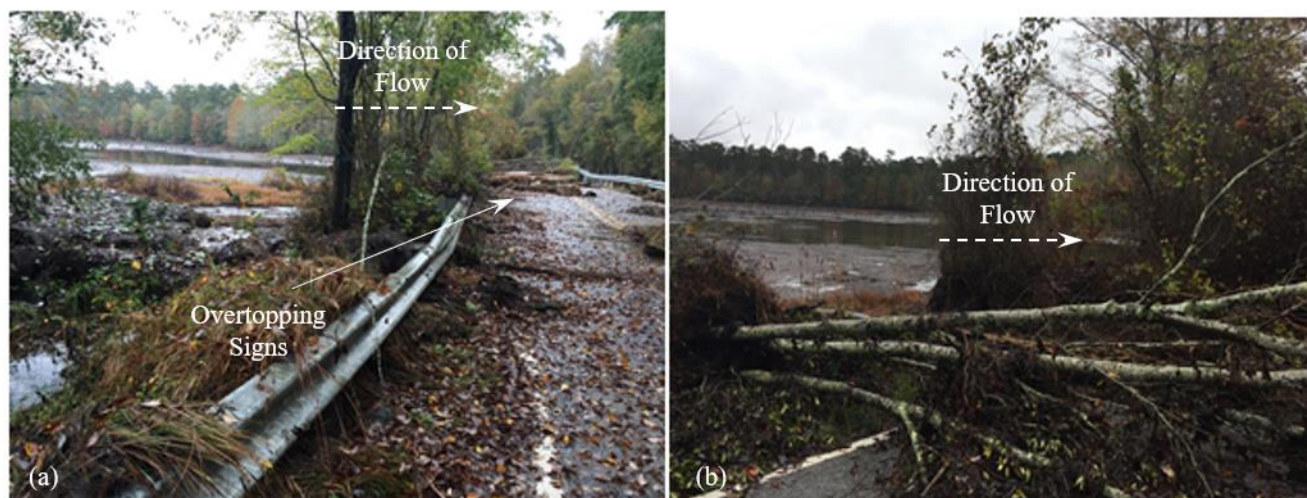
Figure 8. Evidence of overtopping during the flood for Dam A: (a) eroded vegetation and debris on the crest (east view from SR-40-67); and (b) fallen trees on the crest (north view from SR-40-67).

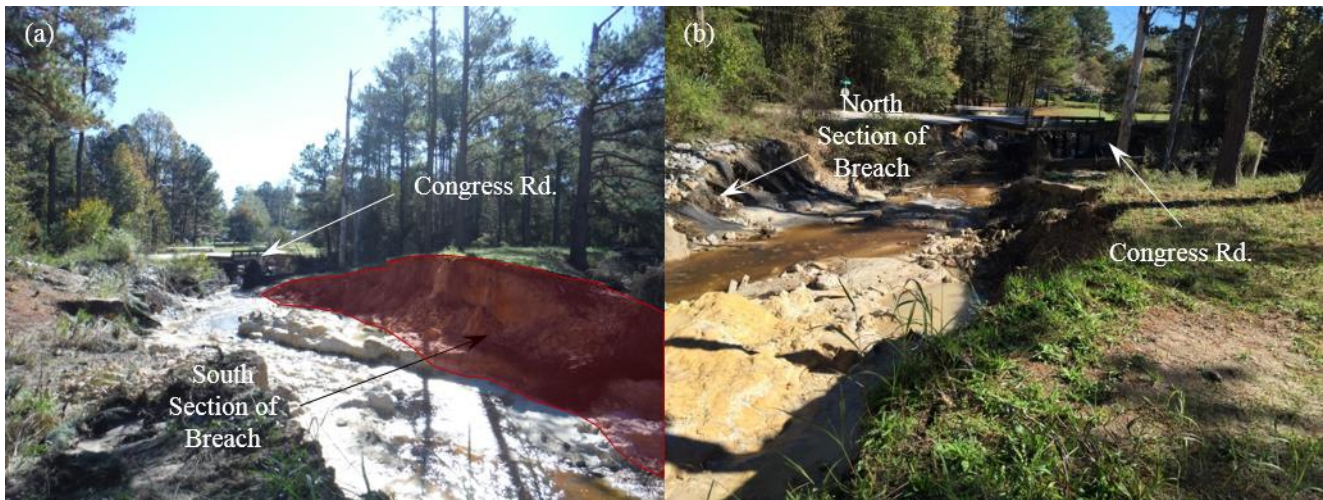
Figure 11. Breach section in Dam B: southeast views from (a) the north section of breach and (b) the south sections of the breach.

The dam was completely breached during the flood as shown in Figure 11. The location of the breach (see Figure 12) was close to the north end of the dam and close to the supposed original location of the second spillway riser pipe. The breach was approximately 15 m of the total 130 m length of the dam. Nearly 1,050 m³ of embankment material was washed out during the flood event. Surface erosion was observed along the downstream side slope extending along the entire length of the dam, as shown in Figure 16. Trees on the downstream side slope of the dam were partially or fully tipped over and some appeared to be displaced (Figure 15b). These observations might indicate overtopping of the dam.

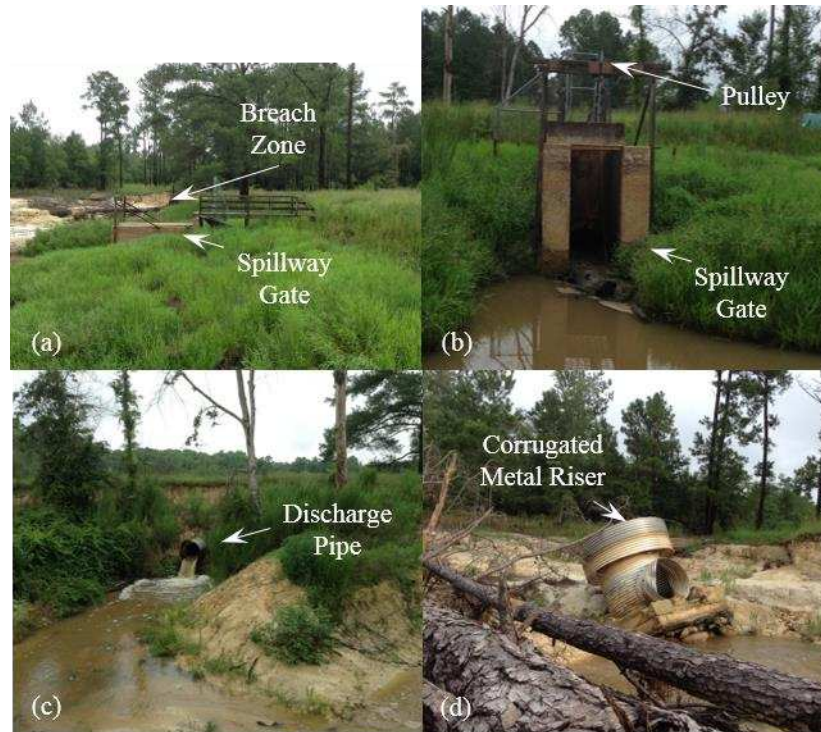
Two spillway systems were observed at Dam B, but it is unknown which worked as primary spillway before the breach. According to USACE (2016), the maximum discharge capacity of the dam was approximately $34 \text{ m}^3/\text{s}$. The first system was located on the west side of the dam, nearly 24 m from the breach zone (location marked in Figure 12). It is composed of a 1.3 m wide concrete inlet structure leading to a 1.2 m diameter concrete discharge pipe (see Figures 14a, 14b and 14c). A pulley lift system is attached to a metal frame surrounding the concrete. The structure appeared to be missing a sliding door that would have been raised and lowered with the pulley to manually control the lake water level. Water from the lake was observed draining through the pipe on the downstream side of the gate (see Figures 12 and 14c). The second spillway was found near the south section of the breach. It consisted of a corrugated-metal riser pipe supported by a concrete base. The dimensions of the conduit were not measured. As shown in Figure 14d, this structure appears to be damaged, displaced, and separated from a conduit that would have been used to drain water from the lake, presumably through or under the dam, towards a creek flowing below the Congress Road bridge (see Figure 12). According to an SCDHEC inspection report from 2008 (SCDHEC 2016), repair procedures were required in the corrugated-metal riser pipe as well as calculations assuring that the spillway met design flood requirements according to the hazard potential. It is unknown whether the spillway was repaired before the flood event.

Figure 14. Spillway structures in Dam B: (a) location (view along the crest looking north), (b) concrete spillway gate (east view from upstream), (c) discharge pipe downstream from gate (east view from downstream), and (d) failed riser (northwest view from breach).

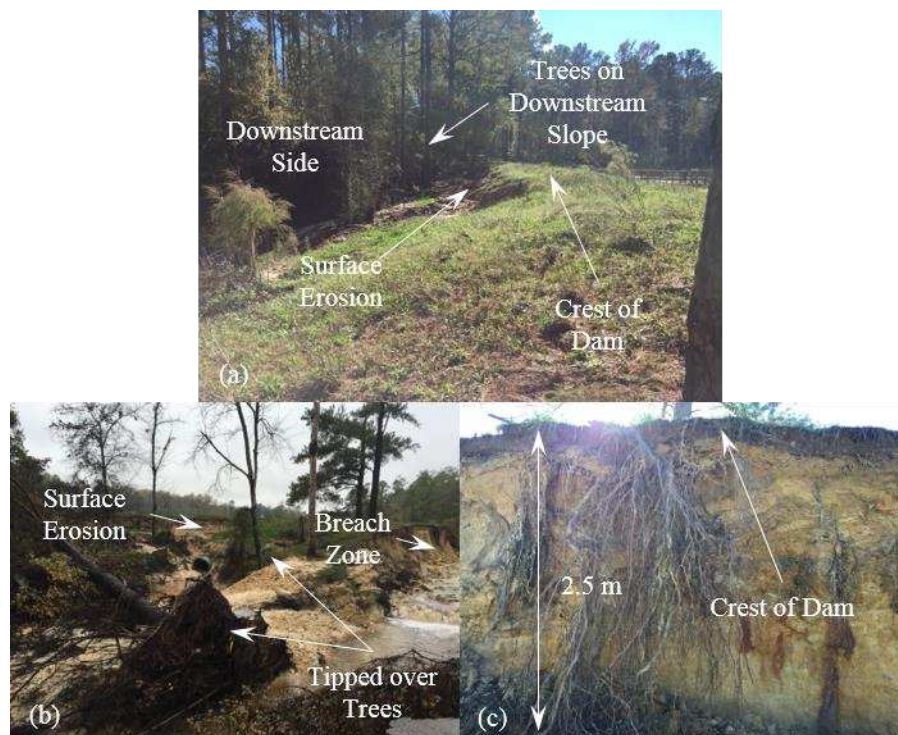
Vegetation was observed over the entire surface of the dam (see Figure 15). The upstream side-slope and crest of the dam are covered with grass and shrubs with heights less than 1 m. Several mature trees with heights from 15 to 18 m were observed on the crest and downstream side-slope of the dam (see Figures 15a and 15b). The roots of one of these trees were exposed by the dam breach, as shown in Figure 15c. The roots reach depths of nearly 2.5 m, penetrating through the upper half and into the lower half of the 4.3 m high dam. The SCDHEC inspection report from 2008 (SCDHEC 2016) also highlighted the need of removing vegetation to an acceptable grass cover. It is clear that the vegetation was not removed, as requested.

Figure 15. Vegetation on Dam B: (a) low grasses and small bushes on the dam crest, trees on downstream side slope (south view from crest), (b) tipped over trees near breach and zone of surface erosion (west view from downstream), and (c) presence of roots throughout the dam on the south breach wall (south view from breach).

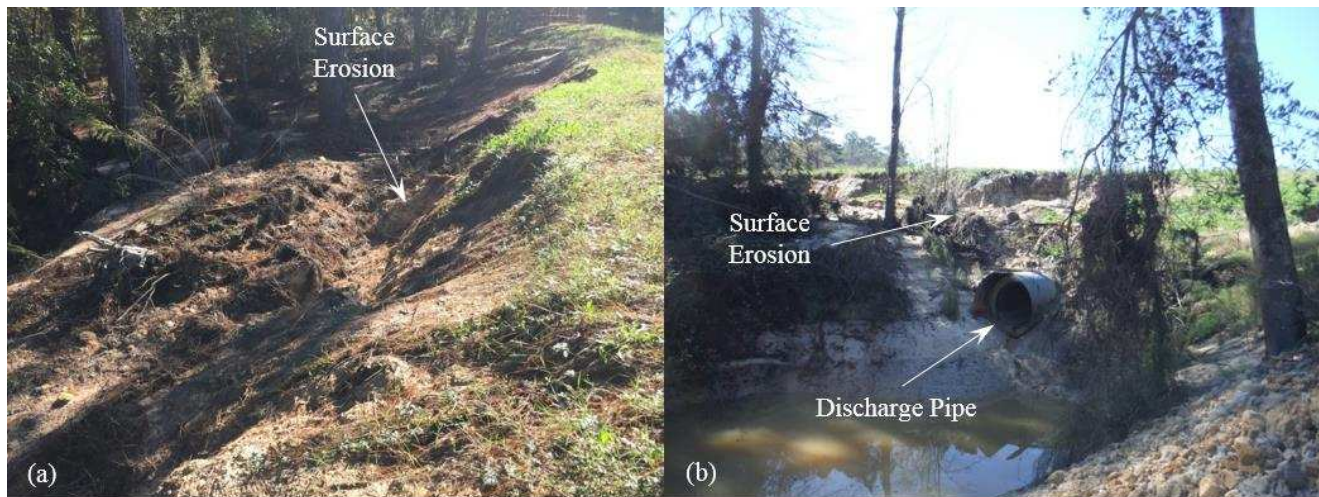
Figure 16. Surface erosion on downstream side slope of Dam B: a) south view from the crest of dam and b) west view from downstream.

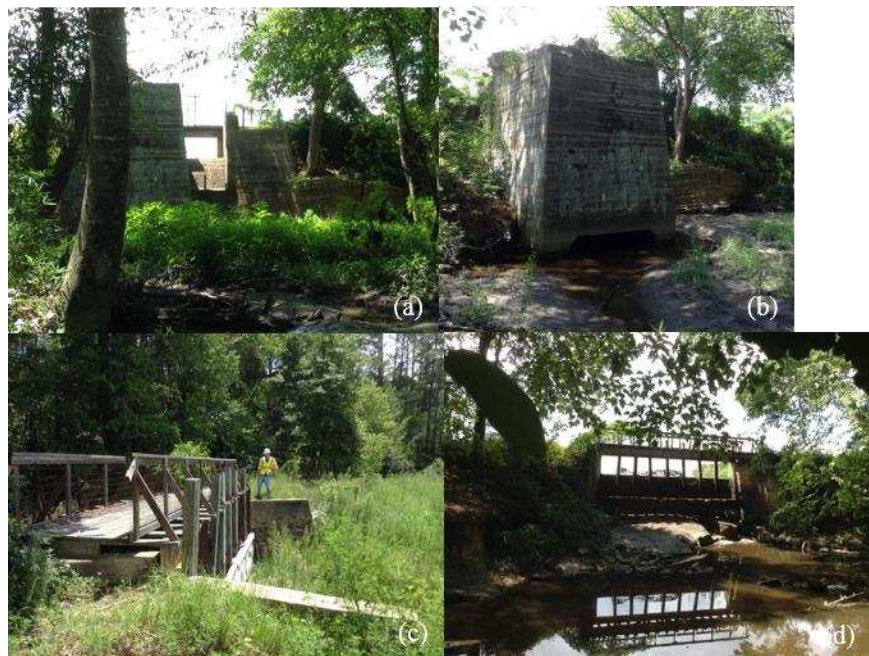
Two spillway systems were found at Dam C as shown in Figure 19. According to USACE (2016), the dam has a maximum discharge capacity of $30 \text{ m}^3/\text{s}$. One of the systems was observed in the middle of the dam (see Figures 20a) and is a spillway gate made of concrete with a length of approximately 9.5 m. The size of the opening in this spillway gate was nearly 2.5 m in width and 9.5 m in height. The spillway system includes a $10 \text{ m} \times 12 \text{ m} \times 8 \text{ m}$ (height x width x length) concrete structure located next to the gate (see Figure 20b). The purpose of this structure is unknown, but it was presumably used for power generation according to the dam owner. The second structure, a spillway gate made of concrete, wood and steel beams (see Figures 20c and 20d), and with a length of approximately 12 m, was found toward the east end of the dam. The opening of this spillway gate was nearly 10 m in length and 2 m in height. Both spillway gates appeared to be in good condition with no observed damage from the flood event. This is expected since the breach zone is 46 m away from the first spillway and 107 m away from the other (see Figure 19). It is unknown whether the spillways worked as primary or emergency drainage systems, or if they were functioning properly before the flood event.

Figure 20. Spillways in Dam C: (a) first spillway structure (southwest view from downstream), (b) close up of concrete gate in first spillway structure (southwest view from downstream), (c) second spillway structure near the southeast end of the dam (southeast view from crest), and (d) southeast view of second spillway structure from downstream.

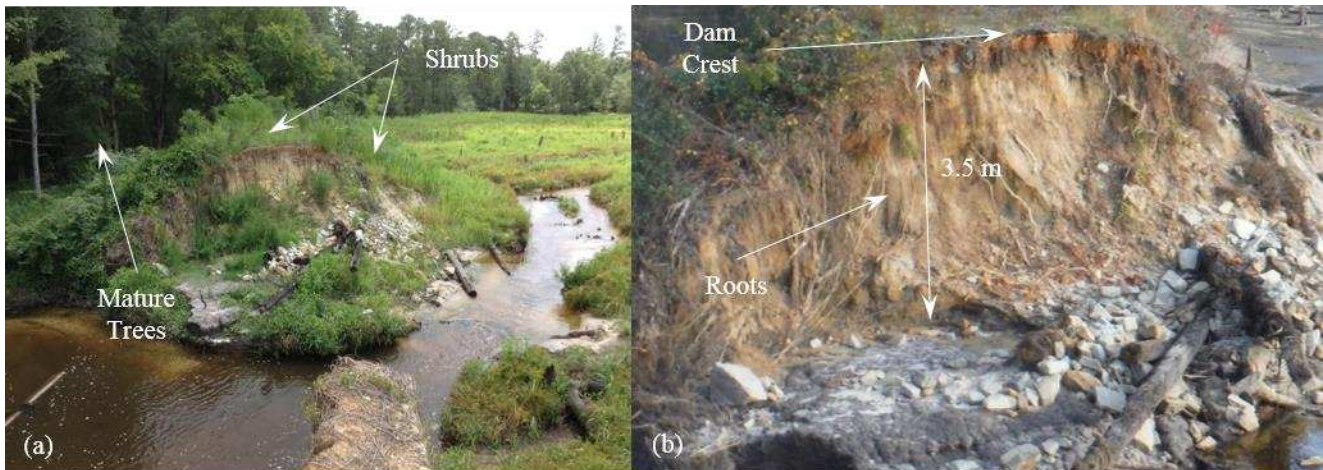
Grass and shrubs with heights up to 1 m were observed over the surface of Dam C (see Figure 21). Mature trees with heights of nearly 15 m were also observed in the area between the downstream toe of the dam and the road (see Figure 21a). Vegetation on the downstream side appears to be part of the natural ecosystem of the area (see Figure 20 and 21a). Roots growing through the dam were exposed in the breach zone (see Figure 21b), with depths of nearly 3.5 m penetrating into the 4 m height of the dam. According to a 2010 SCDHEC inspection report (SCDHEC 2016), vegetation on the downstream side should have been removed to allow inspection of the dam. An inspection report from 2014 indicates that vegetation was partially cleared from the dam, but the presence of trees on the downstream side should have been evaluated for seepage problems. The condition of the vegetation in the crest and side slopes of the dam, before and by the time of the flood event, is unknown.

Figure 21. Vegetation on Dam C: southeast views from crest of a) crest of dam with tall grasses and small shrubs (taken 10 months after breach), and b) exposed deep root structures at southeast breach wall (taken 1 month after breach).

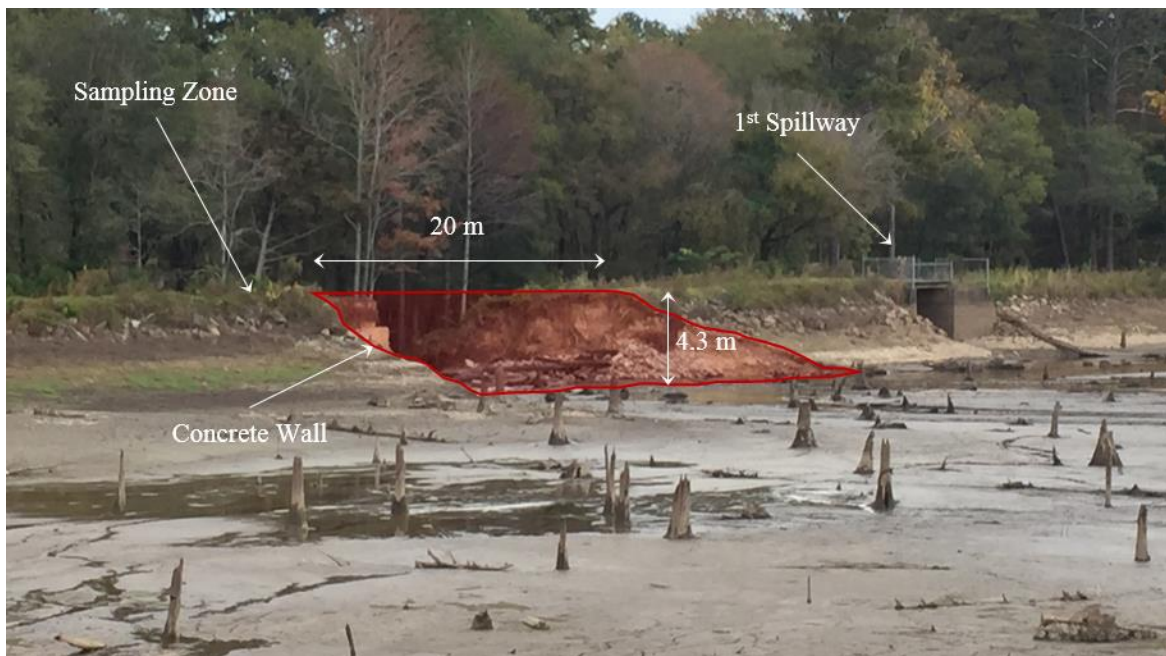
The dam was completely breached during the flood event as shown in Figure 22. The breach was located near the middle of the dam, 46 m northwest from the location of the first spillway gate (see Figure 19). The length of the breach was approximately 20 m of the total 191 m length of the dam, and nearly 900 m³ of soil were washed out. Eyewitnesses during the flood event indicated that overtopping did not occur. Subsequent field observations did not find evidence of surface erosion on the downstream side slope or near the spillways.

Figure 22. Picture of the breached section of Dam C (northeast view from subdivision). Drained pond in the foreground.

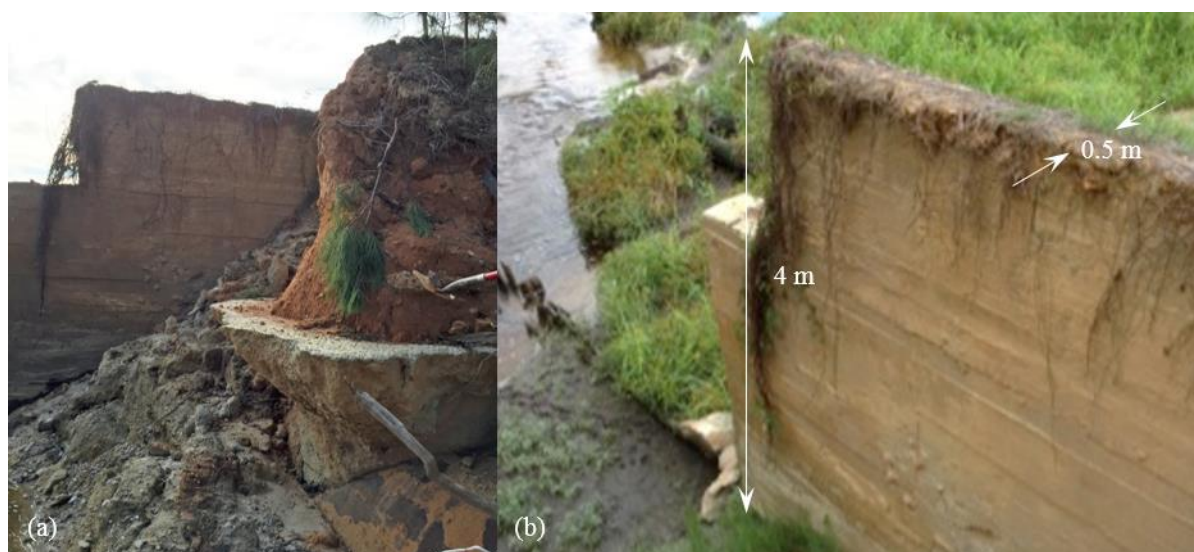
A concrete wall about 4 m high and 0.5 m thick (see Figure 23) was observed at the location of the breach (see Figures 19 and 22). The wall appears to run parallel to the dam crest, within the upstream side slope, but does not extend the entire length of the dam. The purpose of this structure, the actual dimensions, and whether the wall was built before or during the construction of the dam, are unknown. As shown in Figure 23, soil near the wall was washed away during the flood event. According to a SCDHEC inspection report from 2014 (SCDHEC 2016), part of the wall protruded from the dam and had an attached fence that was used as a fishing fence. This fence was no longer attached to the wall at the time of the reconnaissance. The inspection report also highlighted several signs of deterioration in the dam including cracks in the spillway structures

and animal burrows. It is possible that internal erosion near the concrete wall initiated the breach of the dam. Cracks in the wall or gaps between the wall and the surrounding soil due to animal activity may result in concentrated flow initiating internal erosion (Bonelli 2013).

Figure 23. Concrete wall in the upstream section of Dam C, next to the breach zone: a) southwest view from downstream, and b) southeast view from crest of dam.

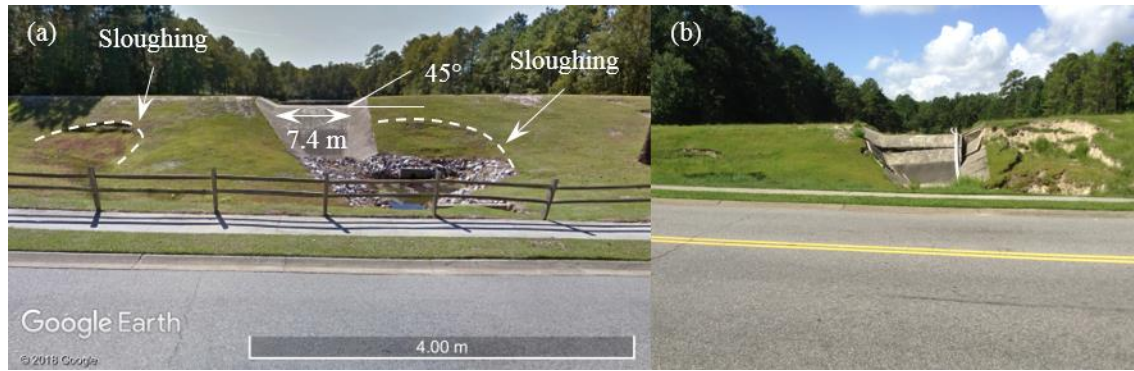
Figure 26. Southwest views of downstream side of Dam D, from Legion Drive: (a) before (Google Earth accessed on January 27, 2016) and (b) after 2015 flood event.

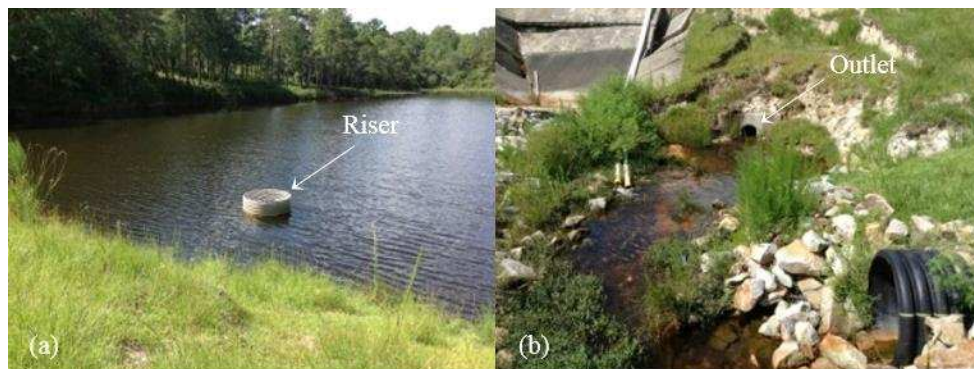
Two spillway systems were found at Dam D. The primary spillway is composed of a corrugated-metal riser used as an inlet (see Figure 27a), and a conduit made of a 0.6 m diameter concrete pipe used as an outlet (Figure 27b). The inlet is located nearly 10 m west of the crest of the dam, while the outlet is located at the toe of the downstream side slope. The second spillway is an emergency (overflow) spillway made of a trapezoidal-shaped concrete channel located in the middle of the dam (see Figure 28). The channel is 7.4 m in length at the base and has side slopes of nearly 45° (see Figure 26). From the photograph in Figure 26a (taken in October 2014), the concrete spillway appears to have been in good condition prior to the heavy rainfall event. After the event, two additional 10 cm diameter PVC pipes were installed on the emergency spillway to lower the water level in the pond (Figure 28a and 28b). All discharge water is directed toward a 1.5 m concrete culvert pipe located below Legion Drive that drains to the lake located downstream (see Figure 25b and 28b).

Figure 27. Primary spillway in Dam D: a) riser structure (southwest view from crest); and b) outlet pipe (southwest view from downstream).

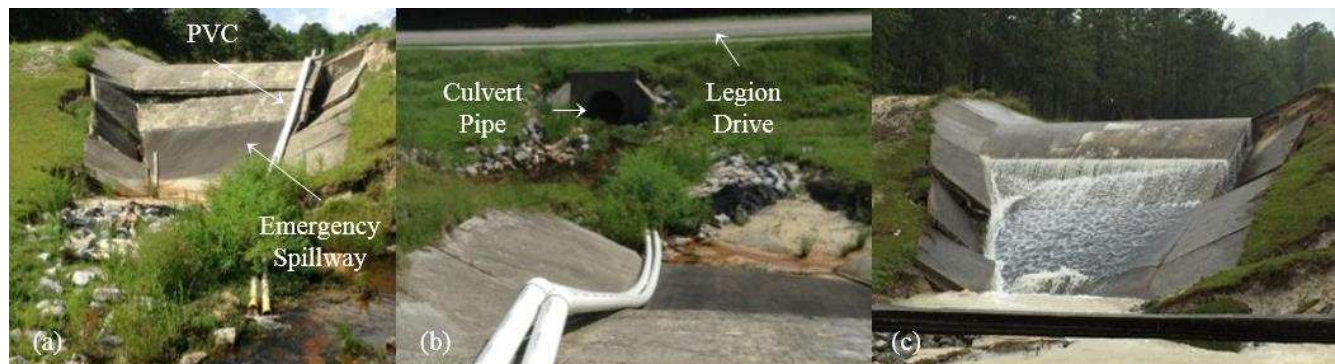
Figure 28. Emergency spillway and PVC drainage pipes at Dam D a) southwest view from downstream; (b) culvert pipe below the two-lane road (northeast view from the crest); and (c) failed concrete spillway during the heavy rain event (southwest view from downstream).

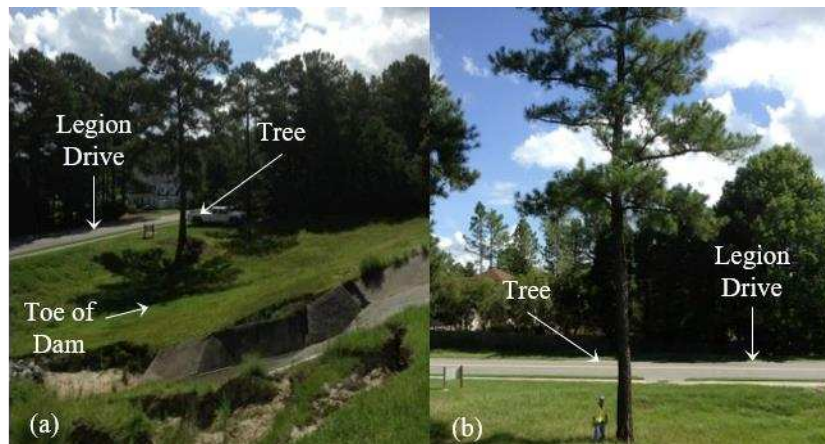
Figure 29. Vegetation on Dam D: a) east view from the crest showing short grasses and trees growing along the roadway near the downstream toe of the dam, and b) north east view from the crest showing a tree near the roadway on the southeast end of the dam.

The crest of the dam and the upstream and downstream side slopes, except for the concrete emergency spillway, are covered by grass with height approximately 0.1 to 0.2 m (see Figure 29). Otherwise, there was minimal intrusive vegetation observed over the surface of the dam. Six mature trees with heights between 10 and 18 m were observed downstream, between the toe of the dam and the road. Trees were not observed to be growing on the dam and roots were not visible within the failure zone.

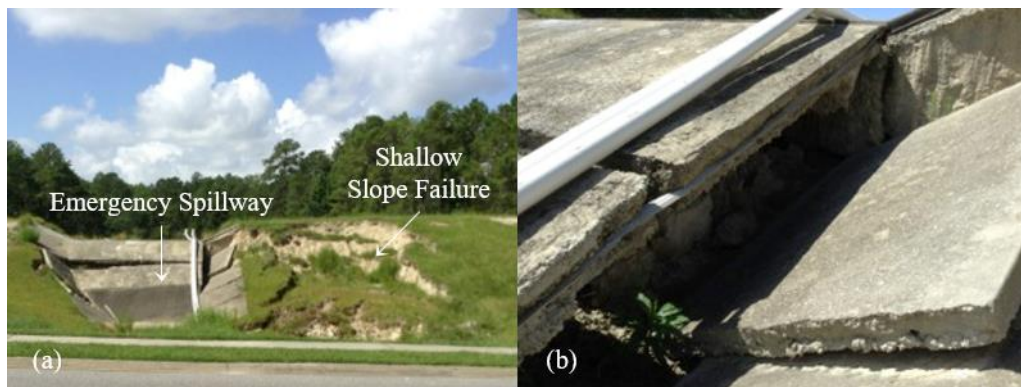
Dam D did not breach during the flood event but was severely damaged. A shallow slope failure, which was observed to be 15 m in length and 9 m in width, developed adjacent to the emergency spillway (see Figure 30a). The scarp of the slide indicates a vertical displacement of nearly 1 m. Right next to the slide, the concrete panels for the emergency spillway were detached and displaced from the side of the channel. Some cracks were observed in the concrete panels and there were voids between the panels and the soil beneath them. These voids (see Figure 30b) are evidence of erosion at the interface between the base of the concrete slabs and the supporting soil. While the specific mechanism(s) cannot be determined from the visual evidence, field observations and information provided from an eyewitness indicate that the crest of the dam was not overtopped. Thus, erosion was most likely caused by either surface water or subsurface water flow at sufficiently high velocity to undermine the soil support. The undermining and displacement of concrete panels may have contributed to the the shallow slope failure. Furthermore, a high volume of high velocity water flowing over the emergency spillway could have diverted onto the downstream side slope, enhancing the erosion in this area. Surface erosion was also observed near the toe of the downstream side slope where the primary and emergency spillway systems converge (see Figure 27b).

Figure 30. Failure of Dam D: (a) shallow slope failure in the downstream side slope and damage to the emergency spillway (southwest view from Legion Drive), and (b) close up view of voids under concrete slabs due to erosion below the slabs.
