# Geotechnical Observations of Dams Failed During the 2015 Historic Flooding in South Carolina

**ABSTRACT:** This paper presents a description of post-flood reconnaissance and geotechnical investigation of four earthen dams that were breached or damaged following an extreme flooding event in South Carolina in 2015. As a result of unprecedented rainfall and flooding that occurred during a five-day period at the beginning of October in 2015, a total of 51 earthen dams failed and nearly 200 were damaged. Many of these dams failed due to overtopping that led to a breach of the dam. Among the four dams investigated, full breach was observed at three dams; two of which were overtopped, and one was not. The fourth dam was not breached but was severely damaged. For each of these dams, the paper documents background information, pre-flood conditions, post-flood field observations and measurements, and laboratory testing results of collected soil samples. Impacts of vegetation on the dams and the effects of dam failure on critical infrastructure are also presented. The detailed descriptions and geotechnical investigations of the dam failures presented herein serve as case histories that can

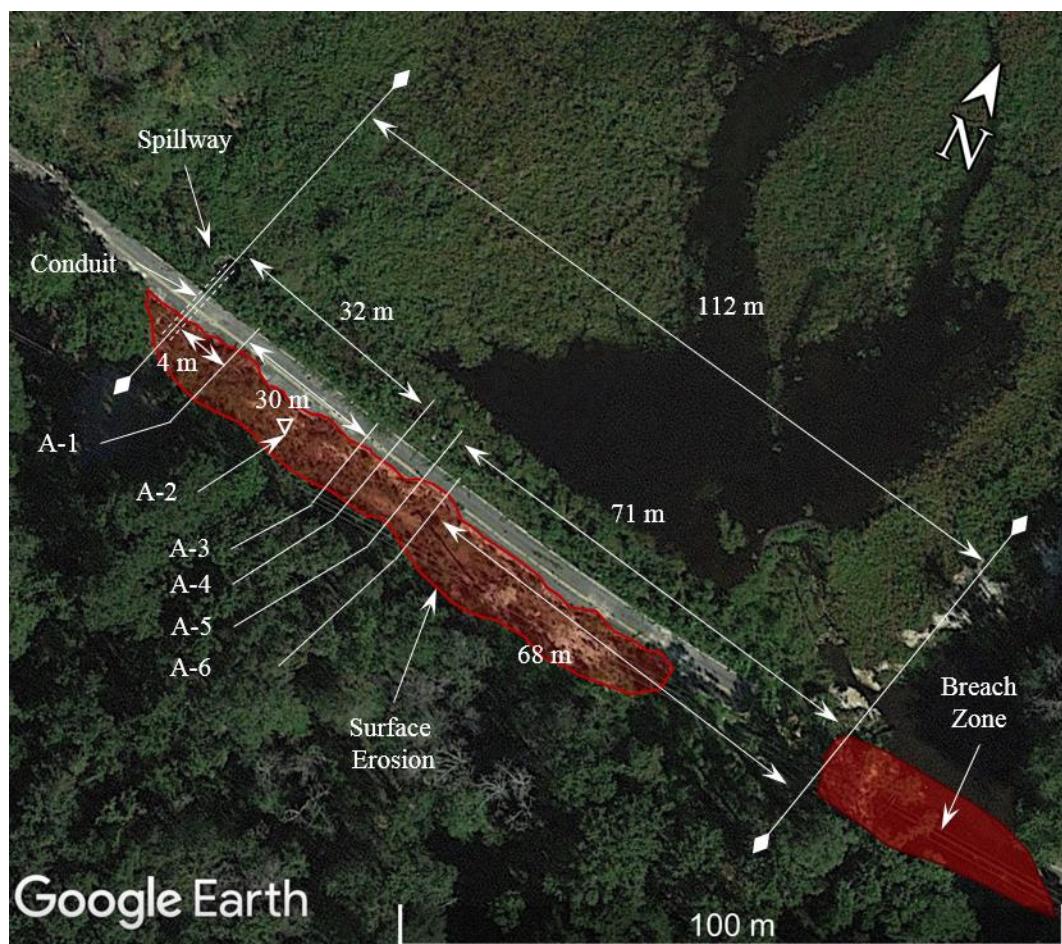
Figure 3. Location of spillway, surface erosion, breach, and sampling locations in Dam A (Google Earth, accessed on April 8, 2018).

The spillway structure of this dam is located on the west side of the dam and about 112 m from the breach zone, as shown in Figure 3. Sampling locations relative to the spillway and the breach zone are also presented in this figure. The spillway is a conduit made of a 1.2 m diameter concrete pipe, as shown in Figure 4a, with a maximum discharge capacity of approximately 17 m<sup>3</sup>/s (USACE 2016). The soil above the pipe on the downstream side was washed out, as shown in Figure 4b. It is unknown whether this structure worked as the primary spillway of the dam, or if an additional spillway structure existed before the breach.

Damage to this dam includes a complete breach and a large zone of surface erosion separate from the breach, as shown in Figure 3. The breach is located near to the east end of the dam. The breach extended approximately 50 m of the total 290 m length of the dam, and nearly 7,300 m<sup>3</sup> of material, including soil and pavement, were washed out (see Figure 6). In the breach zone, several trees on the upstream side slope tipped over the road in the direction of water flow (see Figures 6 and 8), which provides some evidence of overtopping. In the surface erosion zone, the soil erosion along the downstream side slope extended over 60 m parallel to and 20 m perpendicular to the road, as shown in Figures 3, 5b and 7b. As shown in Figure 7a, part of the asphalt shoulder and roadway collapsed above the zone of surface erosion.

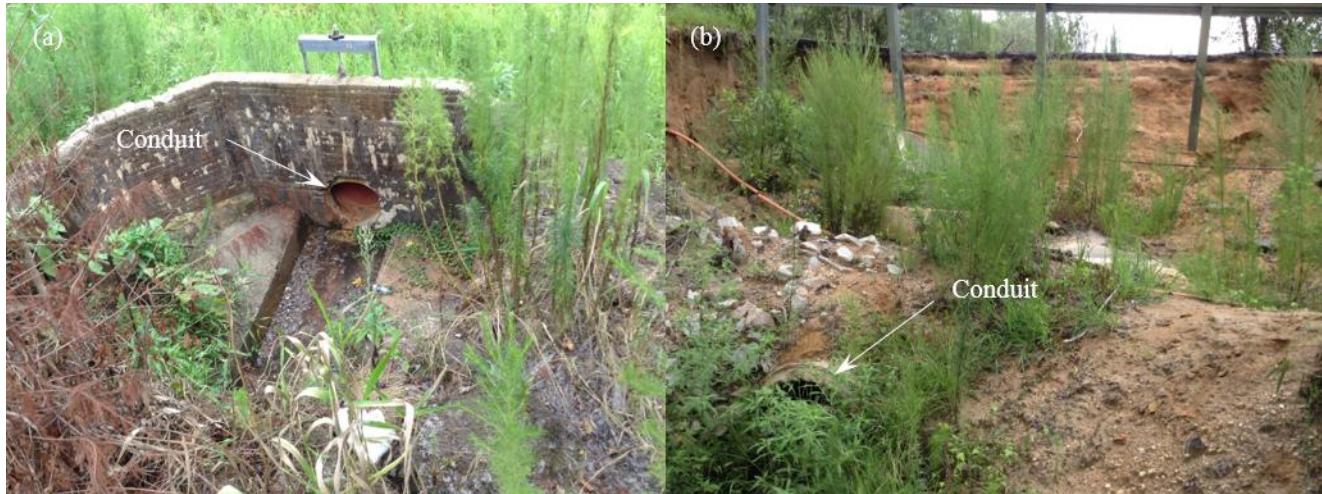
Figure 4. Spillway structure for Dam A: (a) conduit on upstream side (north view from SR-40-67), and (b) conduit and washed out soil above on downstream side (north view from downstream).

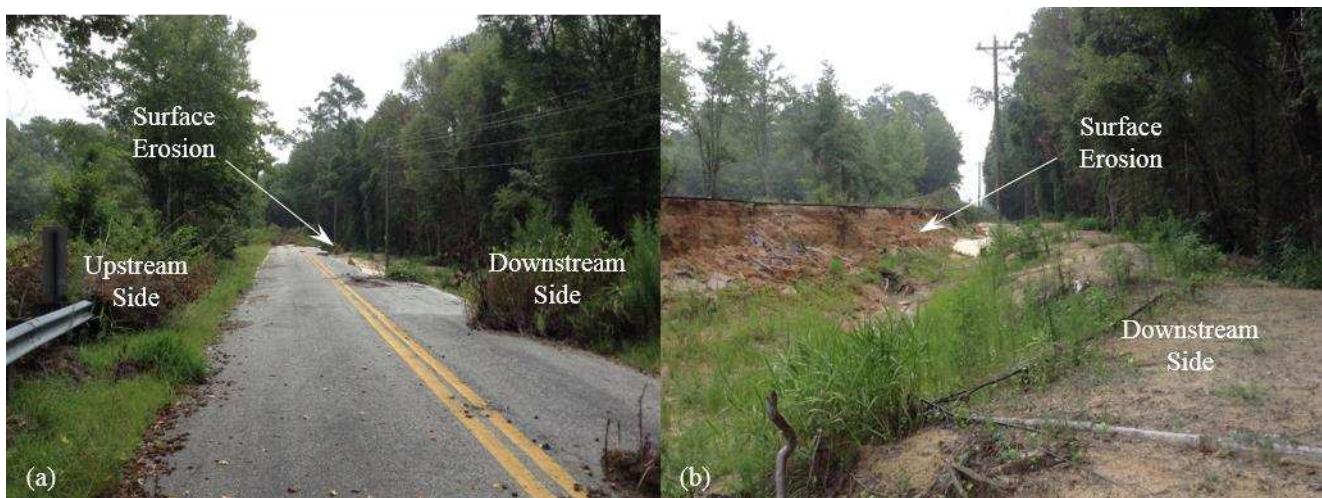
Vegetation was not present on the crest of Dam A where the road is located. However, there is vegetation on the edges of the crest adjacent to the road and on the upstream and downstream sides of the dam. Mature trees with heights of nearly 12 m were observed on the upstream side, parallel to the road and nearly 3 m away from the upstream shoulder (see Figure 5a). Trees on the downstream side have similar heights, but were found nearly 20 m away from the road (see Figure 5b). All of the mature trees appear to be part of the natural growth in the local ecosystem. It is unclear if the presence of vegetation influenced dam performance or contributed to its failure. In the area where soil was exposed on the downstream side slope (noted as surface erosion in Figure 5b), there were no trees present and no roots observed in the soil. Near the northeast section of the breach, several trees were found tipped over the road (see Figure 6), but no roots were observed in the soil.

Figure 5. Vegetation on Dam A: (a) vegetation upstream and downstream of the dam (east view from S-40-67), and (b) vegetation and surface erosion on the downstream side of the dam (east view from downstream).

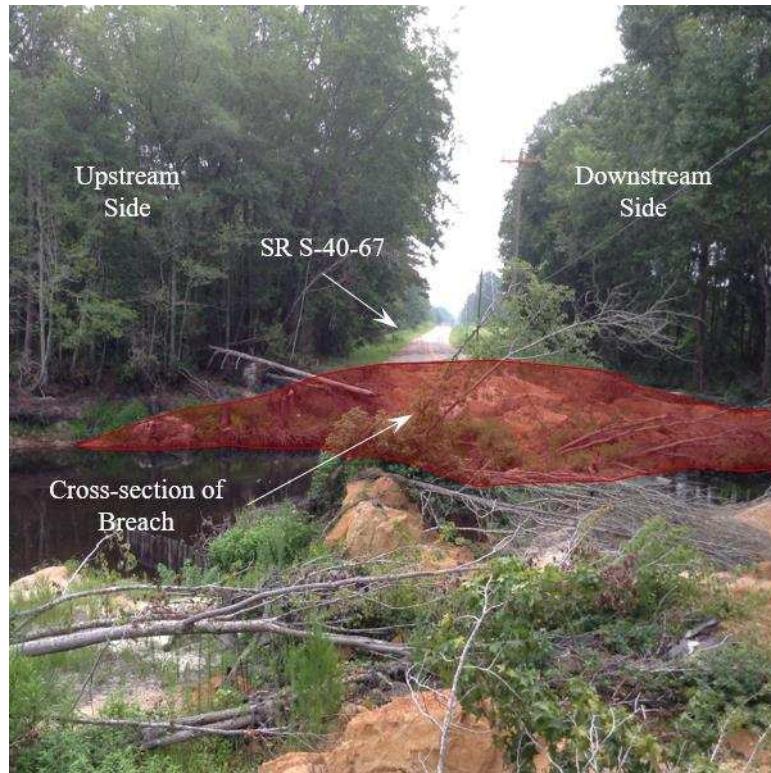
Figure 6. Cross-sectional area of breach in Dam A (east view from SR-40-67).

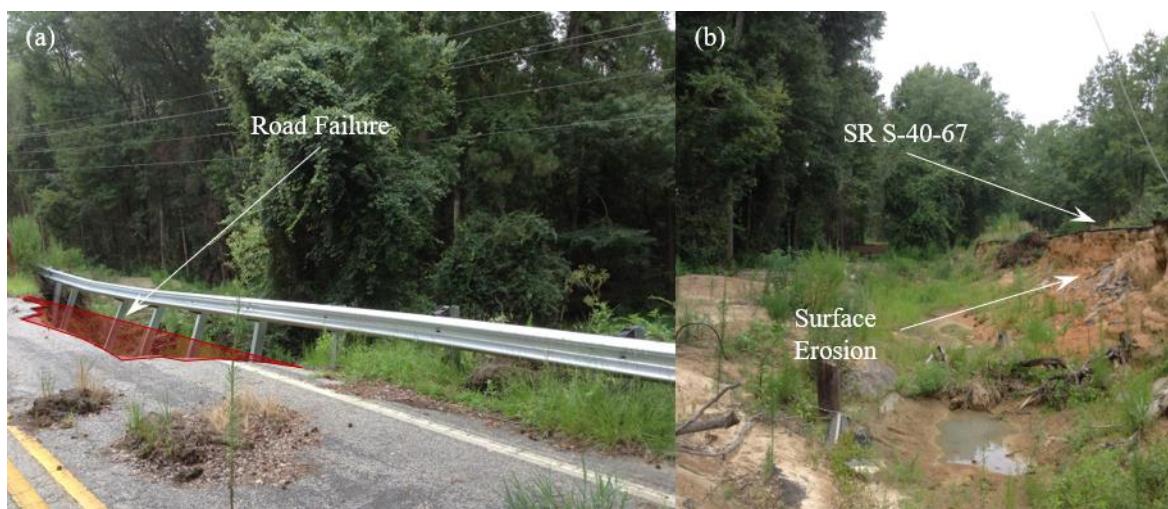
Figure 7. Failure of Dam A: (a) road failure of State Road S-40-67 (southeast view from S-40-67), and (b) surface erosion due to overtopping (west view from downstream).

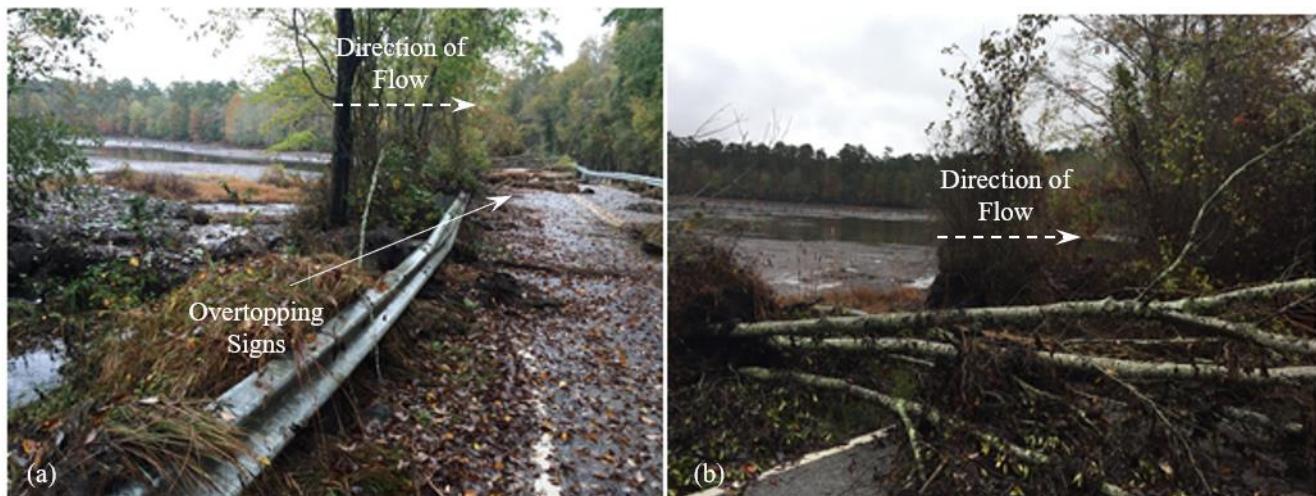
Figure 8. Evidence of overtopping during the flood for Dam A: (a) eroded vegetation and debris on the crest (east view from SR-40-67); and (b) fallen trees on the crest (north view from SR-40-67).

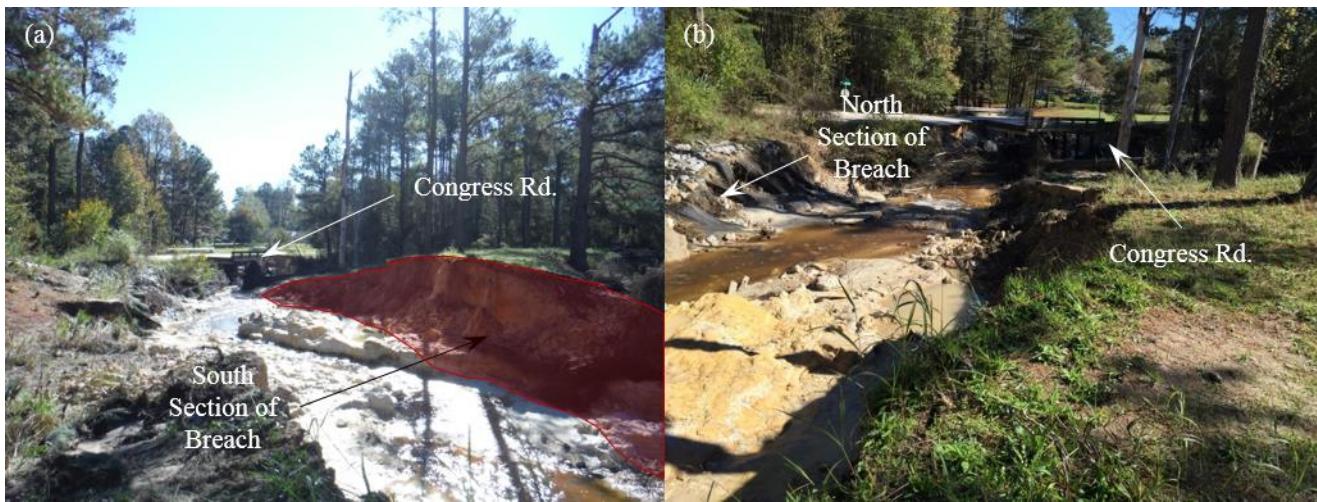
Figure 11. Breach section in Dam B: southeast views from (a) the north section of breach and (b) the south sections of the breach.

The dam was completely breached during the flood as shown in Figure 11. The location of the breach (see Figure 12) was close to the north end of the dam and close to the supposed original location of the second spillway riser pipe. The breach was approximately 15 m of the total 130 m length of the dam. Nearly 1,050 m<sup>3</sup> of embankment material was washed out during the flood event. Surface erosion was observed along the downstream side slope extending along the entire length of the dam, as shown in Figure 16. Trees on the downstream side slope of the dam were partially or fully tipped over and some appeared to be displaced (Figure 15b). These observations might indicate overtopping of the dam.

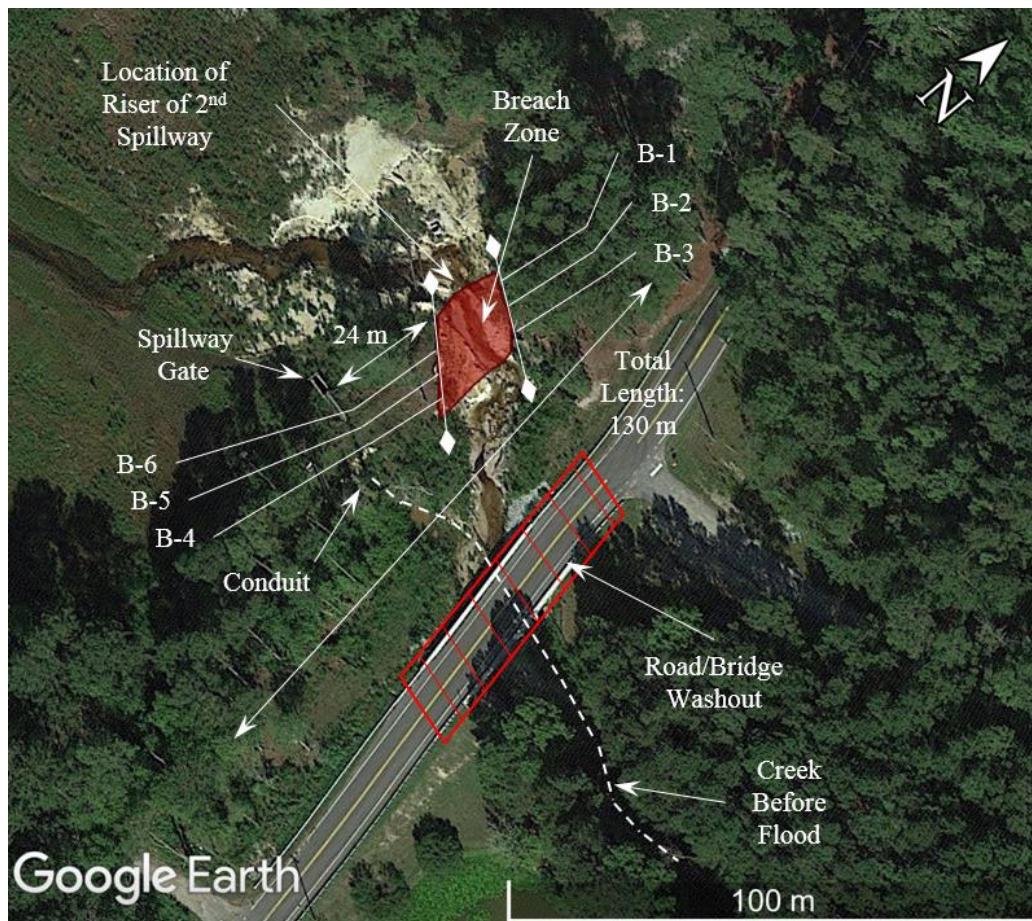
Figure 12. Location of spillways and breach in Dam B (Google Earth, accessed on April 8, 2018).

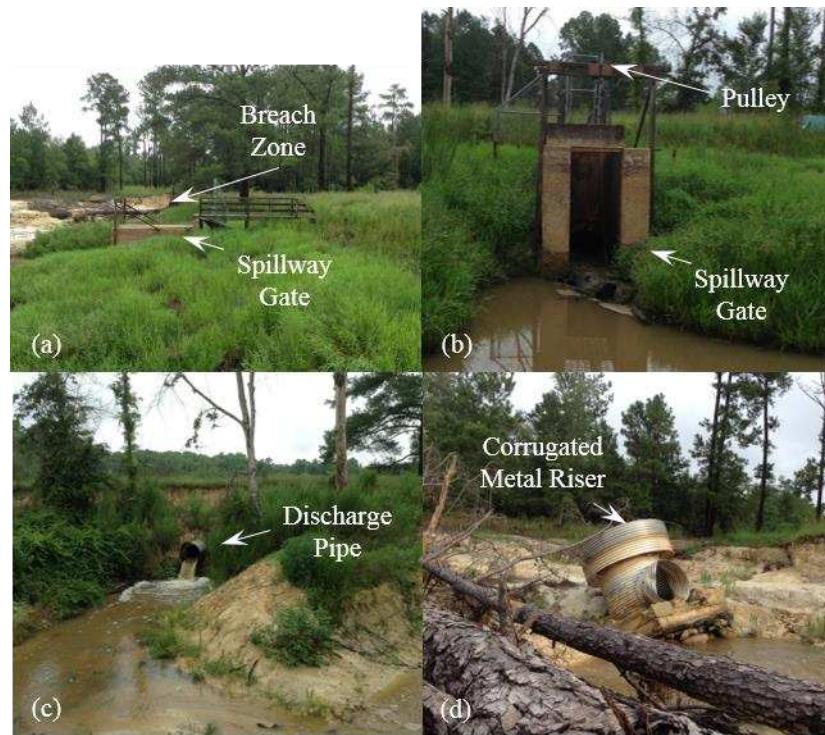
Two spillway systems were observed at Dam B, but it is unknown which worked as primary spillway before the breach. According to USACE (2016), the maximum discharge capacity of the dam was approximately  $34 \text{ m}^3/\text{s}$ . The first system was located on the west side of the dam, nearly 24 m from the breach zone (location marked in Figure 12). It is composed of a 1.3 m wide concrete inlet structure leading to a 1.2 m diameter concrete discharge pipe (see Figures 14a, 14b and 14c). A pulley lift system is attached to a metal frame surrounding the concrete. The structure appeared to be missing a sliding door that would have been raised and lowered with the pulley to manually control the lake water level. Water from the lake was observed draining through the pipe on the downstream side of the gate (see Figures 12 and 14c). The second spillway was found near the south section of the breach. It consisted of a corrugated-metal riser pipe supported by a concrete base. The dimensions of the conduit were not measured. As shown in Figure 14d, this structure appears to be damaged, displaced, and separated from a conduit that would have been used to drain water from the lake, presumably through or under the dam, towards a creek flowing below the Congress Road bridge (see Figure 12). According to an SCDHEC inspection report from 2008 (SCDHEC 2016), repair procedures were required in the corrugated-metal riser pipe as well as calculations assuring that the spillway met design flood requirements according to the hazard potential. It is unknown whether the spillway was repaired before the flood event.

Figure 14. Spillway structures in Dam B: (a) location (view along the crest looking north), (b) concrete spillway gate (east view from upstream), (c) discharge pipe downstream from gate (east view from downstream), and (d) failed riser (northwest view from breach).

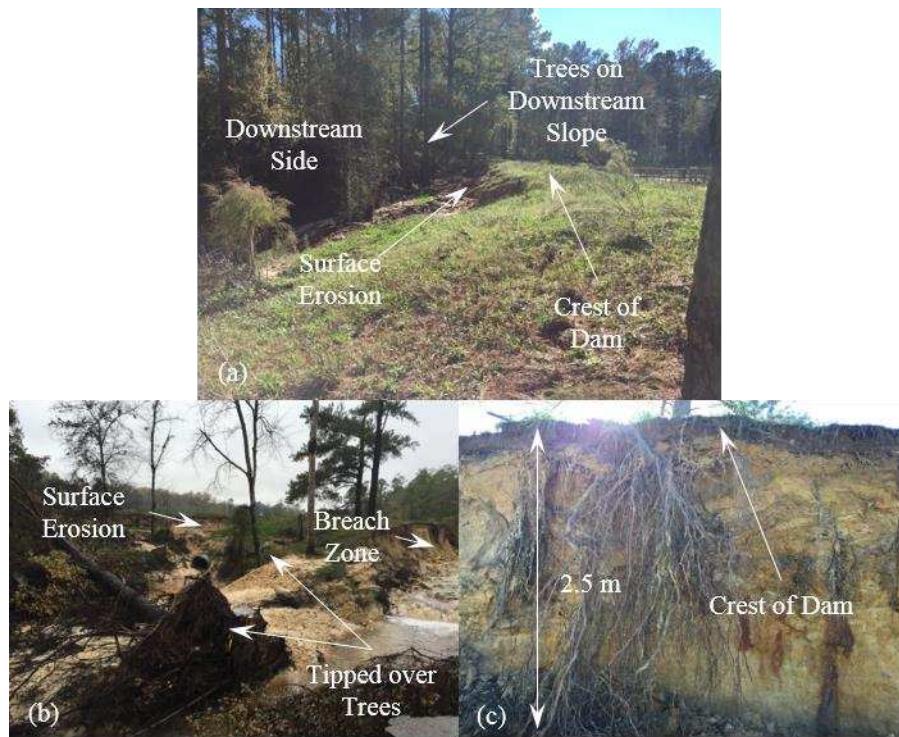
Vegetation was observed over the entire surface of the dam (see Figure 15). The upstream side-slope and crest of the dam are covered with grass and shrubs with heights less than 1 m. Several mature trees with heights from 15 to 18 m were observed on the crest and downstream side-slope of the dam (see Figures 15a and 15b). The roots of one of these trees were exposed by the dam breach, as shown in Figure 15c. The roots reach depths of nearly 2.5 m, penetrating through the upper half and into the lower half of the 4.3 m high dam. The SCDHEC inspection report from 2008 (SCDHEC 2016) also highlighted the need of removing vegetation to an acceptable grass cover. It is clear that the vegetation was not removed, as requested.

Figure 15. Vegetation on Dam B: a) low grasses and small bushes on the dam crest, trees on downstream side slope (south view from crest), (b) tipped over trees near breach and zone of surface erosion (west view from downstream), and c) presence of roots throughout the dam on the south breach wall (south view from breach).

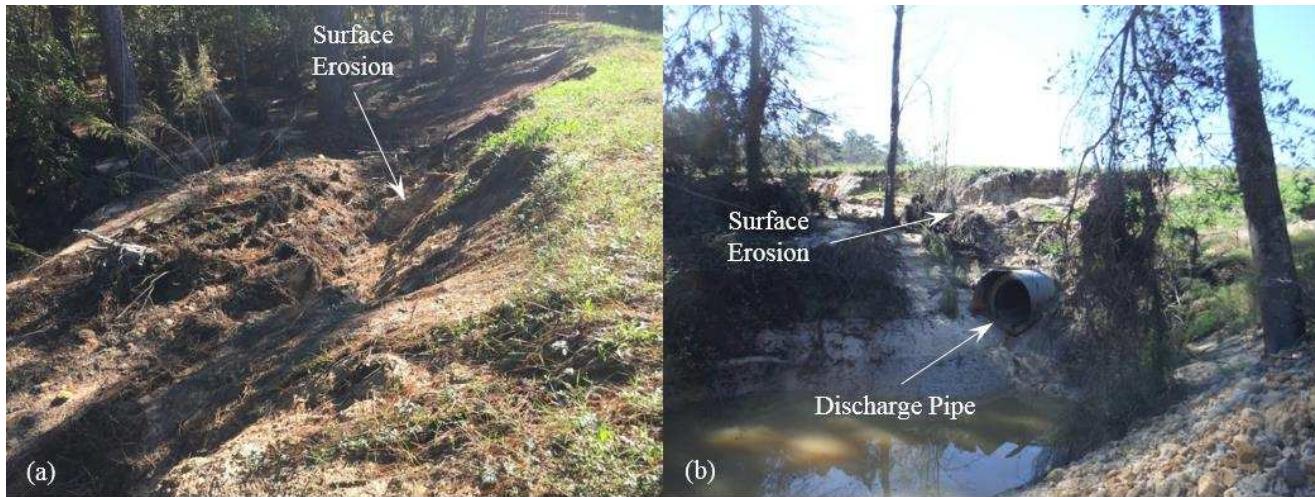
Figure 16. Surface erosion on downstream side slope of Dam B: a) south view from the crest of dam and b) west view from downstream.

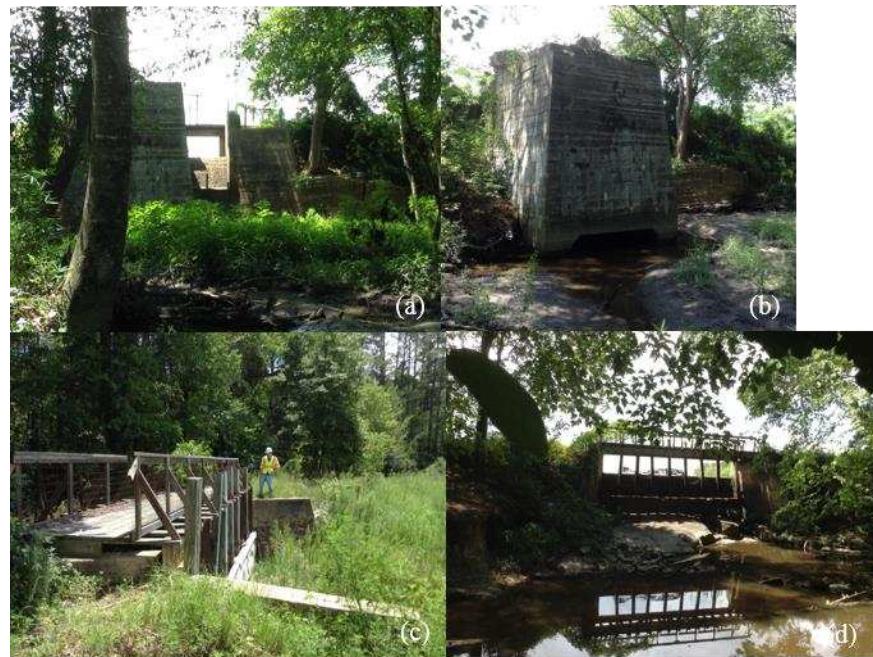
Two spillway systems were found at Dam C as shown in Figure 19. According to USACE (2016), the dam has a maximum discharge capacity of  $30 \text{ m}^3/\text{s}$ . One of the systems was observed in the middle of the dam (see Figures 20a) and is a spillway gate made of concrete with a length of approximately 9.5 m. The size of the opening in this spillway gate was nearly 2.5 m in width and 9.5 m in height. The spillway system includes a  $10 \text{ m} \times 12 \text{ m} \times 8 \text{ m}$  (height x width x length) concrete structure located next to the gate (see Figure 20b). The purpose of this structure is unknown, but it was presumably used for power generation according to the dam owner. The second structure, a spillway gate made of concrete, wood and steel beams (see Figures 20c and 20d), and with a length of approximately 12 m, was found toward the east end of the dam. The opening of this spillway gate was nearly 10 m in length and 2 m in height. Both spillway gates appeared to be in good condition with no observed damage from the flood event. This is expected since the breach zone is 46 m away from the first spillway and 107 m away from the other (see Figure 19). It is unknown whether the spillways worked as primary or emergency drainage systems, or if they were functioning properly before the flood event.

Figure 20. Spillways in Dam C: (a) first spillway structure (southwest view from downstream), (b) close up of concrete gate in first spillway structure (southwest view from downstream), (c) second spillway structure near the southeast end of the dam (southeast view from crest), and (d) southeast view of second spillway structure from downstream.

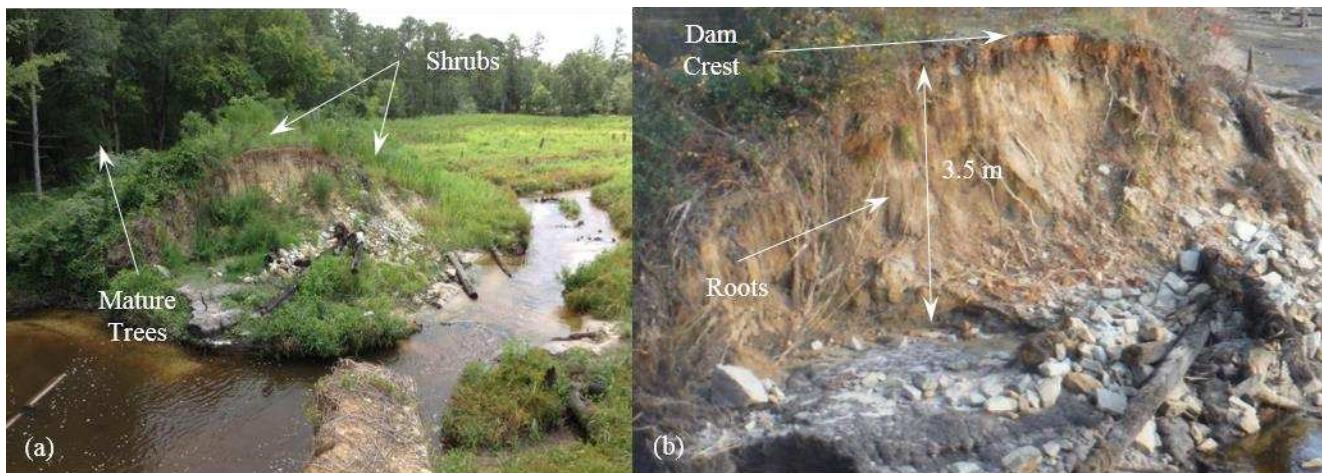
Grass and shrubs with heights up to 1 m were observed over the surface of Dam C (see Figure 21). Mature trees with heights of nearly 15 m were also observed in the area between the downstream toe of the dam and the road (see Figure 21a). Vegetation on the downstream side appears to be part of the natural ecosystem of the area (see Figure 20 and 21a). Roots growing through the dam were exposed in the breach zone (see Figure 21b), with depths of nearly 3.5 m penetrating into the 4 m height of the dam. According to a 2010 SCDHEC inspection report (SCDHEC 2016), vegetation on the downstream side should have been removed to allow inspection of the dam. An inspection report from 2014 indicates that vegetation was partially cleared from the dam, but the presence of trees on the downstream side should have been evaluated for seepage problems. The condition of the vegetation in the crest and side slopes of the dam, before and by the time of the flood event, is unknown.

Figure 21. Vegetation on Dam C: southeast views from crest of a) crest of dam with tall grasses and small shrubs (taken 10 months after breach), and b) exposed deep root structures at southeast breach wall (taken 1 month after breach).

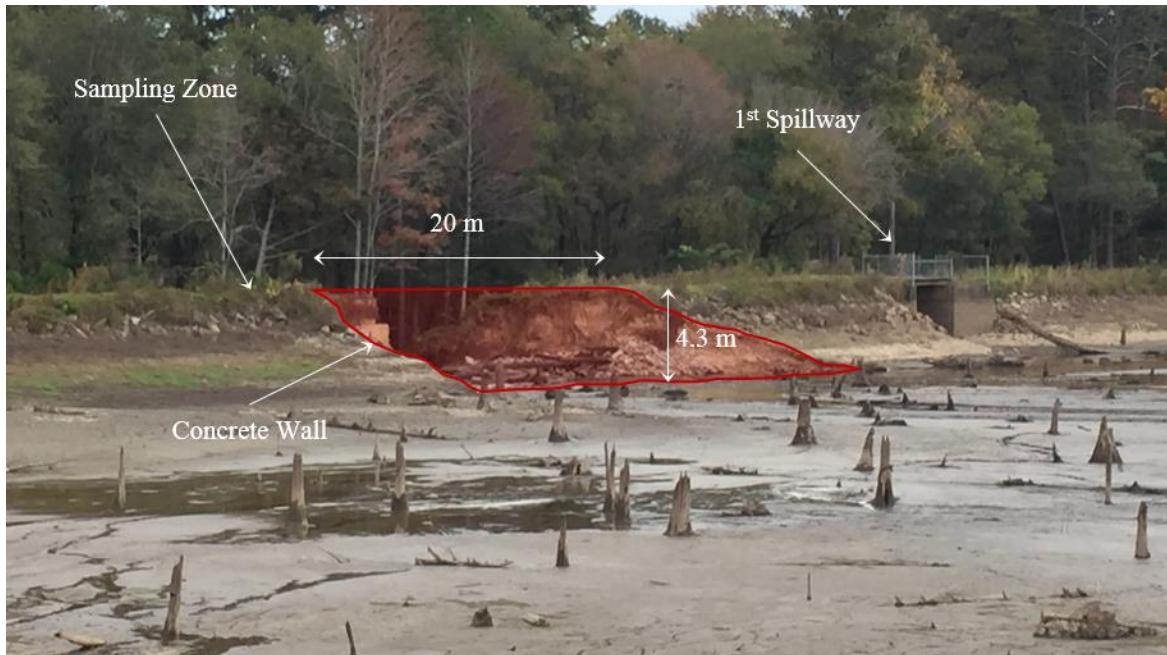
The dam was completely breached during the flood event as shown in Figure 22. The breach was located near the middle of the dam, 46 m northwest from the location of the first spillway gate (see Figure 19). The length of the breach was approximately 20 m of the total 191 m length of the dam, and nearly  $900 \text{ m}^3$  of soil were washed out. Eyewitnesses during the flood event indicated that overtopping did not occur. Subsequent field observations did not find evidence of surface erosion on the downstream side slope or near the spillways.

Figure 22. Picture of the breached section of Dam C (northeast view from subdivision). Drained pond in the foreground.

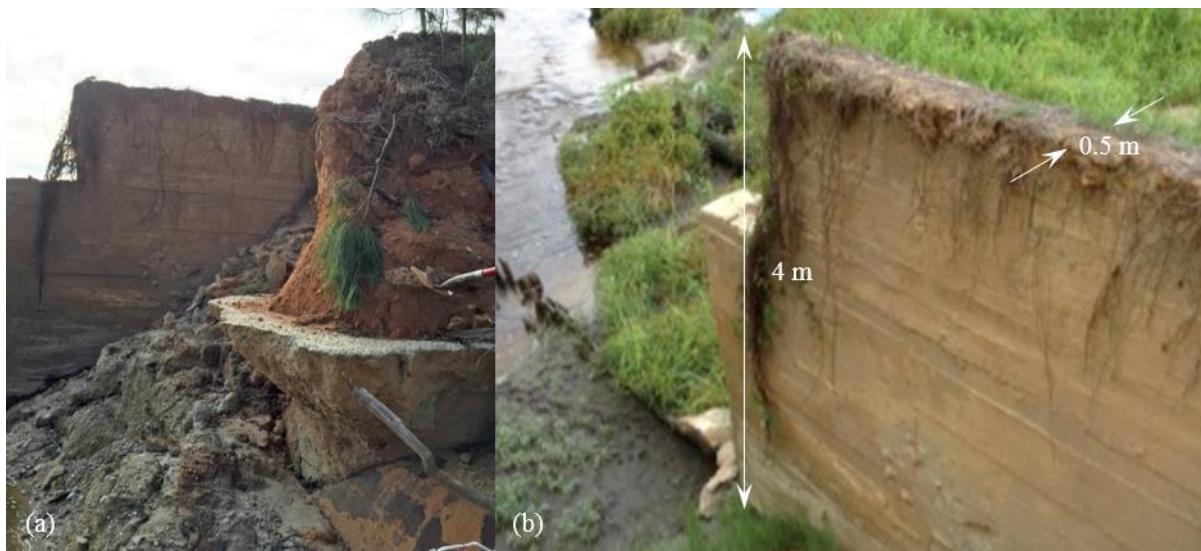
A concrete wall about 4 m high and 0.5 m thick (see Figure 23) was observed at the location of the breach (see Figures 19 and 22). The wall appears to run parallel to the dam crest, within the upstream side slope, but does not extend the entire length of the dam. The purpose of this structure, the actual dimensions, and whether the wall was built before or during the construction of the dam, are unknown. As shown in Figure 23, soil near the wall was washed away during the flood event. According to a SCDHEC inspection report from 2014 (SCDHEC 2016), part of the wall protruded from the dam and had an attached fence that was used as a fishing fence. This fence was no longer attached to the wall at the time of the reconnaissance. The inspection report also highlighted several signs of deterioration in the dam including cracks in the spillway structures.

and animal burrows. It is possible that internal erosion near the concrete wall initiated the breach of the dam. Cracks in the wall or gaps between the wall and the surrounding soil due to animal activity may result in concentrated flow initiating internal erosion (Bonelli 2013).

*Figure 23. Concrete wall in the upstream section of Dam C, next to the breach zone: a) southwest view from downstream, and b) southeast view from crest of dam.*

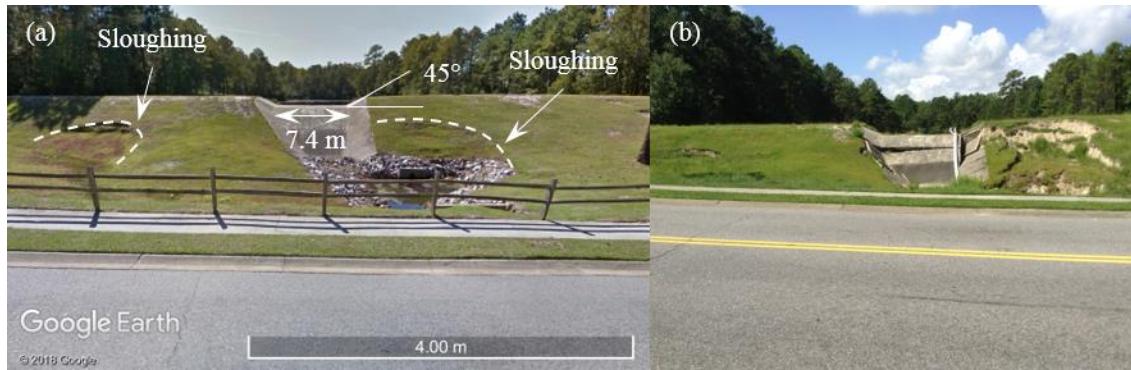
Figure 26. Southwest views of downstream side of Dam D, from Legion Drive: (a) before (Google Earth accessed on January 27, 2016) and (b) after 2015 flood event.

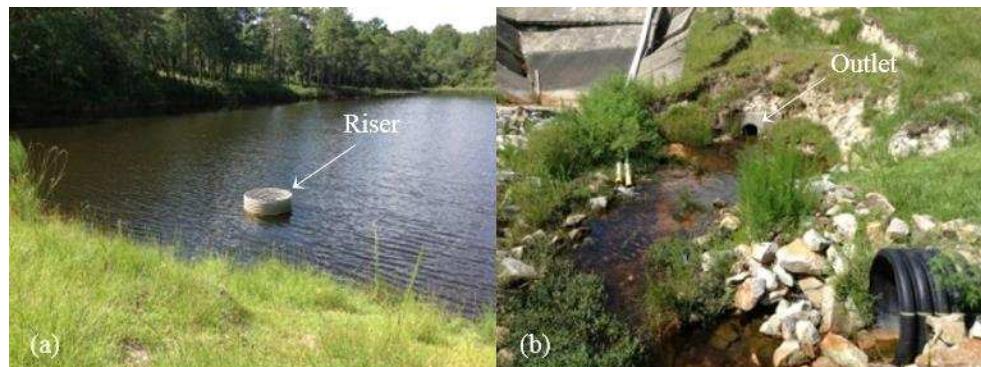
Two spillway systems were found at Dam D. The primary spillway is composed of a corrugated-metal riser used as an inlet (see Figure 27a), and a conduit made of a 0.6 m diameter concrete pipe used as an outlet (Figure 27b). The inlet is located nearly 10 m west of the crest of the dam, while the outlet is located at the toe of the downstream side slope. The second spillway is an emergency (overflow) spillway made of a trapezoidal-shaped concrete channel located in the middle of the dam (see Figure 28). The channel is 7.4 m in length at the base and has side slopes of nearly  $45^\circ$  (see Figure 26). From the photograph in Figure 26a (taken in October 2014), the concrete spillway appears to have been in good condition prior to the heavy rainfall event. After the event, two additional 10 cm diameter PVC pipes were installed on the emergency spillway to lower the water level in the pond (Figure 28a and 28b). All discharge water is directed toward a 1.5 m concrete culvert pipe located below Legion Drive that drains to the lake located downstream (see Figure 25b and 28b).

Figure 27. Primary spillway in Dam D: a) riser structure (southwest view from crest); and b) outlet pipe (southwest view from downstream).

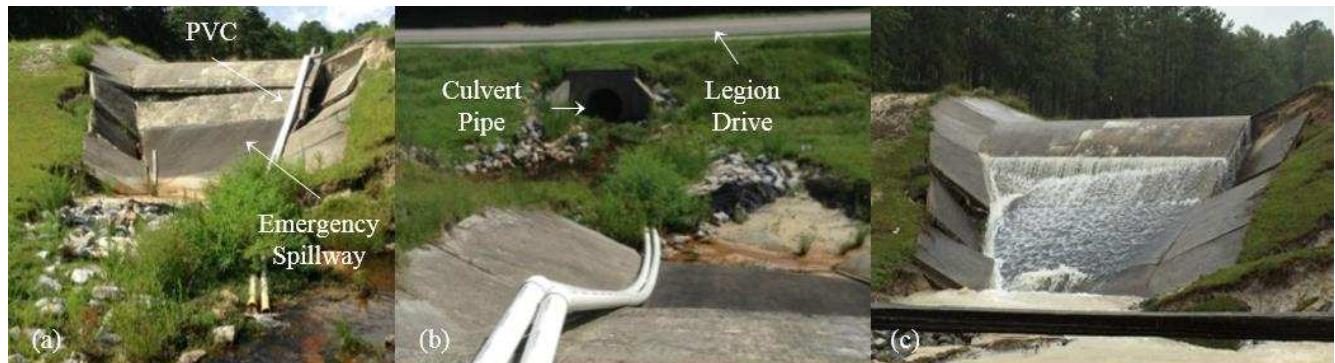
Figure 28. Emergency spillway and PVC drainage pipes at Dam D a) southwest view from downstream; (b) culvert pipe below the two-lane road (northeast view from the crest); and (c) failed concrete spillway during the heavy rain event (southwest view from downstream).

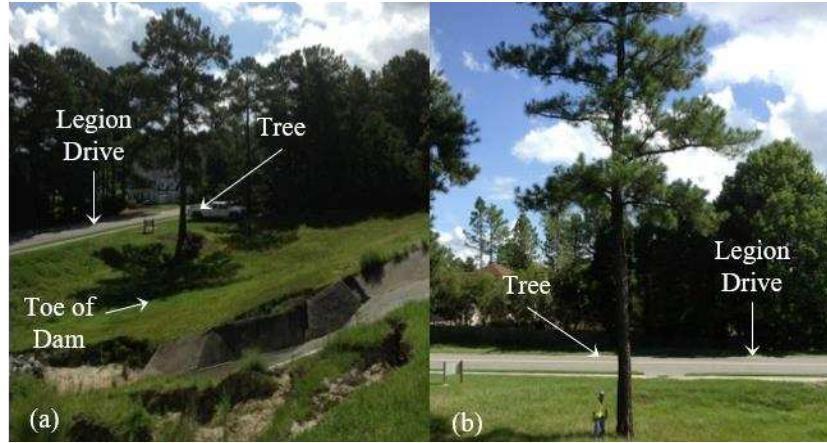
Figure 29. Vegetation on Dam D: a) east view from the crest showing short grasses and trees growing along the roadway near the downstream toe of the dam, and b) north east view from the crest showing a tree near the roadway on the southeast end of the dam.

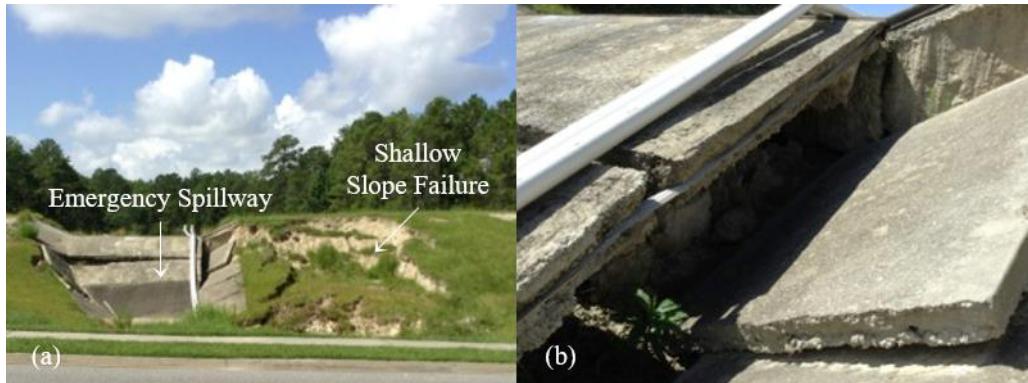
Dam D did not breach during the flood event but was severely damaged. A shallow slope failure, which was observed to be 15 m in length and 9 m in width, developed adjacent to the emergency spillway (see Figure 30a). The scarp of the slide indicates a vertical displacement of nearly 1 m. Right next to the slide, the concrete panels for the emergency spillway were detached and displaced from the side of the channel. Some cracks were observed in the concrete panels and there were voids between the panels and the soil beneath them. These voids (see Figure 30b) are evidence of erosion at the interface between the base of the concrete slabs and the supporting soil. While the specific mechanism(s) cannot be determined from the visual evidence, field observations and information provided from an eyewitness indicate that the crest of the dam was not overtopped. Thus, erosion was most likely caused by either surface water or subsurface water flow at sufficiently high velocity to undermine the soil support. The undermining and displacement of concrete panels may have contributed to the shallow slope failure. Furthermore, a high volume of high velocity water flowing over the emergency spillway could have diverted onto the downstream side slope, enhancing the erosion in this area. Surface erosion was also observed near the toe of the downstream side slope where the primary and emergency spillway systems converge (see Figure 27b).

Figure 30. Failure of Dam D: (a) shallow slope failure in the downstream side slope and damage to the emergency spillway (southwest view from Legion Drive), and (b) close up view of voids under concrete slabs due to erosion below the slabs.
