Geotechnical Observations of Dams Failed During the 2015 Historic Flooding in South Carolina

ABSTRACT: *This paper presents a description of post-flood reconnaissance and geotechnical investigation of four earthen dams that were breached or damaged following an extreme flooding event in South Carolina in 2015. As a result of unprecedented rainfall and flooding that occurred during a five-day period at the beginning of October in 2015, a total of 51 earthen dams failed and nearly 200 were damaged. Many of these dams failed due to overtopping that led to a breach of the dam. Among the four dams investigated, full breach was observed at three dams; two of which were overtopped, and one was not. The fourth dam was not breached but was severely damaged. For each of these dams, the paper documents background information, pre-flood conditions, post-flood field observations and measurements, and laboratory testing results of collected soil samples. Impacts of vegetation on the dams and the effects of dam failure on critical infrastructure are also presented. The detailed descriptions and geotechnical investigations of the dam failures presented herein serve as case histories that can be u

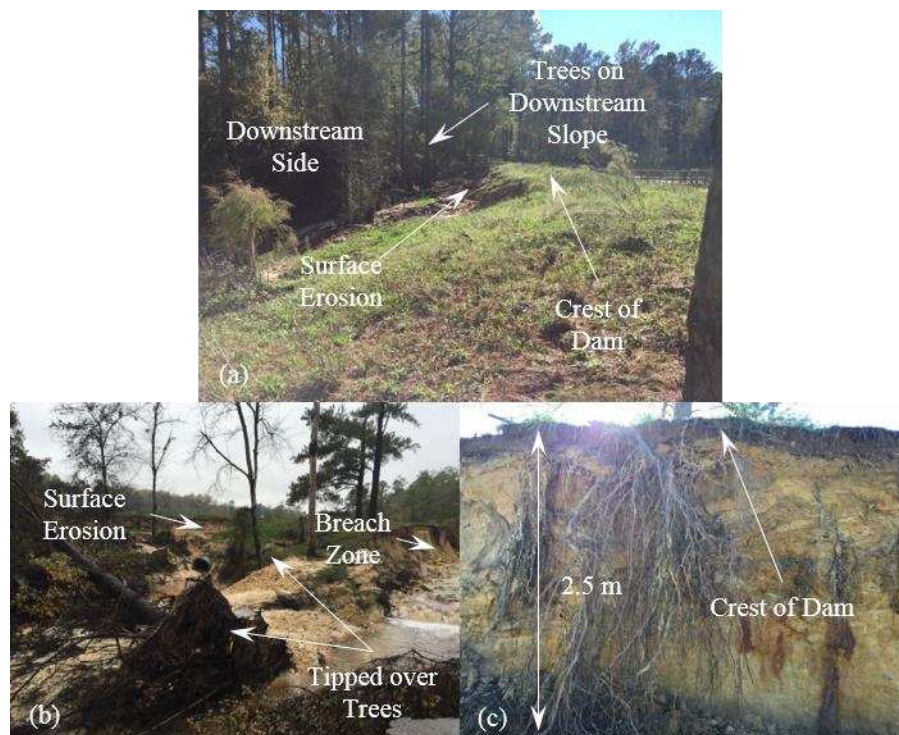
Vegetation was observed over the entire surface of the dam (see Figure 15). The upstream side-slope and crest of the dam are covered with grass and shrubs with heights less than 1 m. Several mature trees with heights from 15 to 18 m were observed on the crest and downstream side-slope of the dam (see Figures 15a and 15b). The roots of one of these trees were exposed by the dam breach, as shown in Figure 15c. The roots reach depths of nearly 2.5 m, penetrating through the upper half and into the lower half of the 4.3 m high dam. The SCDHEC inspection report from 2008 (SCDHEC 2016) also highlighted the need of removing vegetation to an acceptable grass cover. It is clear that the vegetation was not removed, as requested.

Figure 15. Vegetation on Dam B: a) low grasses and small bushes on the dam crest, trees on downstream side slope (south view from crest), (b) tipped over trees near breach and zone of surface erosion (west view from downstream), and (c) presence of roots throughout the dam on the south breach wall (south view from breach).
