## Geotechnical Observations of Dams Failed During the 2015 Historic Flooding in South Carolina

**ABSTRACT:** *This paper presents a description of post-flood reconnaissance and geotechnical investigation of four earthen dams that were breached or damaged following an extreme flooding event in South Carolina in 2015. As a result of unprecedented rainfall and flooding that occurred during a five-day period at the beginning of October in 2015, a total of 51 earthen dams failed and nearly 200 were damaged. Many of these dams failed due to overtopping that led to a breach of the dam. Among the four dams investigated, full breach was observed at three dams; two of which were overtopped, and one was not. The fourth dam was not breached but was severely damaged. For each of these dams, the paper documents background information, pre-flood conditions, post-flood field observations and measurements, and laboratory testing results of collected soil samples. Impacts of vegetation on the dams and the effects of dam failure on critical infrastructure are also presented. The detailed descriptions and geotechnical investigations of the dam failures presented herein serve as case histories that c

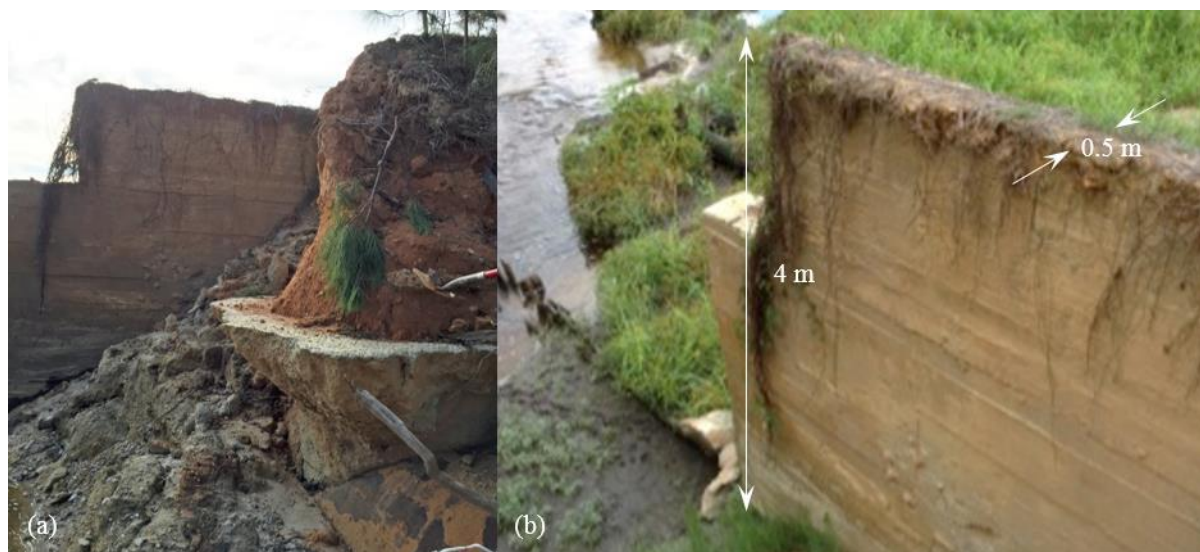
A concrete wall about 4 m high and 0.5 m thick (see Figure 23) was observed at the location of the breach (see Figures 19 and 22). The wall appears to run parallel to the dam crest, within the upstream side slope, but does not extend the entire length of the dam. The purpose of this structure, the actual dimensions, and whether the wall was built before or during the construction of the dam, are unknown. As shown in Figure 23, soil near the wall was washed away during the flood event. According to a SCDHEC inspection report from 2014 (SCDHEC 2016), part of the wall protruded from the dam and had an attached fence that was used as a fishing fence. This fence was no longer attached to the wall at the time of the reconnaissance. The inspection report also highlighted several signs of deterioration in the dam including cracks in the spillway structures

and animal burrows. It is possible that internal erosion near the concrete wall initiated the breach of the dam. Cracks in the wall or gaps between the wall and the surrounding soil due to animal activity may result in concentrated flow initiating internal erosion (Bonelli 2013).

Figure 23. Concrete wall in the upstream section of Dam C, next to the breach zone: a) southwest view from downstream, and b) southeast view from crest of dam.

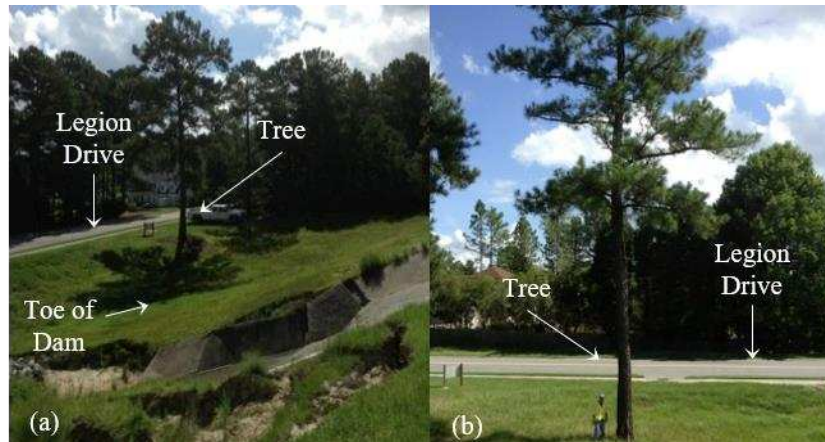
Figure 29. Vegetation on Dam D: a) east view from the crest showing short grasses and trees growing along the roadway near the downstream toe of the dam, and b) north east view from the crest showing a tree near the roadway on the southeast end of the dam.
