Geotechnical Observations of Dams Failed During the 2015 Historic Flooding in South Carolina

ABSTRACT: *This paper presents a description of post-flood reconnaissance and geotechnical investigation of four earthen dams that were breached or damaged following an extreme flooding event in South Carolina in 2015. As a result of unprecedented rainfall and flooding that occurred during a five-day period at the beginning of October in 2015, a total of 51 earthen dams failed and nearly 200 were damaged. Many of these dams failed due to overtopping that led to a breach of the dam. Among the four dams investigated, full breach was observed at three dams; two of which were overtopped, and one was not. The fourth dam was not breached but was severely damaged. For each of these dams, the paper documents background information, pre-flood conditions, post-flood field observations and measurements, and laboratory testing results of collected soil samples. Impacts of vegetation on the dams and the effects of dam failure on critical infrastructure are also presented. The detailed descriptions and geotechnical investigations of the dam failures presented herein serve as case histories that can be u

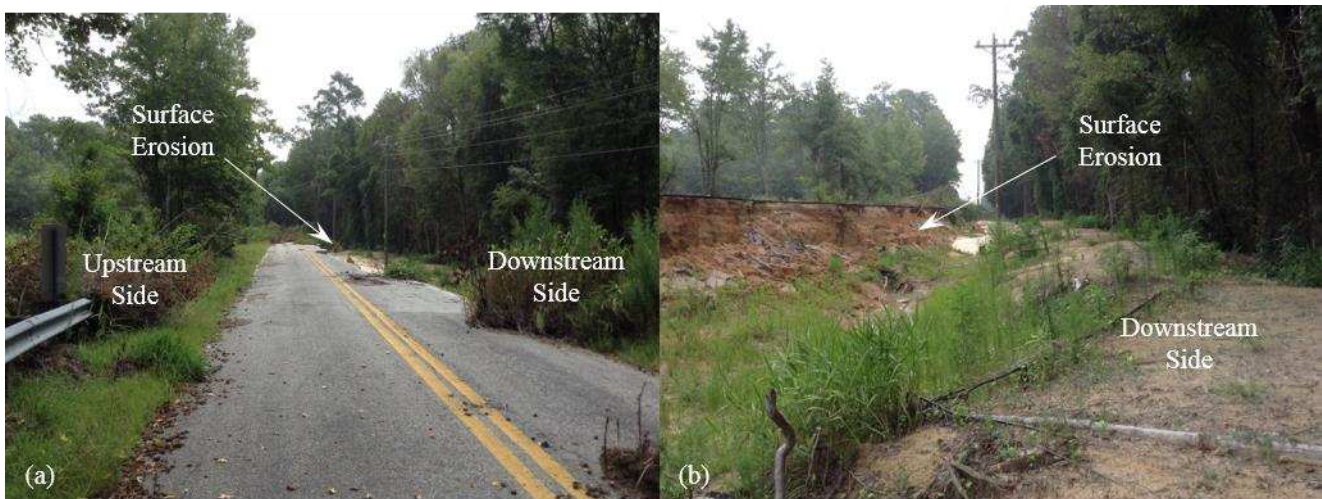
Vegetation was not present on the crest of Dam A where the road is located. However, there is vegetation on the edges of the crest adjacent to the road and on the upstream and downstream sides of the dam. Mature trees with heights of nearly 12 m were observed on the upstream side, parallel to the road and nearly 3 m away from the upstream shoulder (see Figure 5a). Trees on the downstream side have similar heights, but were found nearly 20 m away from the road (see Figure 5b). All of the mature trees appear to be part of the natural growth in the local ecosystem. It is unclear if the presence of vegetation influenced dam performance or contributed to its failure. In the area where soil was exposed on the downstream side slope (noted as surface erosion in Figure 5b), there were no trees present and no roots observed in the soil. Near the northeast section of the breach, several trees were found tipped over the road (see Figure 6), but no roots were observed in the soil.

Figure 5. Vegetation on Dam A: (a) vegetation upstream and downstream of the dam (east view from S-40-67), and (b) vegetation and surface erosion on the downstream side of the dam (east view from downstream).

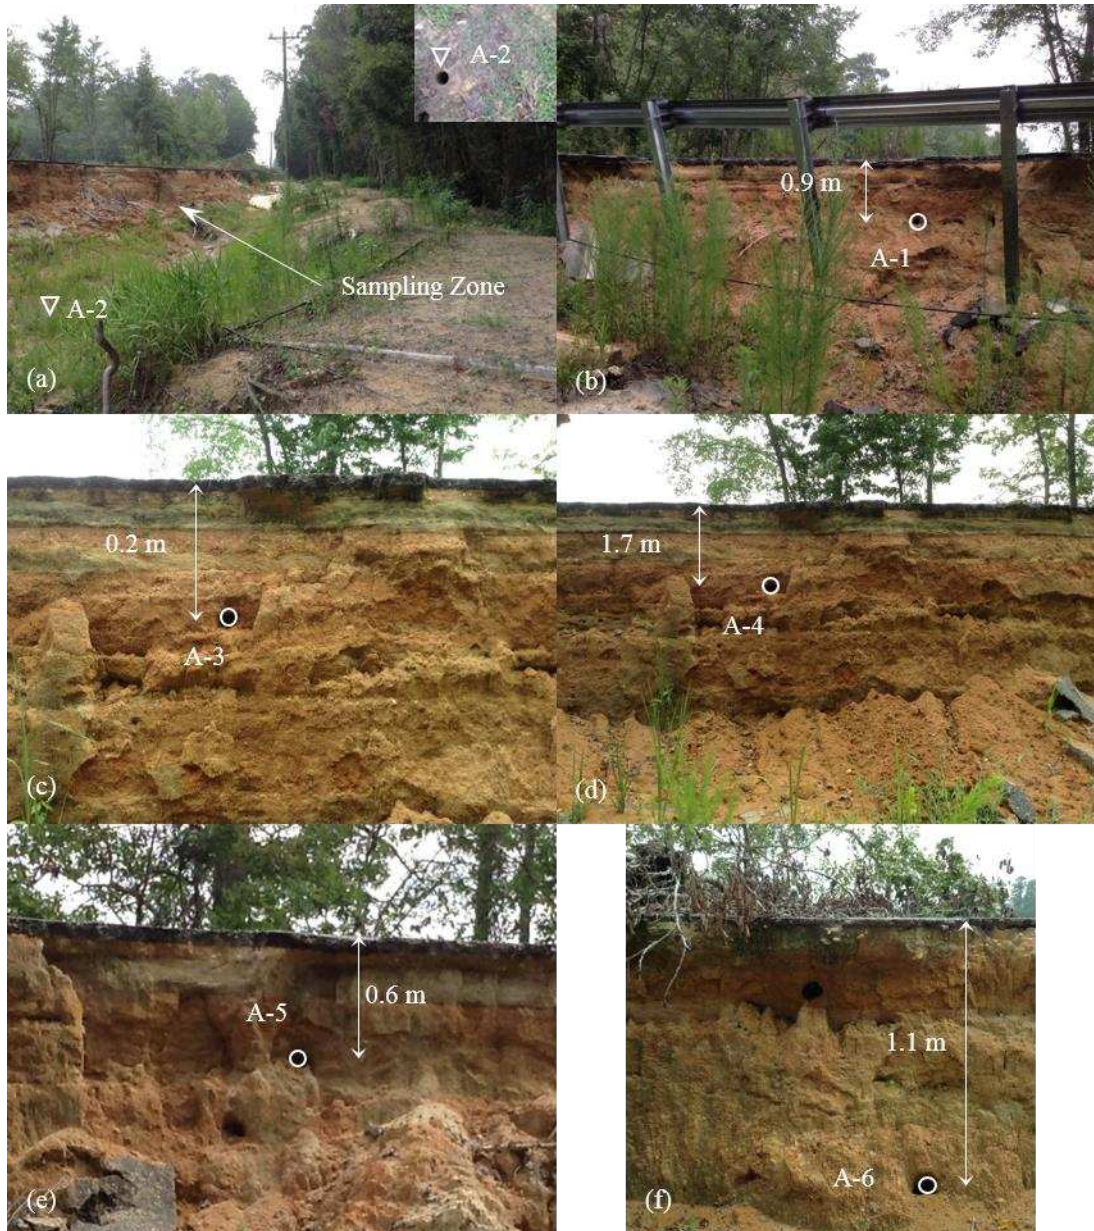
Laboratory testing results from soil samples collected at six locations from the downstream side slope of the dam are presented in Table 1. Approximately half of the road lane collapsed due to slope failure; therefore, the samples were collected relatively close to the center of the embankment. The samples were obtained in the area where surface erosion and slope failure occurred except for sample A-2, which was obtained from the foundation soil. The distance from the crest of the dam to the sample locations is presented in Figure 9, and the sampling depth for each hole is presented in Table 1. The distance of sampling locations relative to the breach zone are shown in Figure 3. The dam materials are mostly silty to clayey sands with 23% to 42% low plasticity fines. The foundation soil (A-2) at a depth of approximately 56-81 cm also appears to be silty sand. Based on these test results and the visual field observations of the soils along the length of the exposed embankment, the dam material appears to be relatively consistent (SM or SC) with no definable core. The coefficient of permeability is low to very low (10^{-4} to 10^{-6} cm/s). Based on the soil characteristics in Dam A, internal erosion would occur moderately to extremely rapidly in the presence of cracks or hydraulic fractures (Wan and Fell 2004).

Figure 9. Sampling locations in Dam A: a) east view from downstream side, and b), c), d), e) and f) north view from downstream side (∇: vertical sample, ○: horizontal sample).

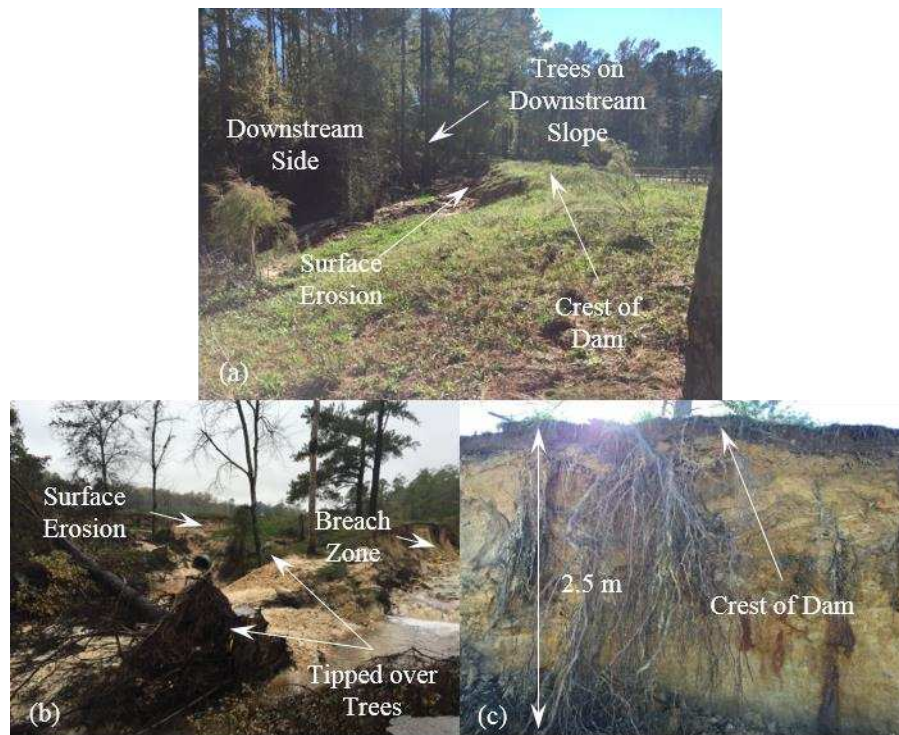
Vegetation was observed over the entire surface of the dam (see Figure 15). The upstream side-slope and crest of the dam are covered with grass and shrubs with heights less than 1 m. Several mature trees with heights from 15 to 18 m were observed on the crest and downstream side-slope of the dam (see Figures 15a and 15b). The roots of one of these trees were exposed by the dam breach, as shown in Figure 15c. The roots reach depths of nearly 2.5 m, penetrating through the upper half and into the lower half of the 4.3 m high dam. The SCDHEC inspection report from 2008 (SCDHEC 2016) also highlighted the need of removing vegetation to an acceptable grass cover. It is clear that the vegetation was not removed, as requested.

Figure 15. Vegetation on Dam B: a) low grasses and small bushes on the dam crest, trees on downstream side slope (south view from crest), (b) tipped over trees near breach and zone of surface erosion (west view from downstream), and (c) presence of roots throughout the dam on the south breach wall (south view from breach).

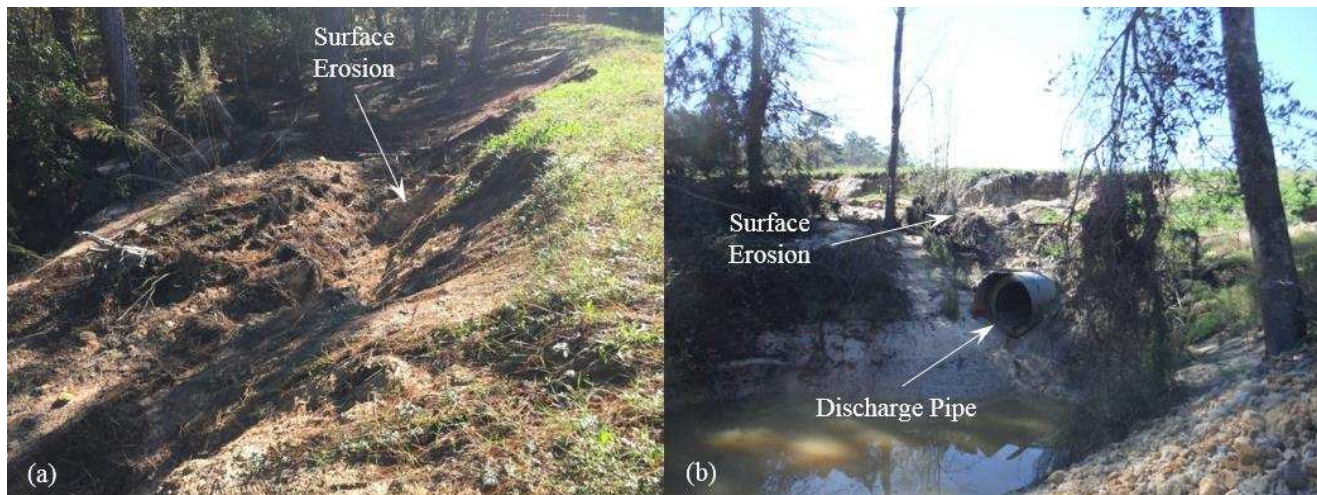
Figure 16. Surface erosion on downstream side slope of Dam B: a) south view from the crest of dam and b) west view from downstream.

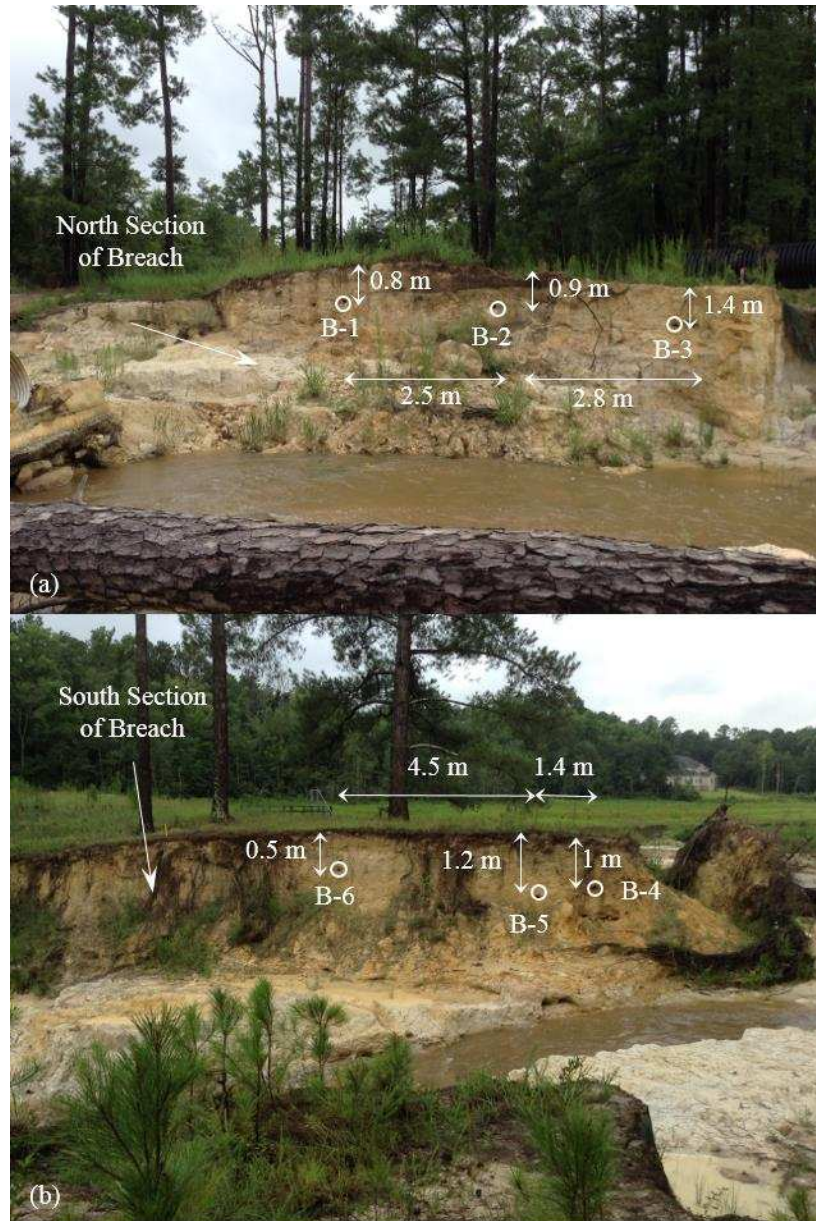
Laboratory testing results from soil samples collected at six locations from the breach section of Dam B are presented in Table 2. The sampling locations were selected to acquire soils representative of the full cross-section of the dam. Figure 17 shows the sampling locations viewed from the crest of the dam. The locations relative to the spillway, Congress Road, and the dam length, are also shown in Figure 12. Soils collected from the north and south sides of the breach are different. Samples B-1 and B-3 collected from the north side of the breach are classified as low to high plasticity clays and silts (MH and CH, and ML and CL, respectively), while the remaining soil samples were classified as silty or clayey sands (SM or SC). It is possible that because samples B-1 and B-3 were obtained from the north end of Dam B, there were natural materials scattered among the dam fill, or two different material types were used in the construction of the dam. In either case, there was no evidence of a dam core. Based on the results of samples taken closer to the middle section of the dam (B-4, B-5, and B-6), the dam material is mostly clayey sand with low plasticity fines. The fines content ranges from 15% to 49%. The erosion rate, based on the characteristics of the soils in this dam, is moderately rapid (Wan and Fell 2004). The presence of roots through the dam may result in significant increments of the erosion rate.

Figure 17. Sampling locations for Dam B, (a) north wall of breach section (north view from crest), and (b) south wall of breach section (south view from crest).

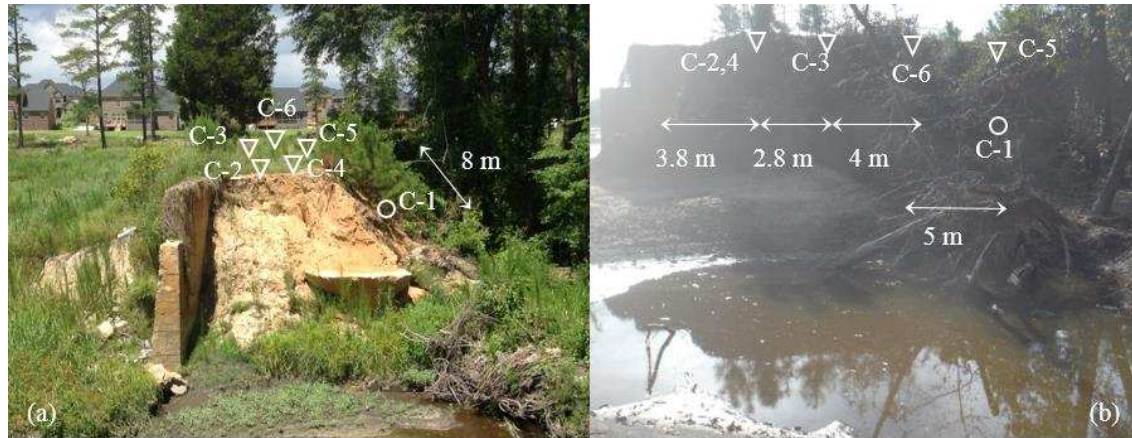
Laboratory testing results from soil samples collected at six locations from the crest and downstream side slope of Dam C are presented in Table 3. The sampling locations are presented in Figures 19 and 24. Dam fill materials are mainly clayey to silty sands with approximately 27% to 53% low plasticity fines. Based on the experimental results and field observations of the cross-section of the breach (see Figure 21), the dam fill materials are relatively consistent and a definable core was not observed. The erosion rate, based on the characteristics of the soils in this dam, is moderately to extremely rapid (Wan and Fell 2004).

Figure 24. Sampling locations for Dam C: a) northwest view from southeast section of breach, and b) southwest view from downstream (∇ : vertical sample, \circ : horizontal sample).

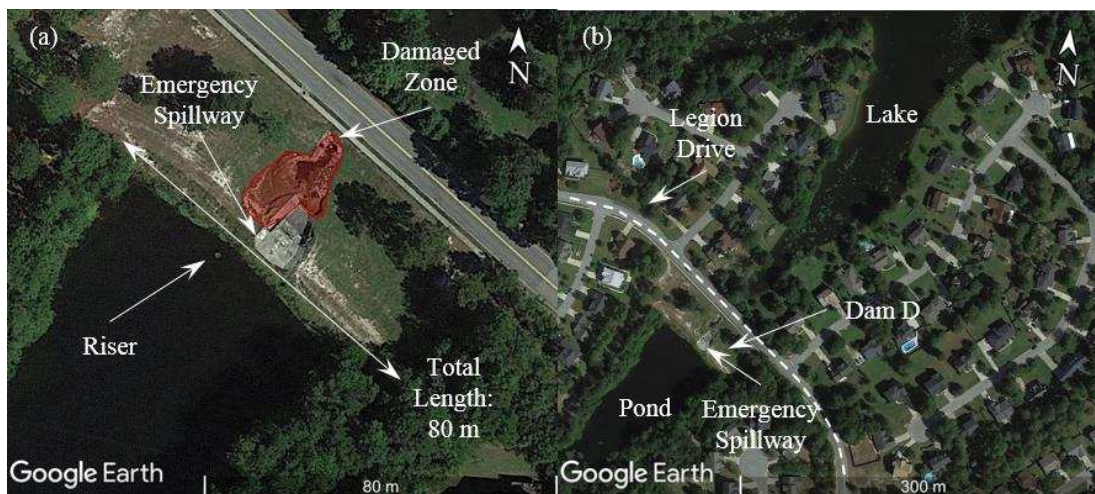
Dam D is located 22 km northeast from downtown Columbia, South Carolina. The dam is not regulated by SCDHEC and the year of construction is unknown. However, based on information provided by the owners, it is assumed to be at least 25 years old. The dam was constructed before the development of a nearby subdivision and has been used to maintain a recreational pond for neighboring communities. Satellite imagery of the dam is shown in Figure 25. Figure 26 presents photographs of the downstream side slope of the dam before and after the flood event. Sloughing in the downstream side-slope occurred before the flood event, as observed in Figure 26a, suggesting saturation of the soil near surface as a result of internal seepage. The crest width was measured to be 4 m, the height of the dam was measured to be 3.7 m, and the upstream and downstream side slopes were measured to be 26° and 23° , respectively. The length of the dam was measured to be 80 m. A two-lane road (labeled Legion Drive in Figure 25b) is located nearly 40 m east and runs parallel to the length of the dam. Many houses are located both upstream and downstream of the dam. Dam D is considered to be a small dam because it impounds a pond with an estimated surface area of $6,900 \text{ m}^2$ and an estimated storage of nearly $8,000 \text{ m}^3$ (ICOLD 2011). These values were estimated from satellite imagery via Google Earth (accessed on September 14, 2016) and information provided by the dam owners. As shown in Figure 25b, water is conducted from the impoundment towards a larger lake located downstream. Dam D was not breached during the 2015 flood event, but was severely damaged. No repairs have been made to date, and based on communication with the dam owners, it is likely that the dam will be removed due to high repair cost.

Figure 25. Aerial views of Dam D: a) geometry, draining structures, and damaged zone, and b) location relative to surrounding community (Google Earth, accessed on April 8, 2018).

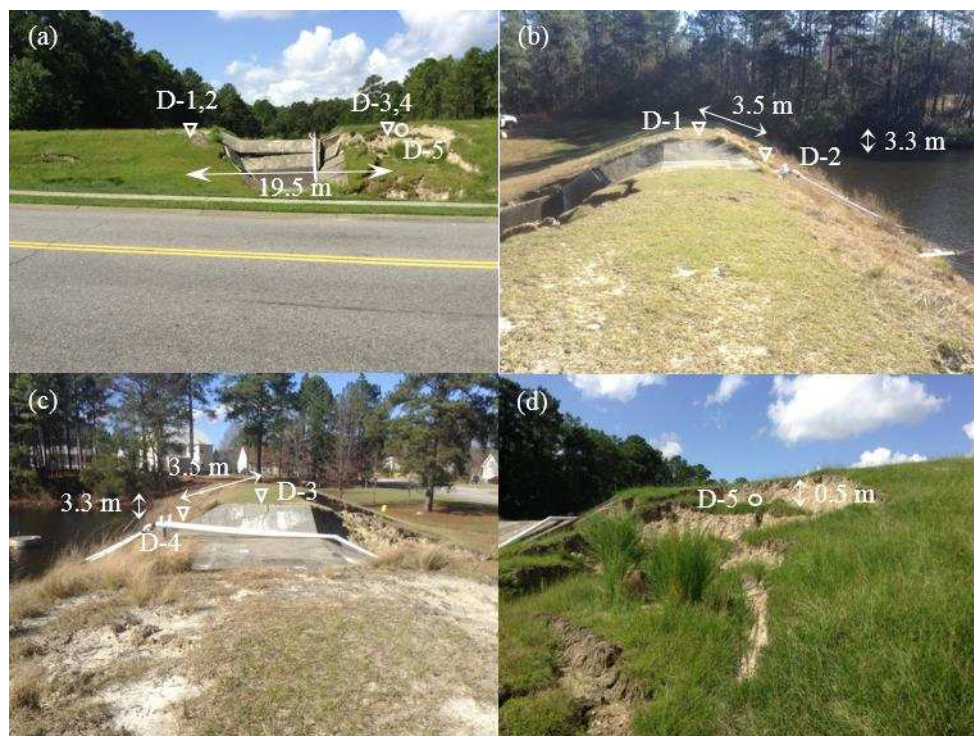
zone adjacent to the emergency spillway. Even though sample location D-5 is expected to be closer to the core of the dam (see Figure 31), pre-failure information provided by the dam owner indicates that Dam D does not have a definable core. In fact, the dam fill materials were consistent across all five sampling locations (primarily silty sands, SM, with little to no plasticity). Test results show that these soils have low to very low permeability (10^{-4} to 10^{-6} cm/s). The erosion rate, based on the characteristics of the soils in this dam, is extremely rapid (Wan and Fell 2004).

Figure 31. Sampling locations in Dam D: a) southwest view from Legion Drive, b) southeast view from the crest, c) northwest view from the crest, and d) southwest view from downstream side slope near the sliding zone (▽: vertical sample, ○: horizontal sample).
