Geotechnical Effects of Hurricane Harvey in the Houston, Beaumont, and Port Arthur Areas

ABSTRACT: The Geotechnical Extreme Events Reconnaissance (GEER) Association deployed multiple teams of engineers from academia and practicing firms to the coast of Texas in late August and early September 2017 following Hurricane Harvey. This report summarizes the observations and data from the GEER team that focused primarily on the inland effects of Hurricane Harvey in the Houston area with some observations in the Port Arthur / Beaumont area east of Houston. Rain, not storm surge or wind, caused the observed damage in Houston, Beaumont, and Port Arthur by overwhelming stormwater management facilities and creating high flows and flooding in and near area waterways. The major Houston-area flood structures, Addicks and Barker Dams, performed well from a geotechnical perspective. Observed damages included shallow slides along levees, severe erosion along riverways, isolated road and culvert erosion and uplift, and area-wide flood effects in low and poorly drained neighborhoods.

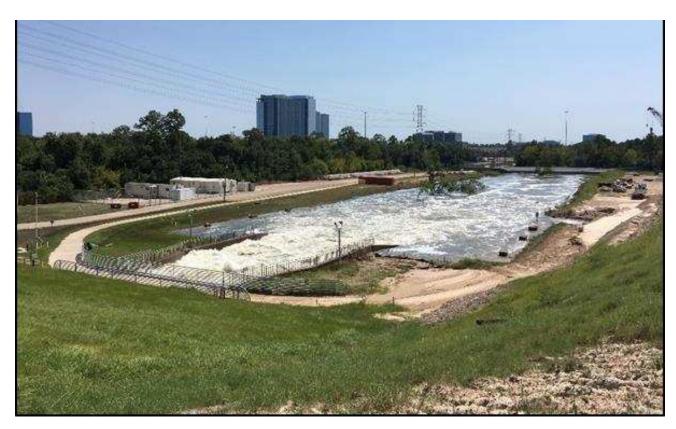
Although hydrologic/hydraulic performance of the dams was outside of our purpose and primary expertise, it appeared that Addicks and Barker Dams fulfilled their mission of reducing the impact of flooding for a significant part of the Houston area, specifically along Buffalo Bayou downstream of the dams, including the central business district. During the heaviest rainfall, around 86-89 cm (34-35 inches) of rainfall was recorded in the watershed. Peak reservoir levels occurred on about August 30, 2017 at 33.3 m (109.1 ft) and 31.0 m (101.6 ft) in the Addicks and Barker reservoirs, respectively. The highest elevations of the crest for these two dams are 34.1m (121 ft) and 34.1 m (112 ft), respectively, which provided freeboards of approximately 3.4 m (11 ft) (Addicks) and 3.0 m (10 ft) (Barker) at the peak reservoir levels. The peak reservoir water level in Addicks slightly exceeded the level of the ground at the north end of Addicks north auxiliary spillway (details below). The USACE opened the Addicks outflow gates on August 28, 2017 to reduce risks associated with higher water levels. These outflows peaked around August 30, 2017 at about 200 cubic meters/second (m³/s) (7,000 cubic ft per second [cfs]) for Addicks and 180 m³/s (6,300 cfs) for Barker. The USACE noted that Addicks and Barker Dams reduced peak flows in Buffalo Bayou by more than 3,540 m³/s (125,000 cfs) during the April 2016 flooding, a smaller event than Hurricane Harvey. The April 2016 event, also known as the Tax Day Flood, resulted from about 43 cm (17 inches) of rain, which accumulated over just 12 hours and caused the previous record pools for the dams. During the time of our visit on September 9, 2017, the gates of the dams were opened to allow flows of 170 m³/s (6,000 cfs) (Addicks) and 110 m³/s (4,000 cfs) (Barker) for a total flow into the Buffalo Bayou of 280 m³/s (10,000 cfs) (see Figs. 5 and 6). The USACE gradually reduced outflows from these levels to a total of $110 \text{ m}^3/\text{s}$ (4,000 cfs) on September 17, 2017.

Figure 5. Addicks outlet releasing ~170 m³/s (~6000 cfs) (September 9, 2017, 29.79026° N, 95.62378° W).

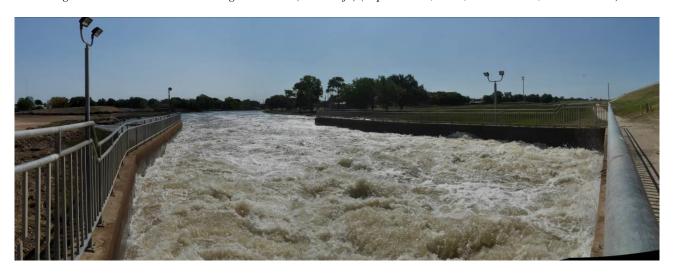
Figure 6. Barker outlet releasing ~110 m³/s (~4000 cfs) (September 9, 2017, 29.76977° N, 95.64629° W).

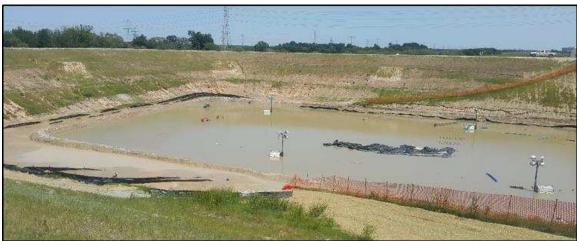
The USACE had contracted to construct new outlet structures and cutoff walls at each dam. This construction was in progress at the time of Hurricane Harvey and was suspended until the consequences of and recovery from the flooding could be assessed. At the time of the hurricane, cofferdams were in place and parts of the cutoff walls had been constructed. The cofferdams performed suitably in keeping the water in the reservoir from flooding the construction zone; however, the high backwater from the channel to Buffalo Bayou flooded the Addicks construction zone (see Fig. 7), and rainwater and underseepage pooled in the Barker cofferdammed area.

Figure 7. Interior of Addicks construction cofferdam for new outlet structure, flooded from Buffalo Bayou backwater; note erosion channels on slopes (September 9, 2017, 29.79063° N, 95.62586° W).

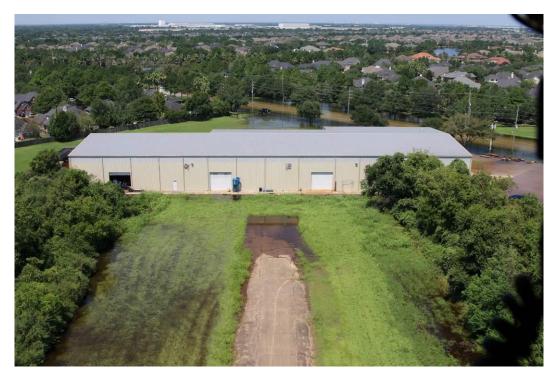
High water in the Addicks Reservoir (~33.3 m [~El. 109.1 ft]) exceeded the elevation of the level ground at the end of the north auxiliary spillway RCC (~El. 108), resulting in small outflows (~6 m³/s [~200 cfs]) that began on August 29, 2017. Figure 8 shows this area on September 7, 2017 when some small spillage was still taking place. These outflows were within the design intent of the dam and the auxiliary spillway, and should not be described as dam overtopping. Overtopping implies that the water levels have risen above the main dam, which is typically a serious condition that can lead to rapid erosion of the dam and a dam failure.

Figure 8. North end of Addicks auxiliary spillway (September 3, 2017, 29.84977° N, 95.58904° W, photo by USACE).

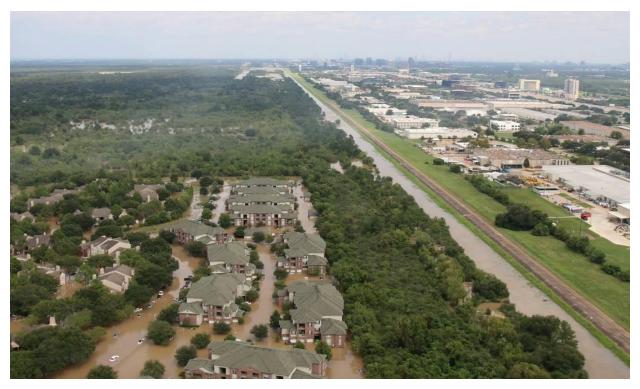
The high-water levels in the Addicks (El. 33.3 m [El. 109.1 ft]) and Barker (El. 31.0 m [El. 101.6 ft]) Reservoirs exceeded not only the April 2016 historic high levels (El. 31.3 m [102.7 ft] at Addicks and El. 29.0 m [95.24 ft] at Barker) but also the elevations at the upstream edge of the USACE property. As noted previously, housing developments extended up to these boundaries and, consequently, were flooded during Harvey (see Figs. 9, 10, and 11). Area subsidence likely contributed to

Figure 9. Aerial photograph of flooding within the Addicks Reservoir along the south auxiliary spillway (September 3, 2017, 29.79222° N, 95.68830° W, USACE photograph).

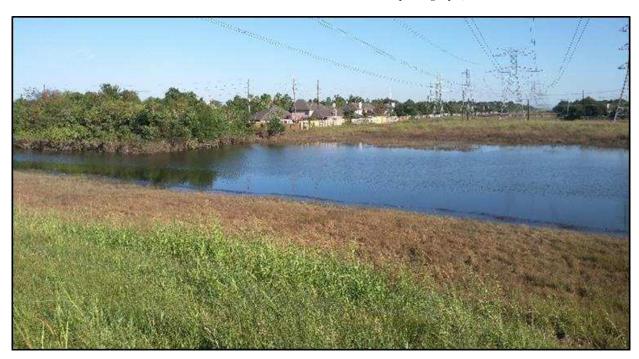
Figure 10. Flooded residential area in the southwest corner of the Barker Dam (September 9, 2017, 29.70706° N, 95.72835° W).

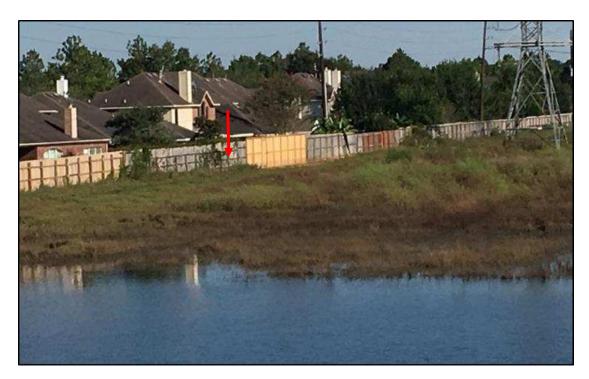
Figure 11. High water mark on fences surrounding residential area (September 9, 2017, 29.70706° N, 95.72835° W).

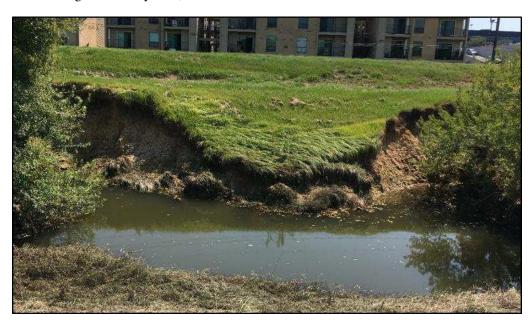
Nearby runoff that is not captured by the dams is managed in drainage ditches or creeks immediately adjacent to the dams' downstream toes. These drainage channels, along with numerous other stormwater / flood management features, are managed by the Harris County Flood Control District. The team observed several slope failures that will require repairs along Turkey Creek near the southeast corner of Addicks Dam (see Figure 12). Contributing factors to the sloughs could have included the steepness of the banks, flow forces acting on trees on the banks or diverted by trees in the waterway, undercutting by flood flows, reduced shear strength in the clay soils, and the drawdown of the creek water level.

Figure 12. Slope failures along Turkey Creek drainage ditch (September 9, 2017, 29.79009° N, 95.59639° W).

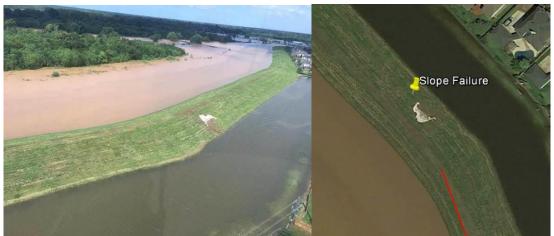
Overall, we understand that the Brazos River LID levees performed well, with no major failures, breaches, or overtopping. One incident of a surficial slide on the protected slope of a Sienna Plantation LID levee was reported and photographed by others as shown in Fig. 14 (see Location 2 on Fig. 13). The GEER team visited the First Colony LID 2 (see Location 3 on Fig. 13) and two of the drainage ditches that serve the LIDs (see Locations 4 and 5 on Fig. 13). Despite the good levee performance, flooding occurred within several LIDs due to the issues with storm water removal from the protected side behind the levees to the river side. Some LIDs were even completely cut off due to water surrounding the entirety of the LID.

Figure 14. Aerial photo (right) and Google Earth (left), August 30, 2017, 29.491844° N, 95.541017° W.

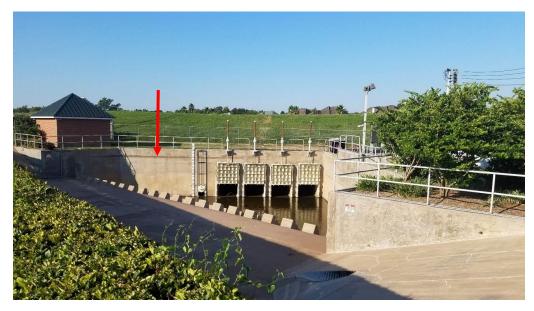
Figure 15. FCLID2 drainage outfall / pumping station basin, showing four 1.4 m (60 inch) flood gates, high water line at ~19.8 m (65 ft) gauge height, levee in background (September 10, 2017, 29.55509° N, 95.61779° W).

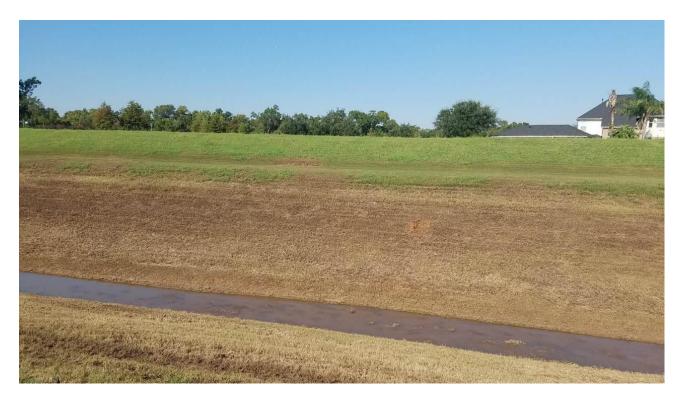
Figure 16. FCLID2 drainage ditch to Brazos River facing FBLID14 levee. High water line and persistent water lines visible on FBLID14 levee (September 10, 2017, 29.55292° N, 95.61820° W).

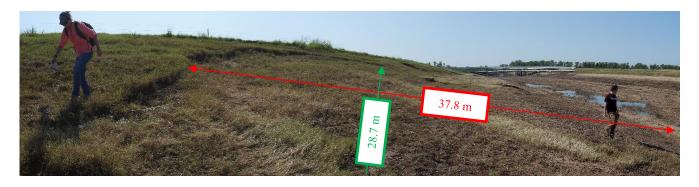
The team observed several slope failures or sloughs along the slopes of Ditch H and numerous feral hog burrows. The east side slopes had some scarps that ranged in height from 15 to 99 cm (6 to 39 inches). Figs. 18 and 19 show two of the sloughs. The slope failures were likely due to softening of the clay soils by the flooding and the subsequent increases in stress on the slope due to drawdown of the flood water. Leakage from either an intact or ruptured CMP could have also contributed to one of the slope failures. The team also observed an erosion gulley below a drainage outfall on the University Avenue bridge (Fig. 20), which could have been prevented with hardened material protection (e.g., riprap, concrete blocks) below the outfall.

Figure 18. Ditch H levee, dimensioned slope failure (September 10, 2017, 29.55797°N, 95.63792°W).

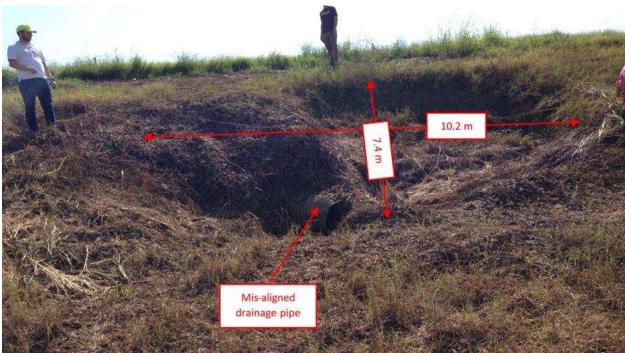
Figure 19. Sour hole at ruptured drainage pipe on Ditch H levee (September 10, 2017, 29.55759°N, 95.63768°W).

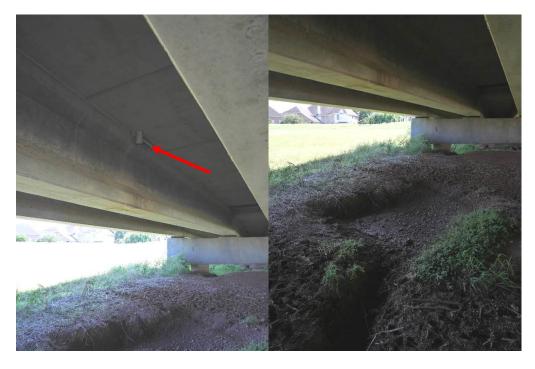
Figure 20. Erosion on Ditch H levee under the University Blvd Bridge due to flow impact from bridge drainage outfall (red arrow, September 10, 2017, 29.55902° N, 95.63744° W).

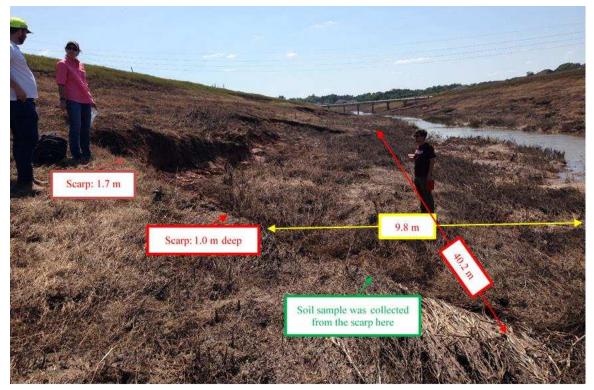
The team observed numerous slope failures along the Flat Bank Diversion Channel (see Fig. 13 for location) between 29.53103° N, 95.56200° W and 29.52572° N, 95.56201° W. Fig. 21 shows the dimensions of one large slide where the team collected a soil sample that was subsequently classified at the Kansas State University laboratory as low plasticity clay (CL) with a 21.3% moisture content. The team noted a drainage CMP outfall on an intact portion of the slope adjacent to this slide and another slide to the south. Figure 22 shows another embankment slough that extended into the base channel.

Figure 21. Slope failure north of damaged drainage pipe on the east side of ditch (September 10, 2017, 29.52647°N 95.56194°W),

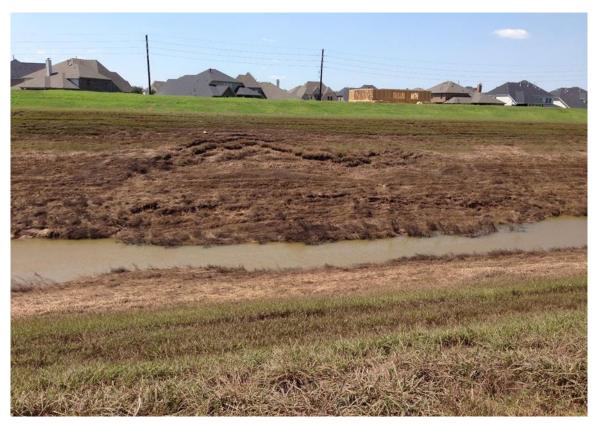
Figure 22. Earth slumping on the west side embankment (September 10, 2017, 29.53103° N, 95.56200° W).

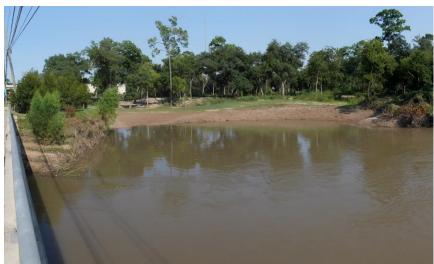
Upon arrival of the GEER team at sites along Buffalo Bayou on September 9, 2017, the observed flows in the bayou were about 210 m³/s (7,300 cfs) at the USGS Addicks gauge. Flooding of residential areas had been largely reduced by September 9, though much of the former parks and trails along the bayou were still inundated with water. Signs of the previous flooding could be seen with river debris noted on bridge girder and railings (see Fig. 24). No critical geotechnical failures were noted along the observed portions of Buffalo Bayou, but scour areas and a slope failure were observed (see Figs. 25 and 26).

Figure 25. Buffalo Bayou evidence of scour a) Bridge abutment, and b) Downstream of Woodway Drive Bridge (September 9, 2017, 29.76457° N 95.45815° W).

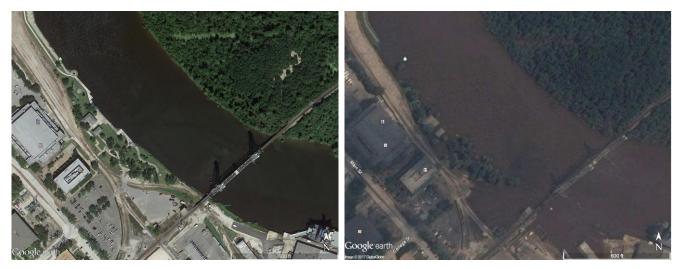
In Beaumont, the team observed significant erosion scour along the Neches River in the downtown area. Riverfront Park, behind City Hall and located on an outside bend of the river, was severely affected with the loss of shoreline and undercutting of many park features. Fig. 1 shows the location of Beaumont within the study area. Fig. 27 shows the location of Riverfront Park along the Neches River. Fig. 28 shows aerial / satellite images from Google Earth of Riverfront Park taken before the Harvey flooding (January 2015) and during the Harvey flooding (September 2015), respectively.

Figure 28. Aerial images of Beaumont Riverfront Park, January 2015 (left) and September 3, 2017 (right) (Google Earth).

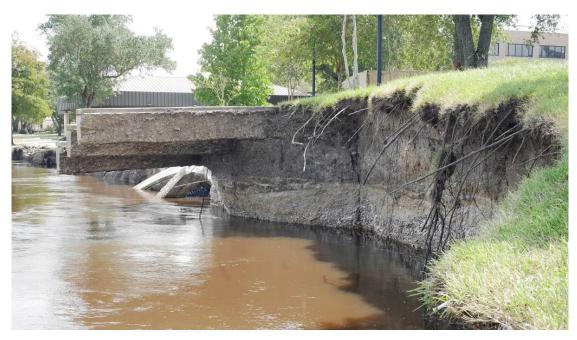
Figs. 29 and 30 show the loss of shoreline and scarps left by the Neches River erosion of the park shoreline, starting from an upstream section protected by riprap and extending through the downriver port area. The pre-hurricane park area shoreline was fronted with a riverwalk/dock (see aerial on Fig. 28), which was largely washed out. Based on pre-hurricane aerials on Google Earth, the shoreline had eroded up to about 15 m (50 ft) from the previous shoreline.

Figure 29. Scour under amphitheater structure. Scarp is estimated to be about 12 m (40 ft) back from previous shoreline (September 11, 2017, 30.08334° N, 94.09441° W).

Scarps along the waterfront were up to about 5 m (15 ft) in height, with the highest scarps at the amphitheater. Exposed soils in accessible scarps were stratified, with fill (primarily sand) over stratified silty/clayey (slightly plastic to non-plastic) sand with shells and varying amounts of organic fines. The riprap-covered (30- to 46-cm- [12- to 18-in-] sized rubble concrete) shoreline at the north end of the park was largely intact.

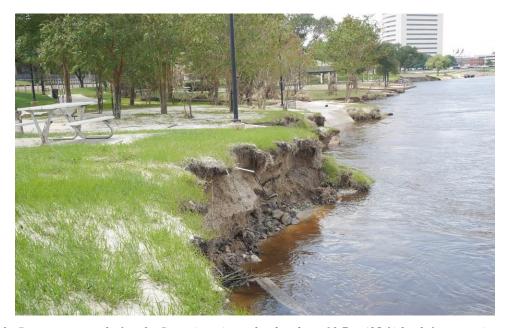
Figure 30. Downstream end of park. Scarp is estimated to be about 10.7 m (35 ft) back from previous shoreline (September 11, 2017, 30.08184° N, 94.09278° W).

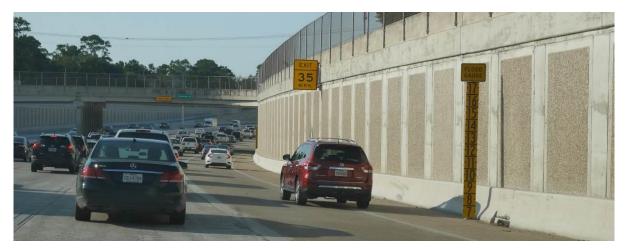
Flooding caused roadway damage to and closure of a major area artery at the underpass intersection of the Sam Houston Parkway / Beltway 8 and Boheme Drive (see Fig. 1 for location, 29.76736° N, 95.56210° W). The parkway is depressed at this intersection and floods often enough that flood depth sign gauges are posted along the road to warn motorists of the standing water depth (see Fig. 31).

Figure 31. Beltway 8 / Boheme Drive underpass and flood depth signs (September 11, 2017, 29.76694° N, 95.56139° W).

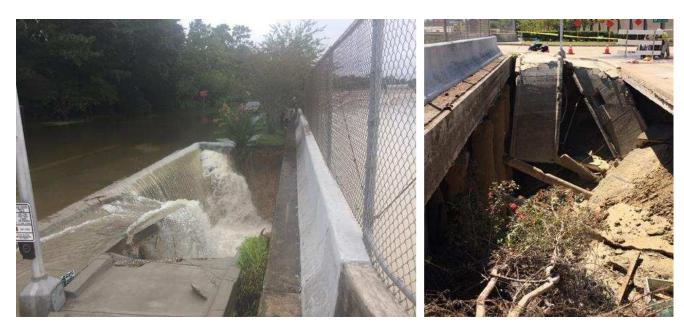
The roadway damage consisted of an uplifted road slab (or slabs) on Beltway 8 and a washout of the adjacent access road, West Sam Houston Parkway N, which is supported about 6.7 m (22 ft) above the parkway by a cantilevered retaining wall consisting of precast panels, which are supported by H-pile reinforced concrete piers. It appears that flood water from the area west of the parkway flooded the access road, drained down behind the retaining wall, and uplifted the Beltway 8 slabs. These flows then washed out soil behind the wall and under the access road and adjacent sidewalk, leaving a 5 m- (17 ft) deep hole. Fig. 32 photographs show the state of the damaged roadway during and after the flooding event. Fig. 33 shows repair work conducted on the uplifted slabs.

Figure 32. Damage of the walkway slab on Beltway 8 (left photo courtesy Brian Klein, a resident in the area, August 27, 2017, and right photo courtesy of a construction worker on site, 29.76735° N, 95.56219° W).

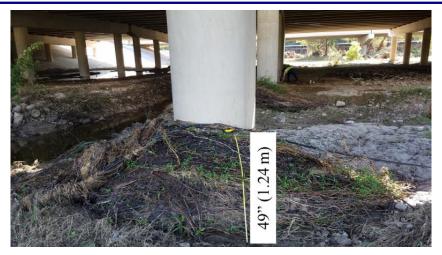
As expected, bridge columns with no erosion control had variable amounts of accumulated debris (see Fig. 35) and scour (see Figs. 36 & 37). No measurable scour was observed around columns with erosion control (see Fig. 38), which included riprap and polymeric reinforcement. Fig. 40 shows the bank of the San Jacinto River from the north side, facing south. The riprap along the banks likely reduced the erosion of the fine, sandy soil. Fig. 41 shows an observed 2.4-m- (8-ft-) diameter scour hole in the sandy bank material. Despite the observed scour, no geotechnical or structural failures were observed on the I-45 Bridge over the San Jacinto River.

Figure 35. Observed debris on first column in flow direction. Debris pile is 1.24 m (49 inches) tall around the 1-m- (3-ft-) diameter bridge column (September 11, 2017, Time 10:04 CDT, 30.24688° N, 95.45796° W).

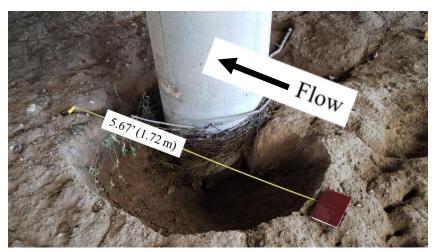
Figure 36. Bridge column scour (September 11, 2017, Time 10:06 CDT, 30.24688° N, 95.45796° W).

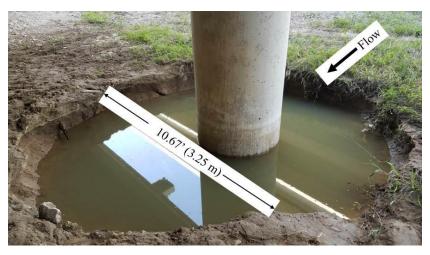
Figure 37. Scour hole on column closer to river. The hole was 3.7 m (12.3 ft) long in the flow direction and 3.25 m (10.67 ft) perpendicular to flow. The depth of the scour hole was 0.8 m (2.75 ft) from the existing ground (September 11, 2017, Time 10:23 CDT, 30.25071° N, 95.45703° W).

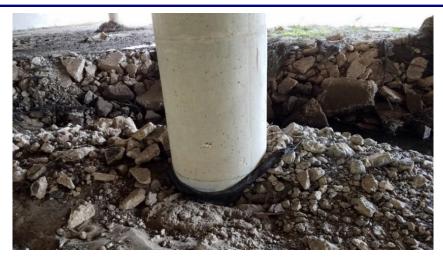
Figure 38. Erosion control riprap, including polymeric reinforcement, with minimal observed scour (September 11, 2017, Time 10:19 CDT, 30.24688° N, 95.45796° W).

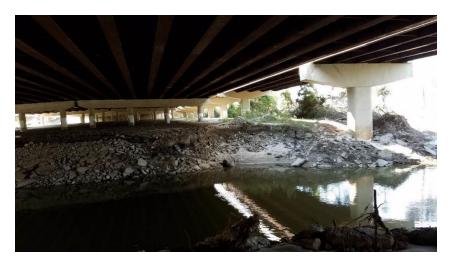
Figure 39. Riprap along south bank of San Jacinto River (September 11, 2017, Time 10:56 CDT, 30.24574° N, 95.45761° W).

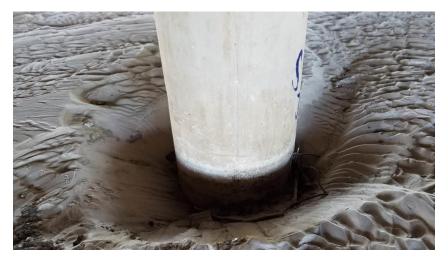
Figure 40. Scour around columns on San Jacinto Banks (sandy soil). The scour hole was approximately 2.4 m (8 ft) across and 0.6 m (2 ft) deep (September 11, 2017, Time 10:59 CDT, 30.243364°N, 95.46452°W).

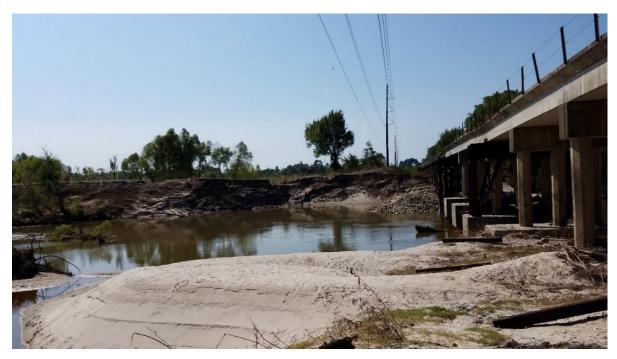
Figs. 41 and 42 show the Missouri Pacific Rail Road Bridge downstream of I-45. Bank erosion was noted on the south bank of the San Jacinto River downstream of the railroad bridge. Fig. 42 shows debris on top of the pile caps and at the top of the bents on the railroad bridge. These high debris levels were consistent with the maximum measured gauge height during Harvey of approximately 10 m (33 ft) above average gauge height.

Figure 41. Bank erosion on the San Jacinto River downstream of I-45 and a railroad bridge parallel to the highway (September 11, 2017, Time 11:05 CDT, 30.24688° N, 95.45796° W).

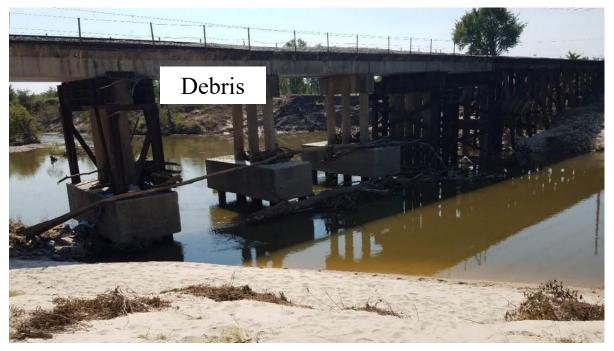
Figure 42. Debris on railroad bridge indicating flow levels and scour around pile caps below current flow levels (September 11, 2017, Time 11:10 CDT, 30.24688° N, 95.45796° W).

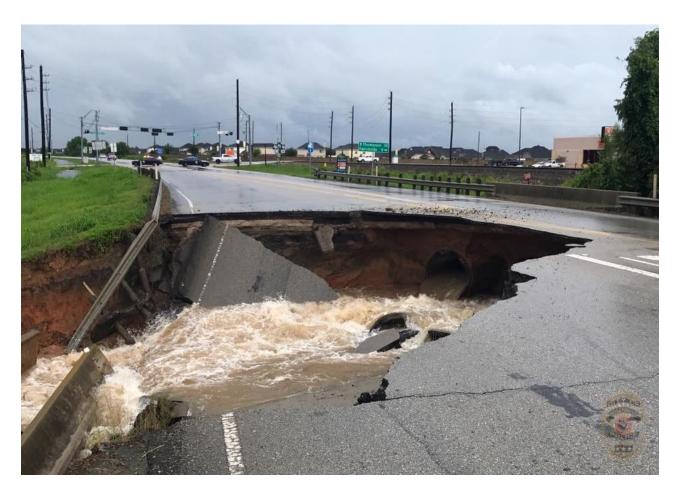
Erosion of the road progressed from the downstream side (see Fig. 43) until the entire width of the road washed out, stopping within 18 m (60 ft) of the adjacent railroad tracks. Repair construction was underway at the time of our visit. Possible erosion mechanisms could have included overtopping flow, culvert leakage or failure, or embankment seepage.

Figure 43. FM 762 Washout on August 27, 2017 (Courtesy of the Rosenberg Police Department, 29.5442° N, 95.7434° W).

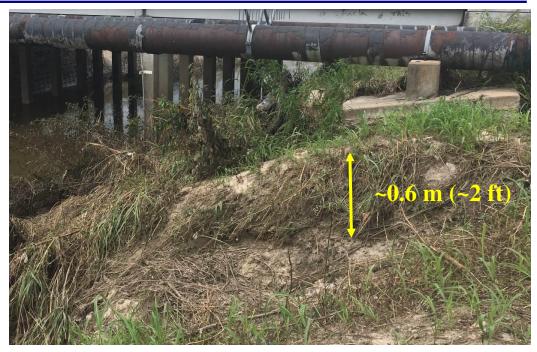
The erosion at the State Highway 35 Bypass bridge and pipe crossing over Mustang Bayou in the city of Alvin (see Fig. 1 for location) was typical for small waterways with high flow. Two shallow soil slump failures with slip depths of about 0.3 to 0.6 m (1 to 2 ft) were noted along the north bank of the bayou, one of which was beside and under a pipeline pile cap (Fig. 44).

Figure 44. Shallow soil failure along the north bank of Mustang Bayou, adjacent to pipe-support foundation (September 4, 2017, Time 12:48 CDT, 29.40889° N, 95.23234° W).

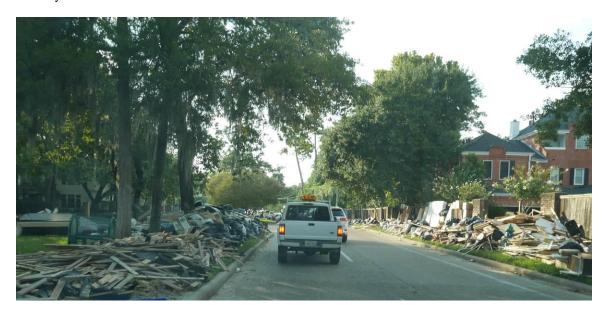
Figure 45. Residential flood damage debris, Houston.

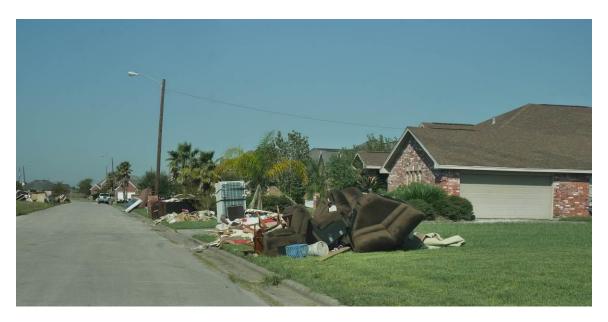
Figure 46. Residential flood damage debris, Port Arthur.
