Geotechnical Effects of Hurricane Harvey in the Houston, Beaumont, and Port Arthur Areas

ABSTRACT: *The Geotechnical Extreme Events Reconnaissance (GEER) Association deployed multiple teams of engineers from academia and practicing firms to the coast of Texas in late August and early September 2017 following Hurricane Harvey. This report summarizes the observations and data from the GEER team that focused primarily on the inland effects of Hurricane Harvey in the Houston area with some observations in the Port Arthur / Beaumont area east of Houston. Rain, not storm surge or wind, caused the observed damage in Houston, Beaumont, and Port Arthur by overwhelming stormwater management facilities and creating high flows and flooding in and near area waterways. The major Houston-area flood structures, Addicks and Barker Dams, performed well from a geotechnical perspective. Observed damages included shallow slides along levees, severe erosion along riverways, isolated road and culvert erosion and uplift, and area-wide flood effects in low and poorly drained neighborhoods.*

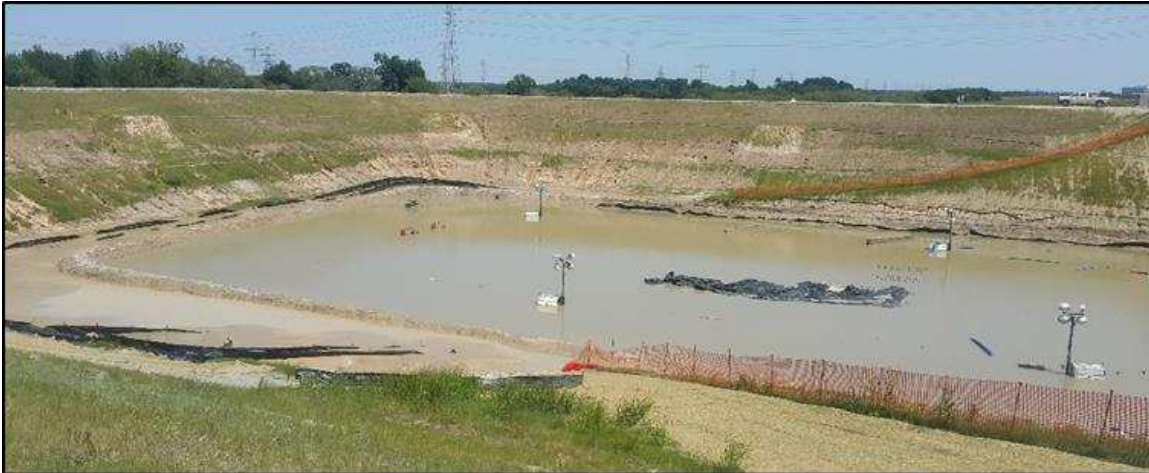
The USACE had contracted to construct new outlet structures and cutoff walls at each dam. This construction was in progress at the time of Hurricane Harvey and was suspended until the consequences of and recovery from the flooding could be assessed. At the time of the hurricane, cofferdams were in place and parts of the cutoff walls had been constructed. The cofferdams performed suitably in keeping the water in the reservoir from flooding the construction zone; however, the high backwater from the channel to Buffalo Bayou flooded the Addicks construction zone (see Fig. 7), and rainwater and underseepage pooled in the Barker cofferdammed area.

Figure 7. Interior of Addicks construction cofferdam for new outlet structure, flooded from Buffalo Bayou backwater; note erosion channels on slopes (September 9, 2017, 29.79063° N, 95.62586° W).

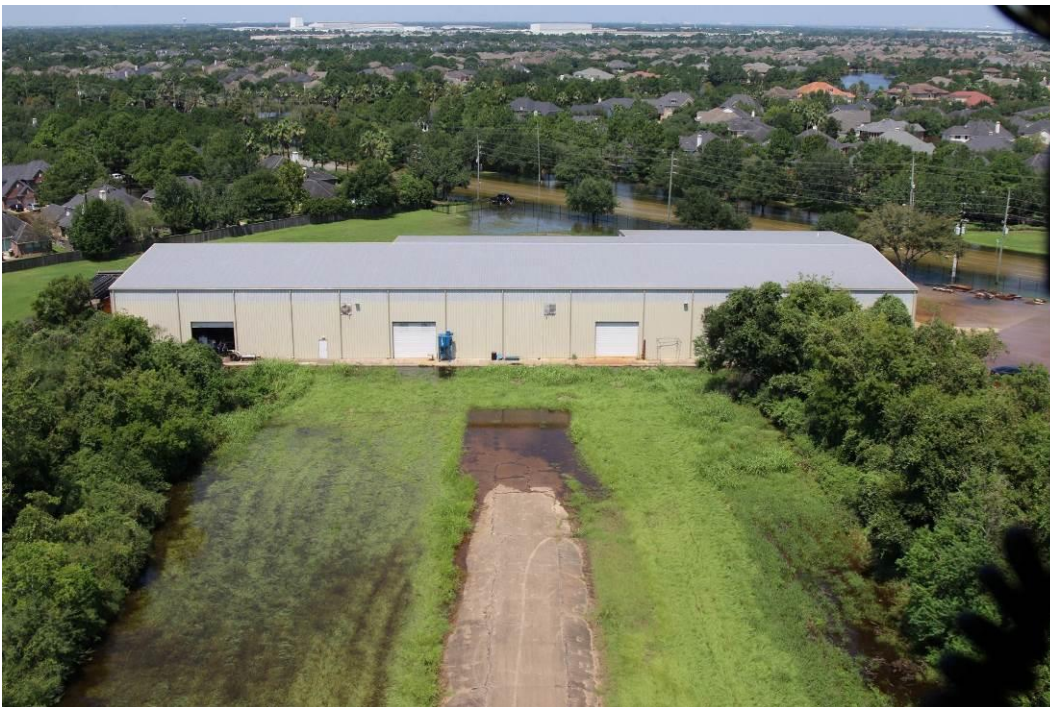
High water in the Addicks Reservoir (~33.3 m [~El. 109.1 ft]) exceeded the elevation of the level ground at the end of the north auxiliary spillway RCC (~El. 108), resulting in small outflows (~6 m³/s [~200 cfs]) that began on August 29, 2017. Figure 8 shows this area on September 7, 2017 when some small spillage was still taking place. These outflows were within the design intent of the dam and the auxiliary spillway, and should not be described as dam overtopping. Overtopping implies that the water levels have risen above the main dam, which is typically a serious condition that can lead to rapid erosion of the dam and a dam failure.

Figure 8. North end of Addicks auxiliary spillway (September 3, 2017, 29.84977° N, 95.58904° W, photo by USACE).

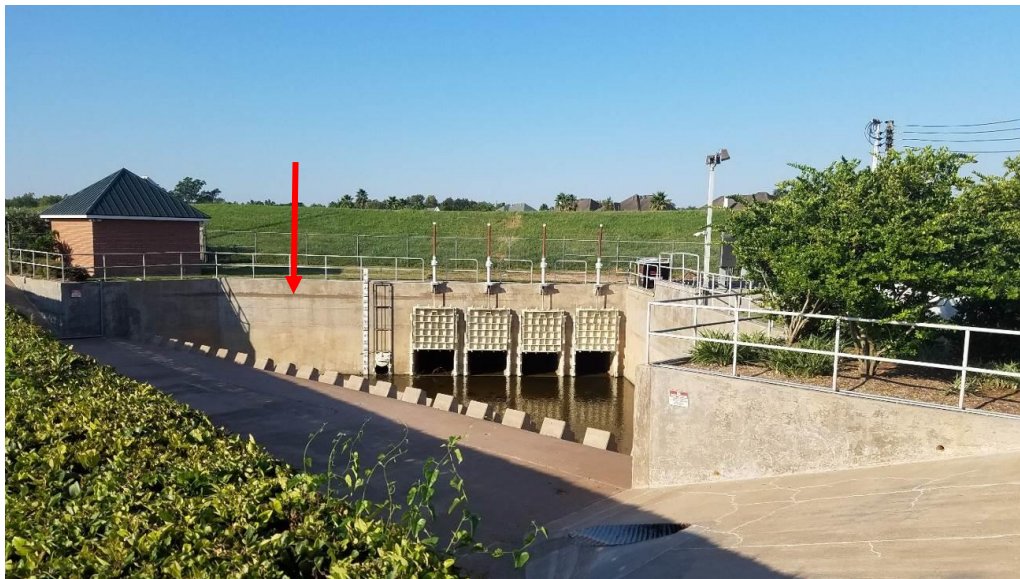
Figure 15. FCLID2 drainage outfall / pumping station basin, showing four 1.4 m (60 inch) flood gates, high water line at ~19.8 m (65 ft) gauge height, levee in background (September 10, 2017, 29.55509° N, 95.61779° W).

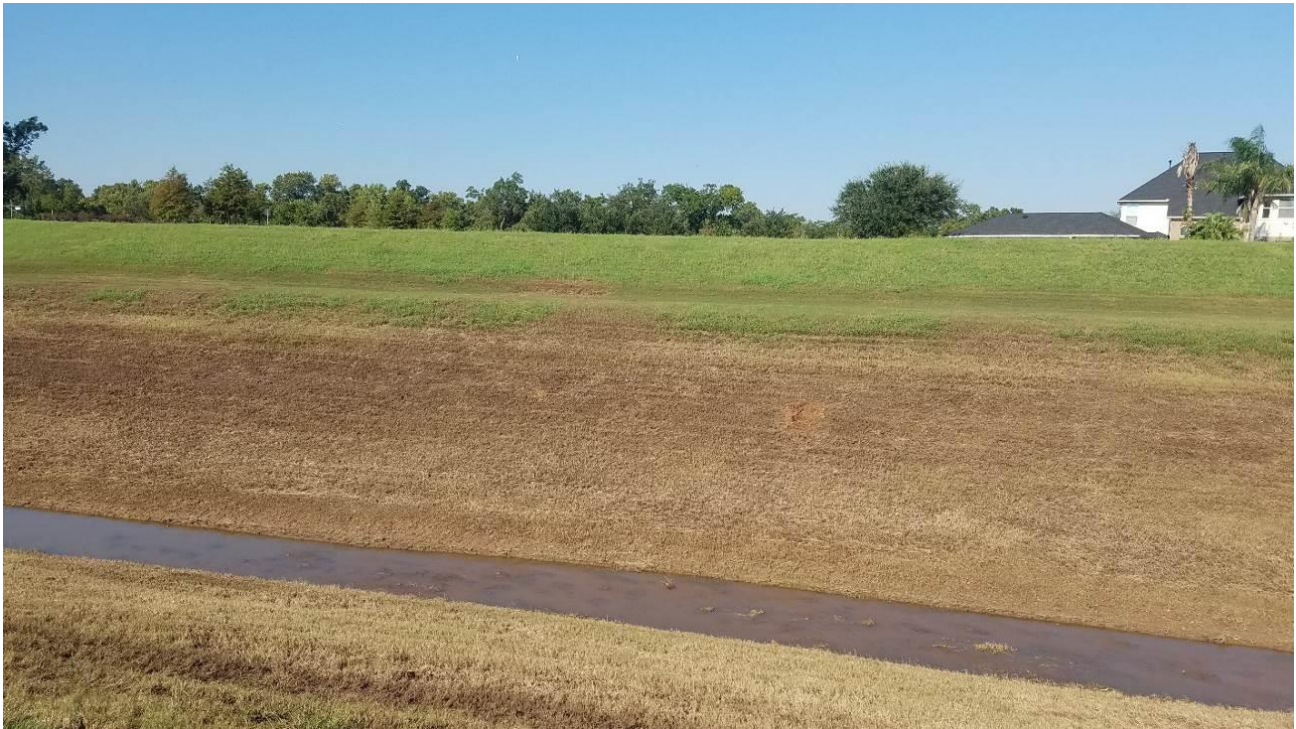
Figure 16. FCLID2 drainage ditch to Brazos River facing FBLID14 levee. High water line and persistent water lines visible on FBLID14 levee (September 10, 2017, 29.55292° N, 95.61820° W).

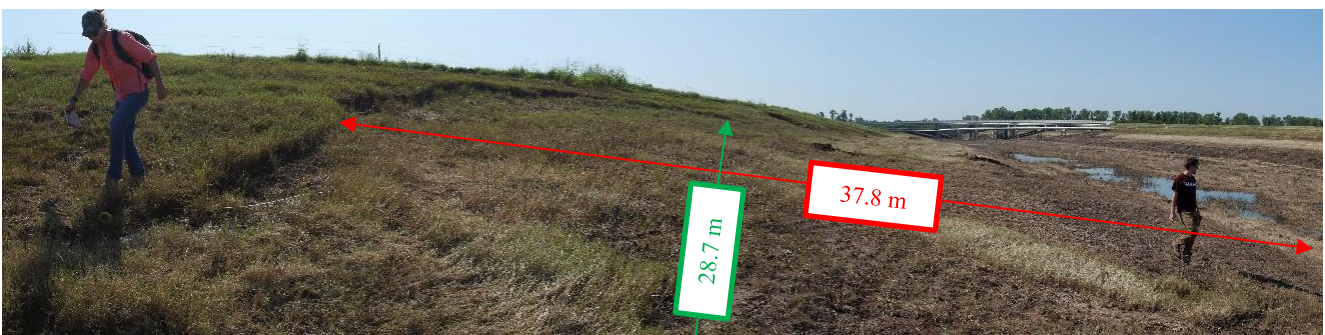
The team observed several slope failures or sloughs along the slopes of Ditch H and numerous feral hog burrows. The east side slopes had some scarps that ranged in height from 15 to 99 cm (6 to 39 inches). Figs. 18 and 19 show two of the sloughs. The slope failures were likely due to softening of the clay soils by the flooding and the subsequent increases in stress on the slope due to drawdown of the flood water. Leakage from either an intact or ruptured CMP could have also contributed to one of the slope failures. The team also observed an erosion gully below a drainage outfall on the University Avenue bridge (Fig. 20), which could have been prevented with hardened material protection (e.g., riprap, concrete blocks) below the outfall.

Figure 18. Ditch H levee, dimensioned slope failure (September 10, 2017, 29.55797°N, 95.63792°W).

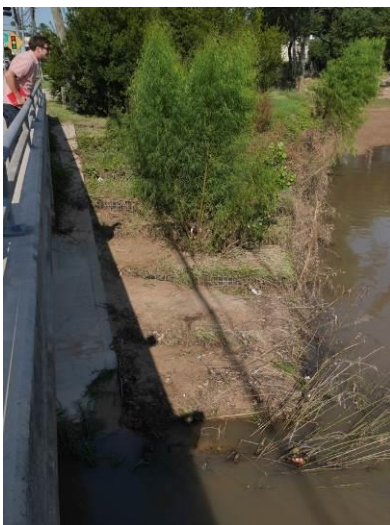
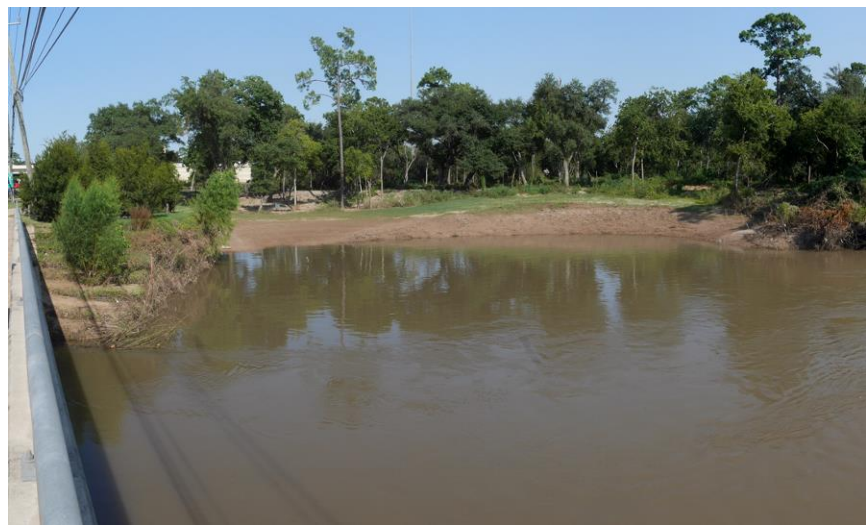
Figure 25. Buffalo Bayou evidence of scour a) Bridge abutment, and b) Downstream of Woodway Drive Bridge (September 9, 2017, 29.76457° N 95.45815° W).

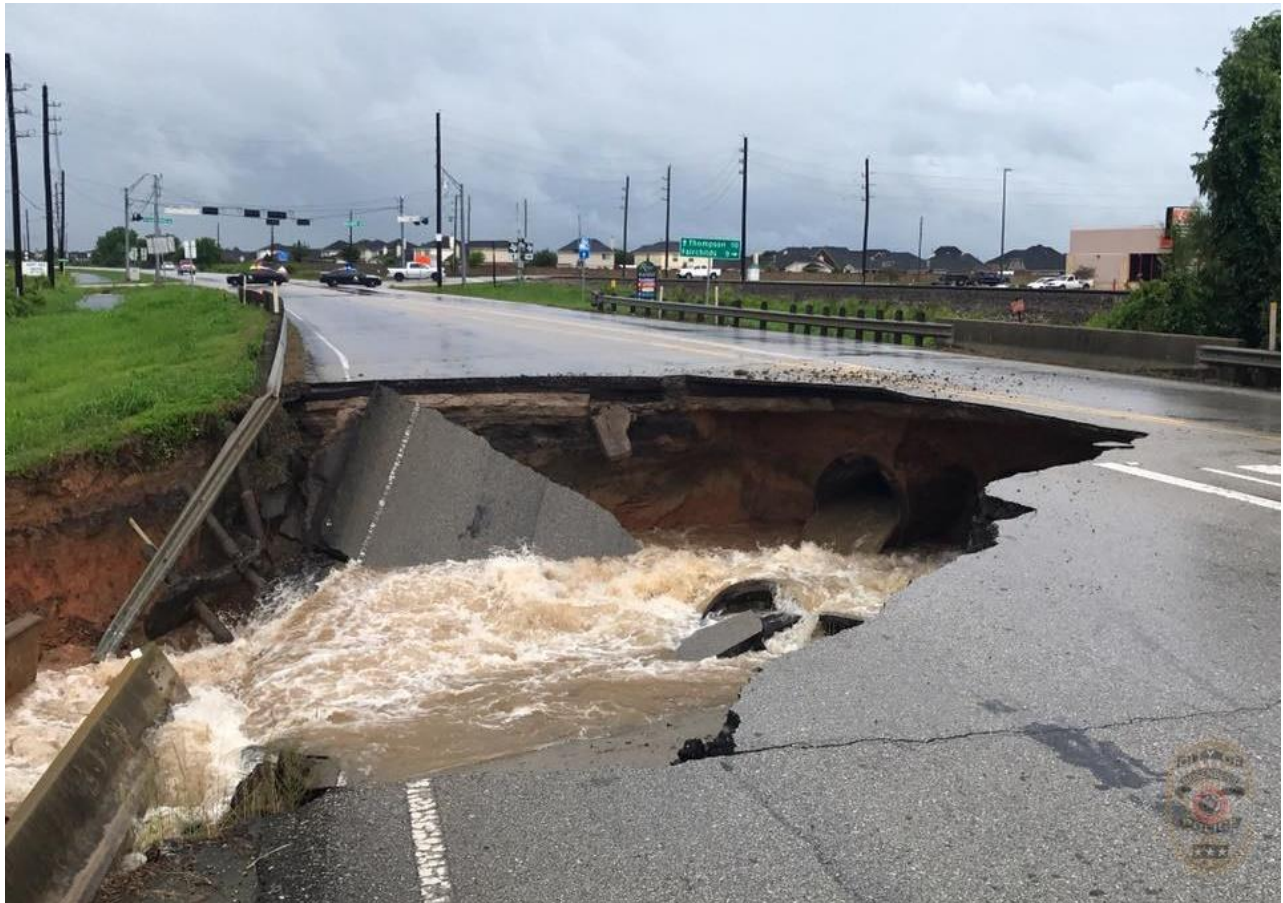
Erosion of the road progressed from the downstream side (see Fig. 43) until the entire width of the road washed out, stopping within 18 m (60 ft) of the adjacent railroad tracks. Repair construction was underway at the time of our visit. Possible erosion mechanisms could have included overtopping flow, culvert leakage or failure, or embankment seepage.

*Figure 43. FM 762 Washout on August 27, 2017
(Courtesy of the Rosenberg Police Department, 29.5442° N, 95.7434° W).*

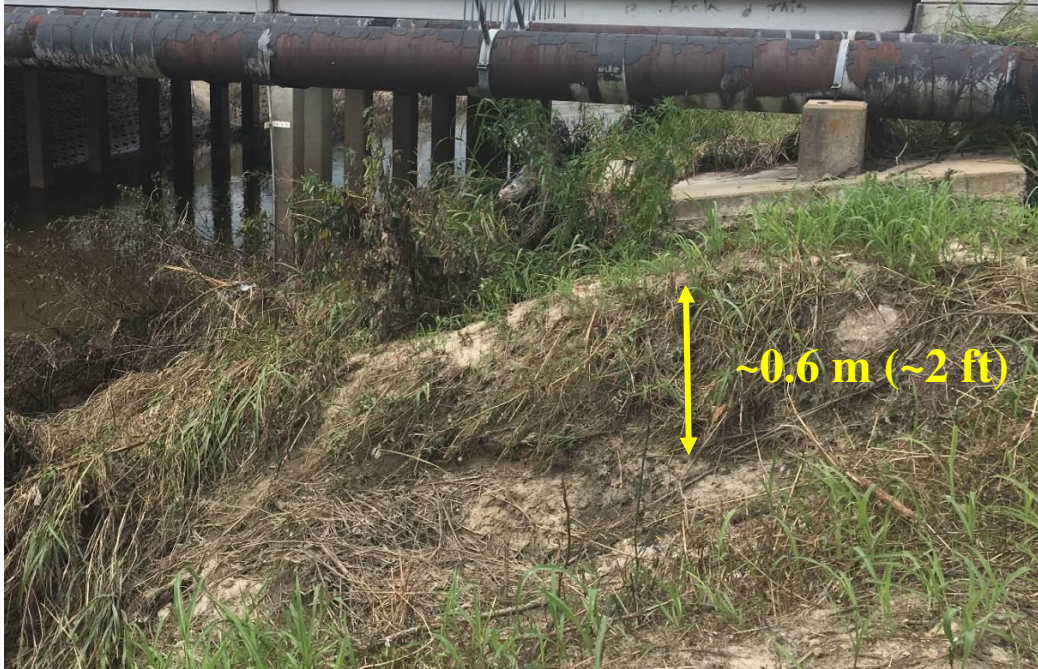
The erosion at the State Highway 35 Bypass bridge and pipe crossing over Mustang Bayou in the city of Alvin (see Fig. 1 for location) was typical for small waterways with high flow. Two shallow soil slump failures with slip depths of about 0.3 to 0.6 m (1 to 2 ft) were noted along the north bank of the bayou, one of which was beside and under a pipeline pile cap (Fig. 44).

Figure 44. Shallow soil failure along the north bank of Mustang Bayou, adjacent to pipe-support foundation (September 4, 2017, Time 12:48 CDT, 29.40889° N, 95.23234° W).
