## Geotechnical Effects of Hurricane Harvey in the Houston, Beaumont, and Port Arthur Areas

**ABSTRACT:** *The Geotechnical Extreme Events Reconnaissance (GEER) Association deployed multiple teams of engineers from academia and practicing firms to the coast of Texas in late August and early September 2017 following Hurricane Harvey. This report summarizes the observations and data from the GEER team that focused primarily on the inland effects of Hurricane Harvey in the Houston area with some observations in the Port Arthur / Beaumont area east of Houston. Rain, not storm surge or wind, caused the observed damage in Houston, Beaumont, and Port Arthur by overwhelming stormwater management facilities and creating high flows and flooding in and near area waterways. The major Houston-area flood structures, Addicks and Barker Dams, performed well from a geotechnical perspective. Observed damages included shallow slides along levees, severe erosion along riverways, isolated road and culvert erosion and uplift, and area-wide flood effects in low and poorly drained neighborhoods.*

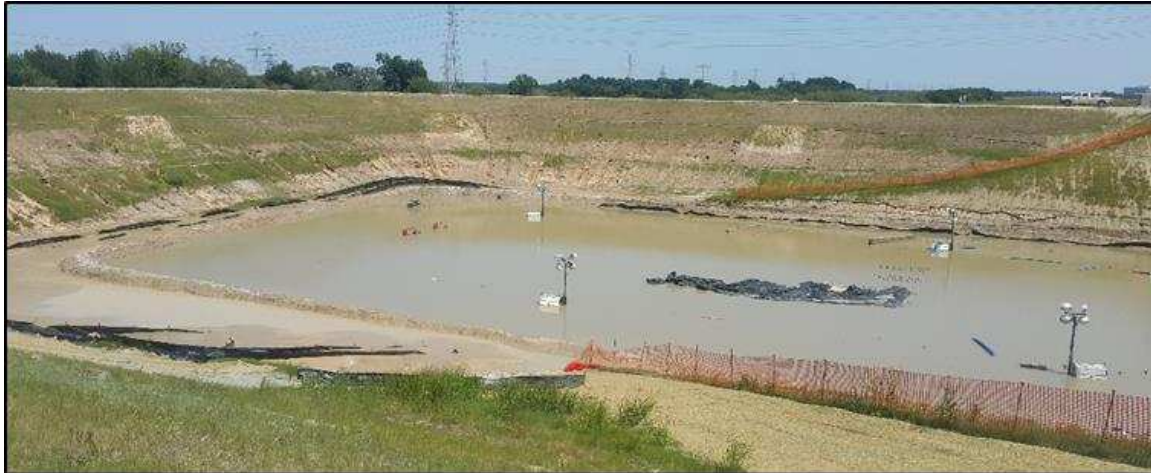
The USACE had contracted to construct new outlet structures and cutoff walls at each dam. This construction was in progress at the time of Hurricane Harvey and was suspended until the consequences of and recovery from the flooding could be assessed. At the time of the hurricane, cofferdams were in place and parts of the cutoff walls had been constructed. The cofferdams performed suitably in keeping the water in the reservoir from flooding the construction zone; however, the high backwater from the channel to Buffalo Bayou flooded the Addicks construction zone (see Fig. 7), and rainwater and underseepage pooled in the Barker cofferdammed area.

*Figure 7. Interior of Addicks construction cofferdam for new outlet structure, flooded from Buffalo Bayou backwater; note erosion channels on slopes (September 9, 2017, 29.79063° N, 95.62586° W).*

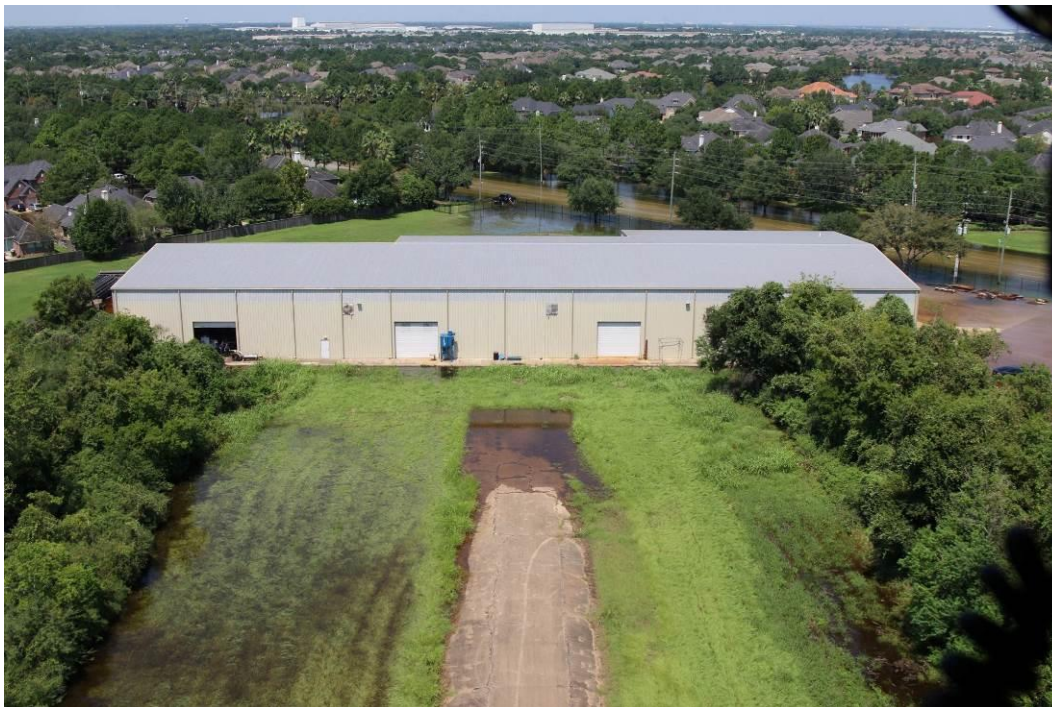
High water in the Addicks Reservoir (~33.3 m [~El. 109.1 ft]) exceeded the elevation of the level ground at the end of the north auxiliary spillway RCC (~El. 108), resulting in small outflows (~6 m<sup>3</sup>/s [~200 cfs]) that began on August 29, 2017. Figure 8 shows this area on September 7, 2017 when some small spillage was still taking place. These outflows were within the design intent of the dam and the auxiliary spillway, and should not be described as dam overtopping. Overtopping implies that the water levels have risen above the main dam, which is typically a serious condition that can lead to rapid erosion of the dam and a dam failure.

*Figure 8. North end of Addicks auxiliary spillway (September 3, 2017, 29.84977° N, 95.58904° W, photo by USACE).*

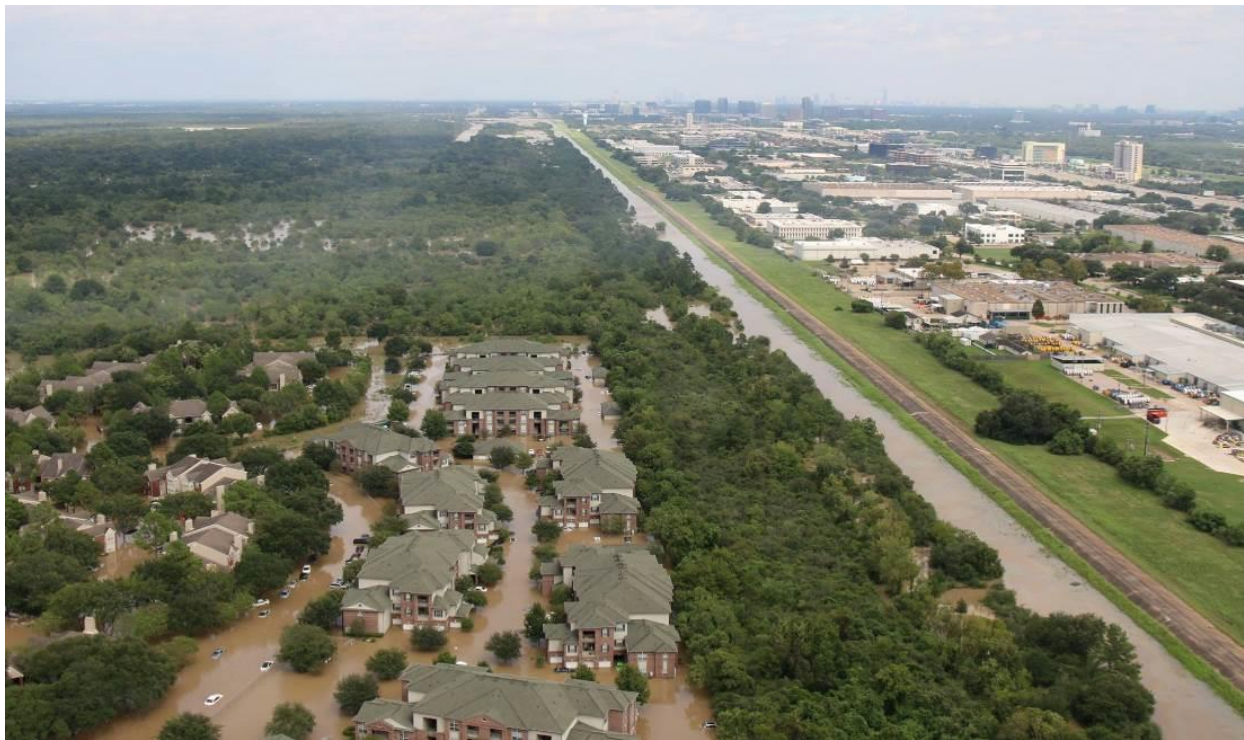
The high-water levels in the Addicks (El. 33.3 m [El. 109.1 ft]) and Barker (El. 31.0 m [El. 101.6 ft]) Reservoirs exceeded not only the April 2016 historic high levels (El. 31.3 m [102.7 ft] at Addicks and El. 29.0 m [95.24 ft] at Barker) but also the elevations at the upstream edge of the USACE property. As noted previously, housing developments extended up to these boundaries and, consequently, were flooded during Harvey (see Figs. 9, 10, and 11). Area subsidence likely contributed to

*Figure 9. Aerial photograph of flooding within the Addicks Reservoir along the south auxiliary spillway (September 3, 2017, 29.79222° N, 95.68830° W, USACE photograph).*

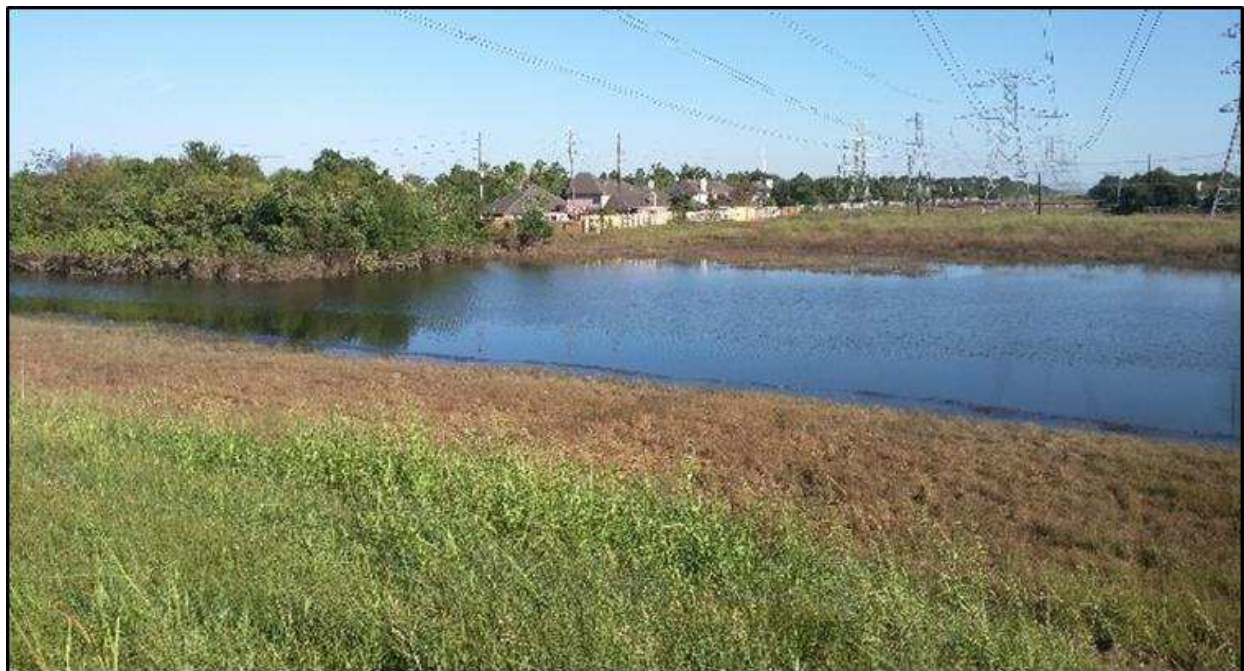
*Figure 10. Flooded residential area in the southwest corner of the Barker Dam (September 9, 2017, 29.70706° N, 95.72835° W).*

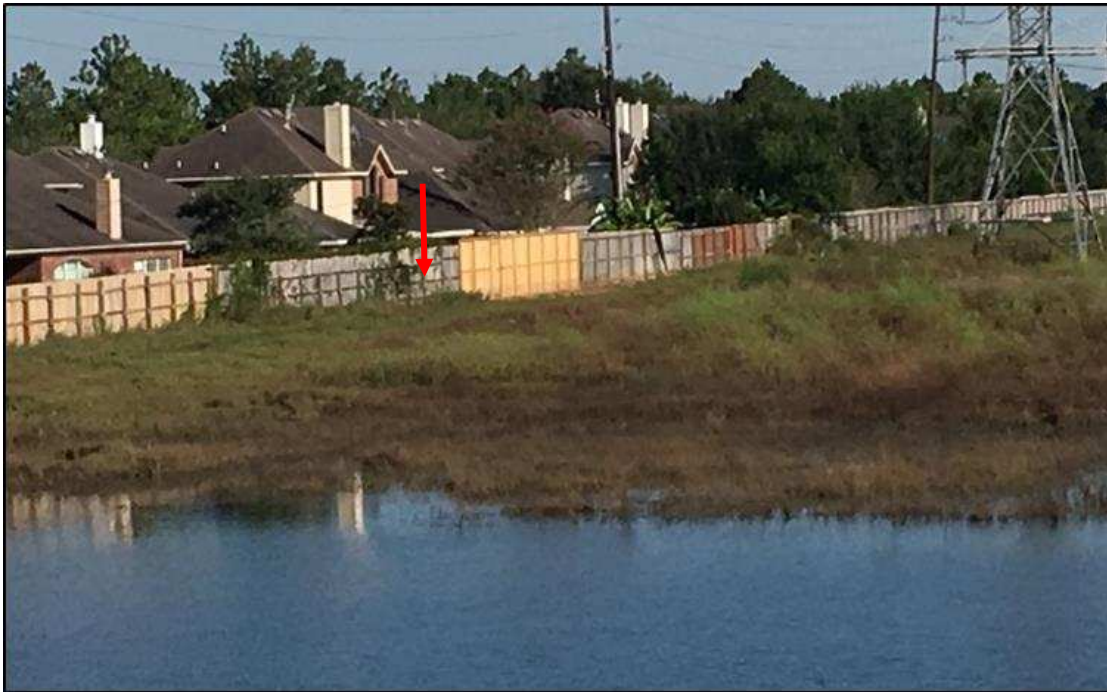
*Figure 11. High water mark on fences surrounding residential area (September 9, 2017, 29.70706° N, 95.72835° W).*

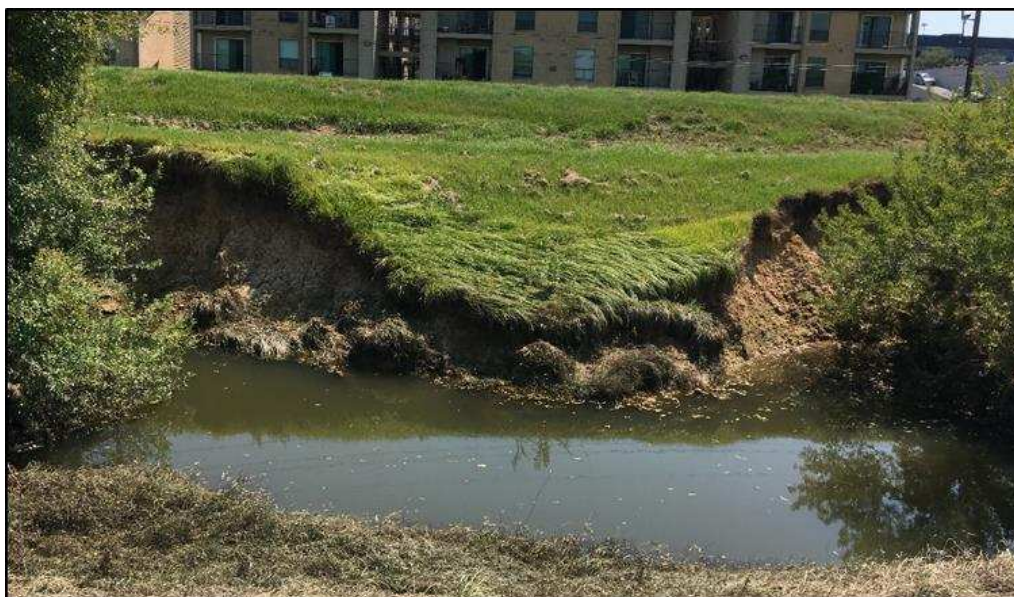
Nearby runoff that is not captured by the dams is managed in drainage ditches or creeks immediately adjacent to the dams' downstream toes. These drainage channels, along with numerous other stormwater / flood management features, are managed by the Harris County Flood Control District. The team observed several slope failures that will require repairs along Turkey Creek near the southeast corner of Addicks Dam (see Figure 12). Contributing factors to the sloughs could have included the steepness of the banks, flow forces acting on trees on the banks or diverted by trees in the waterway, undercutting by flood flows, reduced shear strength in the clay soils, and the drawdown of the creek water level.

*Figure 12. Slope failures along Turkey Creek drainage ditch (September 9, 2017, 29.79009° N, 95.59639° W).*

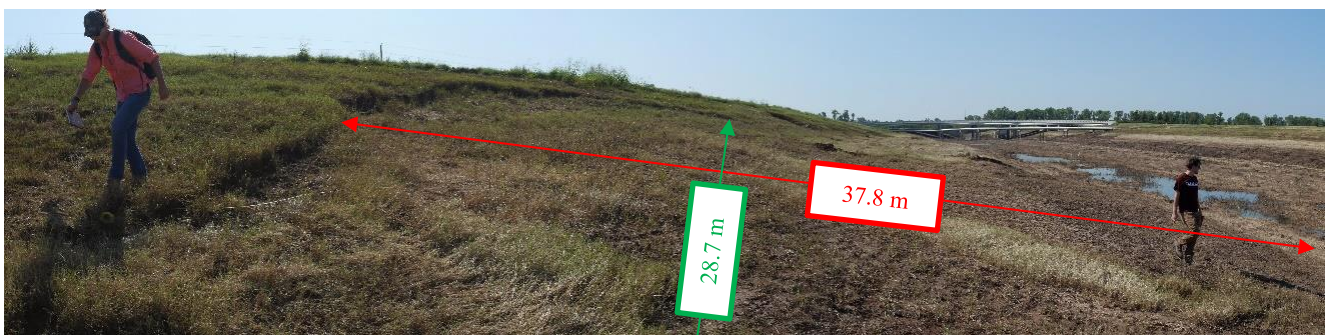
The team observed several slope failures or sloughs along the slopes of Ditch H and numerous feral hog burrows. The east side slopes had some scarps that ranged in height from 15 to 99 cm (6 to 39 inches). Figs. 18 and 19 show two of the sloughs. The slope failures were likely due to softening of the clay soils by the flooding and the subsequent increases in stress on the slope due to drawdown of the flood water. Leakage from either an intact or ruptured CMP could have also contributed to one of the slope failures. The team also observed an erosion gully below a drainage outfall on the University Avenue bridge (Fig. 20), which could have been prevented with hardened material protection (e.g., riprap, concrete blocks) below the outfall.

Figure 18. Ditch H levee, dimensioned slope failure (September 10, 2017, 29.55797°N, 95.63792°W).

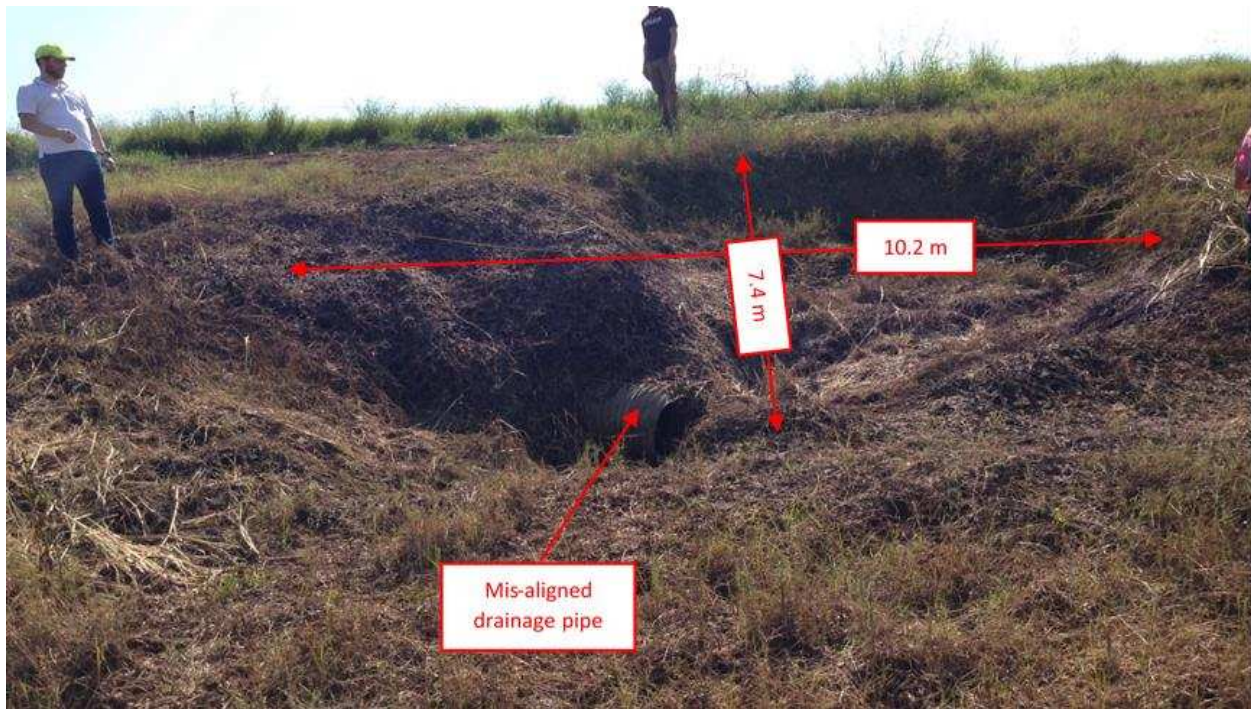
Figure 19. Sour hole at ruptured drainage pipe on Ditch H levee (September 10, 2017, 29.55759°N, 95.63768°W).

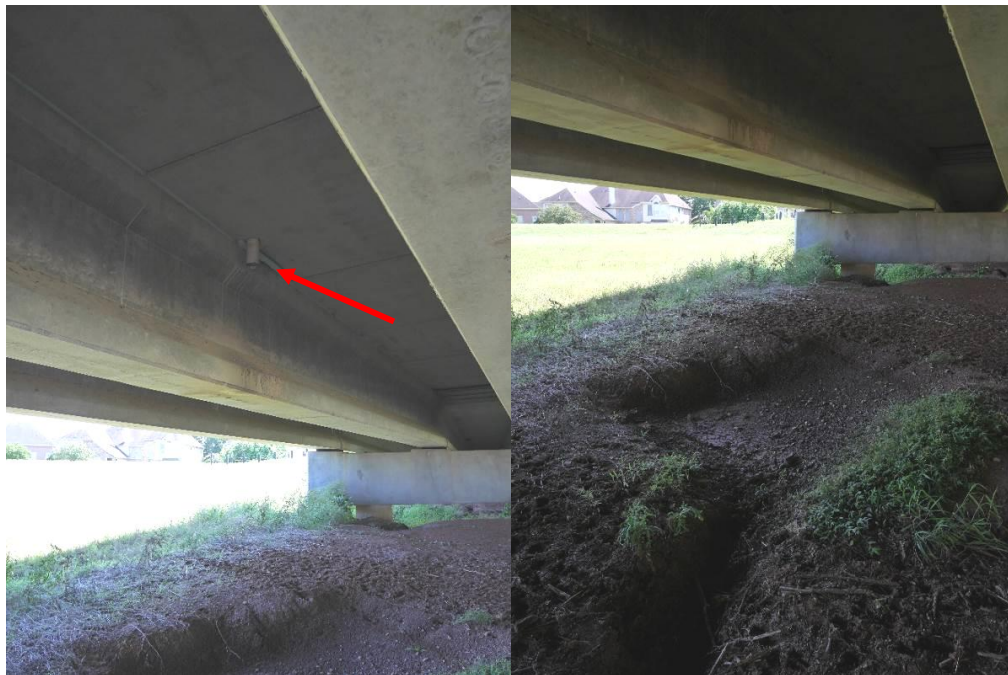
Figure 20. Erosion on Ditch H levee under the University Blvd Bridge due to flow impact from bridge drainage outfall (red arrow, September 10, 2017, 29.55902° N, 95.63744° W).

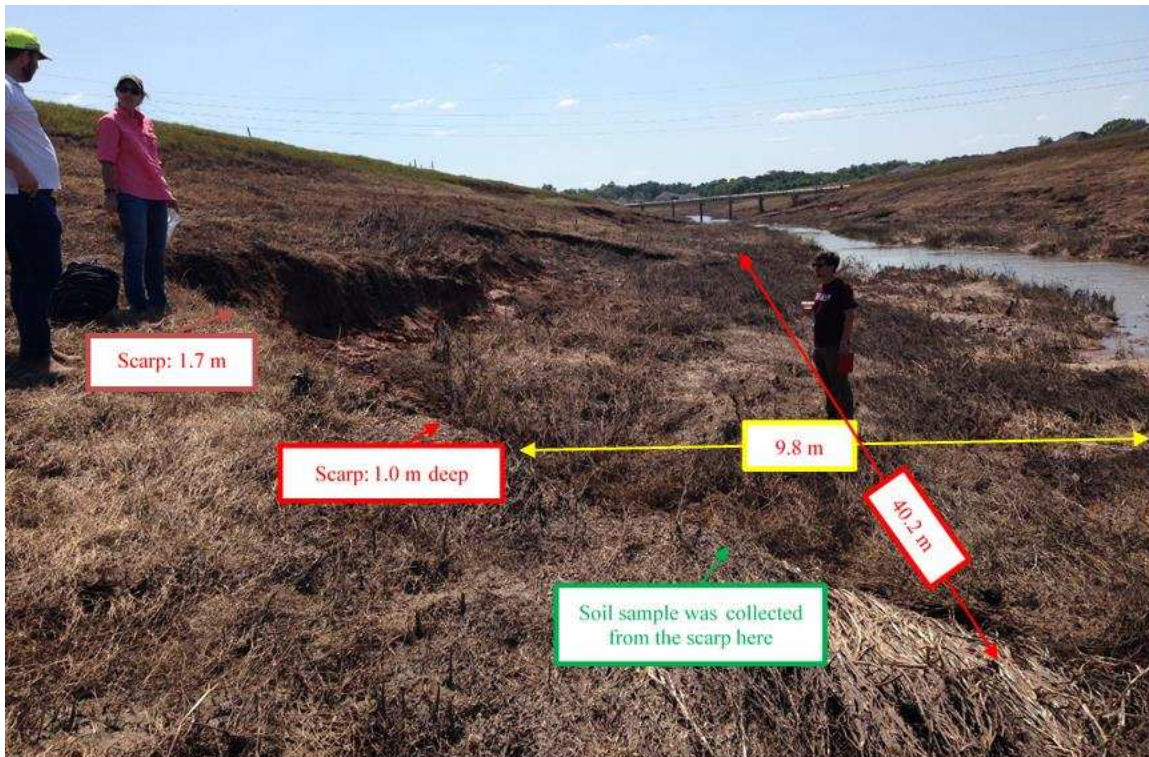
The team observed numerous slope failures along the Flat Bank Diversion Channel (see Fig. 13 for location) between 29.53103° N, 95.56200° W and 29.52572° N, 95.56201° W. Fig. 21 shows the dimensions of one large slide where the team collected a soil sample that was subsequently classified at the Kansas State University laboratory as low plasticity clay (CL) with a 21.3% moisture content. The team noted a drainage CMP outfall on an intact portion of the slope adjacent to this slide and another slide to the south. Figure 22 shows another embankment slough that extended into the base channel.

Figure 21. Slope failure north of damaged drainage pipe on the east side of ditch (September 10, 2017, 29.52647°N 95.56194°W),

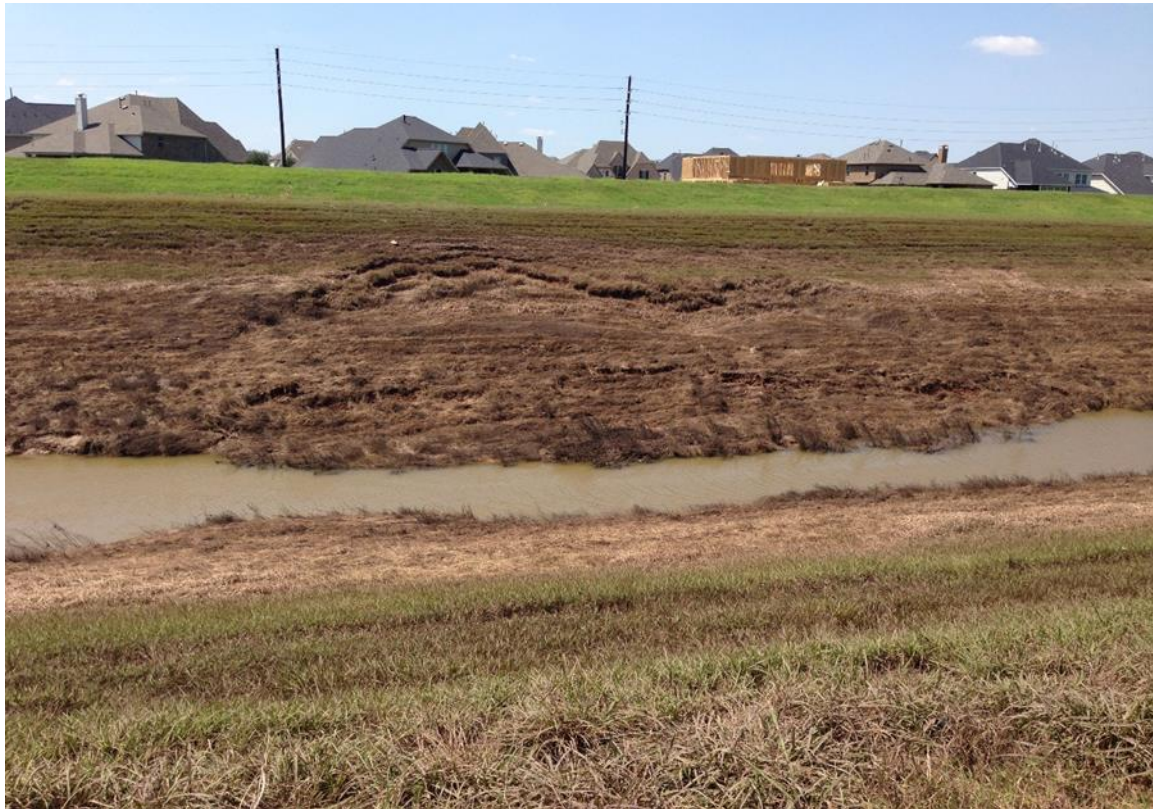
Figure 22. Earth slumping on the west side embankment (September 10, 2017, 29.53103° N, 95.56200° W).

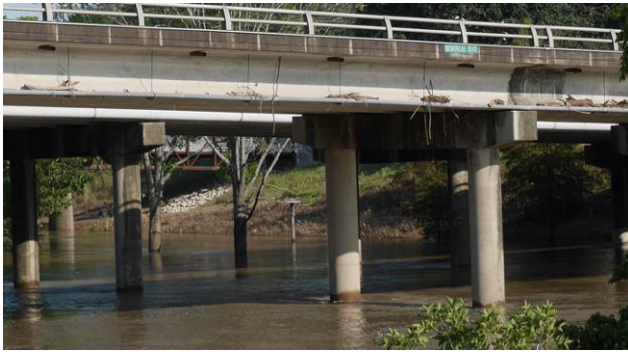
Figure 24. Buffalo Bayou evidence of bridge overtopping (flood debris:) a) Montrose Bridge (September 9, 2017, 29.76307° N 95.39377° W), and b) Memorial Bridge (September 9, 2017, 29.76219° N 95.38425° W).

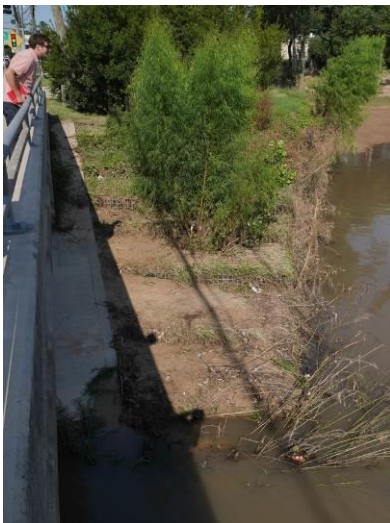
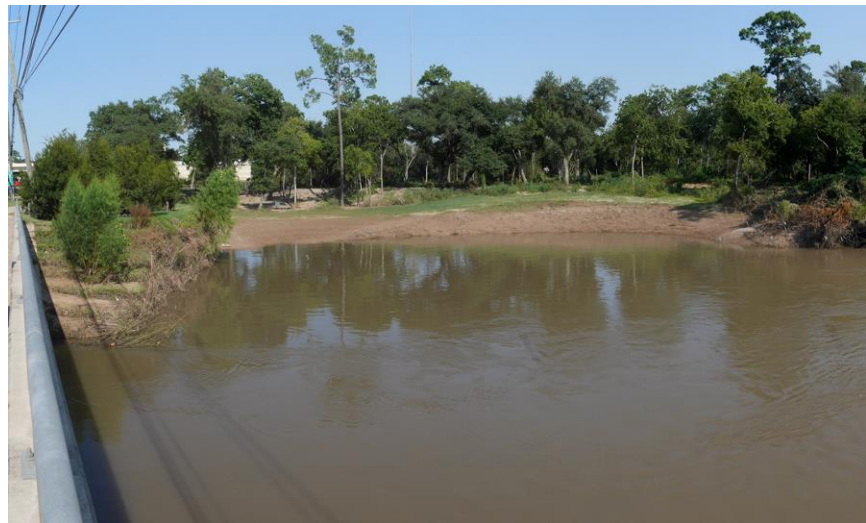
Upon arrival of the GEER team at sites along Buffalo Bayou on September 9, 2017, the observed flows in the bayou were about  $210 \text{ m}^3/\text{s}$  (7,300 cfs) at the USGS Addicks gauge. Flooding of residential areas had been largely reduced by September 9, though much of the former parks and trails along the bayou were still inundated with water. Signs of the previous flooding could be seen with river debris noted on bridge girder and railings (see Fig. 24). No critical geotechnical failures were noted along the observed portions of Buffalo Bayou, but scour areas and a slope failure were observed (see Figs. 25 and 26).

Figure 25. Buffalo Bayou evidence of scour a) Bridge abutment, and b) Downstream of Woodway Drive Bridge (September 9, 2017, 29.76457° N 95.45815° W).

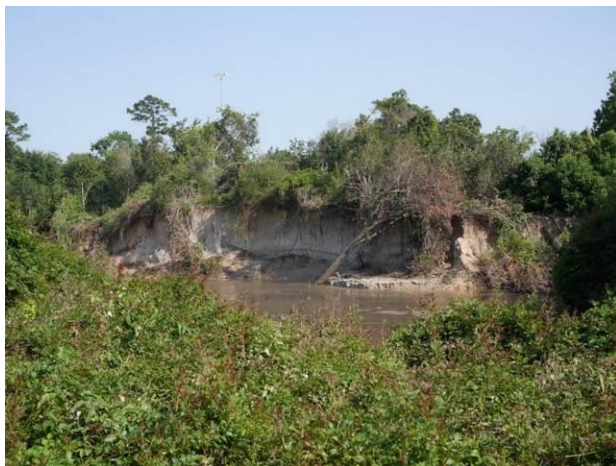
Figure 26. Buffalo Bayous slope failures (September 9, 2017, 29.76318° N, 95.45945° W).

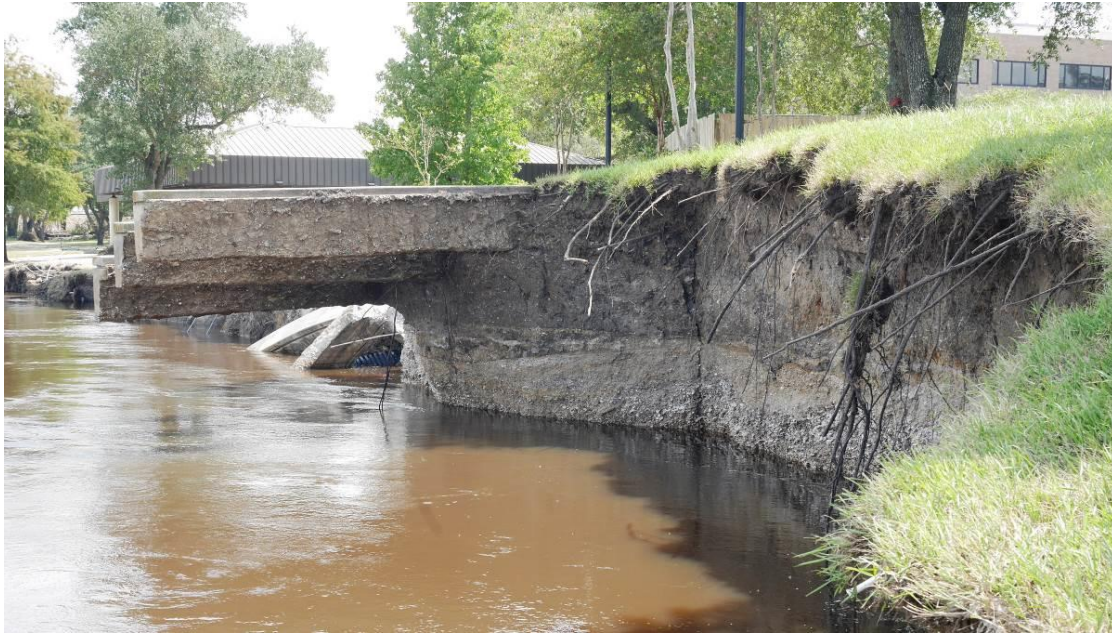
Figs. 29 and 30 show the loss of shoreline and scarps left by the Neches River erosion of the park shoreline, starting from an upstream section protected by riprap and extending through the downriver port area. The pre-hurricane park area shoreline was fronted with a riverwalk/dock (see aerial on Fig. 28), which was largely washed out. Based on pre-hurricane aerials on Google Earth, the shoreline had eroded up to about 15 m (50 ft) from the previous shoreline.

*Figure 29. Scour under amphitheater structure. Scarp is estimated to be about 12 m (40 ft) back from previous shoreline (September 11, 2017, 30.08334° N, 94.09441° W).*

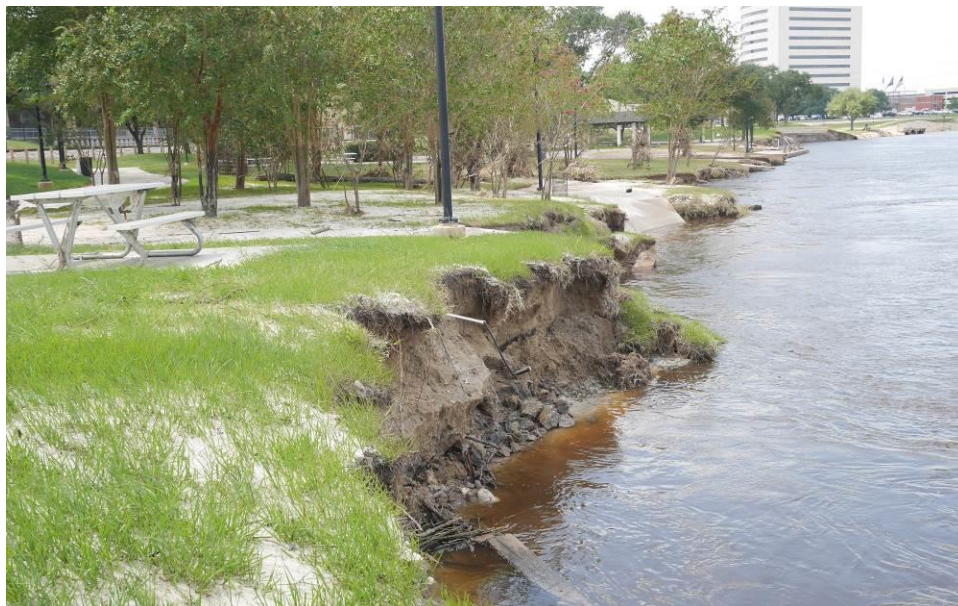
*Figure 30. Downstream end of park. Scarp is estimated to be about 10.7 m (35 ft) back from previous shoreline (September 11, 2017, 30.08184° N, 94.09278° W).*

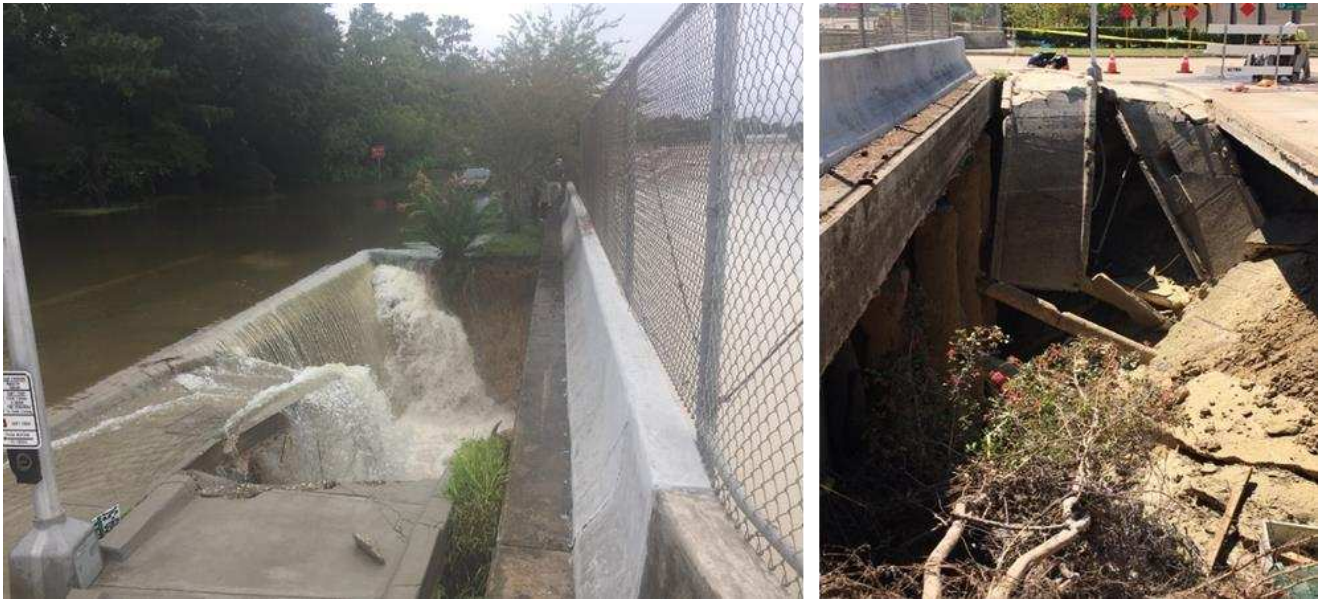
The roadway damage consisted of an uplifted road slab (or slabs) on Beltway 8 and a washout of the adjacent access road, West Sam Houston Parkway N, which is supported about 6.7 m (22 ft) above the parkway by a cantilevered retaining wall consisting of precast panels, which are supported by H-pile reinforced concrete piers. It appears that flood water from the area west of the parkway flooded the access road, drained down behind the retaining wall, and uplifted the Beltway 8 slabs. These flows then washed out soil behind the wall and under the access road and adjacent sidewalk, leaving a 5 m- (17 ft) deep hole. Fig. 32 photographs show the state of the damaged roadway during and after the flooding event. Fig. 33 shows repair work conducted on the uplifted slabs.

Figure 32. Damage of the walkway slab on Beltway 8 (left photo courtesy Brian Klein, a resident in the area, August 27, 2017, and right photo courtesy of a construction worker on site, 29.76735° N, 95.56219° W).

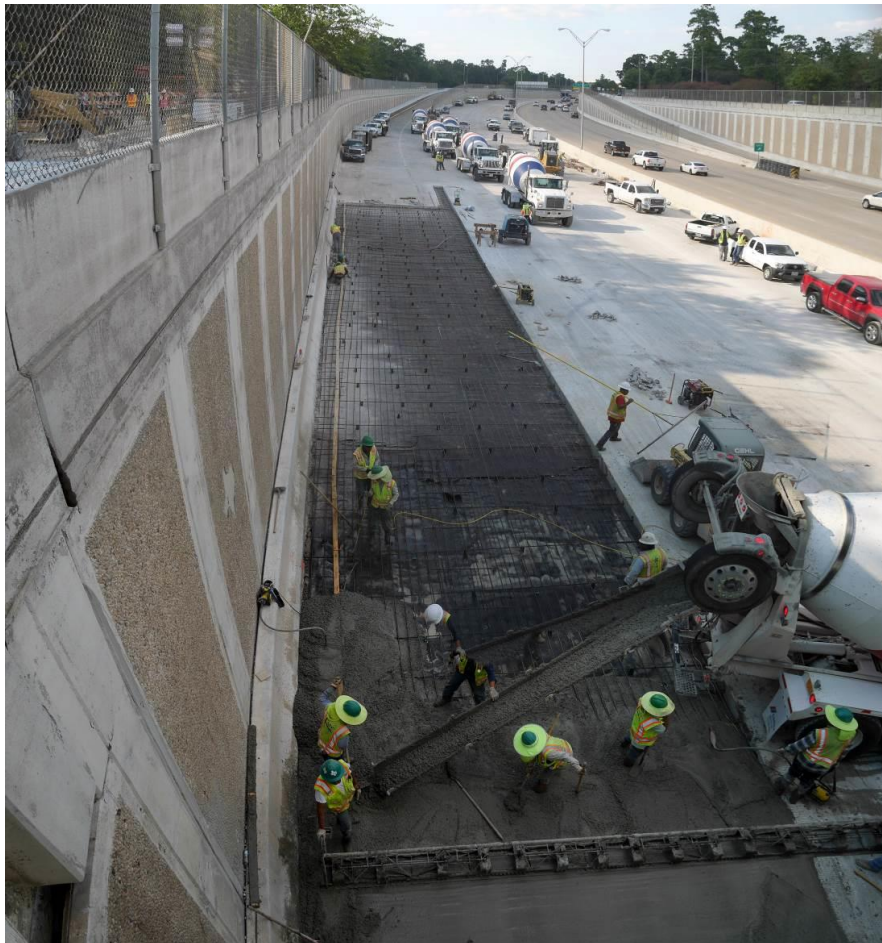
Figure 33. Road pavement repair in progress on Beltway 8 (September 10, 2017, 29.76736° N, 95.56208° W).

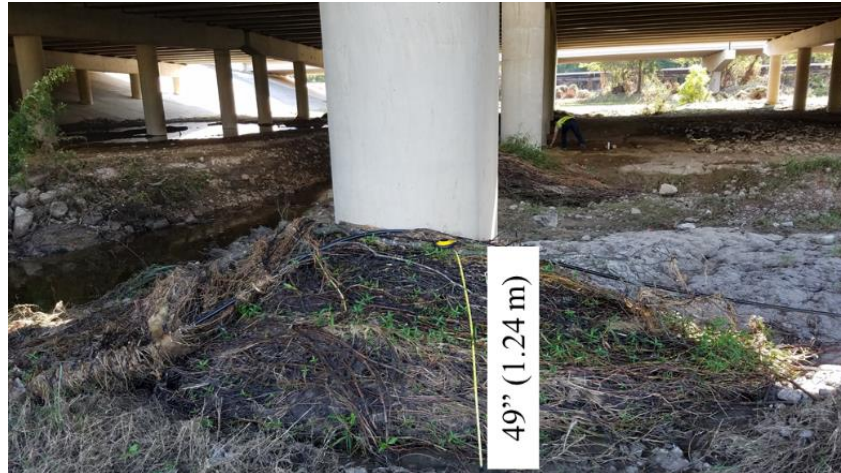
As expected, bridge columns with no erosion control had variable amounts of accumulated debris (see Fig. 35) and scour (see Figs. 36 & 37). No measurable scour was observed around columns with erosion control (see Fig. 38), which included riprap and polymeric reinforcement. Fig. 40 shows the bank of the San Jacinto River from the north side, facing south. The riprap along the banks likely reduced the erosion of the fine, sandy soil. Fig. 41 shows an observed 2.4-m- (8-ft-) diameter scour hole in the sandy bank material. Despite the observed scour, no geotechnical or structural failures were observed on the I-45 Bridge over the San Jacinto River.

Figure 35. Observed debris on first column in flow direction. Debris pile is 1.24 m (49 inches) tall around the 1-m- (3-ft-) diameter bridge column (September 11, 2017, Time 10:04 CDT, 30.24688° N, 95.45796° W).

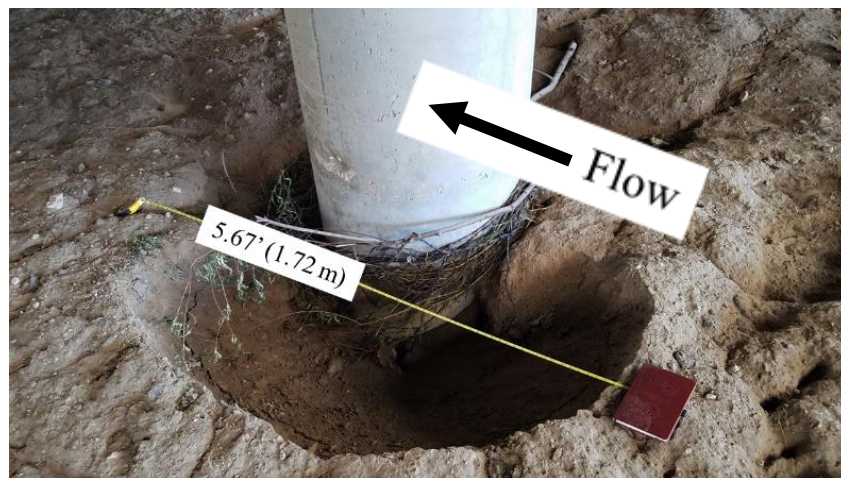
Figure 36. Bridge column scour (September 11, 2017, Time 10:06 CDT, 30.24688° N, 95.45796° W).

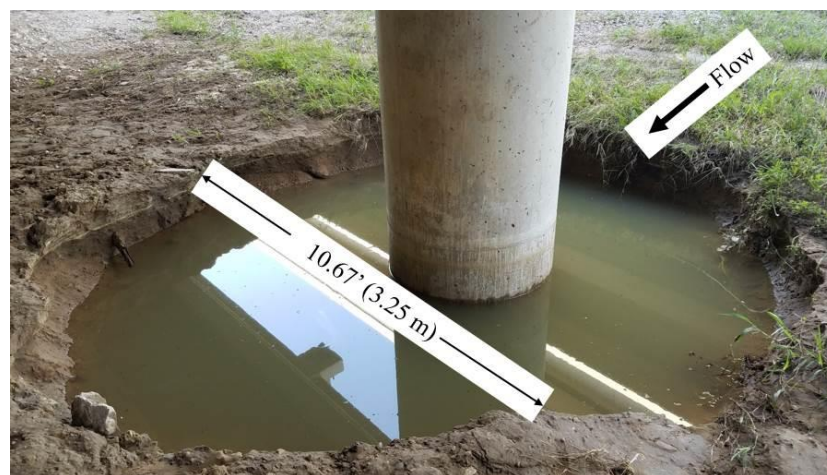
Figure 37. Scour hole on column closer to river. The hole was 3.7 m (12.3 ft) long in the flow direction and 3.25 m (10.67 ft) perpendicular to flow. The depth of the scour hole was 0.8 m (2.75 ft) from the existing ground (September 11, 2017, Time 10:23 CDT, 30.25071° N, 95.45703° W).

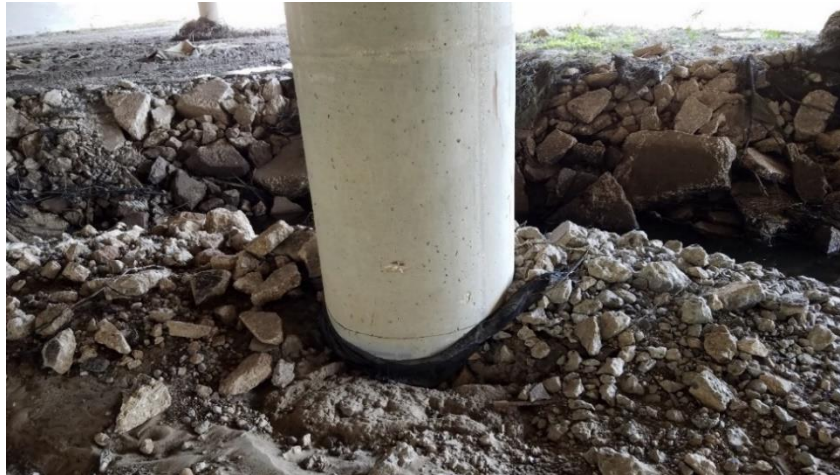
Figure 38. Erosion control riprap, including polymeric reinforcement, with minimal observed scour (September 11, 2017, Time 10:19 CDT, 30.24688° N, 95.45796° W).

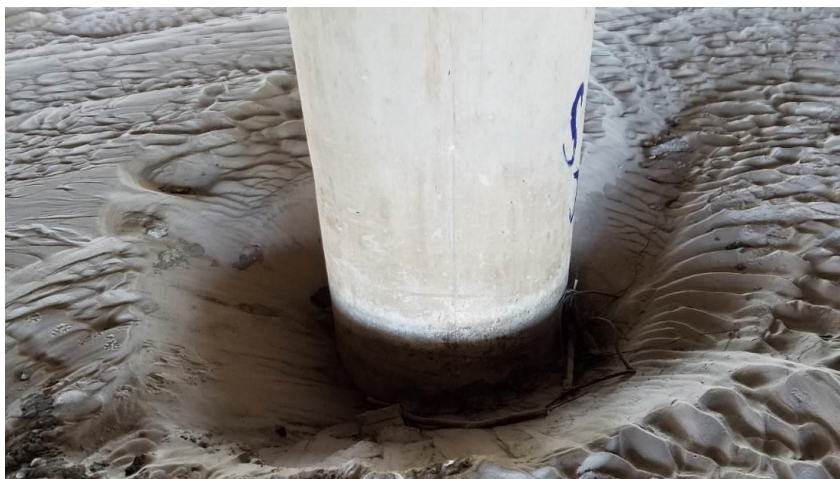
Figure 40. Scour around columns on San Jacinto Banks (sandy soil). The scour hole was approximately 2.4 m (8 ft) across and 0.6 m (2 ft) deep (September 11, 2017, Time 10:59 CDT, 30.243364°N, 95.46452°W).

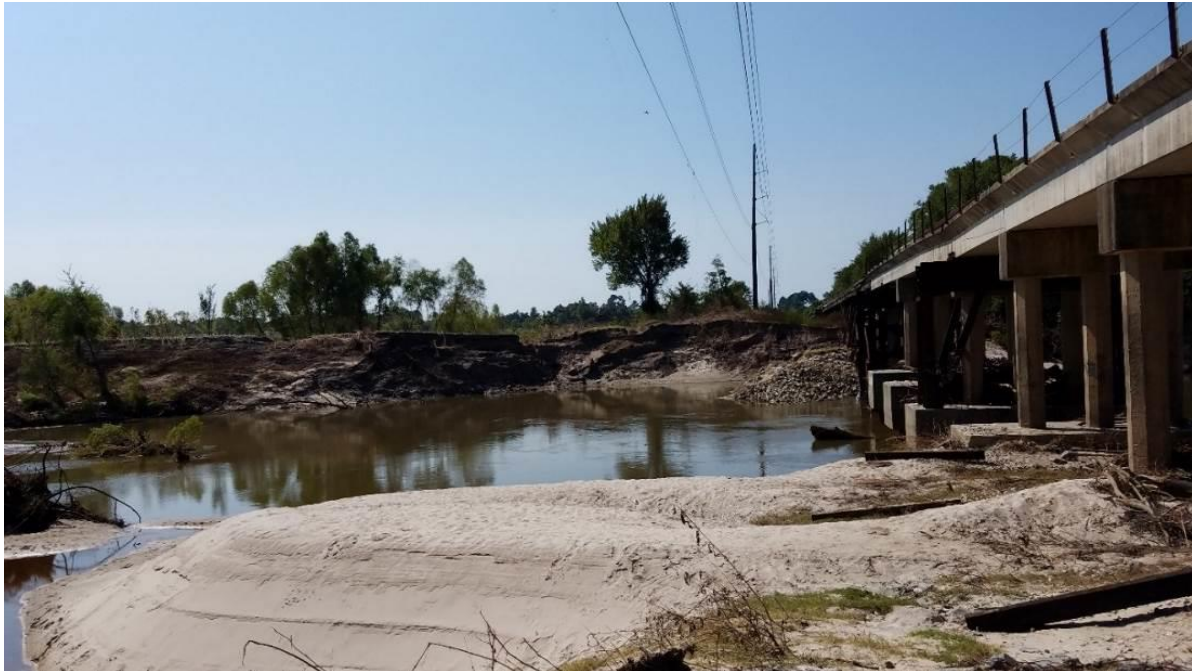
Figs. 41 and 42 show the Missouri Pacific Rail Road Bridge downstream of I-45. Bank erosion was noted on the south bank of the San Jacinto River downstream of the railroad bridge. Fig. 42 shows debris on top of the pile caps and at the top of the bents on the railroad bridge. These high debris levels were consistent with the maximum measured gauge height during Harvey of approximately 10 m (33 ft) above average gauge height.

*Figure 41. Bank erosion on the San Jacinto River downstream of I-45 and a railroad bridge parallel to the highway (September 11, 2017, Time 11:05 CDT, 30.24688° N, 95.45796° W).*

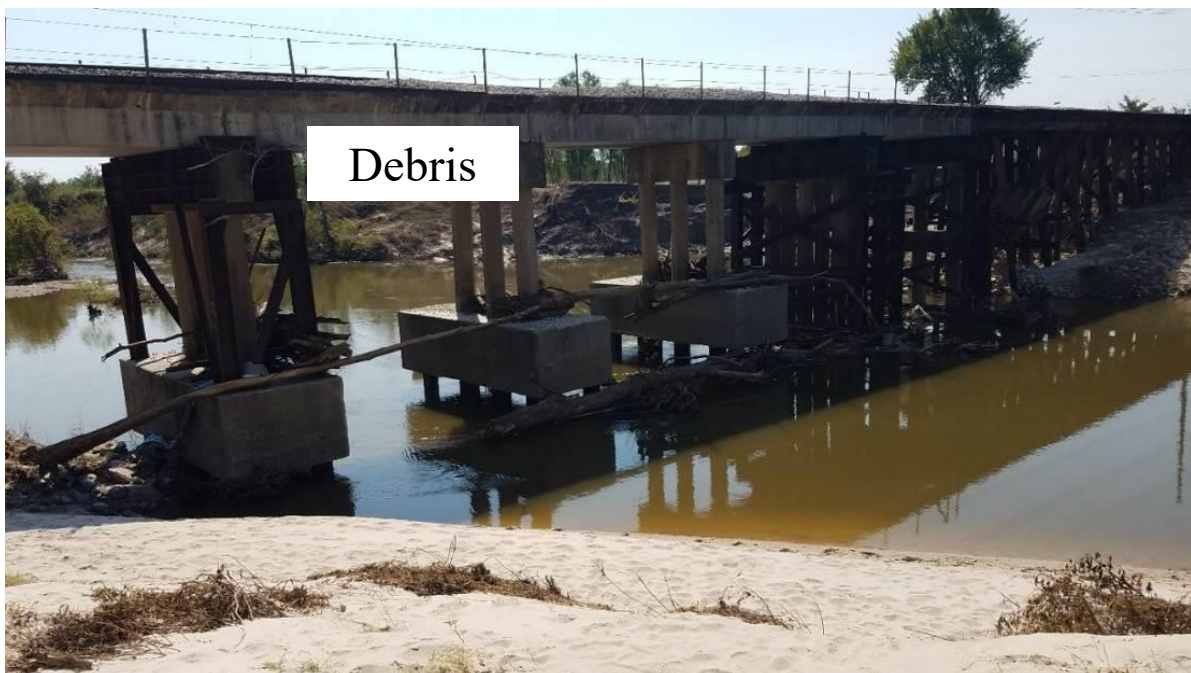
*Figure 42. Debris on railroad bridge indicating flow levels and scour around pile caps below current flow levels (September 11, 2017, Time 11:10 CDT, 30.24688° N, 95.45796° W).*

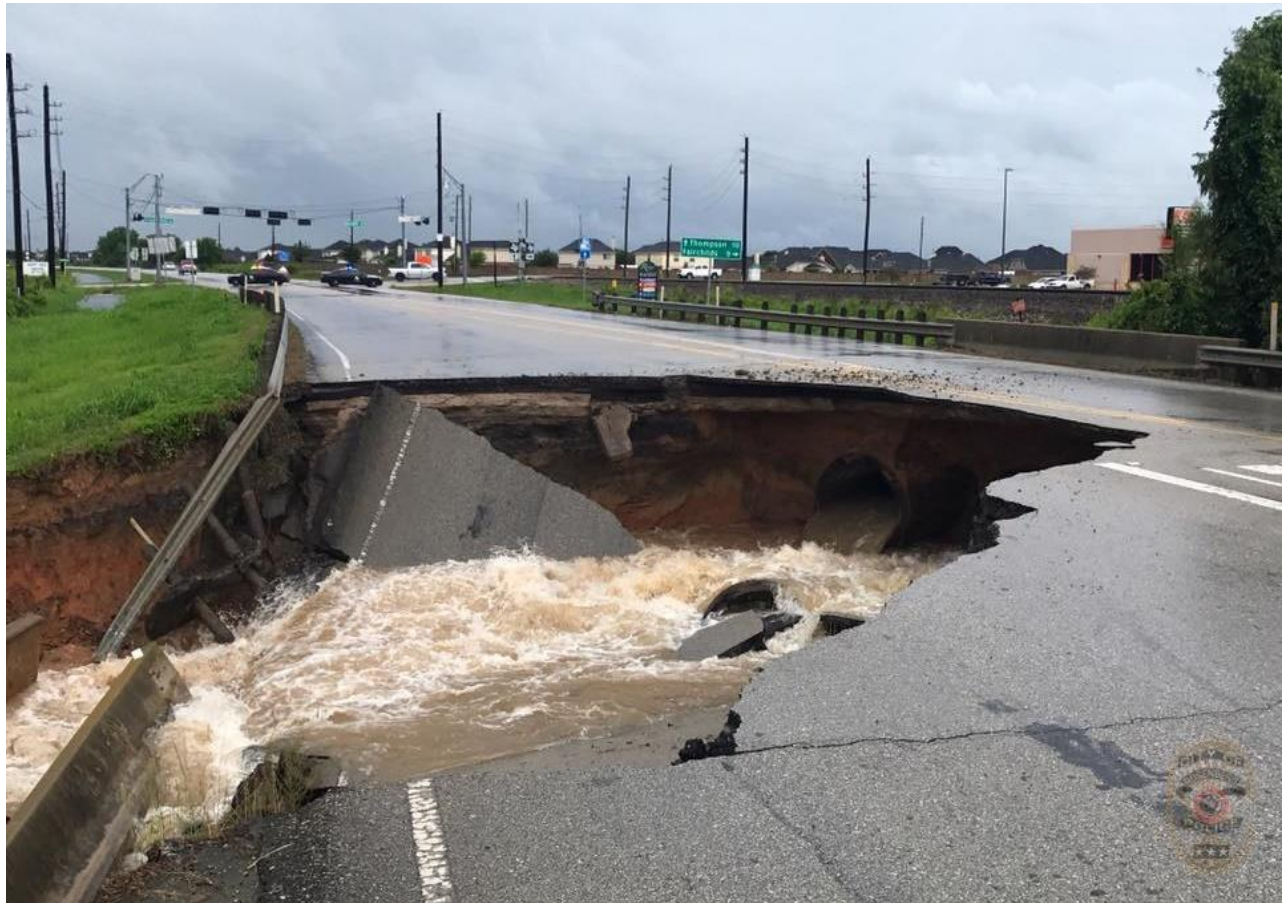
Erosion of the road progressed from the downstream side (see Fig. 43) until the entire width of the road washed out, stopping within 18 m (60 ft) of the adjacent railroad tracks. Repair construction was underway at the time of our visit. Possible erosion mechanisms could have included overtopping flow, culvert leakage or failure, or embankment seepage.

*Figure 43. FM 762 Washout on August 27, 2017  
(Courtesy of the Rosenberg Police Department, 29.5442° N, 95.7434° W).*

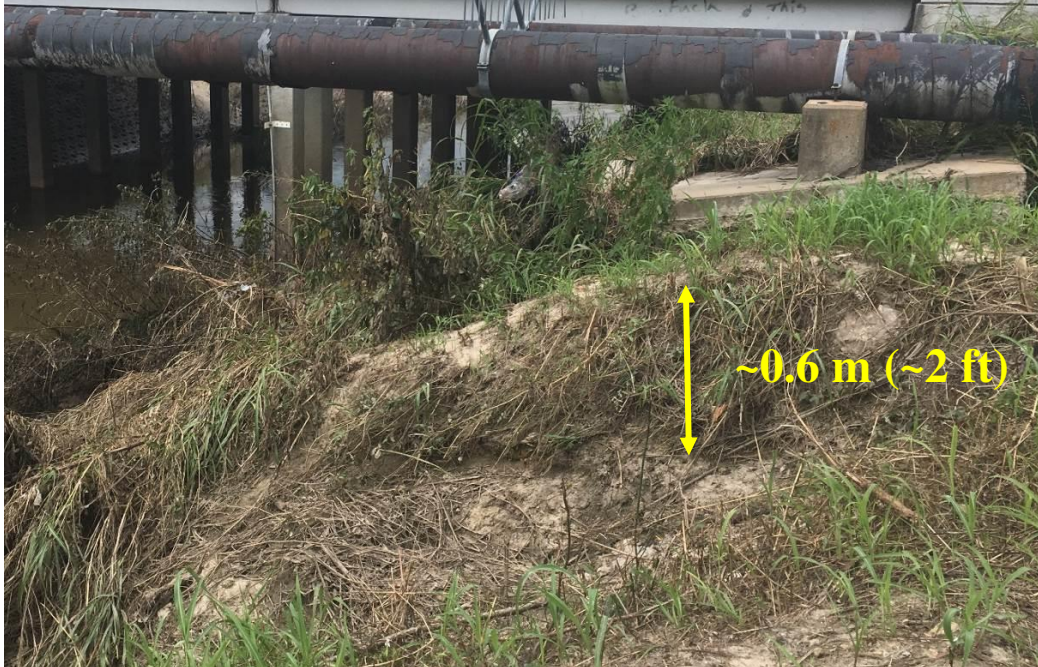
The erosion at the State Highway 35 Bypass bridge and pipe crossing over Mustang Bayou in the city of Alvin (see Fig. 1 for location) was typical for small waterways with high flow. Two shallow soil slump failures with slip depths of about 0.3 to 0.6 m (1 to 2 ft) were noted along the north bank of the bayou, one of which was beside and under a pipeline pile cap (Fig. 44).

Figure 44. Shallow soil failure along the north bank of Mustang Bayou, adjacent to pipe-support foundation (September 4, 2017, Time 12:48 CDT, 29.40889° N, 95.23234° W).

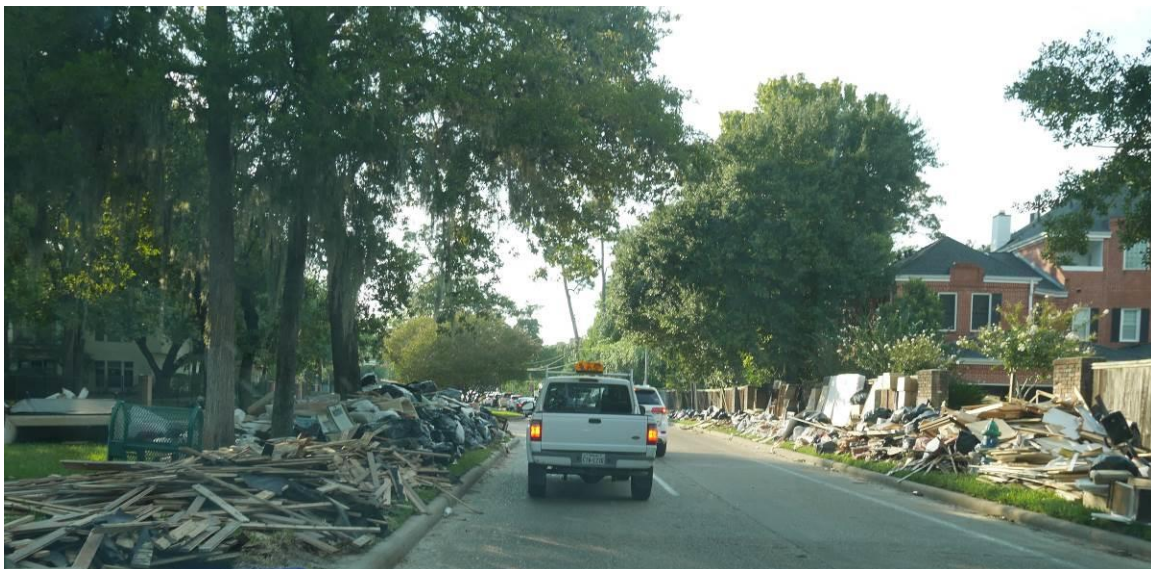
Figure 45. Residential flood damage debris, Houston.

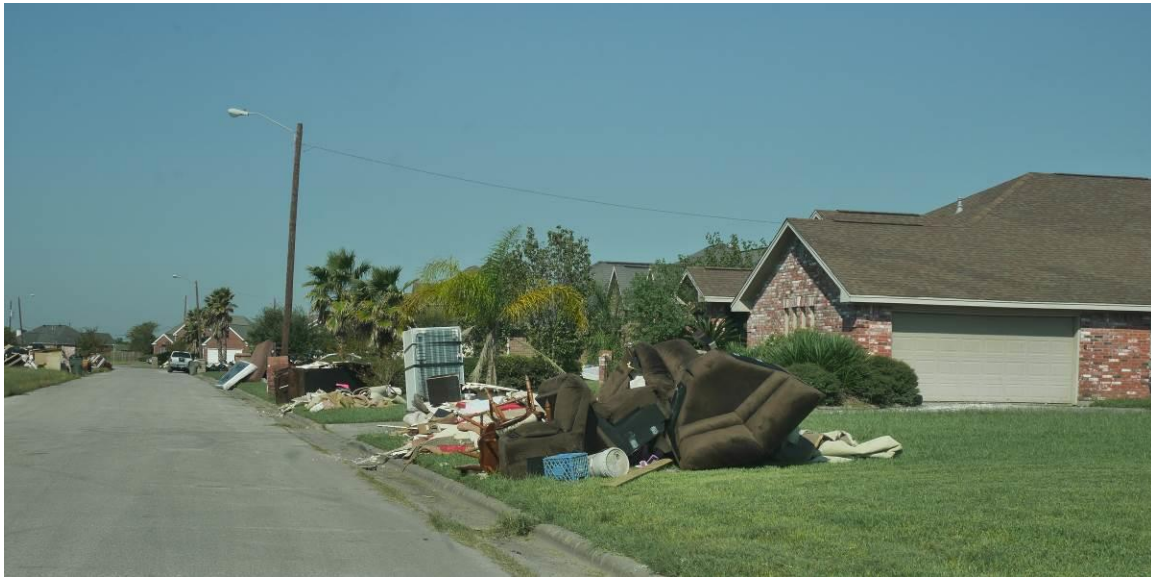
*Figure 46. Residential flood damage debris, Port Arthur.*
