Geotechnical Effects of Hurricane Harvey in the Houston, Beaumont, and Port Arthur Areas

ABSTRACT: *The Geotechnical Extreme Events Reconnaissance (GEER) Association deployed multiple teams of engineers from academia and practicing firms to the coast of Texas in late August and early September 2017 following Hurricane Harvey. This report summarizes the observations and data from the GEER team that focused primarily on the inland effects of Hurricane Harvey in the Houston area with some observations in the Port Arthur / Beaumont area east of Houston. Rain, not storm surge or wind, caused the observed damage in Houston, Beaumont, and Port Arthur by overwhelming stormwater management facilities and creating high flows and flooding in and near area waterways. The major Houston-area flood structures, Addicks and Barker Dams, performed well from a geotechnical perspective. Observed damages included shallow slides along levees, severe erosion along riverways, isolated road and culvert erosion and uplift, and area-wide flood effects in low and poorly drained neighborhoods.*

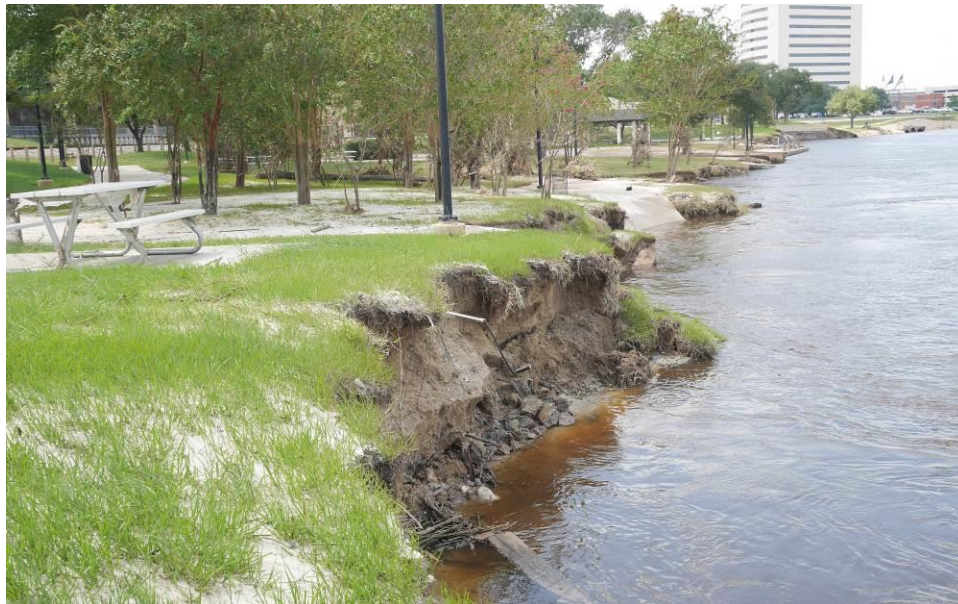
Figs. 29 and 30 show the loss of shoreline and scarps left by the Neches River erosion of the park shoreline, starting from an upstream section protected by riprap and extending through the downriver port area. The pre-hurricane park area shoreline was fronted with a riverwalk/dock (see aerial on Fig. 28), which was largely washed out. Based on pre-hurricane aerials on Google Earth, the shoreline had eroded up to about 15 m (50 ft) from the previous shoreline.

Figure 30. Downstream end of park. Scarp is estimated to be about 10.7 m (35 ft) back from previous shoreline (September 11, 2017, 30.08184° N, 94.09278° W).
