## Geotechnical Effects of Hurricane Harvey in the Houston, Beaumont, and Port Arthur Areas

**ABSTRACT:** *The Geotechnical Extreme Events Reconnaissance (GEER) Association deployed multiple teams of engineers from academia and practicing firms to the coast of Texas in late August and early September 2017 following Hurricane Harvey. This report summarizes the observations and data from the GEER team that focused primarily on the inland effects of Hurricane Harvey in the Houston area with some observations in the Port Arthur / Beaumont area east of Houston. Rain, not storm surge or wind, caused the observed damage in Houston, Beaumont, and Port Arthur by overwhelming stormwater management facilities and creating high flows and flooding in and near area waterways. The major Houston-area flood structures, Addicks and Barker Dams, performed well from a geotechnical perspective. Observed damages included shallow slides along levees, severe erosion along riverways, isolated road and culvert erosion and uplift, and area-wide flood effects in low and poorly drained neighborhoods.*

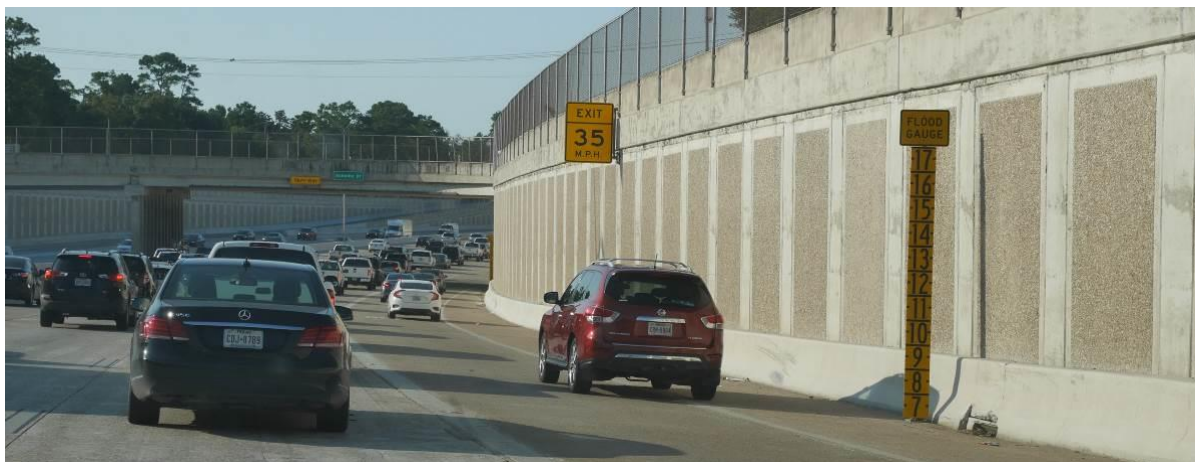
Flooding caused roadway damage to and closure of a major area artery at the underpass intersection of the Sam Houston Parkway / Beltway 8 and Boheme Drive (see Fig. 1 for location, 29.76736° N, 95.56210° W). The parkway is depressed at this intersection and floods often enough that flood depth sign gauges are posted along the road to warn motorists of the standing water depth (see Fig. 31).

Figure 31. Beltway 8 / Boheme Drive underpass and flood depth signs (September 11, 2017, 29.76694° N, 95.56139° W).

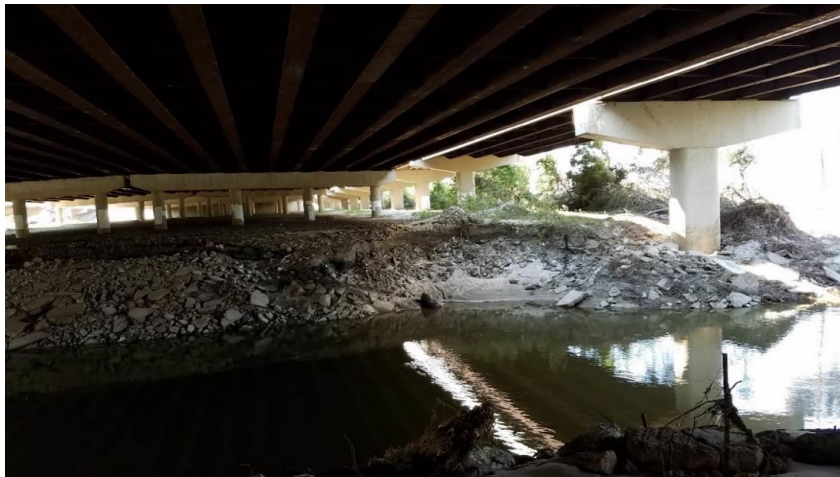
Figure 39. Riprap along south bank of San Jacinto River (September 11, 2017, Time 10:56 CDT, 30.24574° N, 95.45761° W).
