Geotechnical Effects of Hurricane Harvey in the Houston, Beaumont, and Port Arthur Areas

ABSTRACT: The Geotechnical Extreme Events Reconnaissance (GEER) Association deployed multiple teams of engineers from academia and practicing firms to the coast of Texas in late August and early September 2017 following Hurricane Harvey. This report summarizes the observations and data from the GEER team that focused primarily on the inland effects of Hurricane Harvey in the Houston area with some observations in the Port Arthur / Beaumont area east of Houston. Rain, not storm surge or wind, caused the observed damage in Houston, Beaumont, and Port Arthur by overwhelming stormwater management facilities and creating high flows and flooding in and near area waterways. The major Houston-area flood structures, Addicks and Barker Dams, performed well from a geotechnical perspective. Observed damages included shallow slides along levees, severe erosion along riverways, isolated road and culvert erosion and uplift, and area-wide flood effects in low and poorly drained neighborhoods.

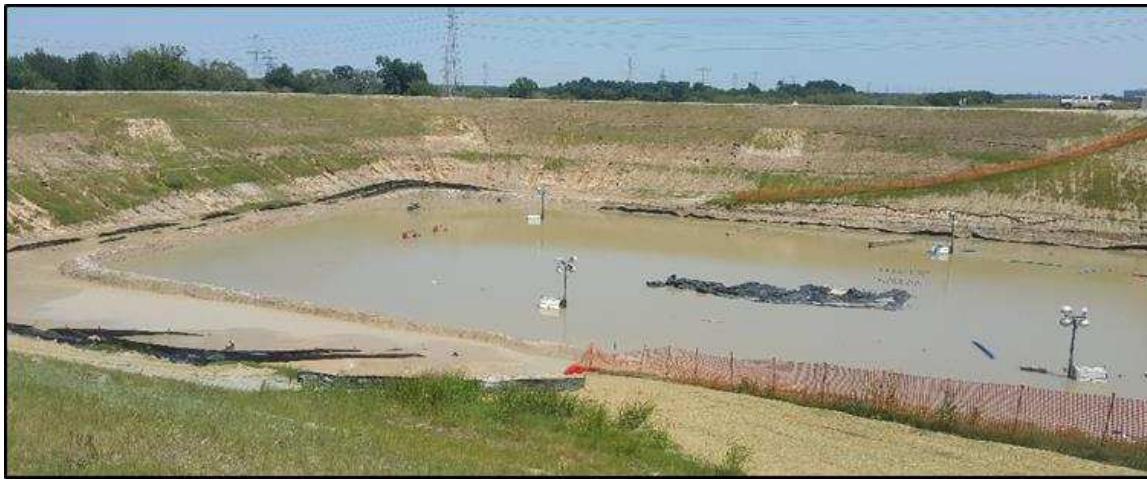
The USACE had contracted to construct new outlet structures and cutoff walls at each dam. This construction was in progress at the time of Hurricane Harvey and was suspended until the consequences of and recovery from the flooding could be assessed. At the time of the hurricane, cofferdams were in place and parts of the cutoff walls had been constructed. The cofferdams performed suitably in keeping the water in the reservoir from flooding the construction zone; however, the high backwater from the channel to Buffalo Bayou flooded the Addicks construction zone (see Fig. 7), and rainwater and underseepage pooled in the Barker cofferdammed area.

Figure 7. Interior of Addicks construction cofferdam for new outlet structure, flooded from Buffalo Bayou backwater; note erosion channels on slopes (September 9, 2017, 29.79063° N, 95.62586° W).

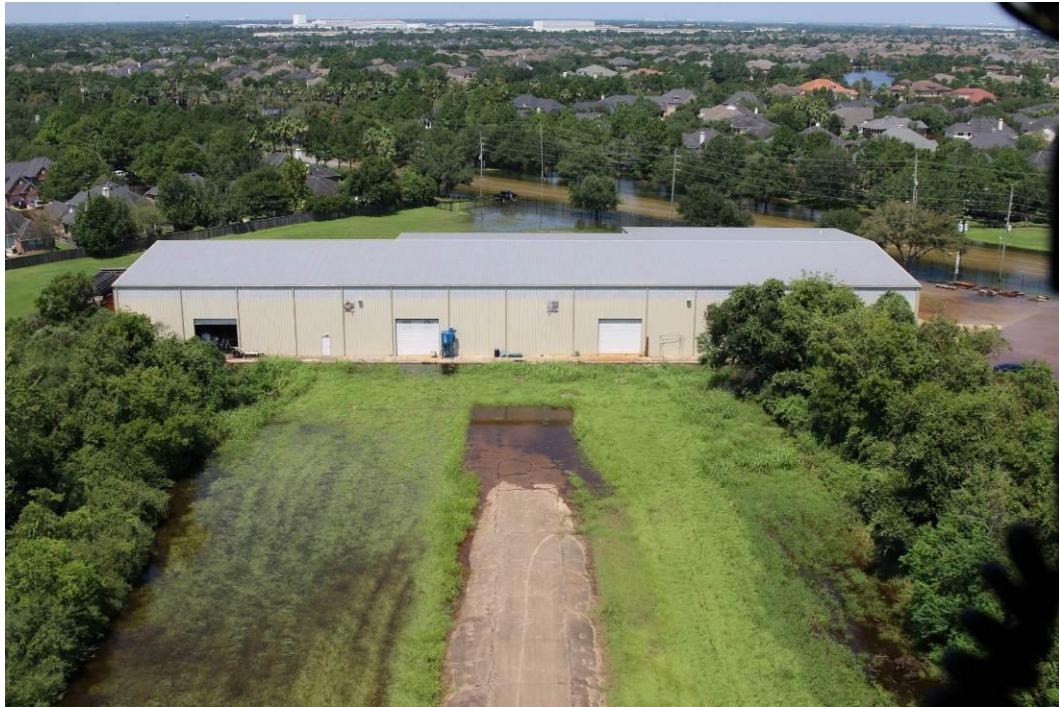
High water in the Addicks Reservoir (~33.3 m [~El. 109.1 ft]) exceeded the elevation of the level ground at the end of the north auxiliary spillway RCC (~El. 108), resulting in small outflows (~6 m³/s [~200 cfs]) that began on August 29, 2017. Figure 8 shows this area on September 7, 2017 when some small spillage was still taking place. These outflows were within the design intent of the dam and the auxiliary spillway, and should not be described as dam overtopping. Overtopping implies that the water levels have risen above the main dam, which is typically a serious condition that can lead to rapid erosion of the dam and a dam failure.

Figure 8. North end of Addicks auxiliary spillway (September 3, 2017, 29.84977° N, 95.58904° W, photo by USACE).

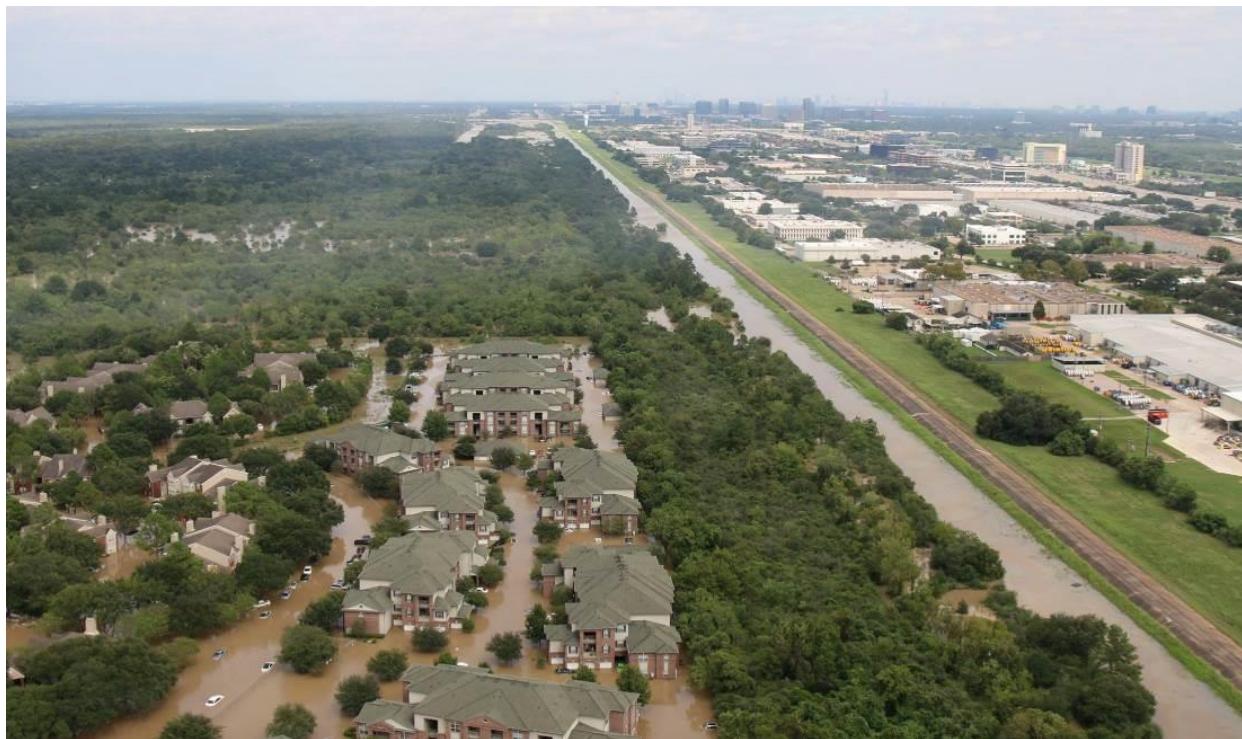
The high-water levels in the Addicks (El. 33.3 m [El. 109.1 ft]) and Barker (El. 31.0 m [El. 101.6 ft]) Reservoirs exceeded not only the April 2016 historic high levels (El. 31.3 m [102.7 ft] at Addicks and El. 29.0 m [95.24 ft] at Barker) but also the elevations at the upstream edge of the USACE property. As noted previously, housing developments extended up to these boundaries and, consequently, were flooded during Harvey (see Figs. 9, 10, and 11). Area subsidence likely contributed to

Figure 9. Aerial photograph of flooding within the Addicks Reservoir along the south auxiliary spillway (September 3, 2017, 29.79222° N, 95.68830° W, USACE photograph).

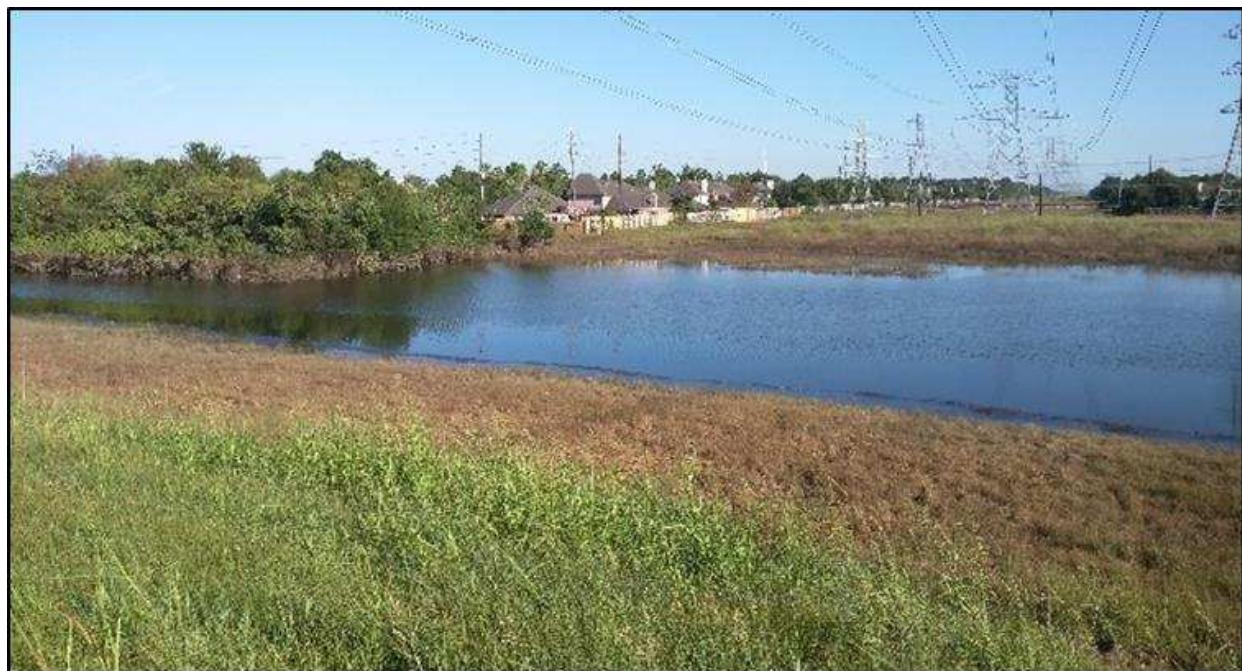
Figure 10. Flooded residential area in the southwest corner of the Barker Dam (September 9, 2017, 29.70706° N, 95.72835° W).

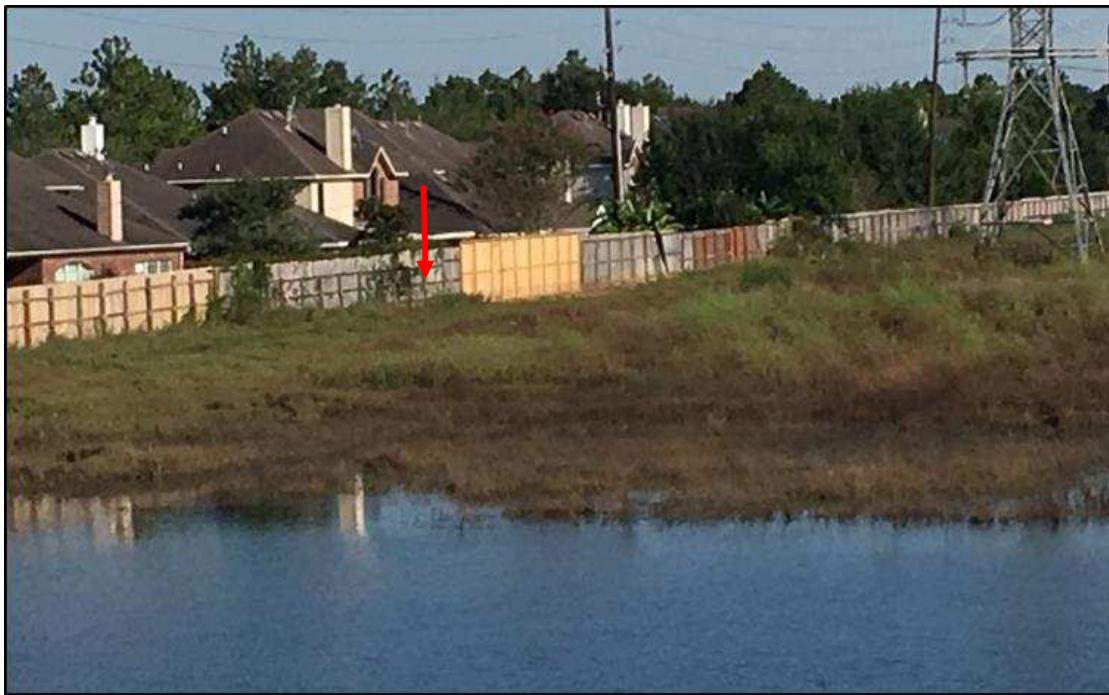
Figure 11. High water mark on fences surrounding residential area (September 9, 2017, 29.70706° N, 95.72835° W).

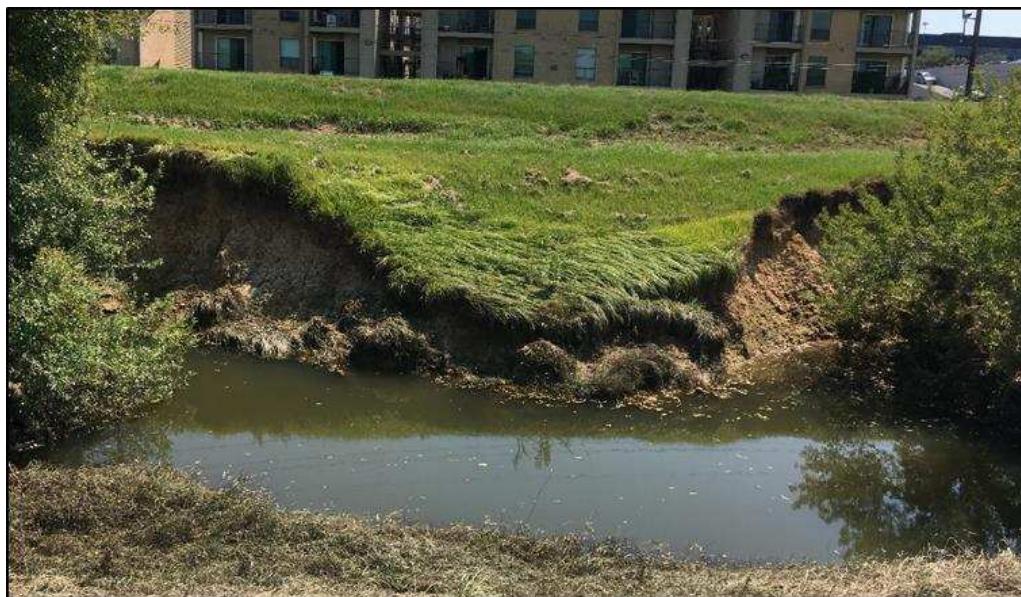
Nearby runoff that is not captured by the dams is managed in drainage ditches or creeks immediately adjacent to the dams' downstream toes. These drainage channels, along with numerous other stormwater / flood management features, are managed by the Harris County Flood Control District. The team observed several slope failures that will require repairs along Turkey Creek near the southeast corner of Addicks Dam (see Figure 12). Contributing factors to the sloughs could have included the steepness of the banks, flow forces acting on trees on the banks or diverted by trees in the waterway, undercutting by flood flows, reduced shear strength in the clay soils, and the drawdown of the creek water level.

Figure 12. Slope failures along Turkey Creek drainage ditch (September 9, 2017, 29.79009° N, 95.59639° W).

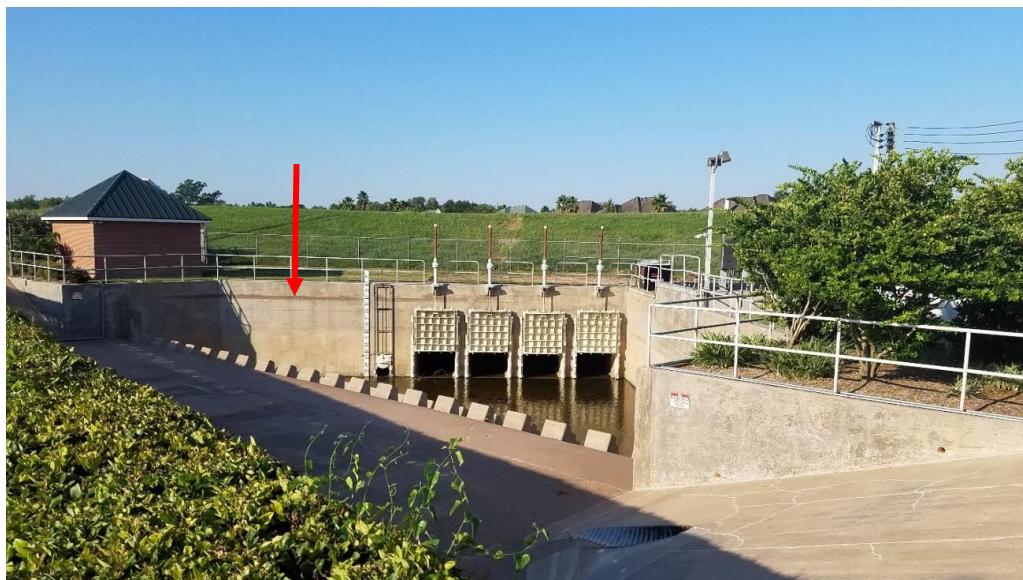
Figure 15. FCLID2 drainage outfall / pumping station basin, showing four 1.4 m (60 inch) flood gates, high water line at ~19.8 m (65 ft) gauge height, levee in background (September 10, 2017, 29.55509° N, 95.61779° W).

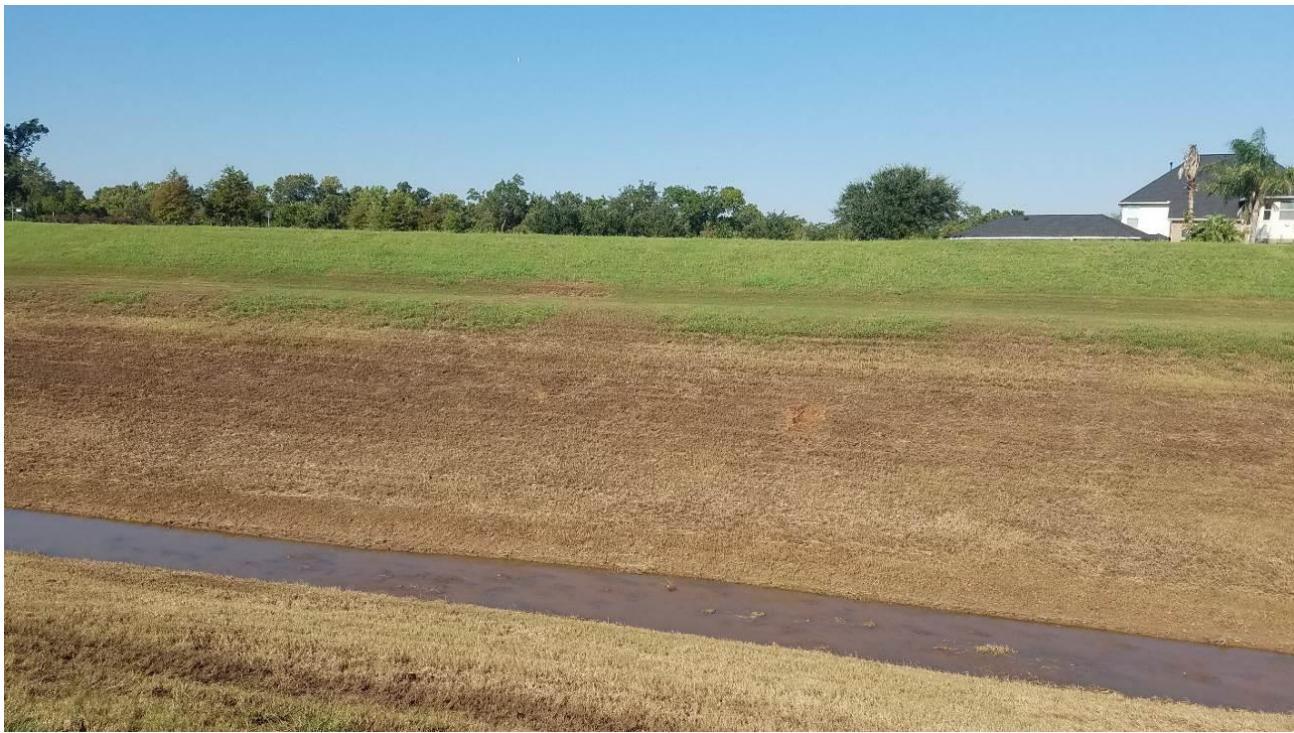
Figure 16. FCLID2 drainage ditch to Brazos River facing FBLID14 levee. High water line and persistent water lines visible on FBLID14 levee (September 10, 2017, 29.55292° N, 95.61820° W).

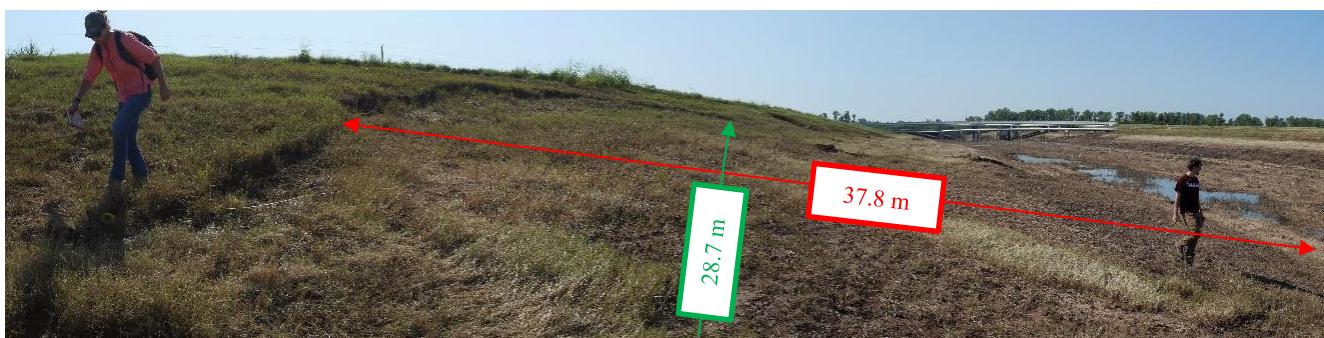
The team observed several slope failures or sloughs along the slopes of Ditch H and numerous feral hog burrows. The east side slopes had some scarps that ranged in height from 15 to 99 cm (6 to 39 inches). Figs. 18 and 19 show two of the sloughs. The slope failures were likely due to softening of the clay soils by the flooding and the subsequent increases in stress on the slope due to drawdown of the flood water. Leakage from either an intact or ruptured CMP could have also contributed to one of the slope failures. The team also observed an erosion gully below a drainage outfall on the University Avenue bridge (Fig. 20), which could have been prevented with hardened material protection (e.g., riprap, concrete blocks) below the outfall.

Figure 18. Ditch H levee, dimensioned slope failure (September 10, 2017, 29.55797°N, 95.63792°W).

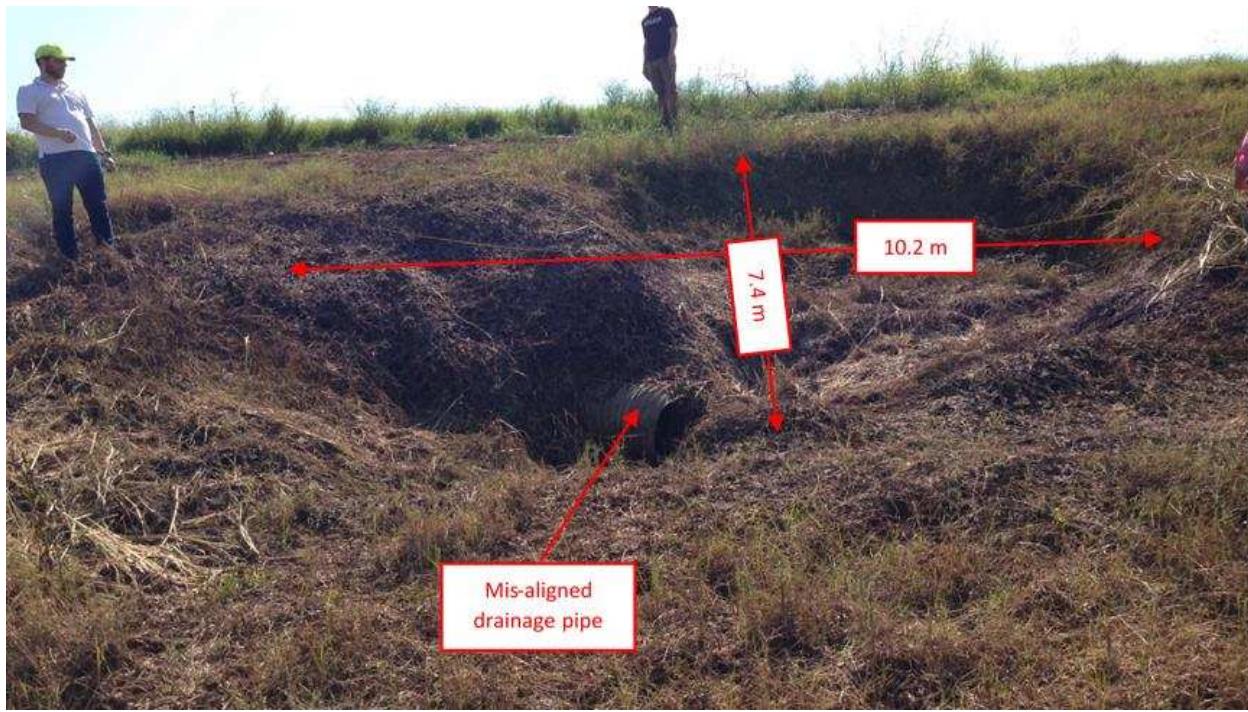
Figure 19. Sour hole at ruptured drainage pipe on Ditch H levee (September 10, 2017, 29.55759°N, 95.63768°W).

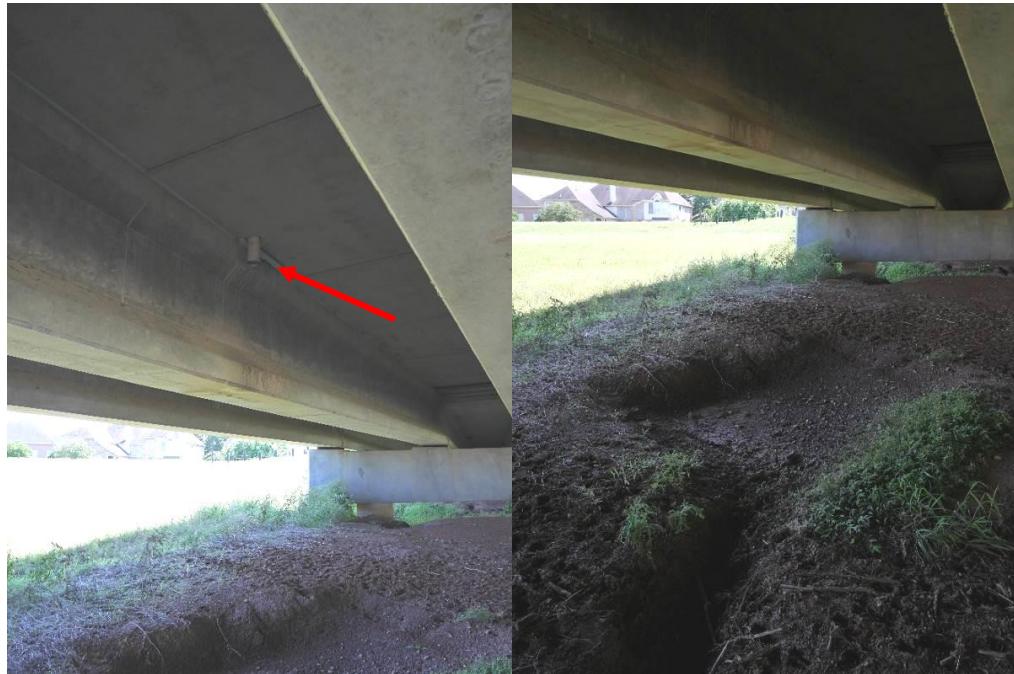
Figure 20. Erosion on Ditch H levee under the University Blvd Bridge due to flow impact from bridge drainage outfall (red arrow, September 10, 2017, 29.55902° N, 95.63744° W).

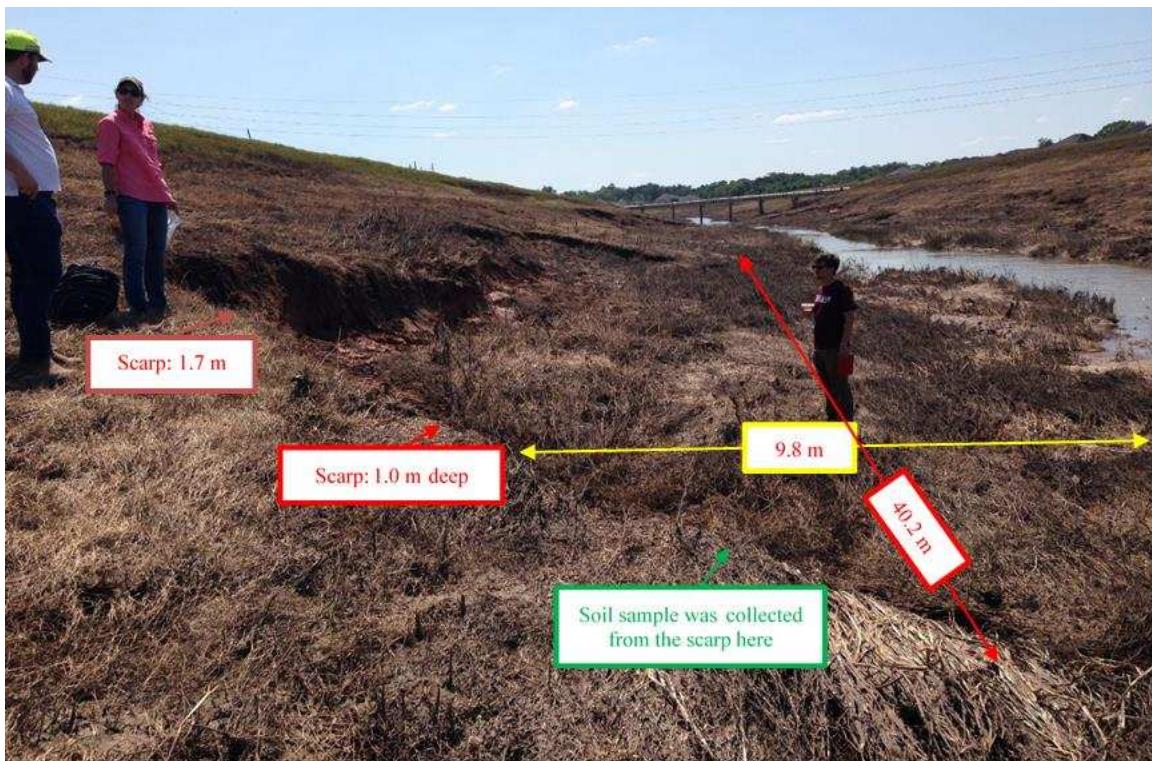
The team observed numerous slope failures along the Flat Bank Diversion Channel (see Fig. 13 for location) between 29.53103° N, 95.56200° W and 29.52572° N, 95.56201° W. Fig. 21 shows the dimensions of one large slide where the team collected a soil sample that was subsequently classified at the Kansas State University laboratory as low plasticity clay (CL) with a 21.3% moisture content. The team noted a drainage CMP outfall on an intact portion of the slope adjacent to this slide and another slide to the south. Figure 22 shows another embankment slough that extended into the base channel.

Figure 21. Slope failure north of damaged drainage pipe on the east side of ditch (September 10, 2017, 29.52647°N 95.56194°W),

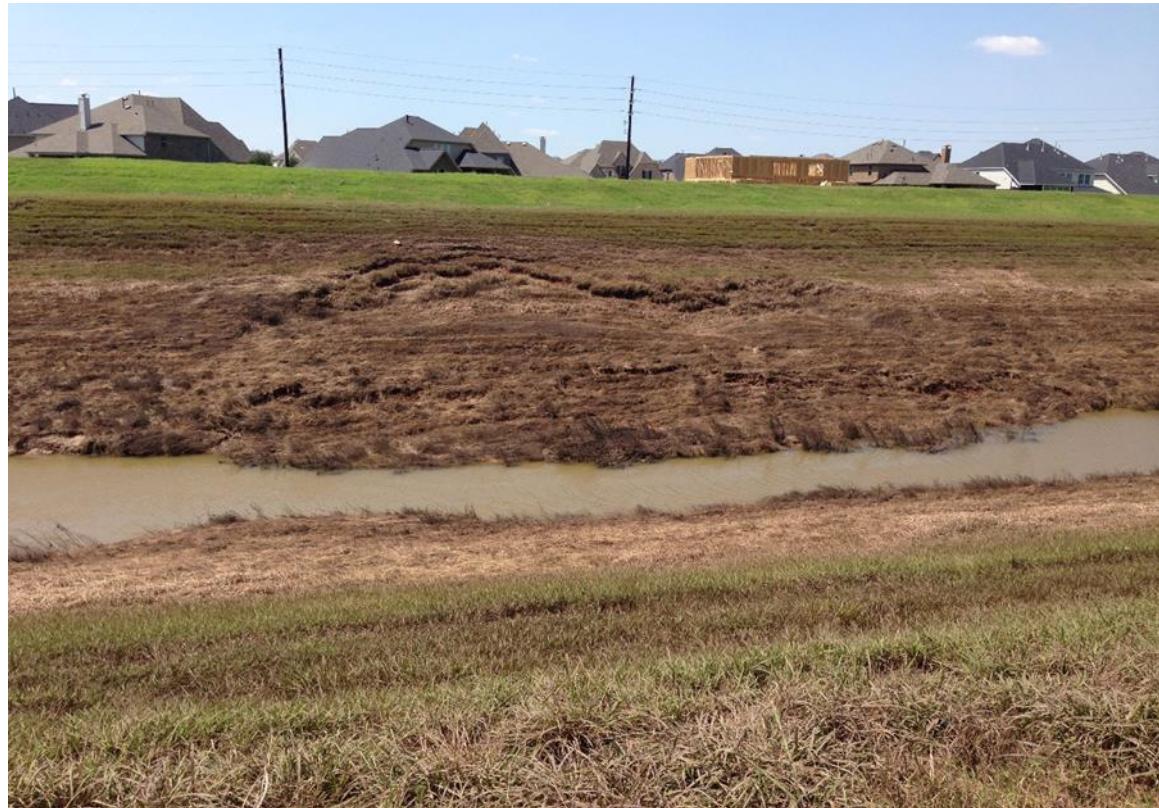
Figure 22. Earth slumping on the west side embankment (September 10, 2017, 29.53103° N, 95.56200° W).

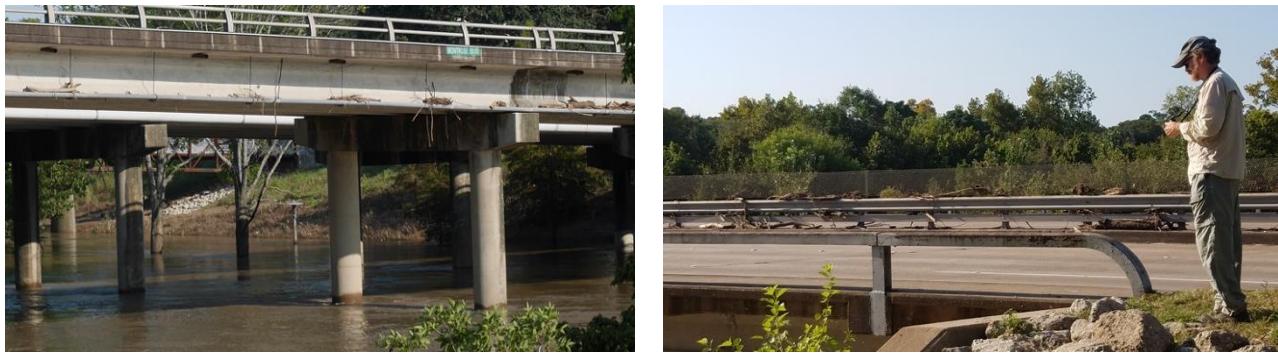
Figure 24. Buffalo Bayou evidence of bridge overtopping (flood debris:) a) Montrose Bridge (September 9, 2017, 29.76307° N 95.39377° W), and b) Memorial Bridge (September 9, 2017, 29.76219° N 95.38425° W).

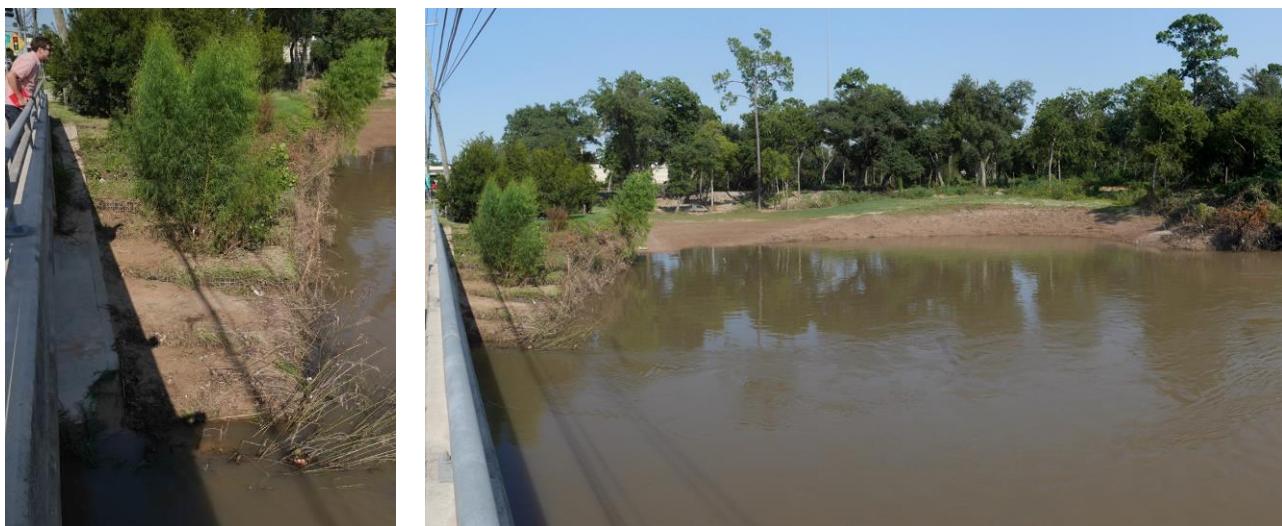
Upon arrival of the GEER team at sites along Buffalo Bayou on September 9, 2017, the observed flows in the bayou were about $210 \text{ m}^3/\text{s}$ (7,300 cfs) at the USGS Addicks gauge. Flooding of residential areas had been largely reduced by September 9, though much of the former parks and trails along the bayou were still inundated with water. Signs of the previous flooding could be seen with river debris noted on bridge girder and railings (see Fig. 24). No critical geotechnical failures were noted along the observed portions of Buffalo Bayou, but scour areas and a slope failure were observed (see Figs. 25 and 26).

Figure 25. Buffalo Bayou evidence of scour a) Bridge abutment, and b) Downstream of Woodway Drive Bridge (September 9, 2017, 29.76457° N 95.45815° W).

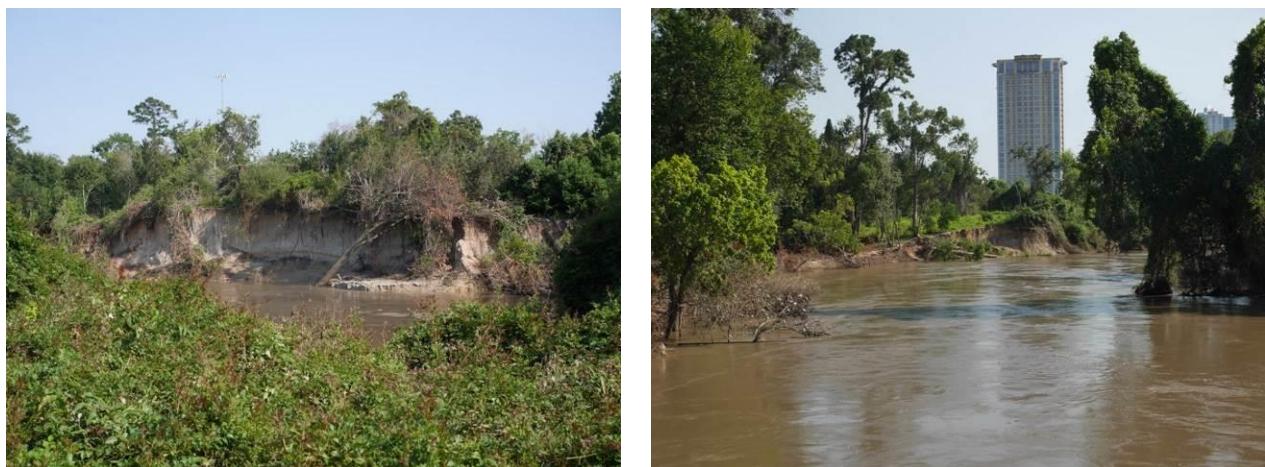
Figure 26. Buffalo Bayous slope failures (September 9, 2017, 29.76318° N, 95.45945° W).

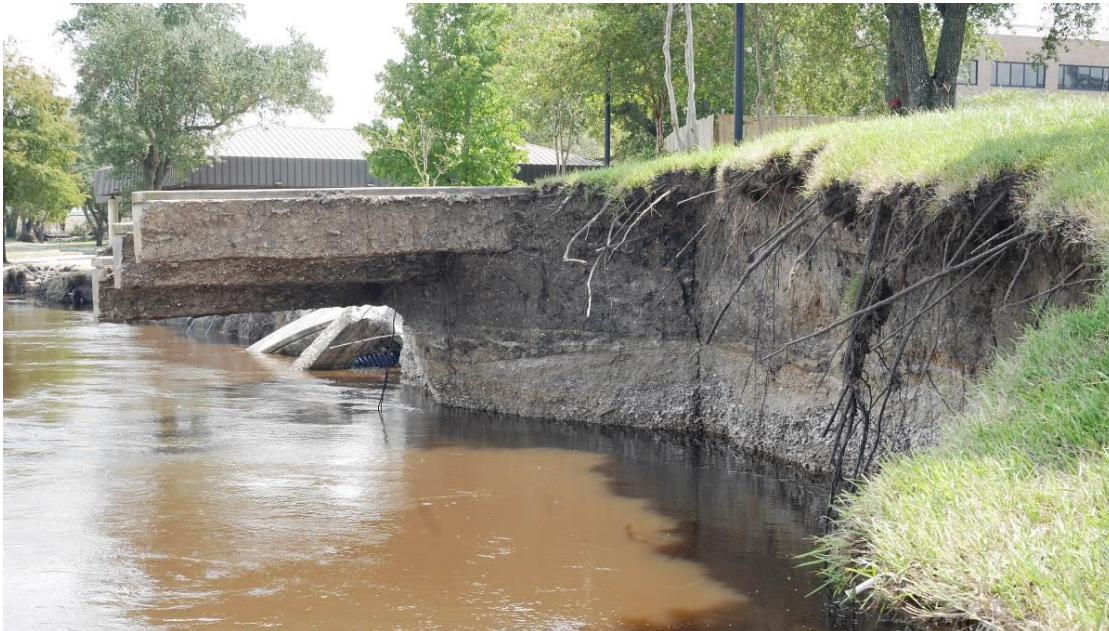
Figs. 29 and 30 show the loss of shoreline and scarps left by the Neches River erosion of the park shoreline, starting from an upstream section protected by riprap and extending through the downriver port area. The pre-hurricane park area shoreline was fronted with a riverwalk/dock (see aerial on Fig. 28), which was largely washed out. Based on pre-hurricane aerials on Google Earth, the shoreline had eroded up to about 15 m (50 ft) from the previous shoreline.

Figure 29. Scour under amphitheater structure. Scarp is estimated to be about 12 m (40 ft) back from previous shoreline (September 11, 2017, 30.08334° N, 94.09441° W).

Scarps along the waterfront were up to about 5 m (15 ft) in height, with the highest scarps at the amphitheater. Exposed soils in accessible scarps were stratified, with fill (primarily sand) over stratified silty/clayey (slightly plastic to non-plastic) sand with shells and varying amounts of organic fines. The riprap-covered (30- to 46-cm- [12- to 18-in-] sized rubble concrete) shoreline at the north end of the park was largely intact.

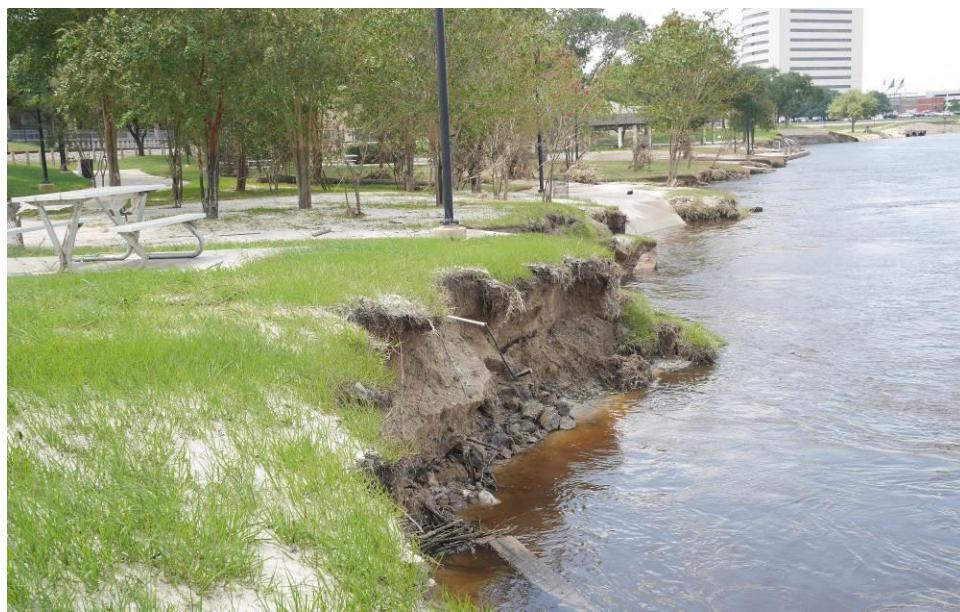
Figure 30. Downstream end of park. Scarp is estimated to be about 10.7 m (35 ft) back from previous shoreline (September 11, 2017, 30.08184° N, 94.09278° W).

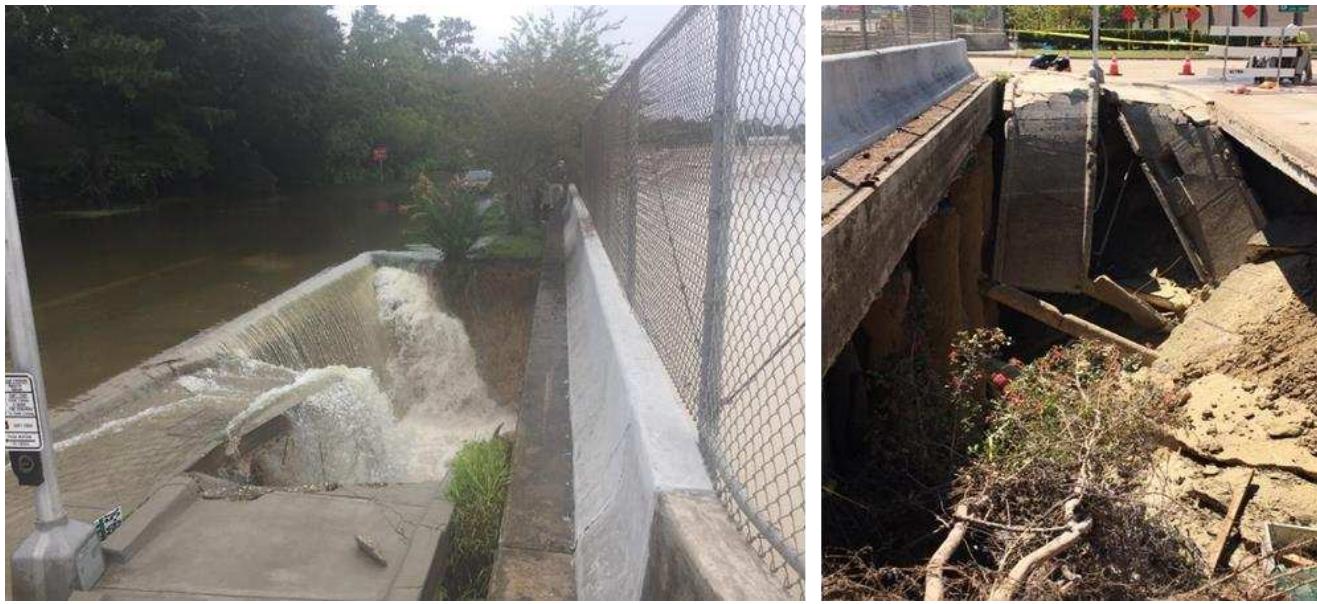
The roadway damage consisted of an uplifted road slab (or slabs) on Beltway 8 and a washout of the adjacent access road, West Sam Houston Parkway N, which is supported about 6.7 m (22 ft) above the parkway by a cantilevered retaining wall consisting of precast panels, which are supported by H-pile reinforced concrete piers. It appears that flood water from the area west of the parkway flooded the access road, drained down behind the retaining wall, and uplifted the Beltway 8 slabs. These flows then washed out soil behind the wall and under the access road and adjacent sidewalk, leaving a 5 m- (17 ft) deep hole. Fig. 32 photographs show the state of the damaged roadway during and after the flooding event. Fig. 33 shows repair work conducted on the uplifted slabs.

Figure 32. Damage of the walkway slab on Beltway 8 (left photo courtesy Brian Klein, a resident in the area, August 27, 2017, and right photo courtesy of a construction worker on site, $29.76735^\circ N$, $95.56219^\circ W$).

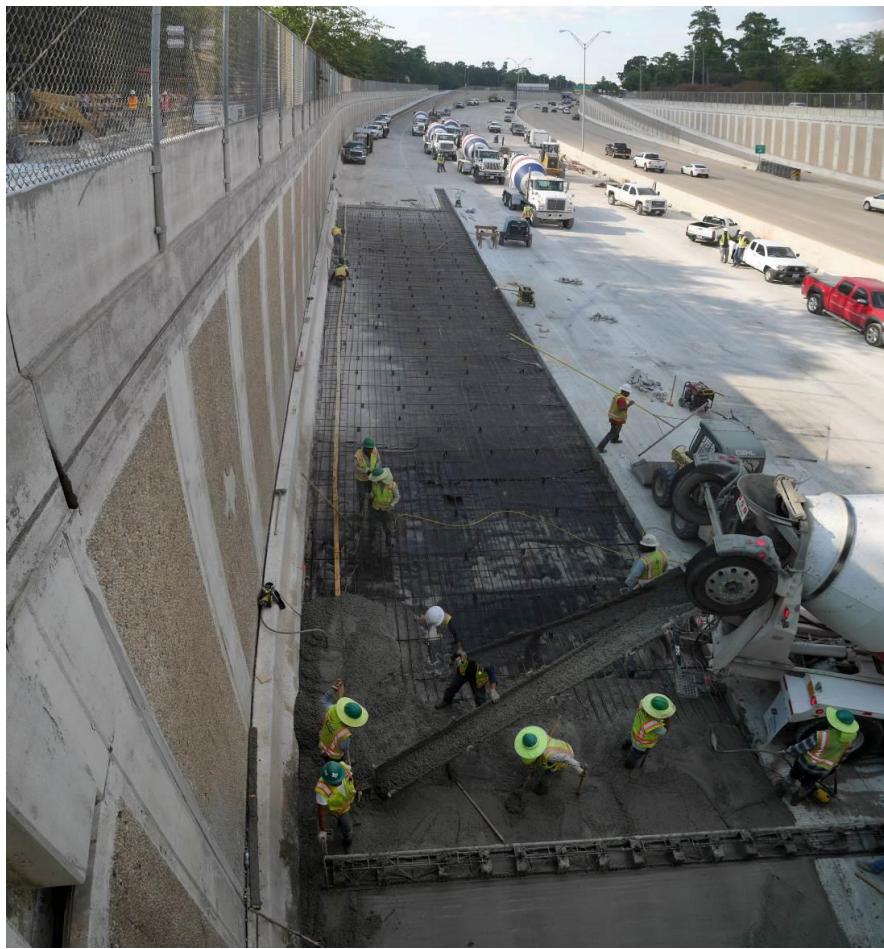
Figure 33. Road pavement repair in progress on Beltway 8 (September 10, 2017, $29.76736^\circ N$, $95.56208^\circ W$).

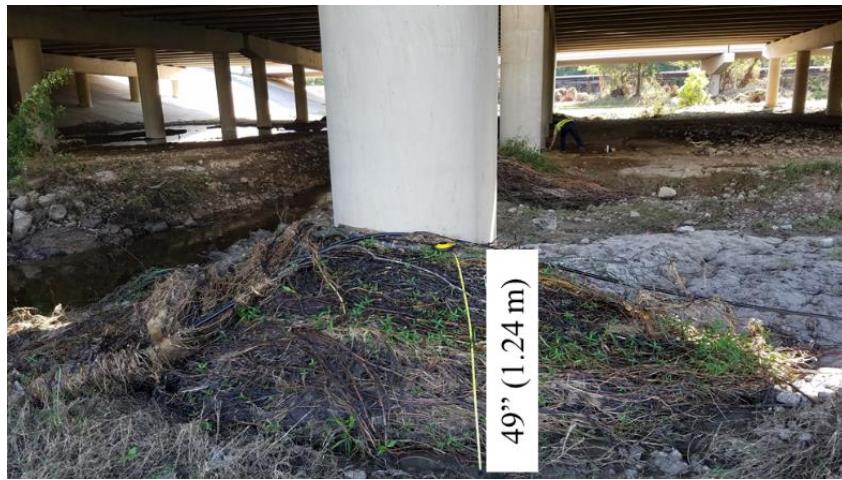
Figure 35. Observed debris on first column in flow direction. Debris pile is 1.24 m (49 inches) tall around the 1-m- (3-ft-) diameter bridge column (September 11, 2017, Time 10:04 CDT, 30.24688° N, 95.45796° W).

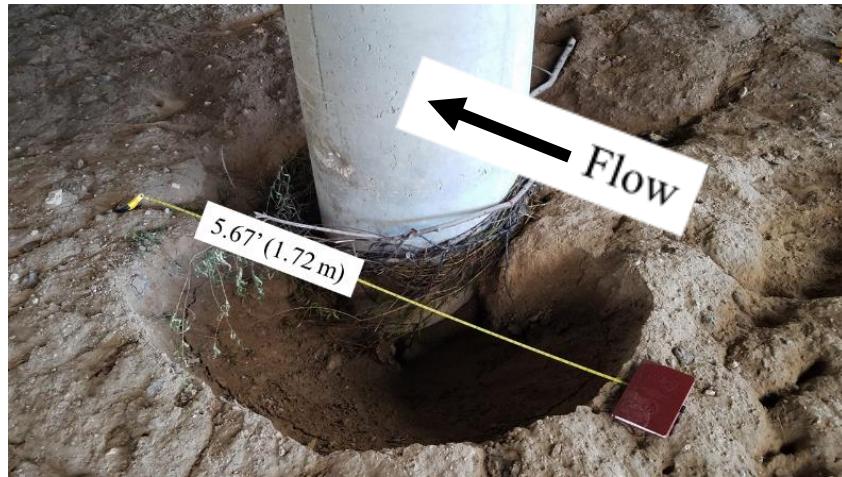
Figure 36. Bridge column scour (September 11, 2017, Time 10:06 CDT, 30.24688° N, 95.45796° W).

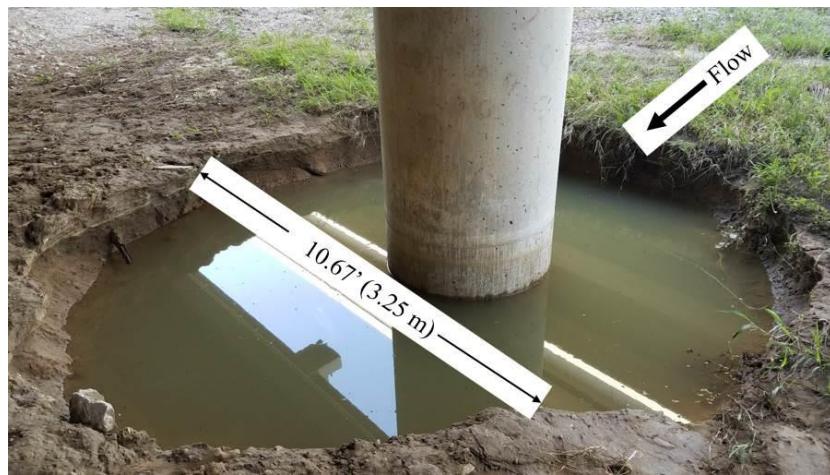
Figure 37. Scour hole on column closer to river. The hole was 3.7 m (12.3 ft) long in the flow direction and 3.25 m (10.67 ft) perpendicular to flow. The depth of the scour hole was 0.8 m (2.75 ft) from the existing ground (September 11, 2017, Time 10:23 CDT, 30.25071° N, 95.45703° W).

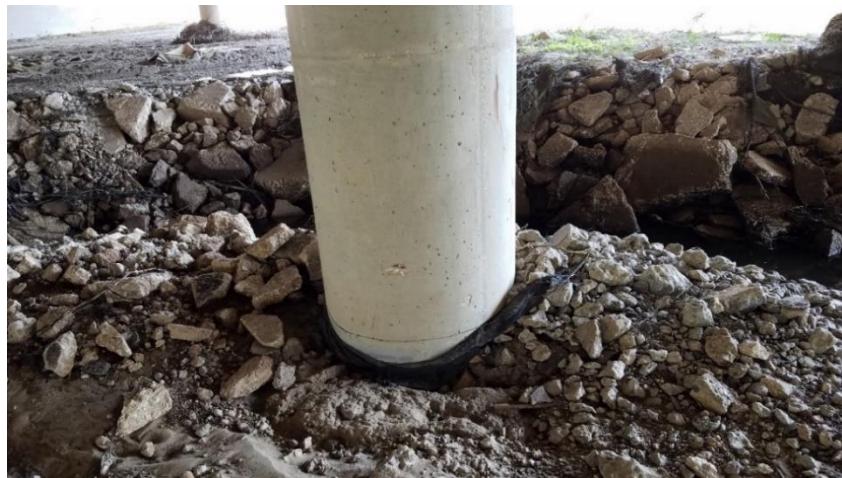
Figure 38. Erosion control riprap, including polymeric reinforcement, with minimal observed scour (September 11, 2017, Time 10:19 CDT, 30.24688° N, 95.45796° W).

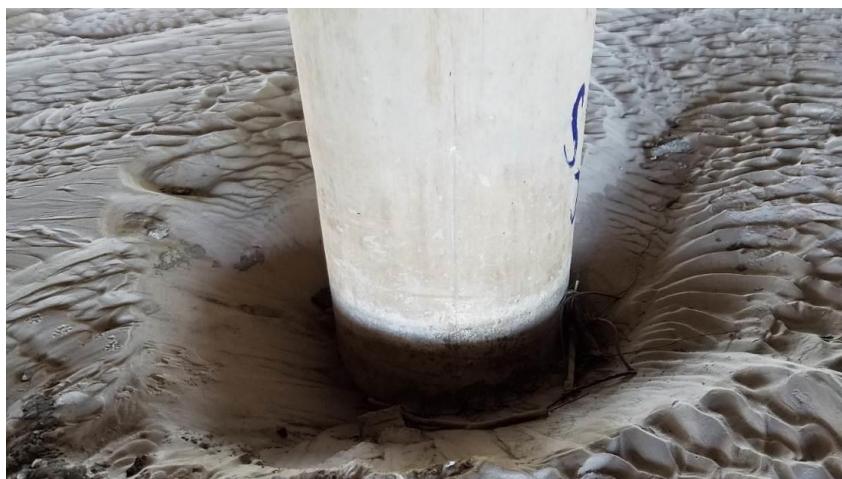
Figure 40. Scour around columns on San Jacinto Banks (sandy soil). The scour hole was approximately 2.4 m (8 ft) across and 0.6 m (2 ft) deep (September 11, 2017, Time 10:59 CDT, 30.243364°N, 95.46452°W).

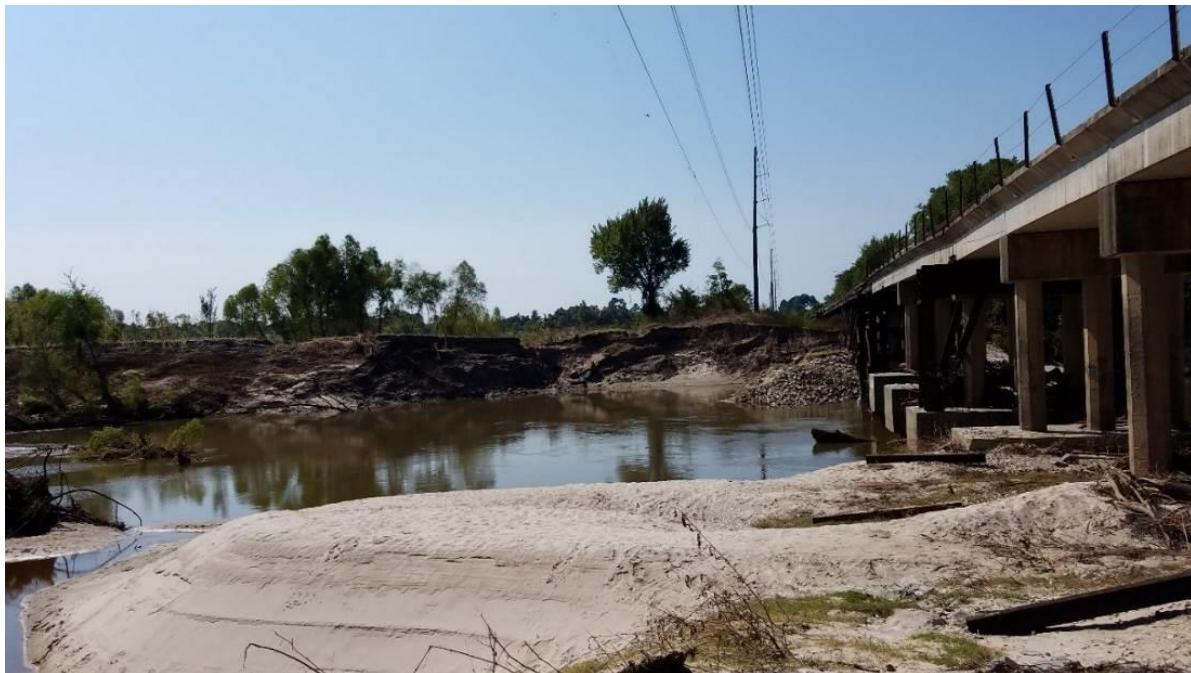
Figs. 41 and 42 show the Missouri Pacific Rail Road Bridge downstream of I-45. Bank erosion was noted on the south bank of the San Jacinto River downstream of the railroad bridge. Fig. 42 shows debris on top of the pile caps and at the top of the bents on the railroad bridge. These high debris levels were consistent with the maximum measured gauge height during Harvey of approximately 10 m (33 ft) above average gauge height.

Figure 41. Bank erosion on the San Jacinto River downstream of I-45 and a railroad bridge parallel to the highway (September 11, 2017, Time 11:05 CDT, 30.24688° N, 95.45796° W).

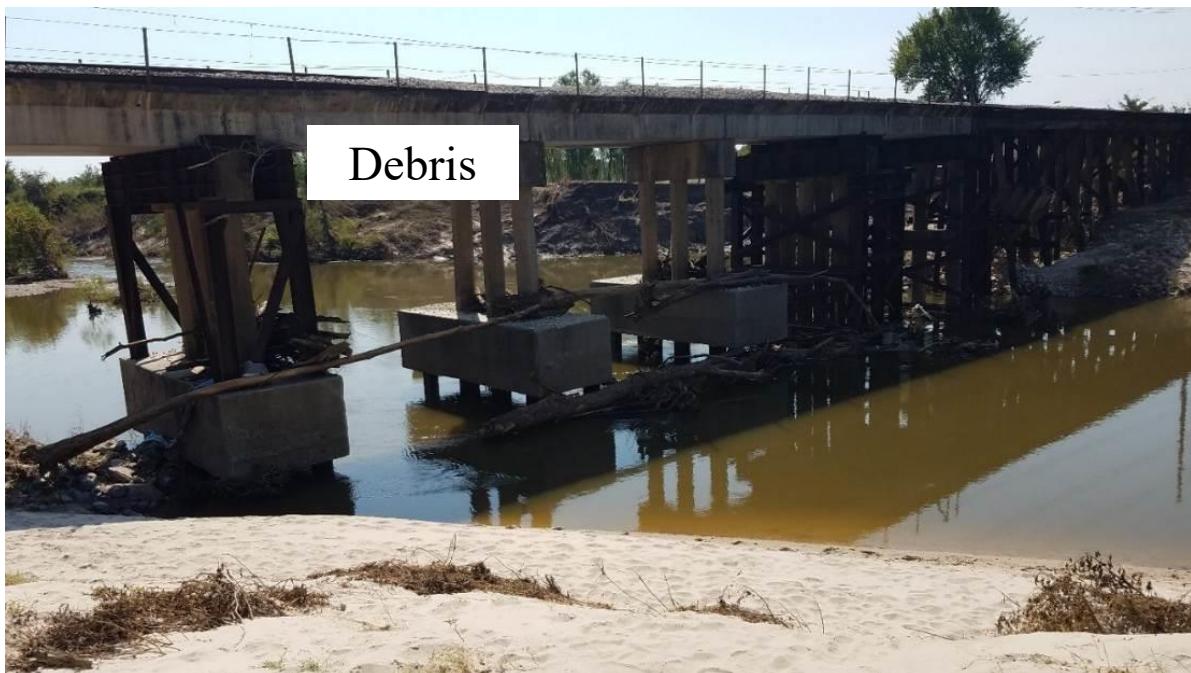
Figure 42. Debris on railroad bridge indicating flow levels and scour around pile caps below current flow levels (September 11, 2017, Time 11:10 CDT, 30.24688° N, 95.45796° W).

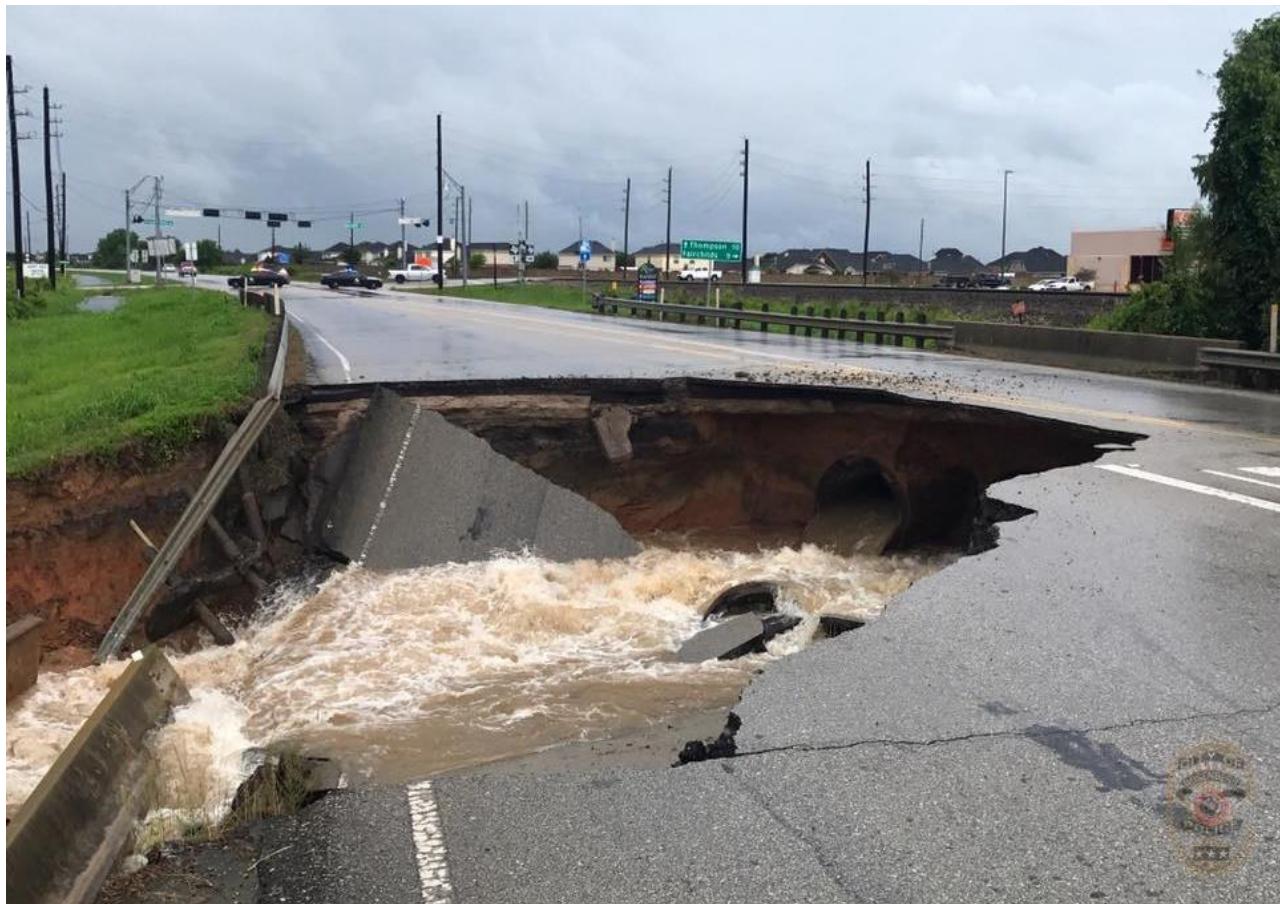
Erosion of the road progressed from the downstream side (see Fig. 43) until the entire width of the road washed out, stopping within 18 m (60 ft) of the adjacent railroad tracks. Repair construction was underway at the time of our visit. Possible erosion mechanisms could have included overtopping flow, culvert leakage or failure, or embankment seepage.

*Figure 43. FM 762 Washout on August 27, 2017
(Courtesy of the Rosenberg Police Department, 29.5442° N, 95.7434° W).*
