Geotechnical Effects of Hurricane Harvey in the Houston, Beaumont, and Port Arthur Areas

ABSTRACT: The Geotechnical Extreme Events Reconnaissance (GEER) Association deployed multiple teams of engineers from academia and practicing firms to the coast of Texas in late August and early September 2017 following Hurricane Harvey. This report summarizes the observations and data from the GEER team that focused primarily on the inland effects of Hurricane Harvey in the Houston area with some observations in the Port Arthur / Beaumont area east of Houston. Rain, not storm surge or wind, caused the observed damage in Houston, Beaumont, and Port Arthur by overwhelming stormwater management facilities and creating high flows and flooding in and near area waterways. The major Houston-area flood structures, Addicks and Barker Dams, performed well from a geotechnical perspective. Observed damages included shallow slides along levees, severe erosion along riverways, isolated road and culvert erosion and uplift, and area-wide flood effects in low and poorly drained neighborhoods.

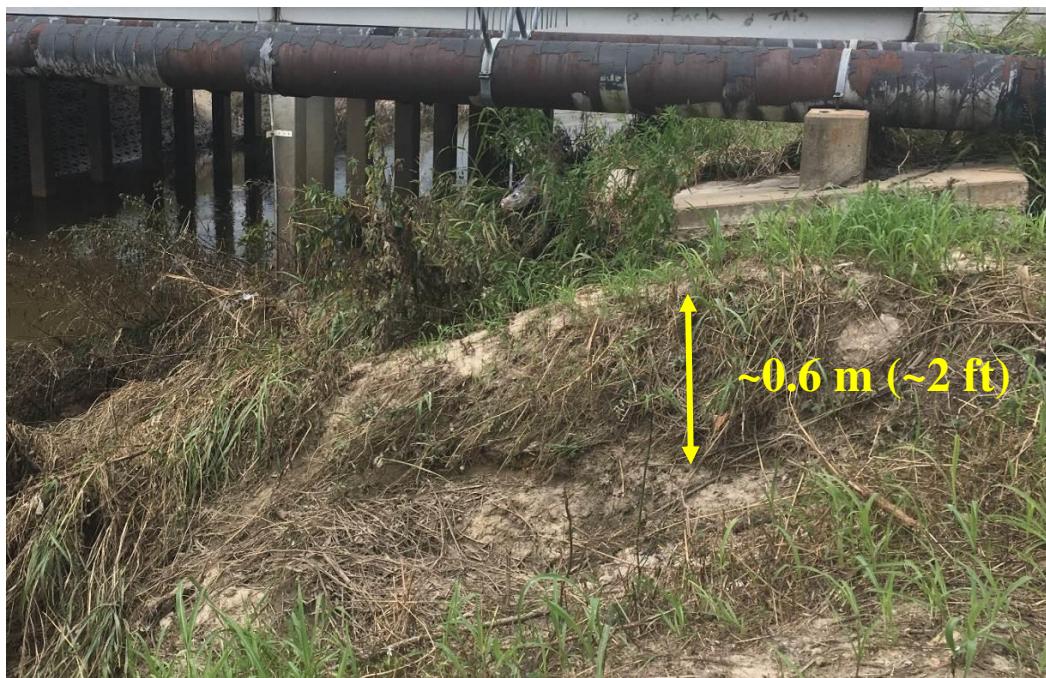
The erosion at the State Highway 35 Bypass bridge and pipe crossing over Mustang Bayou in the city of Alvin (see Fig. 1 for location) was typical for small waterways with high flow. Two shallow soil slump failures with slip depths of about 0.3 to 0.6 m (1 to 2 ft) were noted along the north bank of the bayou, one of which was beside and under a pipeline pile cap (Fig. 44).

Figure 44. Shallow soil failure along the north bank of Mustang Bayou, adjacent to pipe-support foundation (September 4, 2017, Time 12:48 CDT, 29.40889° N, 95.23234° W).

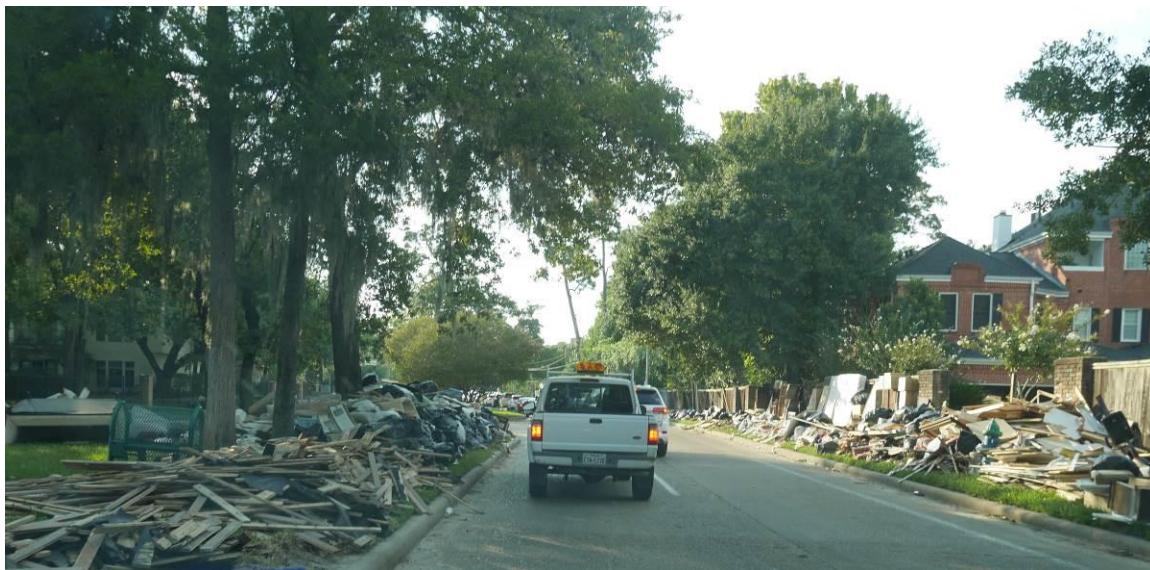
Figure 45. Residential flood damage debris, Houston.

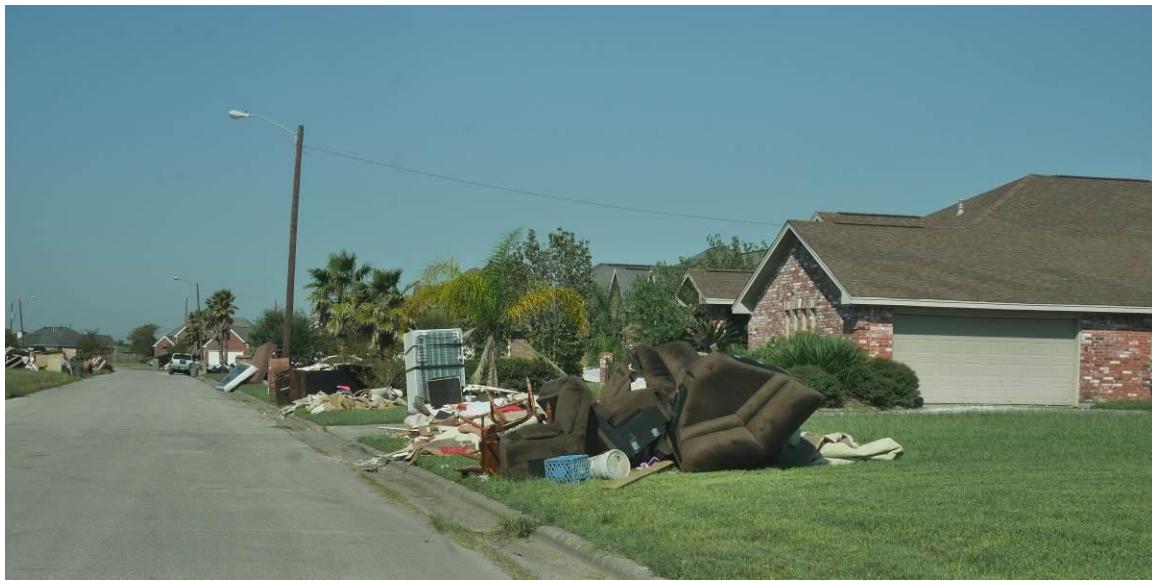
Figure 46. Residential flood damage debris, Port Arthur.
