# Geotechnical Extreme Event Site Reconnaissance in Puerto Rico After The Passage of Hurricane Maria

Reference: Silva-Tulla F., and Pando M. A. (2020). Geotechnical Extreme Event Site Reconnaissance in Puerto Rico after the Passage of Hurricane Maria. International Journal of Geoengineering Case Histories, Volume 5, Issue 4, pp. 1-25, doi: 10.4417/IJGCH-05-04-01

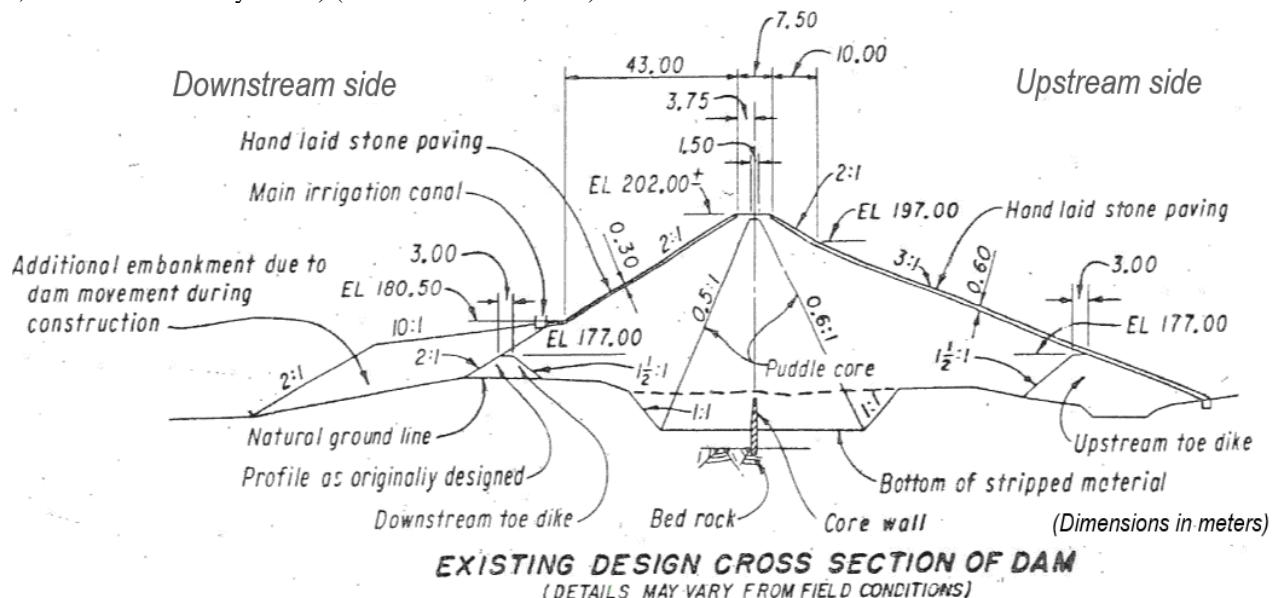
Figure 9. Cross-section of Guajataca Dam from the 1920s (date of drawing is unknown; USBR, 2002).

Figure 9 shows the cross section of Guajataca Dam, as reported by USBR (2002). Available records suggest that a large part of the dam consists of hydraulic fill, but its internal geometry and composition remain unclear. For example, the center of the dam is reported as a “puddle core”, but the USBR (2002) report suggests that the hydraulic fill process left the coarsest fill materials near the dam faces and the finest in the core area. The same report indicates that fill placement was changed to “dry” roller compaction in 1927 to address field observations of dam instability. Instability during the initial construction of the dam was reported in February 1927 as cracks, slippage, and other signs of movement, including bulging and settlement of the cofferdams. Reportedly, many locations showed movements on both the dam and the downstream natural ground; maximum movements included a 0.96 m (3.2 ft) downstream horizontal displacement and 1.44 m (4.7 ft) of vertical settlement.

Figure 9 shows the remedial berm constructed on the downstream side of the dam early in 1927 after the reservoir was drained, implemented to stabilize the ongoing sliding in the downstream direction. USBR (2002) also indicates that stabilization measures included the installation of numerous drain holes and replacing the fill placement technique to “dry” roller compaction. As construction of the dam proceeded, new movements of up to 35 cm (14 in) were reported on the upstream face and a heel was installed (location unknown). The USBR (2002) report indicates that in November 1927, as the dam was nearing completion, movements reported as “creep-type” were still observed. To enhance stability, fill was placed at the toe of the dam. The USBR (2002) report indicates that crest movements were measured during the years following the original dam’s completion. Movement varied from about 35 cm/yr (13.2 in/yr) between 1927 and 1929 to about 1 cm/yr (0.4 in/yr) between 1942 and 1951. In 1954, about 2,000 m<sup>3</sup> of fill were added to the crest area to restore its original elevation.

In 1971, the USBR was requested to evaluate the dam; in 1977, it recommended various remedial measures, including rebuilding the crest and replacing part of the spillway. During an excavation near the toe of the spillway in 1981, movement of the spillway occurred. The excavation revealed a plastic layer with slickensides, and a subsequent investigation resulted in landslides being mapped under the spillway and dam. To increase the stability, the USBR recommended limiting the elevation of the downstream face berm (Figure 9) and filling or buttressing the river channel area. The work included the placement of a 2.44 m (8 ft) diameter pipeline, completed in 1984, to carry outlet flows.

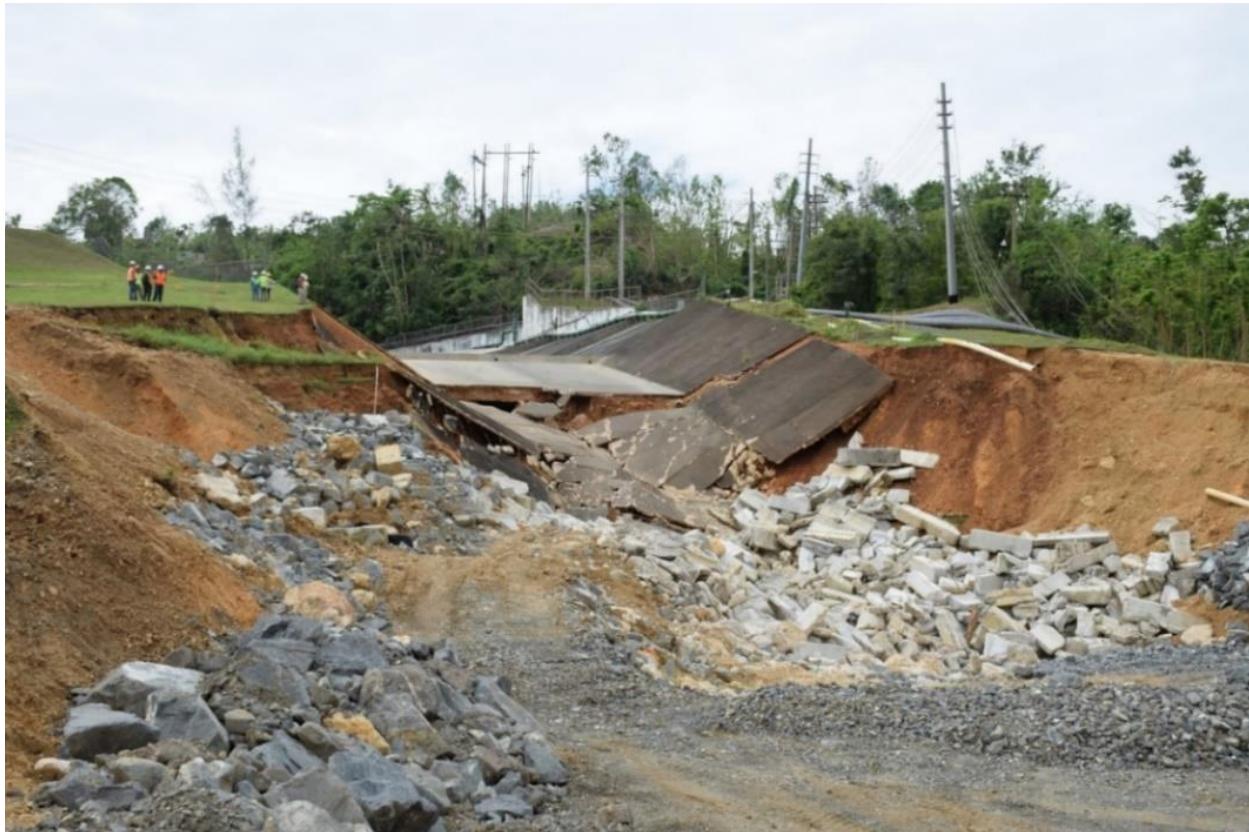
During Hurricane Maria, scour severely damaged the spillway and siphon at Guajataca Dam, as shown in Figure 10. The siphon, replaced by pumps after the damage from the hurricane, supplied raw water for the Aqueduct and Sewer Authority pump located near the reservoir. Concerns about the dam's stability prompted emergency remedial measures and the evacuation of about 70,000 residents located downstream of the dam. The maximum reservoir elevation that resulted from Hurricane Maria remains unknown.

Figure 10. Damaged condition of Guajataca Dam spillway (Silva-Tulla et al., 2018).

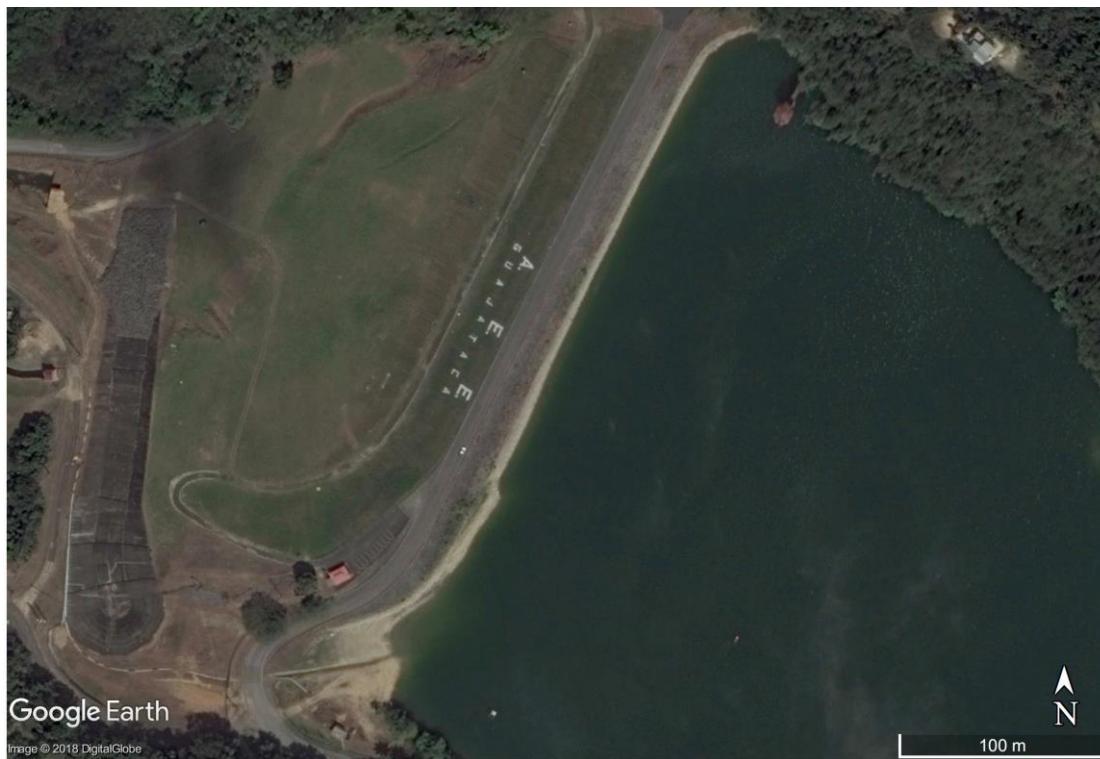
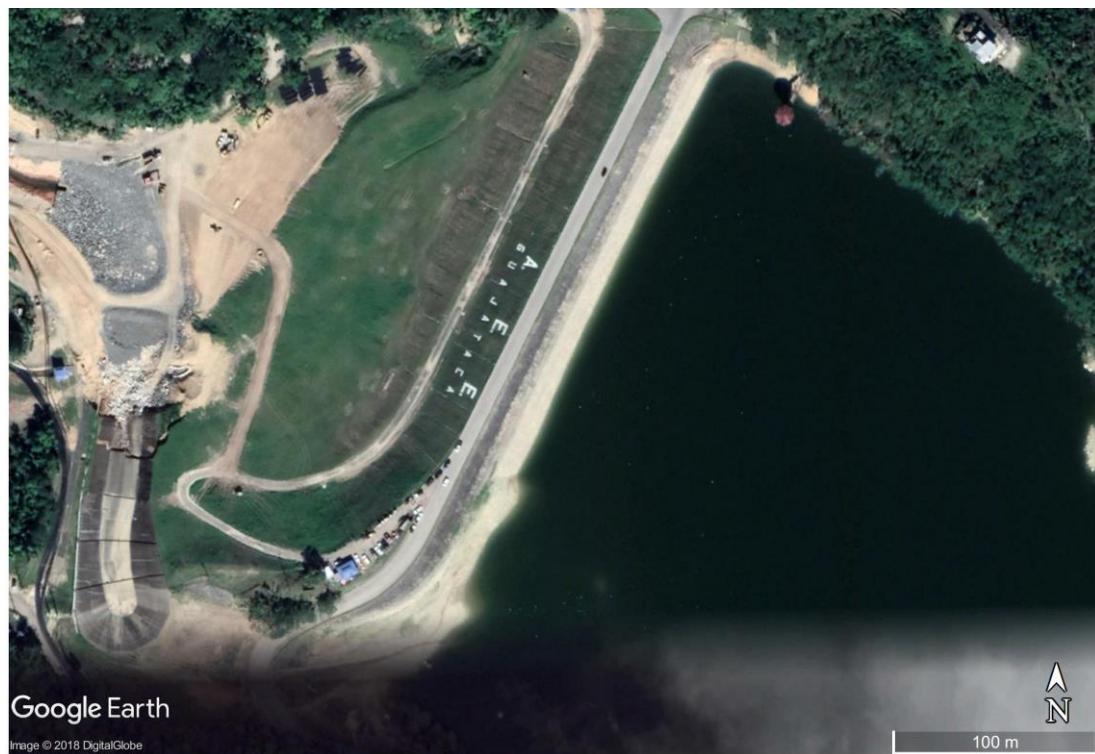
The Google Earth aerial image shown in Figure 11(a) shows the spillway, apparently in good condition in March 2017. In contrast, a Google Earth image from November 2017, shown in Figure 11(b), illustrates significant damage after Hurricane Maria. Figure 11(b) shows that about 100 m (300 ft) of spillway was completely destroyed (roughly 40 m of concrete and 60 m of riprap), and that an additional 25 m of concrete spillway was significantly undermined and displaced. A siphon located under the spillway was also destroyed. Aerial photographs taken during the aftermath of Hurricane Maria show water spilling out of the upstream side of the siphon (on the north side of the spillway), indicating that the siphon was operational during Hurricane Maria. Scour depths below the spillway could not be measured since the area had already been partly filled, but photographs and witness accounts indicate that extensive scour occurred.

Figure 11. Comparison of the Guajataca Dam condition between March and November 2017.

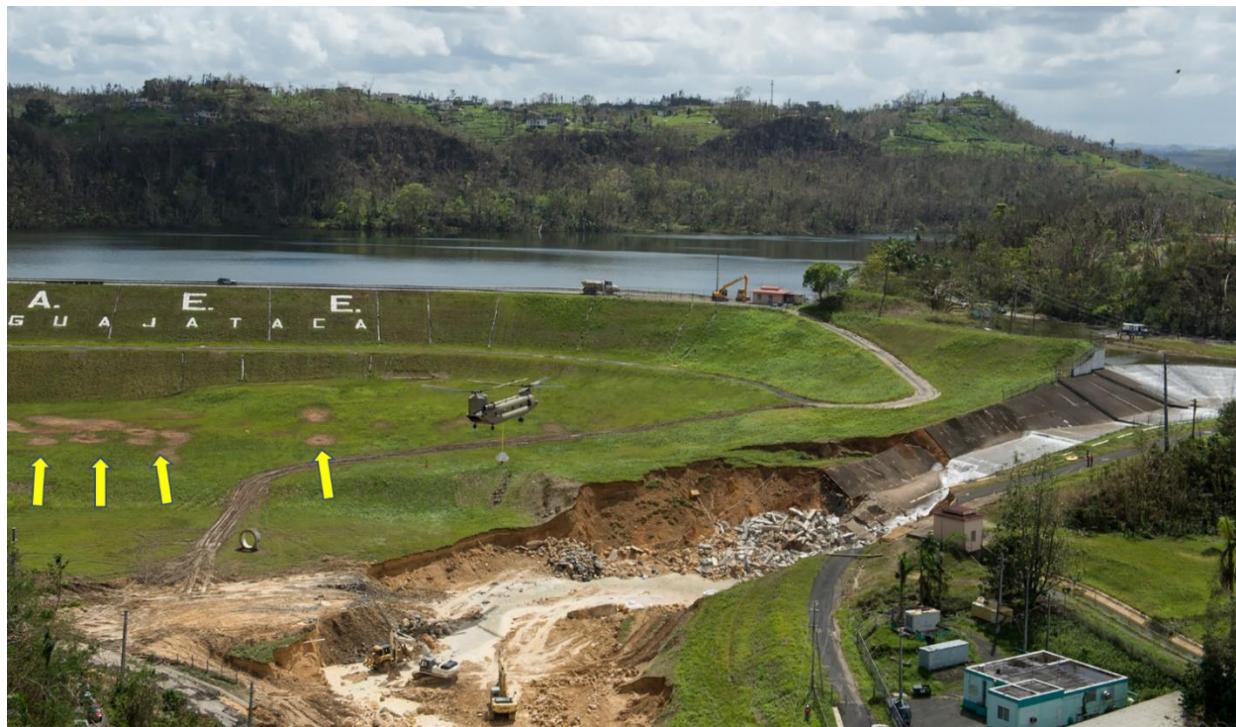
What appear to be sand boils along the toe of the earth dam suggest that its foundation materials were also subject to soil transport during Hurricane Maria (Figure 12). The seepage path and source of the eroded materials remain unknown, and considerable uncertainty exists about the origin and nature of the features shown in Figure 12. The GEER team observed water, soil, and other debris in the capped piezometer protective pipes consistent with a recent spike in groundwater pressures. During their visit, the team noted a large void approximately 0.3 m in diameter, located 10 m downstream of the toe and directly downstream of the "A" of the AEE sign on the downstream slope. Excavations, structures, poles, or posts were not reported or visible in aerial photographs near the location of the reported cavity. It seems possible that the void was either created or exacerbated by underseepage resulting from high hydraulic head during Hurricane Maria (Silva-Tulla et al., 2018).

*Note: Yellow arrows show location of apparent sand boils downstream of the dam toe.*

*Figure 12. Apparent sand boils downstream of the dam toe (photograph from the Pennsylvania National Guard; figure adapted from Silva-Tulla et al., 2018).*

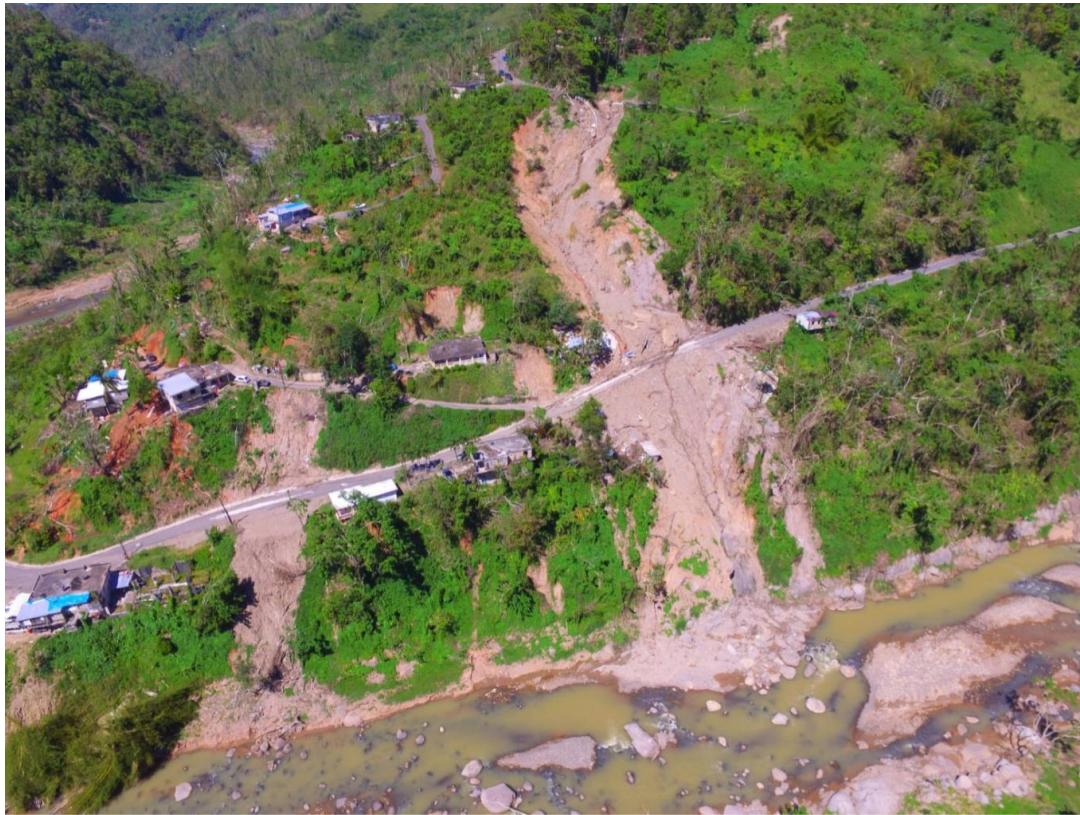
The majority of the slides shown in Figure 14 consisted of shallow debris flows. Figure 16 shows a site, visited by the GEER team, which was affected by some debris flows; this site is located along Puerto Rico State Road 4131 (PR-4131) near the Rio Blanco River in the municipality of Lares. The largest debris flow shown destroyed three homes along the lower road alignment (Silva-Tulla et al., 2018). Luckily, the inhabitants of those homes were not present at the time of the landslide. The debris flow initiated just above the highest road cut on a switchback along PR-4131. The upper area is the primary zone of volume loss, while the lower portion of the road was only covered by debris. The hillslope material slid directly into the river below, which carried much of the small- to medium-sized sediment downstream. Figure 17 shows aerial imagery of the landslide before and after Hurricane Maria.

Figure 16. Photo of debris flow above the Rio Blanco River along PR-4131 in Municipality of Lares (photo taken using UAV at location: Lat. +18.250348° Lon. -66.884155°, looking toward the North).

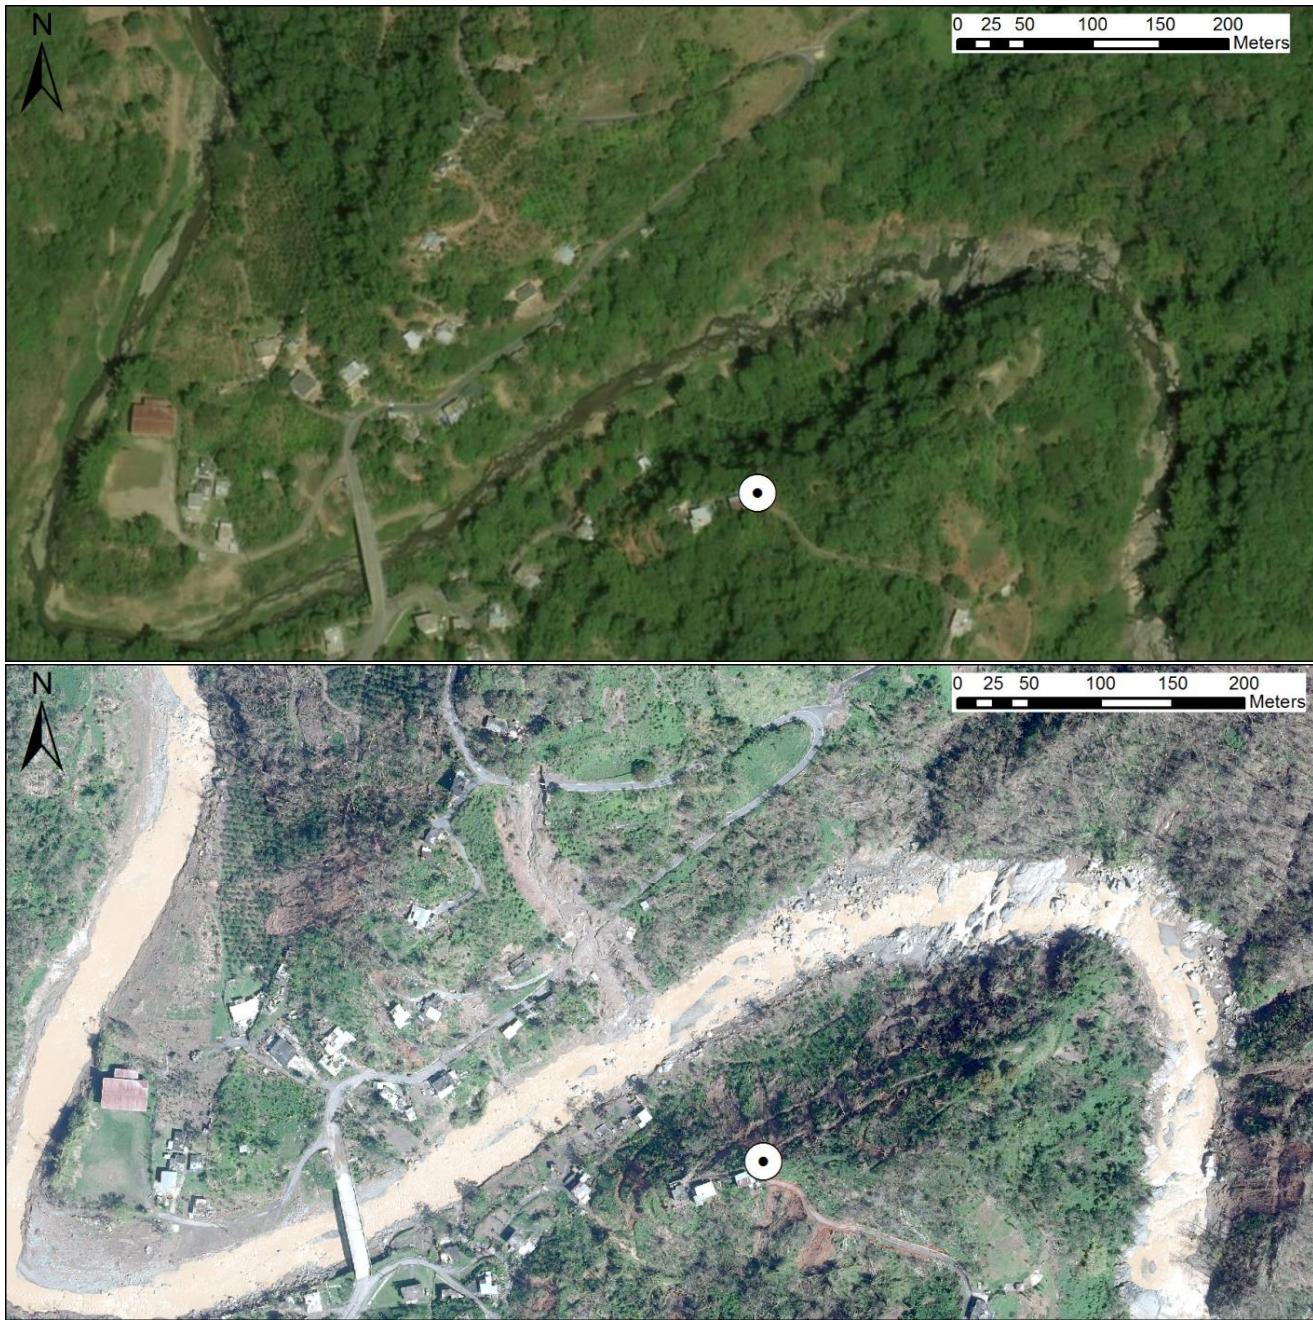
*Note: Upper image taken before Hurricane Maria. Lower photo captured by FEMA on October 12, 2017. The white circle with black center dot indicates the location of the TLS Lidar performed in January 2018.*

*Figure 17. Aerial photos of debris flow site on PR-4131 in central Lares along the Rio Blanco (Silva-Tulla et al., 2018).*

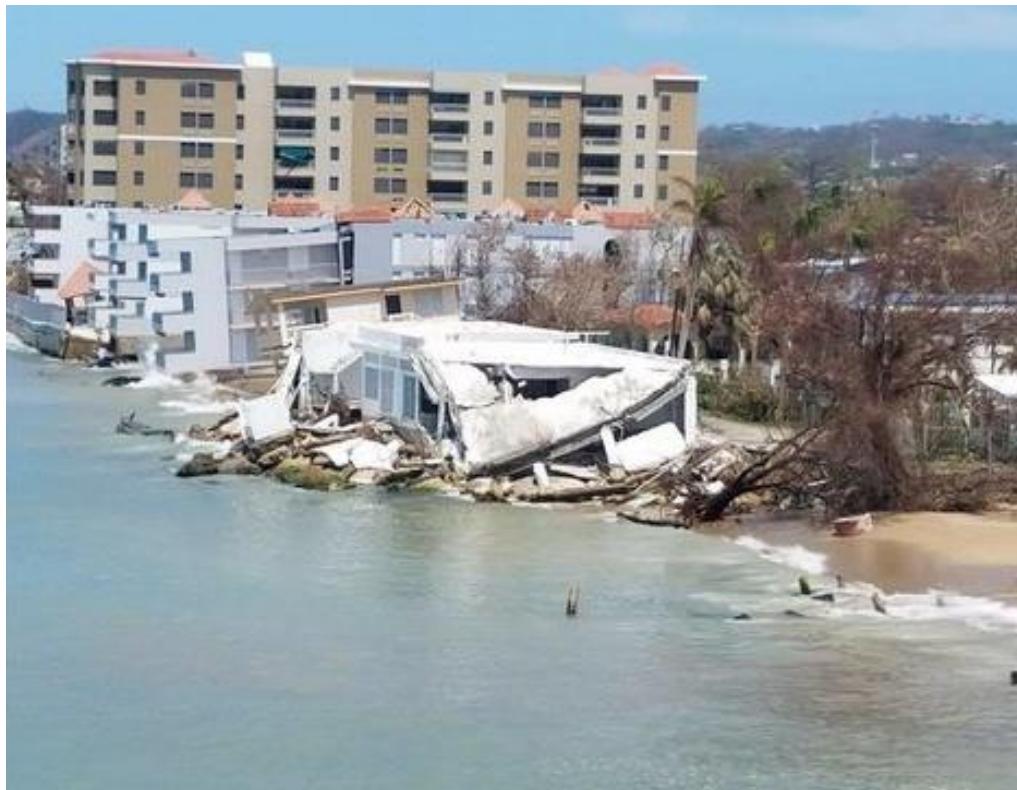
After Hurricane Maria, several buildings in the area of Site CE3 suffered severe damage, as shown in Figure 20. This figure shows extensive damage from waves or scour at the three-story Rincón Ocean Club I building, which was supported on shallow footings, and at the common areas of the terrace and swimming pool. A large volume of soil eroded from the front of the buildings and from beneath the swimming pool. Footings and beams supporting the terrace were exposed and sheared off from the building foundation. Part of Building A collapsed into the ocean and what remained standing was severely cracked. The Victoria Del Mar Condominium, the tallest building in this area and located to the north of Rincón Ocean Club I, also suffered extensive damage due to coastal scour. The terrace and swimming pool area of this condominium collapsed thanks to the storm.

The beachfront in the Córcega Beach area suffered extensive coastal scour. The approximately 6 to 9 m (20 to 30 ft) of beachfront shown in the pre-storm photo (Figure 19) was drastically reduced at the time of the site reconnaissance. The GEER Team did not observe sand washout deposits or shoreline erosion protection measures during the field reconnaissance of Site CE3. Unfortunately, there were no storm tide sensors available near Rincón to help assess tidal levels or the magnitude of wave action during this hurricane. However, NOAA (2017) reported highest water levels of 0.3 to 0.6 m (1 to 2 ft) above maximum higher high water (MHHW) for the northwest coastline of PR, where MHHW is defined as the average daily highest tide. This is consistent with a high-water elevation mark data recorded at USGS Stations (Silva-Tulla et al., 2018).

Figure 20. Oceanfront damage in Córcega Beach area (Site CE3; Silva-Tulla et al., 2018).

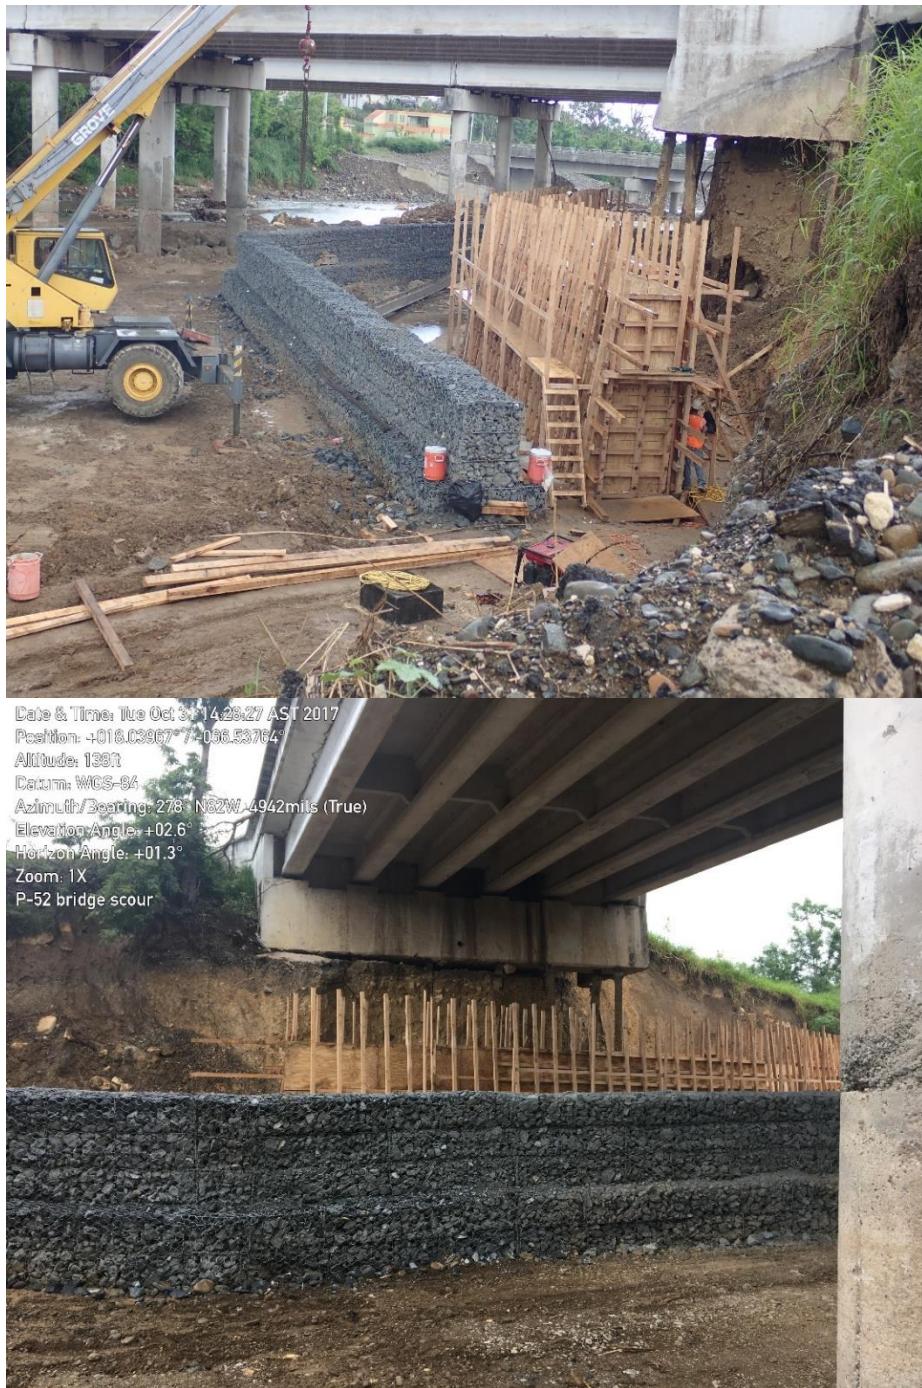
On October 31, 2017, the GEER team observed scour and erosion near the piers and abutments of Highway 52 bridges over the Inabón River at site RE1, just east of the city of Ponce, PR. Figure 21 shows select photos taken during the site visit. The photos show exposed abutment H-piles and ongoing emergency work, including the erection of formwork for abutment repairs and a temporary protective gabion wall. The gabion wall should protect the abutment and reinforced concrete shield under construction in front of the original exposed piles.

Figure 21: Photos of west abutment of westbound Highway 52 Bridge over the Inabón River (October 31, 2017; Silva-Tulla et al., 2018).

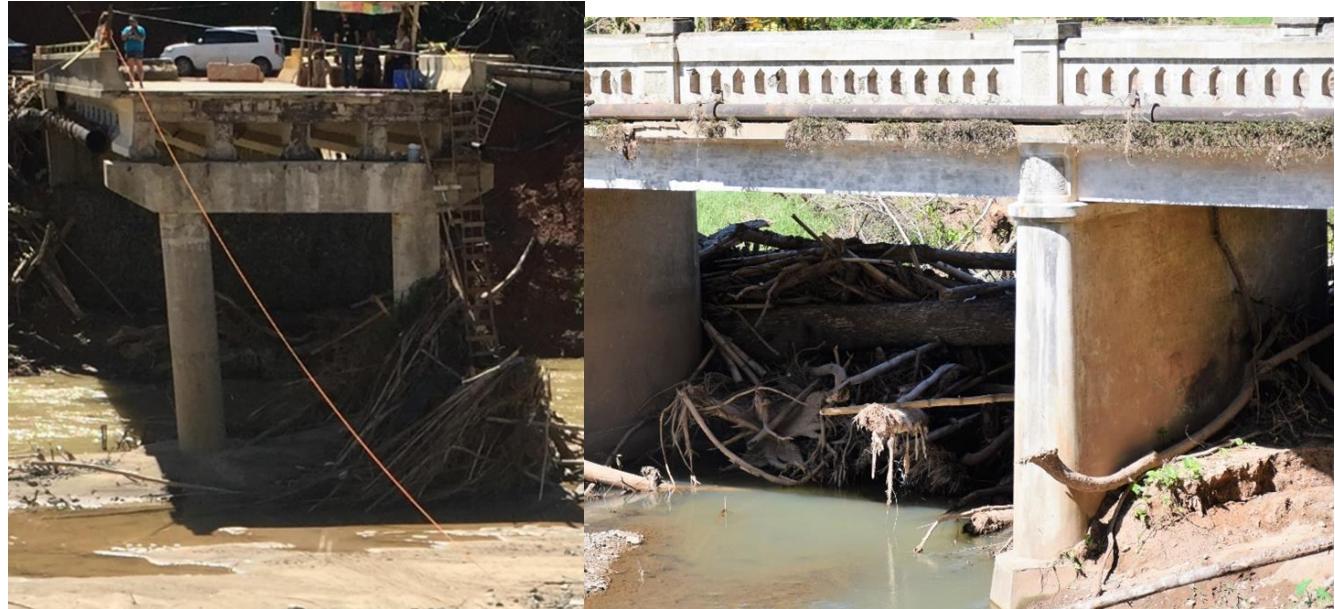
The GEER team visited several bridge sites and observed damage related to the large hydrodynamic forces from the increased volume and flow speeds associated with Hurricane Maria floods. Figure 22 shows photos from two bridge sites visited by the GEER team; these provide an idea of the magnitude of debris accumulation and the associated large hydrodynamic forces.

(Lat: +18.301439°, Lon: -66.698319°, 11/02/17)  
 a) PR-123 bridge failure ("Los Olvidados")

(Lat: +18.28683°, Lon: -67.10610°, 11/03/17)  
 b) Debris blocked at bridge

Figure 22. Images showing debris accumulation and damage at bridges during Hurricane Maria (Silva-Tulla et al., 2018).

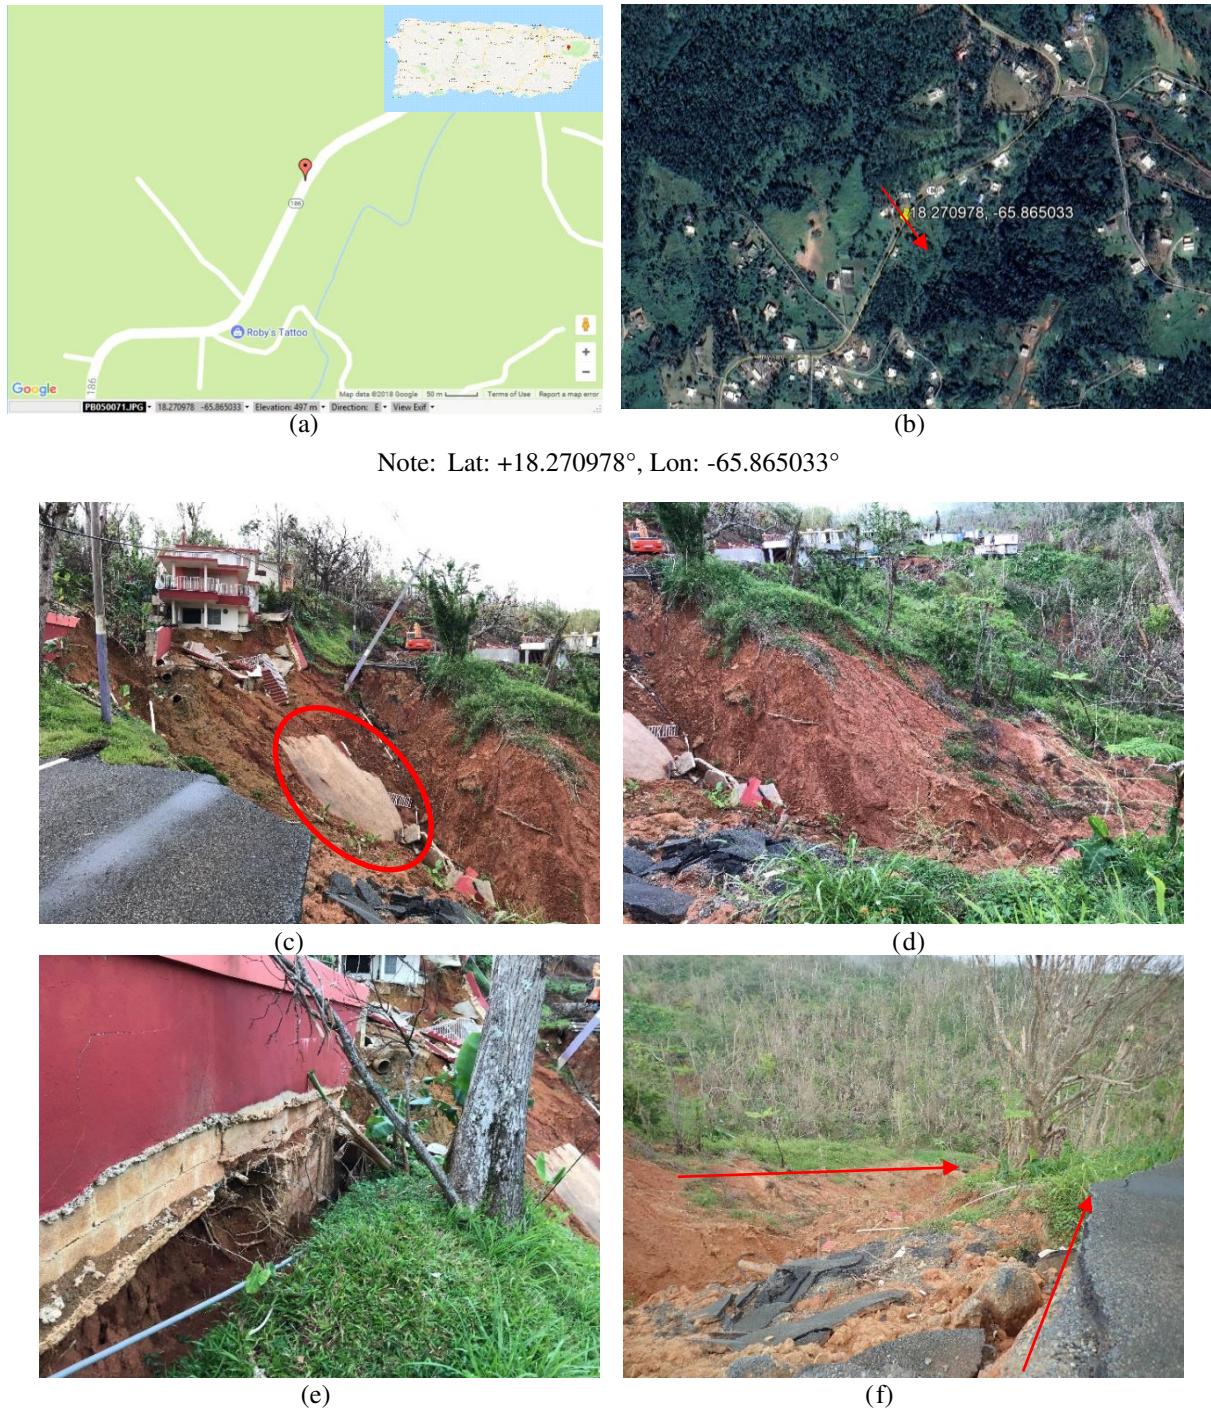
Figure 23. Road failure affecting PR-186 (GEER mission Site 7; Silva-Tulla et al., 2018).

Figure 23(a) shows the location of a road failure on the northeast side of the island near the west boundary of the El Yunque National Rain Forest, along road PR-186. The failure affected the full width of PR-186 and the entrance driveway of a residence on the west side of the road (upslope side). The arrow shown in Figure 23(b) points toward the slope failure direction (southeast). Figure 23(c) shows the upper portion of the failure that resulted in a complete cut-off of PR-186. Figure 23(c)

shows a portion of the concrete pavement driveway of a residence to the left of the image (residence not shown); the final position of the piece of concrete driveway is shown inside the red oval. Additional exemplifying photos are shown in Figures 23 (d), (e), and (f). The arrows in Figure 23(f) point toward the slope failure direction (southeast).

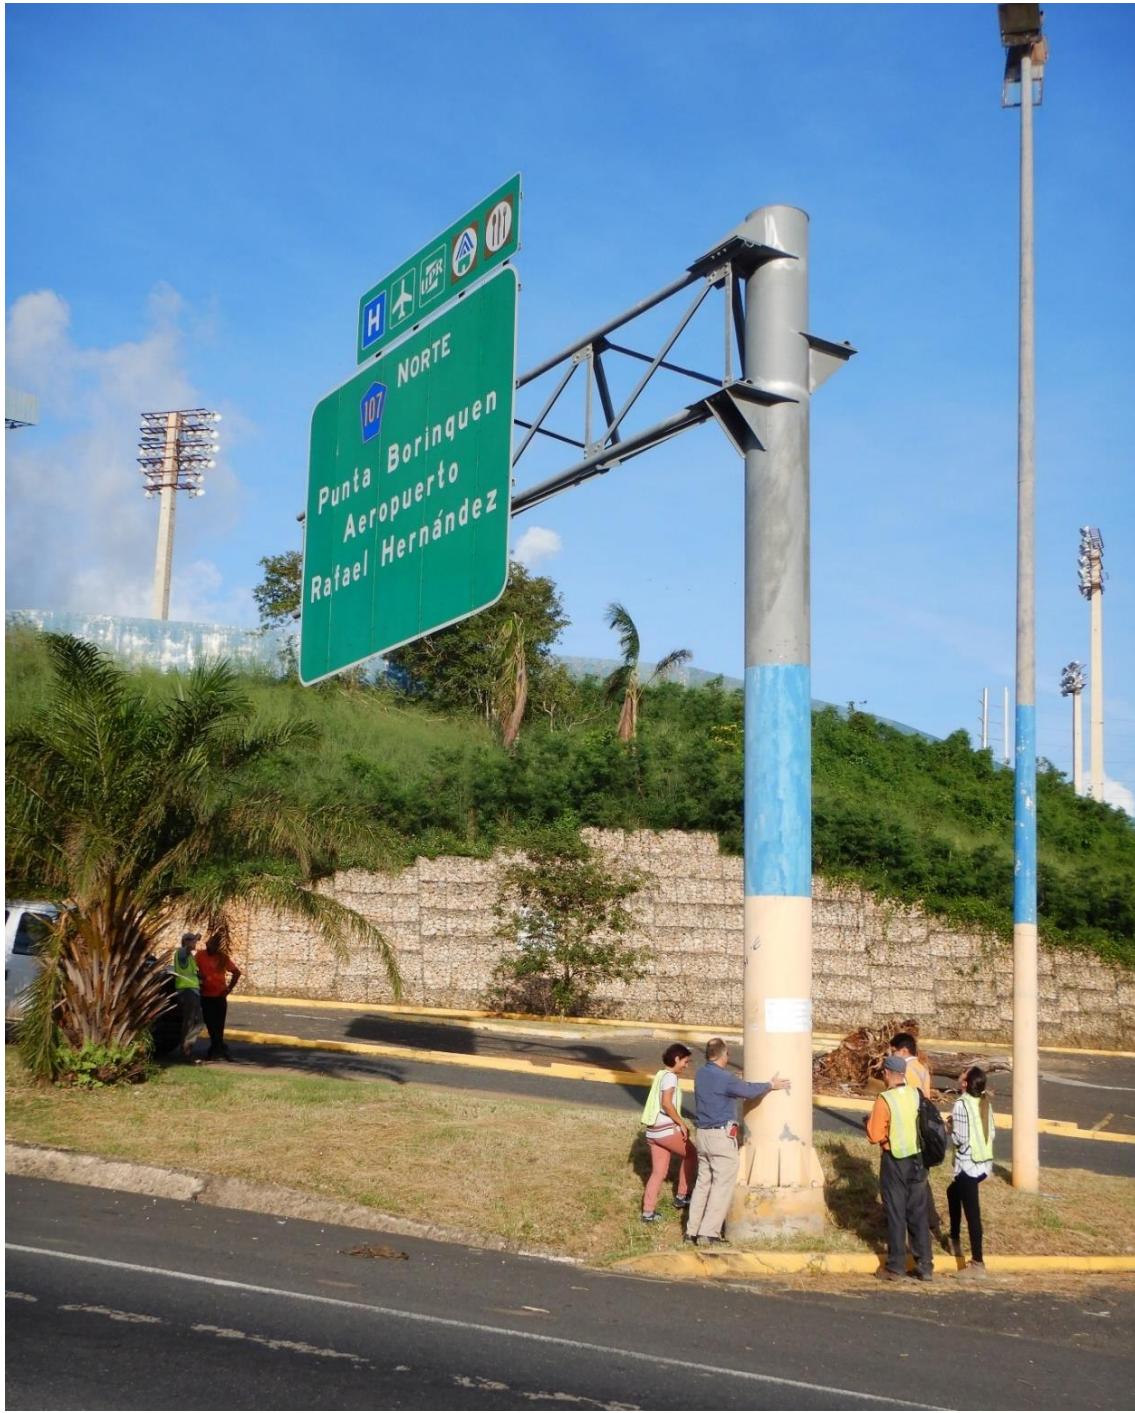
Foundation failures observed by the team included lighting towers, electrical transmission poles, and many road sign failures. Some of the road signs simply rotated about the axis of their circular drilled shaft foundation, while others also experienced bearing capacity failures. Although some electrical transmission poles failed from bearing capacity failures, the large number of reinforced concrete poles that had snapped at mid-height provided graphic evidence of the storm power. Figure 24 shows a representative torsional foundation failure of a highway sign structure.

Figure 24. Photo of cantilevered sign foundation failure (GEER Mission Site F2; Silva-Tulla et al. 2018).
