Geotechnical Extreme Event Site Reconnaissance in Puerto Rico After The Passage of Hurricane Maria

Francisco Silva-Tulla, Consulting Civil Engineer, GeoEngineering and Environment, Lexington, Massachusetts, U.S.A.; email: silva@alum.mit.edu

Miguel A. Pando, Associate Professor, Department of Civil, Architectural, and Environmental Engineering, Drexel University, Philadelphia, PA, 19104, U.S.A.; email: miguel.a.pando@drexel.edu

Reference: Silva-Tulla F., and Pando M. A. (2020). Geotechnical Extreme Event Site Reconnaissance in Puerto Rico after the Passage of Hurricane Maria. International Journal of Geoengineering Case Histories, Volume 5, Issue 4, pp. 1-25, doi: 10.4417/IJGCH-05-04-01

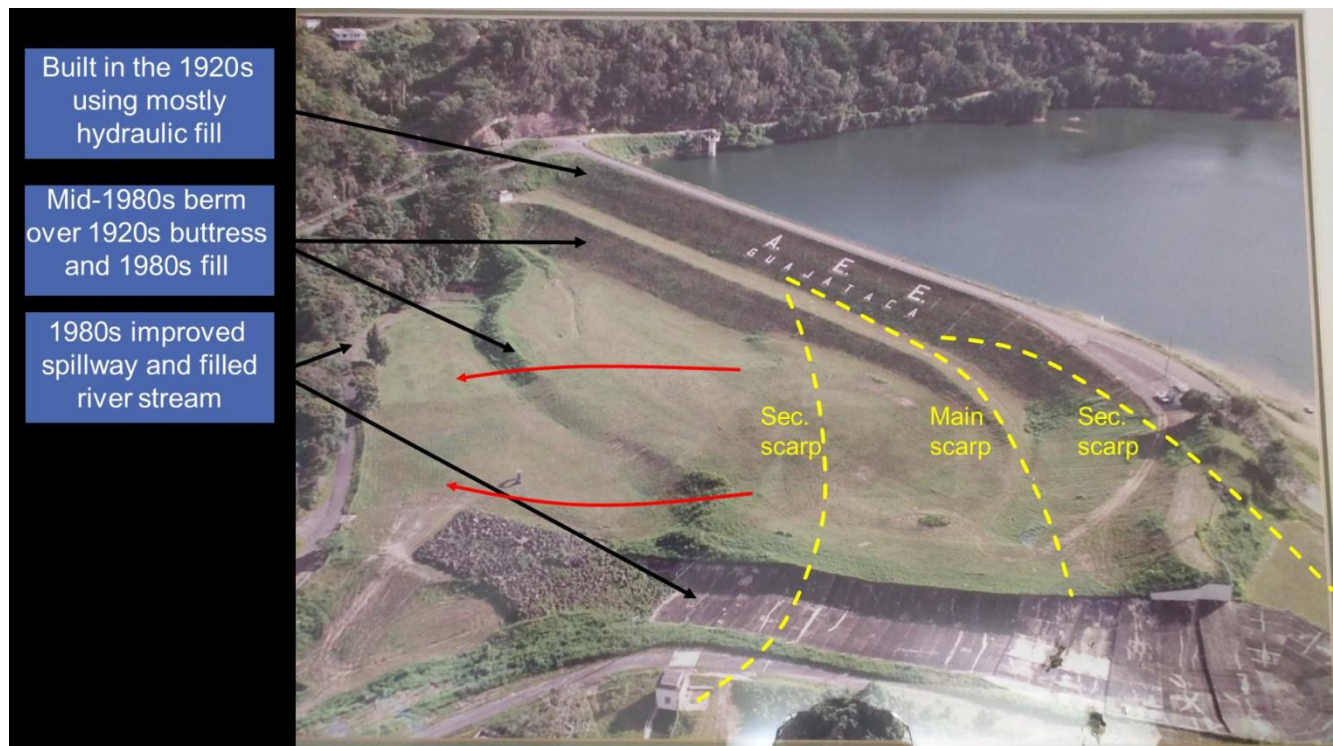
Figure 8. Photo of Guajataca Dam (Lat. +18.397895, Lon. -66.923725), taken a few decades before Hurricane Maria – exact date of photo unknown (adapted from Silva-Tulla et al., 2018).

In 1971, the USBR was requested to evaluate the dam; in 1977, it recommended various remedial measures, including rebuilding the crest and replacing part of the spillway. During an excavation near the toe of the spillway in 1981, movement of the spillway occurred. The excavation revealed a plastic layer with slickensides, and a subsequent investigation resulted in landslides being mapped under the spillway and dam. To increase the stability, the USBR recommended limiting the elevation of the downstream face berm (Figure 9) and filling or buttressing the river channel area. The work included the placement of a 2.44 m (8 ft) diameter pipeline, completed in 1984, to carry outlet flows.

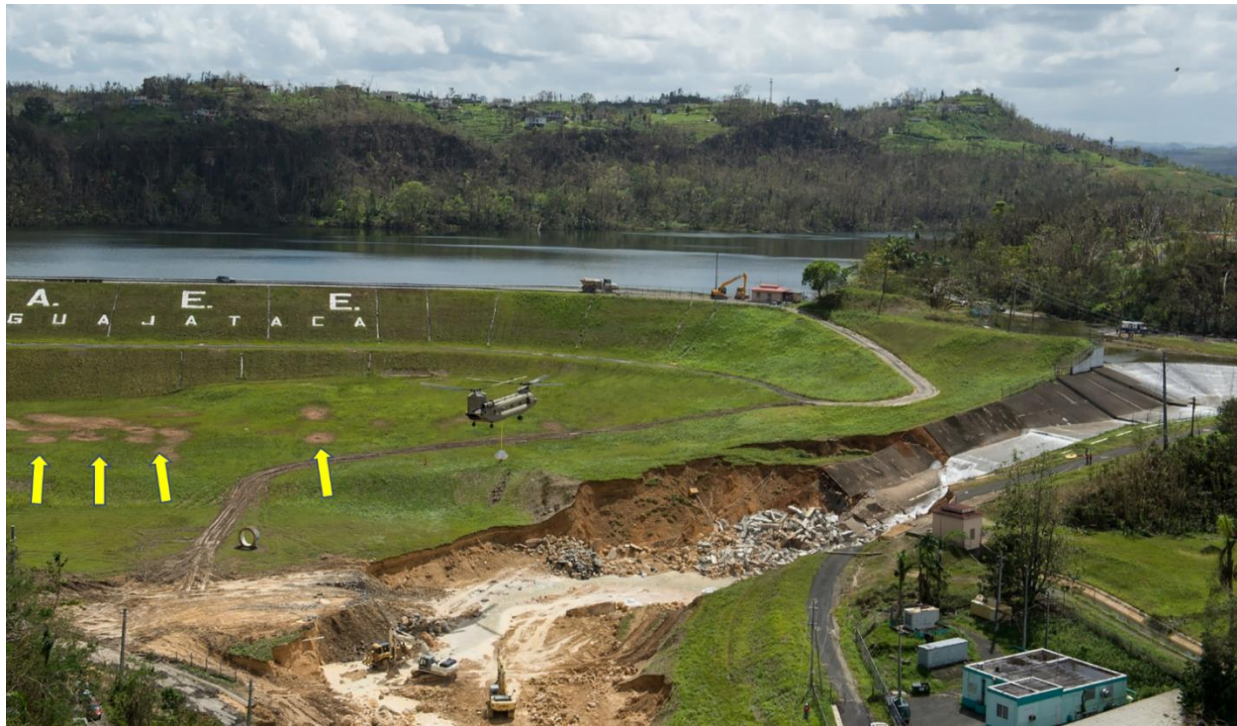
What appear to be sand boils along the toe of the earth dam suggest that its foundation materials were also subject to soil transport during Hurricane Maria (Figure 12). The seepage path and source of the eroded materials remain unknown, and considerable uncertainty exists about the origin and nature of the features shown in Figure 12. The GEER team observed water, soil, and other debris in the capped piezometer protective pipes consistent with a recent spike in groundwater pressures. During their visit, the team noted a large void approximately 0.3 m in diameter, located 10 m downstream of the toe and directly downstream of the “A” of the AEE sign on the downstream slope. Excavations, structures, poles, or posts were not reported or visible in aerial photographs near the location of the reported cavity. It seems possible that the void was either created or exacerbated by underseepage resulting from high hydraulic head during Hurricane Maria (Silva-Tulla et al., 2018).

Note: Yellow arrows show location of apparent sand boils downstream of the dam toe.

Figure 12. Apparent sand boils downstream of the dam toe (photograph from the Pennsylvania National Guard; figure adapted from Silva-Tulla et al., 2018).
