Geotechnical Extreme Event Site Reconnaissance in Puerto Rico After The Passage of Hurricane Maria

Reference: Silva-Tulla F., and Pando M. A. (2020). Geotechnical Extreme Event Site Reconnaissance in Puerto Rico after the Passage of Hurricane Maria. International Journal of Geoengineering Case Histories, Volume 5, Issue 4, pp. 1-25, doi: 10.4417/IJGCH-05-04-01

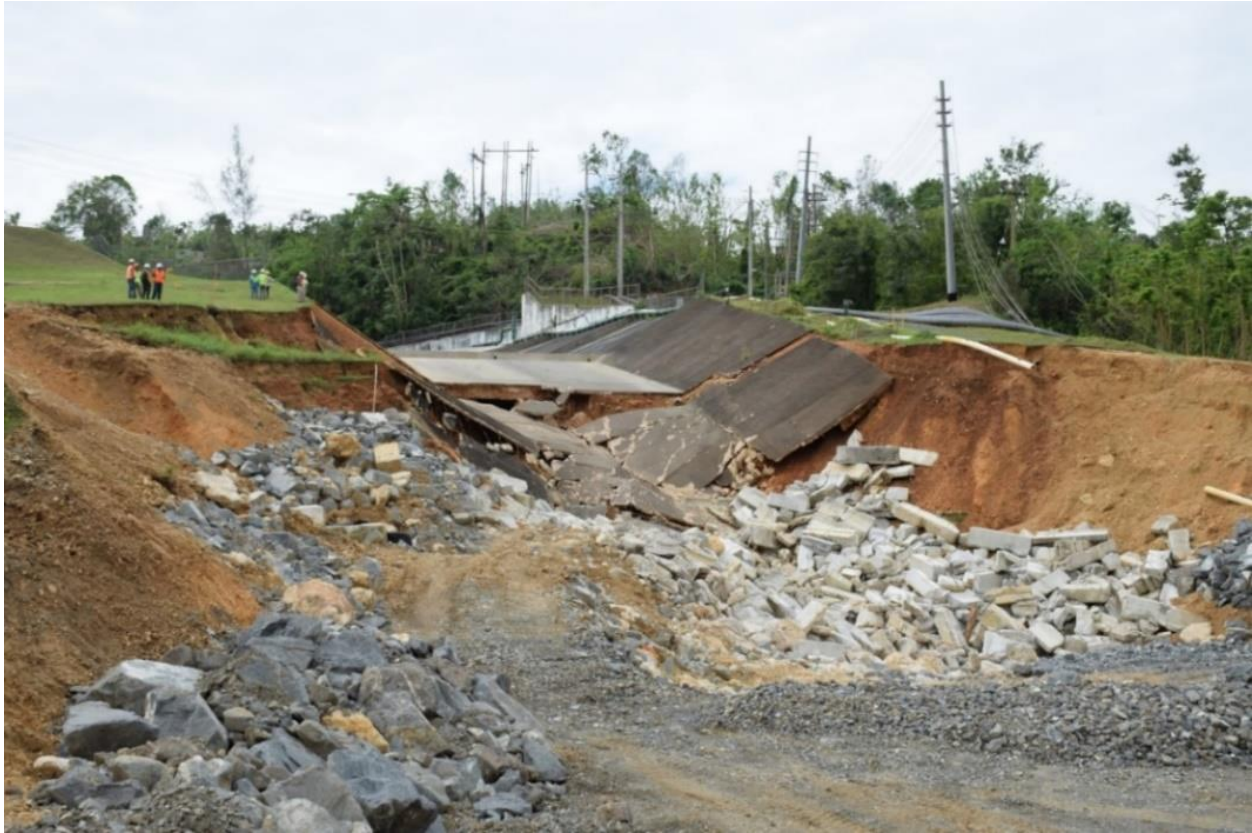
During Hurricane Maria, scour severely damaged the spillway and siphon at Guajataca Dam, as shown in Figure 10. The siphon, replaced by pumps after the damage from the hurricane, supplied raw water for the Aqueduct and Sewer Authority pump located near the reservoir. Concerns about the dam's stability prompted emergency remedial measures and the evacuation of about 70,000 residents located downstream of the dam. The maximum reservoir elevation that resulted from Hurricane Maria remains unknown.

Figure 10. Damaged condition of Guajataca Dam spillway (Silva-Tulla et al., 2018).

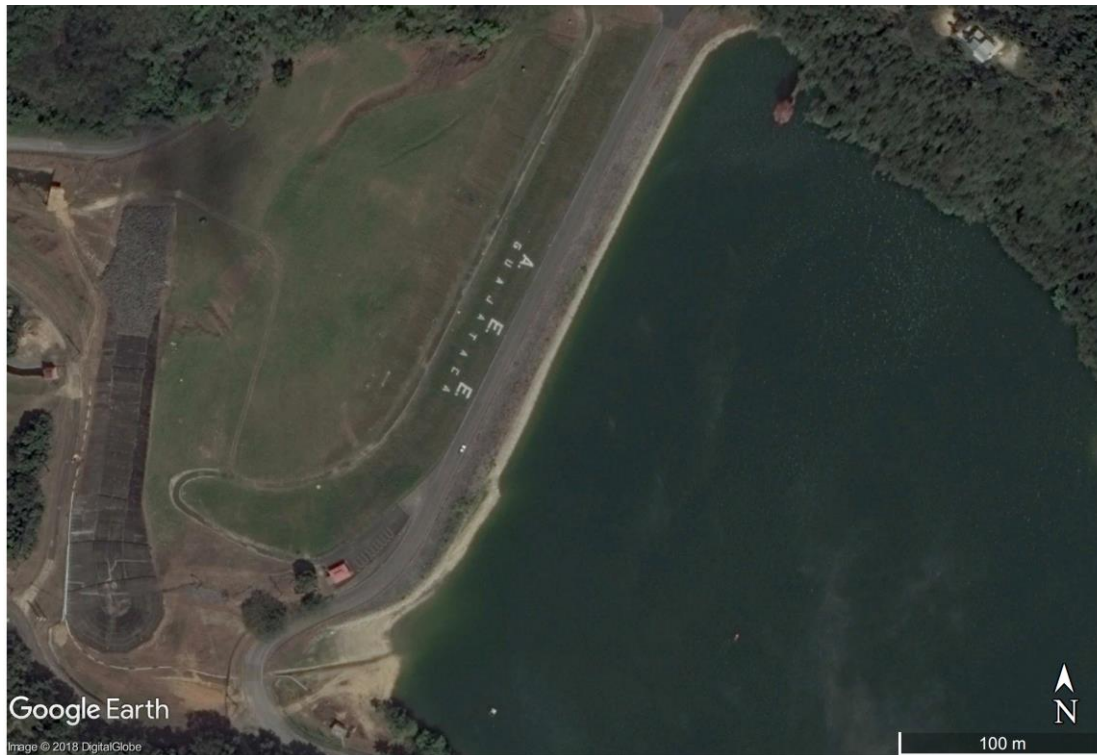
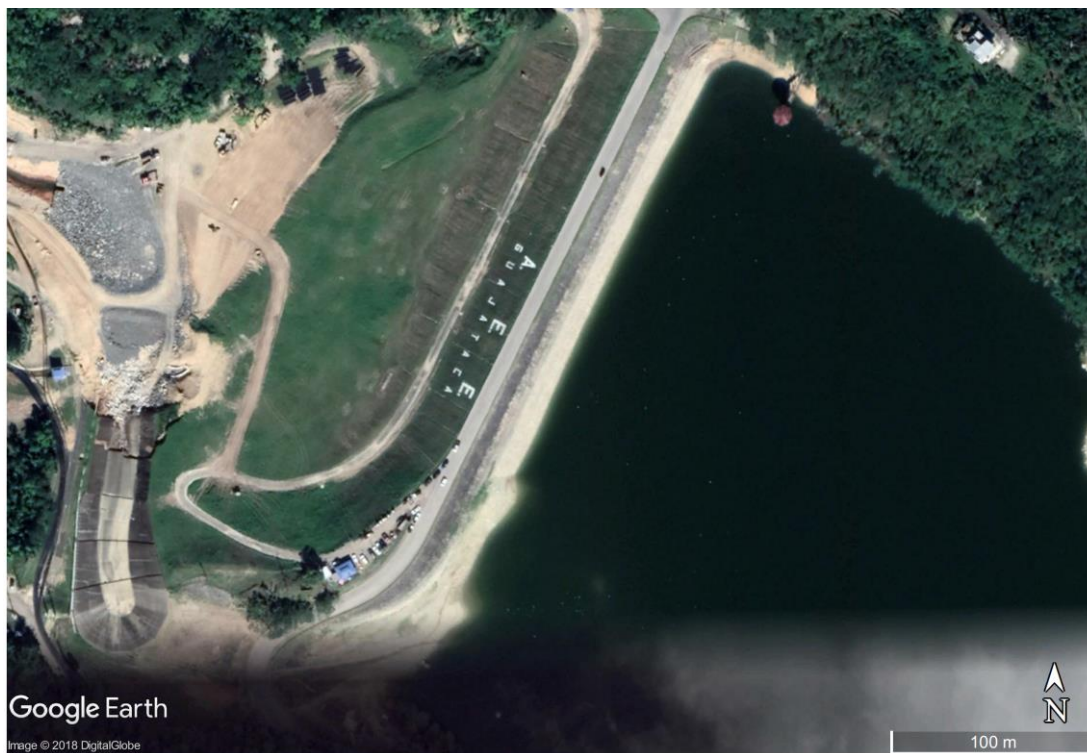
The Google Earth aerial image shown in Figure 11(a) shows the spillway, apparently in good condition in March 2017. In contrast, a Google Earth image from November 2017, shown in Figure 11(b), illustrates significant damage after Hurricane Maria. Figure 11(b) shows that about 100 m (300 ft) of spillway was completely destroyed (roughly 40 m of concrete and 60 m of riprap), and that an additional 25 m of concrete spillway was significantly undermined and displaced. A siphon located under the spillway was also destroyed. Aerial photographs taken during the aftermath of Hurricane Maria show water spilling out of the upstream side of the siphon (on the north side of the spillway), indicating that the siphon was operational during Hurricane Maria. Scour depths below the spillway could not be measured since the area had already been partly filled, but photographs and witness accounts indicate that extensive scour occurred.

Figure 11. Comparison of the Guajataca Dam condition between March and November 2017.

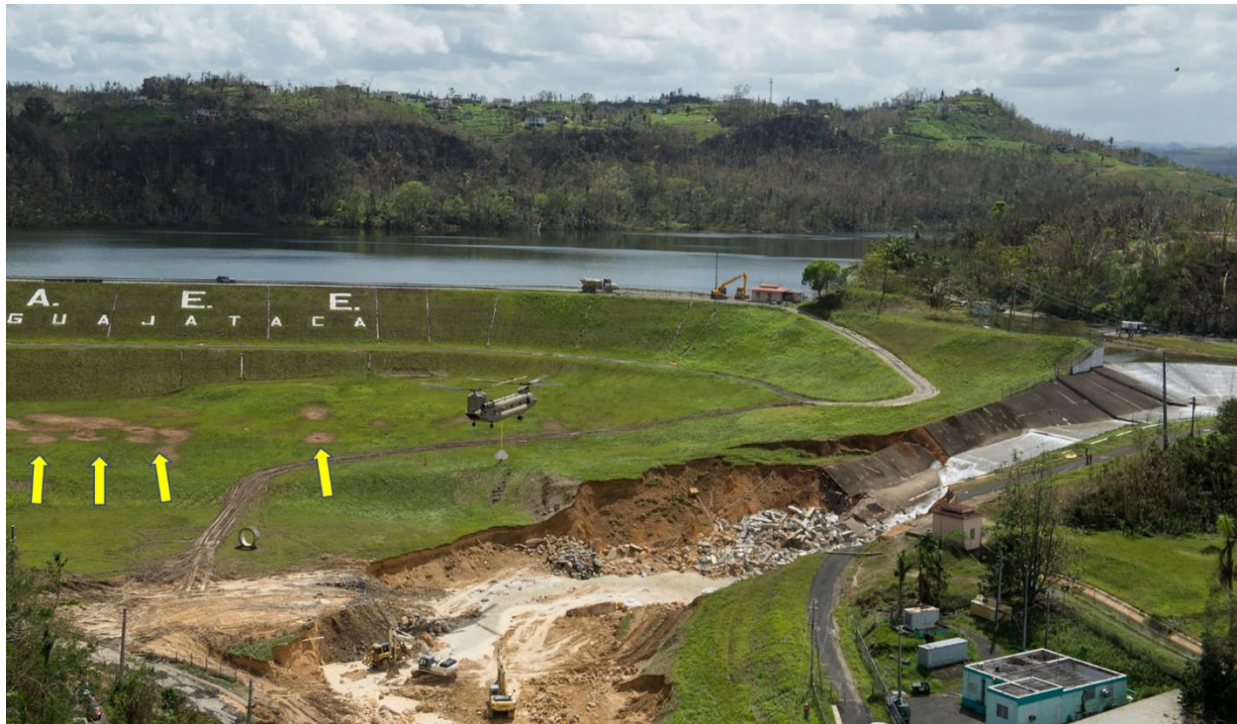
What appear to be sand boils along the toe of the earth dam suggest that its foundation materials were also subject to soil transport during Hurricane Maria (Figure 12). The seepage path and source of the eroded materials remain unknown, and considerable uncertainty exists about the origin and nature of the features shown in Figure 12. The GEER team observed water, soil, and other debris in the capped piezometer protective pipes consistent with a recent spike in groundwater pressures. During their visit, the team noted a large void approximately 0.3 m in diameter, located 10 m downstream of the toe and directly downstream of the “A” of the AEE sign on the downstream slope. Excavations, structures, poles, or posts were not reported or visible in aerial photographs near the location of the reported cavity. It seems possible that the void was either created or exacerbated by underseepage resulting from high hydraulic head during Hurricane Maria (Silva-Tulla et al., 2018).

Note: Yellow arrows show location of apparent sand boils downstream of the dam toe.

Figure 12. Apparent sand boils downstream of the dam toe (photograph from the Pennsylvania National Guard; figure adapted from Silva-Tulla et al., 2018).

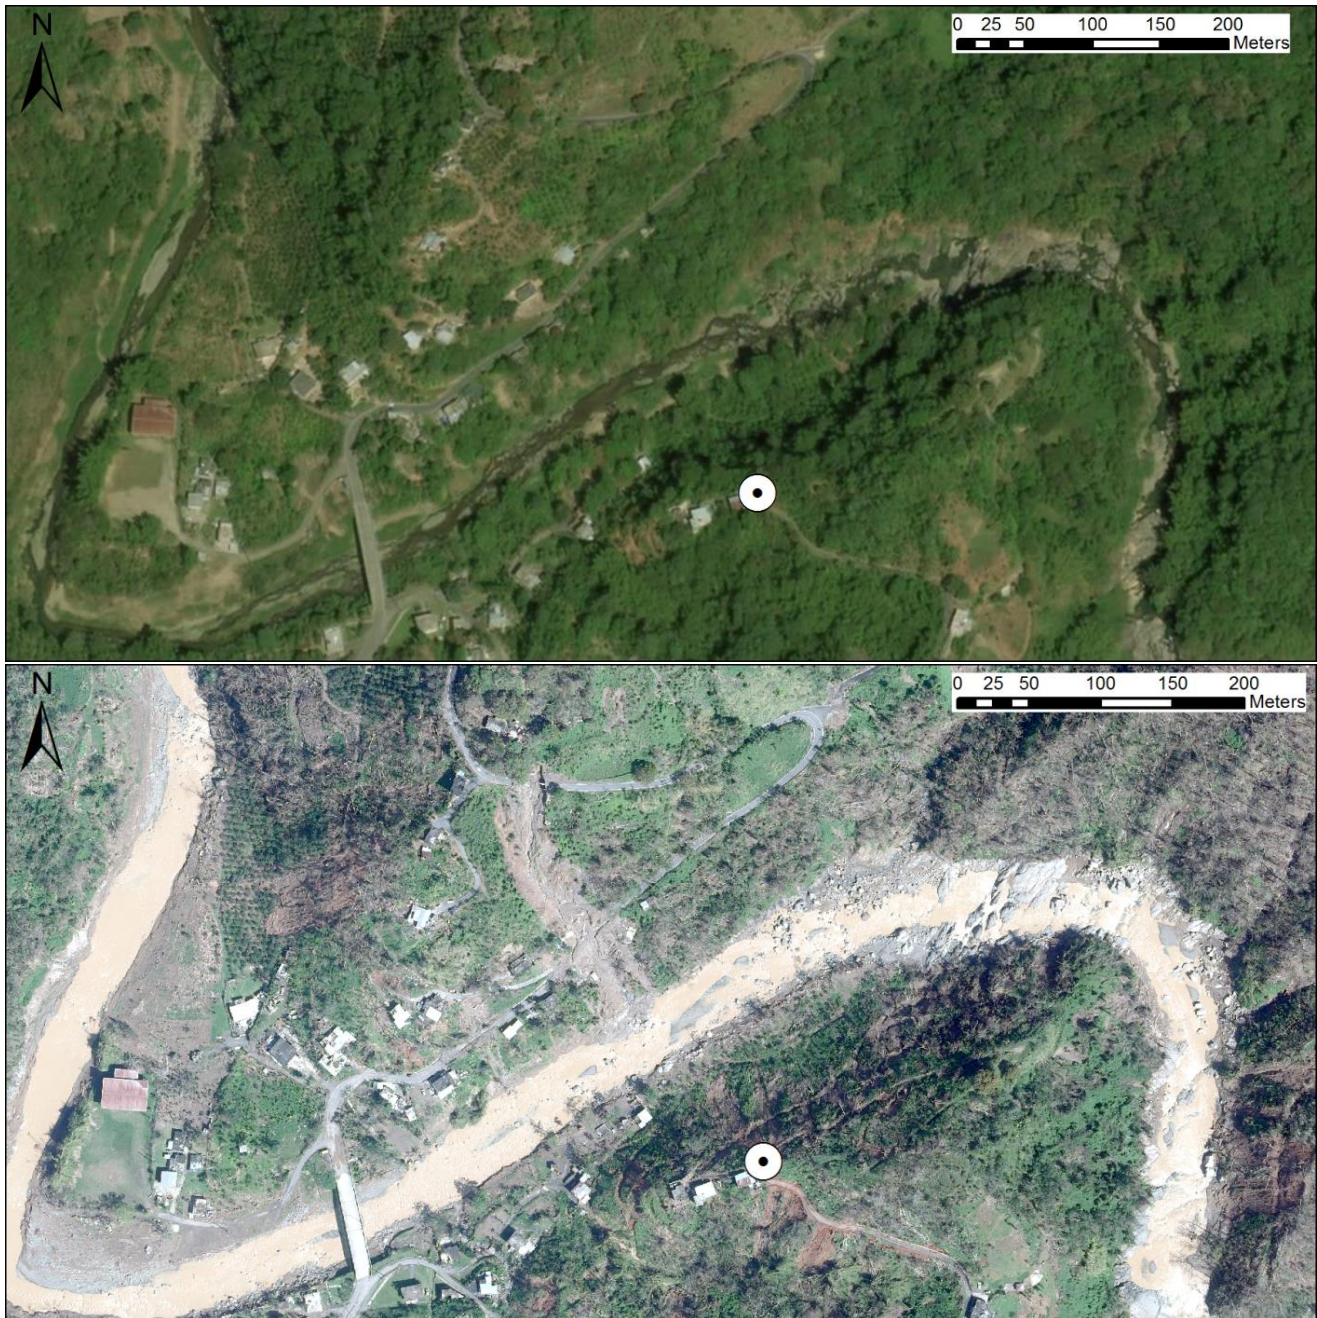
Figure 17. Aerial photos of debris flow site on PR-4131 in central Lares along the Rio Blanco (Silva-Tulla et al., 2018).

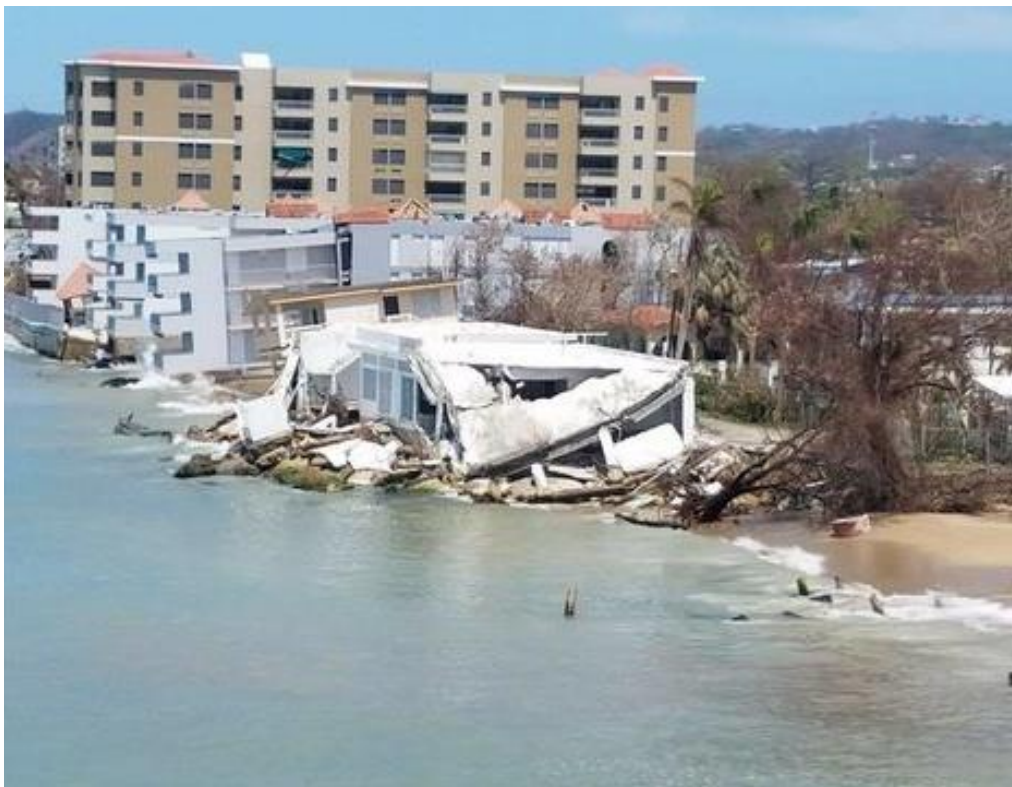
After Hurricane Maria, several buildings in the area of Site CE3 suffered severe damage, as shown in Figure 20. This figure shows extensive damage from waves or scour at the three-story Rincón Ocean Club I building, which was supported on shallow footings, and at the common areas of the terrace and swimming pool. A large volume of soil eroded from the front of the buildings and from beneath the swimming pool. Footings and beams supporting the terrace were exposed and sheared off from the building foundation. Part of Building A collapsed into the ocean and what remained standing was severely cracked. The Victoria Del Mar Condominium, the tallest building in this area and located to the north of Rincón Ocean Club I, also suffered extensive damage due to coastal scour. The terrace and swimming pool area of this condominium collapsed thanks to the storm.

Figure 20. Oceanfront damage in Córcega Beach area (Site CE3; Silva-Tulla et al., 2018).

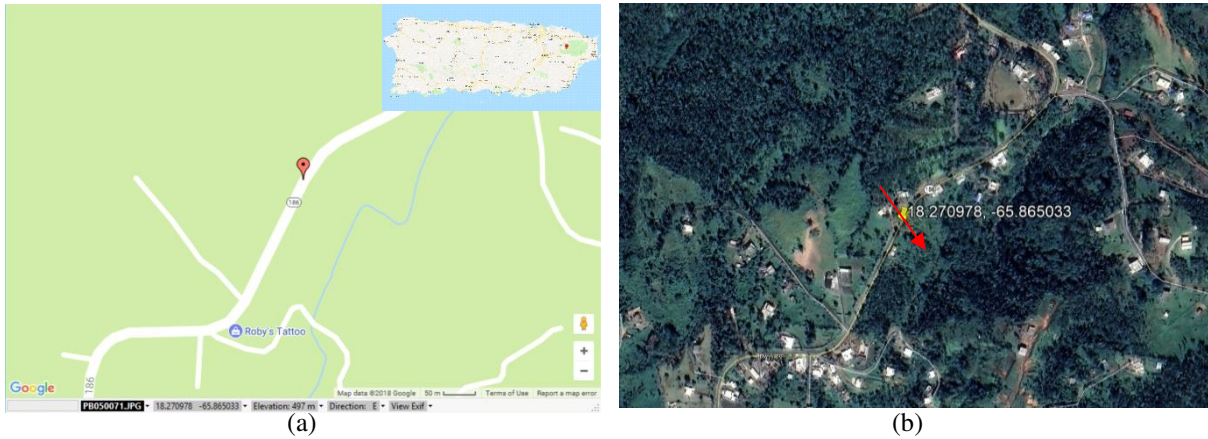
Figure 23(a) shows the location of a road failure on the northeast side of the island near the west boundary of the El Yunque National Rain Forest, along road PR-186. The failure affected the full width of PR-186 and the entrance driveway of a residence on the west side of the road (upslope side). The arrow shown in Figure 23(b) points toward the slope failure direction (southeast). Figure 23(c) shows the upper portion of the failure that resulted in a complete cut-off of PR-186. Figure 23(c)

shows a portion of the concrete pavement driveway of a residence to the left of the image (residence not shown); the final position of the piece of concrete driveway is shown inside the red oval. Additional exemplifying photos are shown in Figures 23 (d), (e), and (f). The arrows in Figure 23(f) point toward the slope failure direction (southeast).

Figure 23. Road failure affecting PR-186 (GEER mission Site 7; Silva-Tulla et al., 2018).
