Geotechnical Extreme Event Site Reconnaissance in Puerto Rico After The Passage of Hurricane Maria

This paper summarizes observations on geotechnical impacts such as: the Guajataca Dam spillway failure, coastal erosion events (including foundation failures due to coastal erosion in Córcega, Rincón), bridge abutment scour failures, over 2,000 landslides along the PR highway system (e.g., along the PR-10, region of Lares, Barranquitas and Utuado); foundation failures, and other failures related to this destructive hurricane. Rainfall-induced landslides in Puerto Rico have been a serious recurring problem (e.g., Jibson, 1987; Larsen and Simon, 1993; Larsen and Santiago-Roman, 2001; Pando et al., 2005) observed in the different physiographic regions of the island as result of Maria and other hurricanes such as Hortense (1996), Georges (1998), and Debby (1999). The passage of Hurricane Maria triggered thousands of landslides, with the most common type of failure mode consisting of shallow debris flows. However, many deeper-seated failures were also observed, typically at sites with a road fill and blocked drainage. The geotechnical failures presented in this article provide insight to

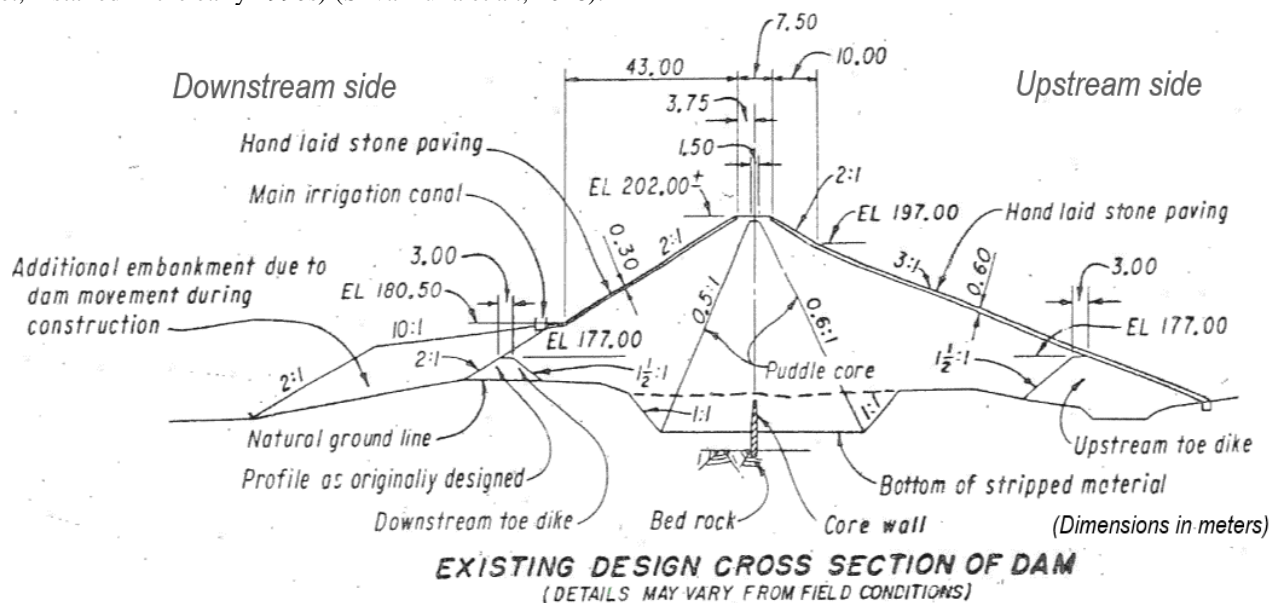
Figure 9. Cross-section of Guajataca Dam from the 1920s (date of drawing is unknown; USBR, 2002).

Figure 9 shows the cross section of Guajataca Dam, as reported by USBR (2002). Available records suggest that a large part of the dam consists of hydraulic fill, but its internal geometry and composition remain unclear. For example, the center of the dam is reported as a “puddle core”, but the USBR (2002) report suggests that the hydraulic fill process left the coarsest fill materials near the dam faces and the finest in the core area. The same report indicates that fill placement was changed to “dry” roller compaction in 1927 to address field observations of dam instability. Instability during the initial construction of the dam was reported in February 1927 as cracks, slippage, and other signs of movement, including bulging and settlement of the cofferdams. Reportedly, many locations showed movements on both the dam and the downstream natural ground; maximum movements included a 0.96 m (3.2 ft) downstream horizontal displacement and 1.44 m (4.7 ft) of vertical settlement.

Figure 9 shows the remedial berm constructed on the downstream side of the dam early in 1927 after the reservoir was drained, implemented to stabilize the ongoing sliding in the downstream direction. USBR (2002) also indicates that stabilization measures included the installation of numerous drain holes and replacing the fill placement technique to “dry” roller compaction. As construction of the dam proceeded, new movements of up to 35 cm (14 in) were reported on the upstream face and a heel was installed (location unknown). The USBR (2002) report indicates that in November 1927, as the dam was nearing completion, movements reported as “creep-type” were still observed. To enhance stability, fill was placed at the toe of the dam. The USBR (2002) report indicates that crest movements were measured during the years following the original dam’s completion. Movement varied from about 35 cm/yr (13.2 in/yr) between 1927 and 1929 to about 1 cm/yr (0.4 in/yr) between 1942 and 1951. In 1954, about 2,000 m³ of fill were added to the crest area to restore its original elevation.

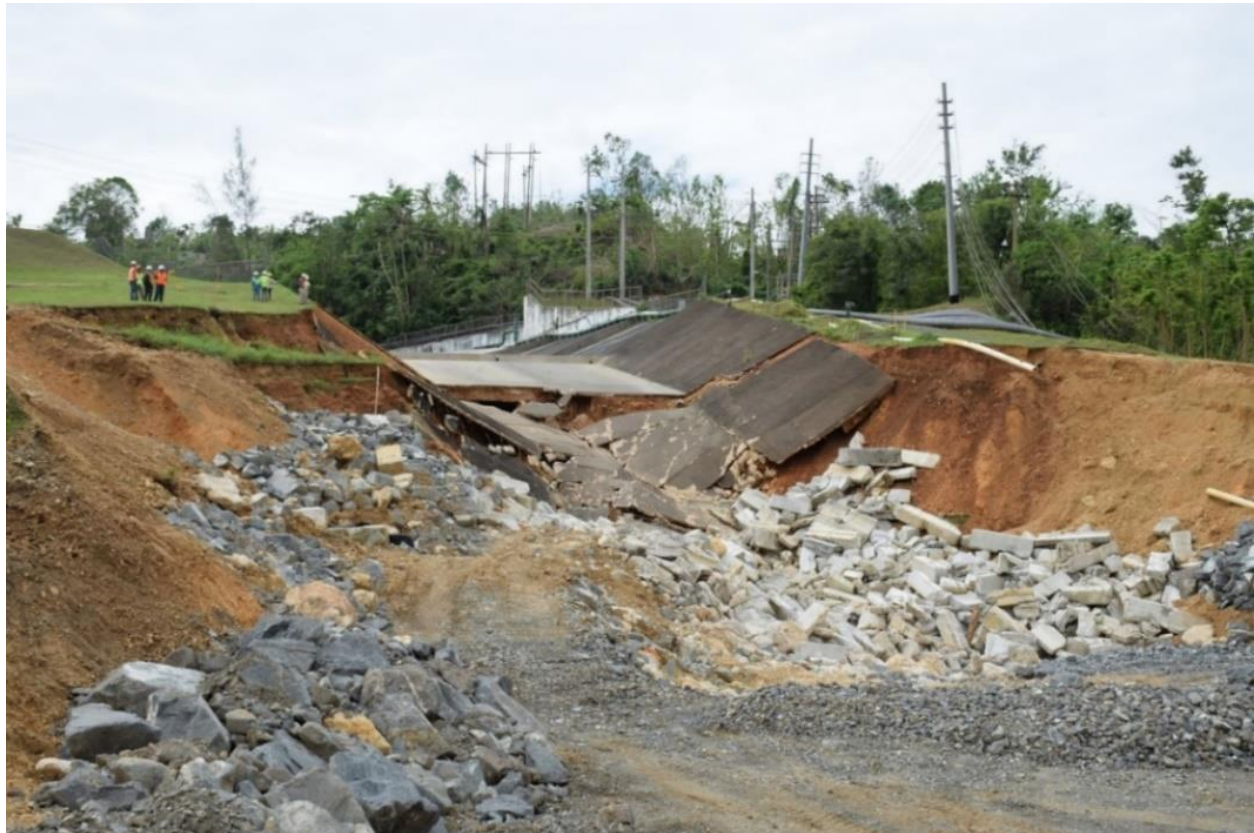
Figure 10. Damaged condition of Guajataca Dam spillway (Silva-Tulla et al., 2018).

During Hurricane Maria, scour severely damaged the spillway and siphon at Guajataca Dam, as shown in Figure 10. The siphon, replaced by pumps after the damage from the hurricane, supplied raw water for the Aqueduct and Sewer Authority pump located near the reservoir. Concerns about the dam's stability prompted emergency remedial measures and the evacuation of about 70,000 residents located downstream of the dam. The maximum reservoir elevation that resulted from Hurricane Maria remains unknown.

(Photo location: Lat. +18.39717° Lon. -66.92759°, photo taken 10/30/2017 looking south)

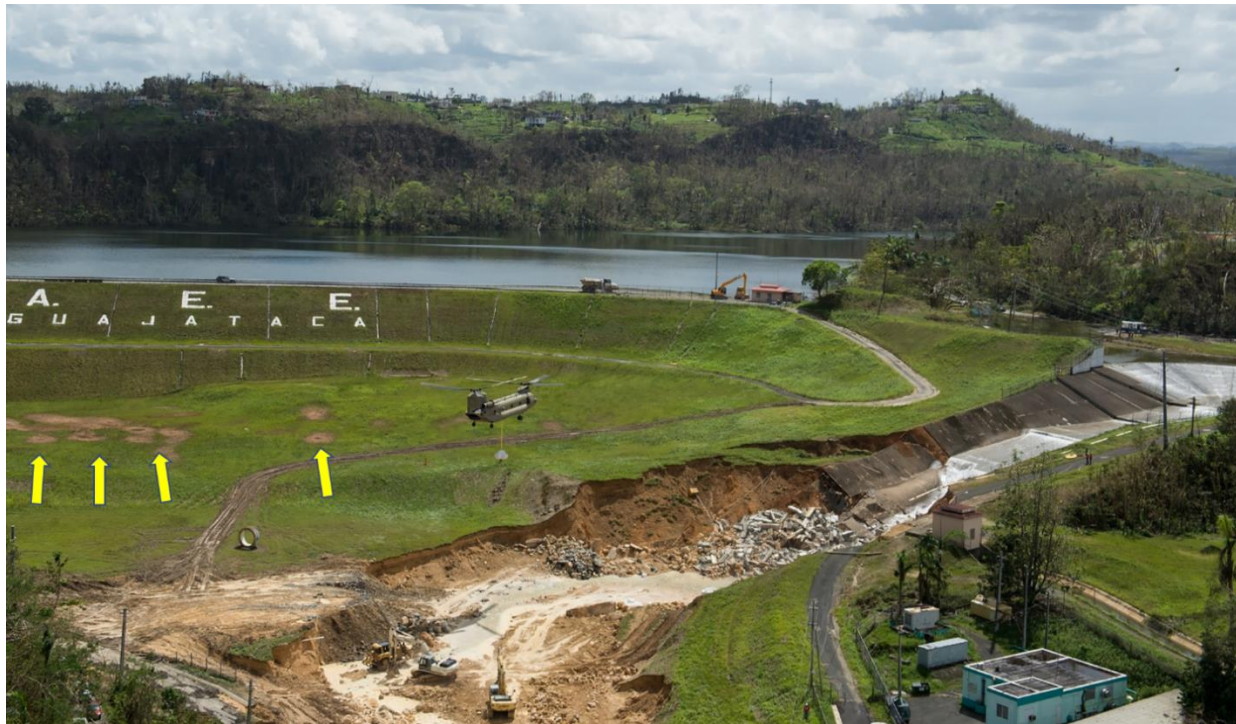
Figure 12. Apparent sand boils downstream of the dam toe (photograph from the Pennsylvania National Guard; figure adapted from Silva-Tulla et al., 2018).

What appear to be sand boils along the toe of the earth dam suggest that its foundation materials were also subject to soil transport during Hurricane Maria (Figure 12). The seepage path and source of the eroded materials remain unknown, and considerable uncertainty exists about the origin and nature of the features shown in Figure 12. The GEER team observed water, soil, and other debris in the capped piezometer protective pipes consistent with a recent spike in groundwater pressures. During their visit, the team noted a large void approximately 0.3 m in diameter, located 10 m downstream of the toe and directly downstream of the “A” of the AEE sign on the downstream slope. Excavations, structures, poles, or posts were not reported or visible in aerial photographs near the location of the reported cavity. It seems possible that the void was either created or exacerbated by underseepage resulting from high hydraulic head during Hurricane Maria (Silva-Tulla et al., 2018).

Note: Yellow arrows show location of apparent sand boils downstream of the dam toe.

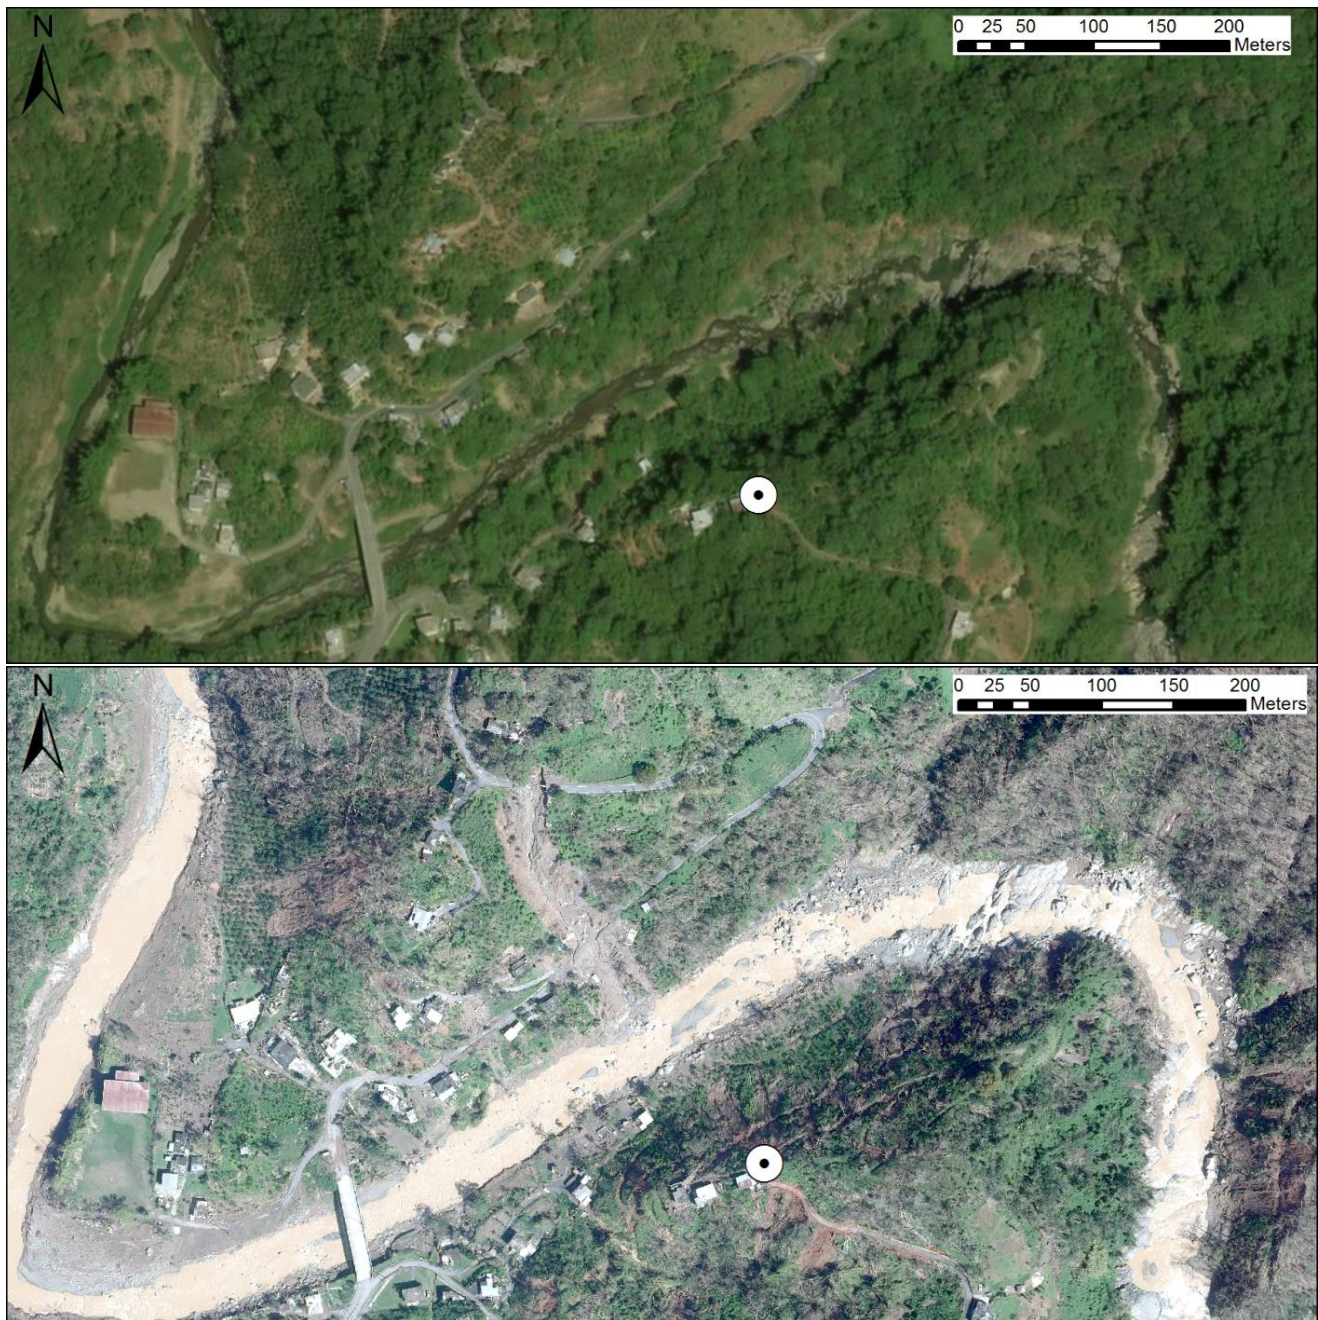
Figure 17. Aerial photos of debris flow site on PR-4131 in central Lares along the Rio Blanco (Silva-Tulla et al., 2018).

Note: Upper image taken before Hurricane Maria. Lower photo captured by FEMA on October 12, 2017. The white circle with black center dot indicates the location of the TLS Lidar performed in January 2018.

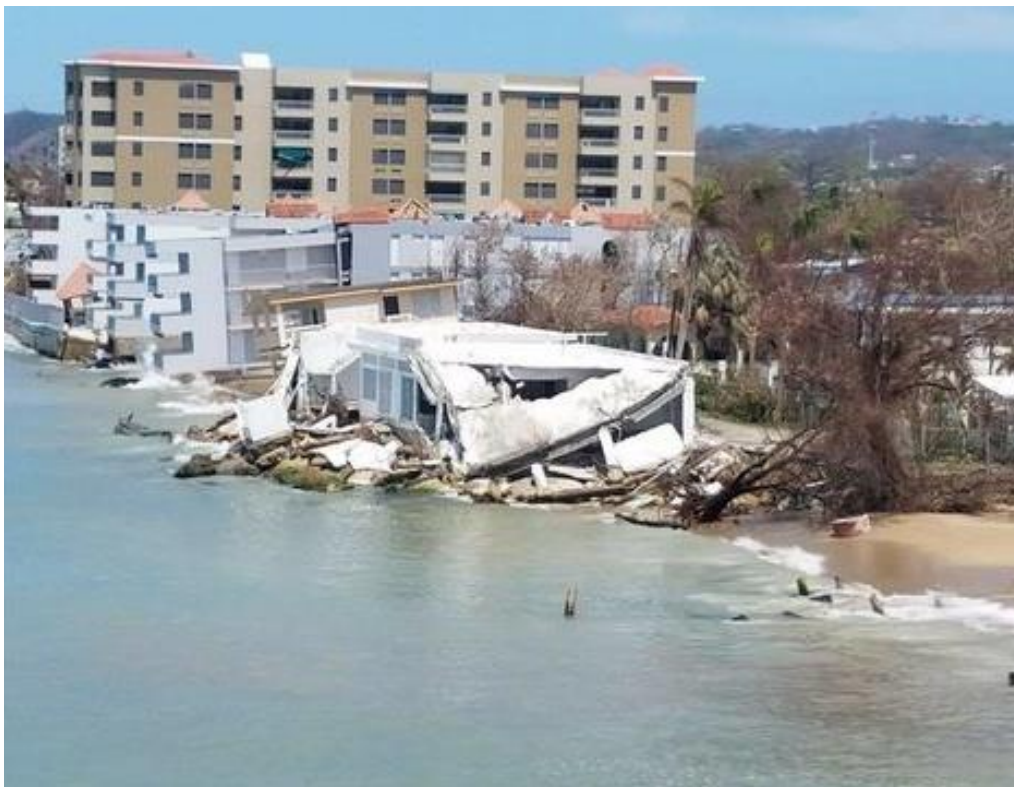
Figure 20. Oceanfront damage in Córcega Beach area (Site CE3; Silva-Tulla et al., 2018).

After Hurricane Maria, several buildings in the area of Site CE3 suffered severe damage, as shown in Figure 20. This figure shows extensive damage from waves or scour at the three-story Rincón Ocean Club I building, which was supported on shallow footings, and at the common areas of the terrace and swimming pool. A large volume of soil eroded from the front of the buildings and from beneath the swimming pool. Footings and beams supporting the terrace were exposed and sheared off from the building foundation. Part of Building A collapsed into the ocean and what remained standing was severely cracked. The Victoria Del Mar Condominium, the tallest building in this area and located to the north of Rincón Ocean Club I, also suffered extensive damage due to coastal scour. The terrace and swimming pool area of this condominium collapsed thanks to the storm.

The beachfront in the Córcega Beach area suffered extensive coastal scour. The approximately 6 to 9 m (20 to 30 ft) of beachfront shown in the pre-storm photo (Figure 19) was drastically reduced at the time of the site reconnaissance. The GEER Team did not observe sand washout deposits or shoreline erosion protection measures during the field reconnaissance of Site CE3. Unfortunately, there were no storm tide sensors available near Rincón to help assess tidal levels or the magnitude of wave action during this hurricane. However, NOAA (2017) reported highest water levels of 0.3 to 0.6 m (1 to 2 ft) above maximum higher high water (MHHW) for the northwest coastline of PR, where MHHW is defined as the average daily highest tide. This is consistent with a high-water elevation mark data recorded at USGS Stations (Silva-Tulla et al, 2018).

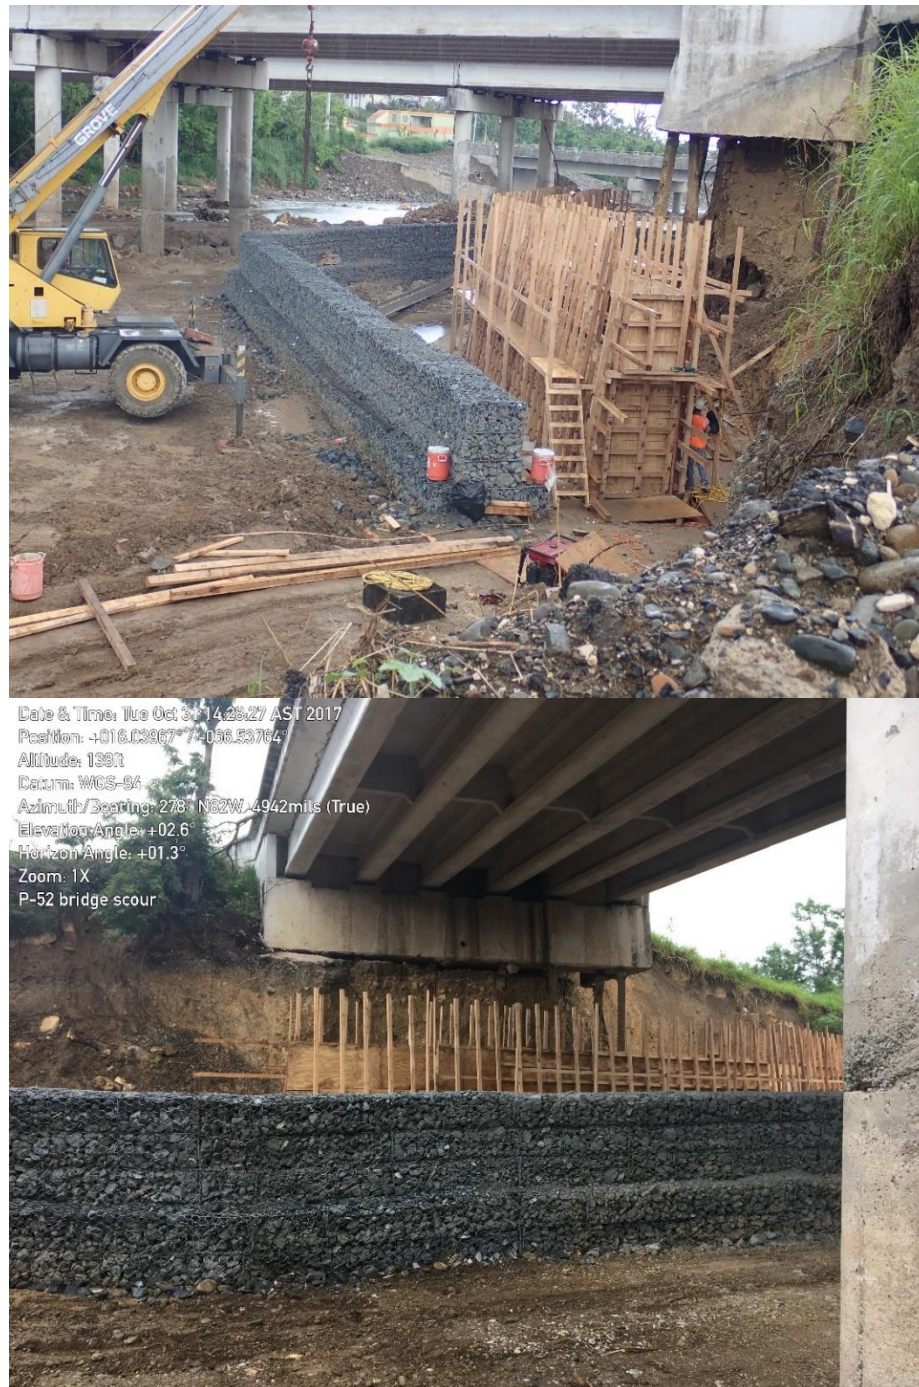
Figure 21: Photos of west abutment of westbound Highway 52 Bridge over the Inabón River (October 31, 2017; Silva-Tulla et al., 2018).

On October 31, 2017, the GEER team observed scour and erosion near the piers and abutments of Highway 52 bridges over the Inabón River at site RE1, just east of the city of Ponce, PR. Figure 21 shows select photos taken during the site visit. The photos show exposed abutment H-piles and ongoing emergency work, including the erection of formwork for abutment repairs and a temporary protective gabion wall. The gabion wall should protect the abutment and reinforced concrete shield under construction in front of the original exposed piles.

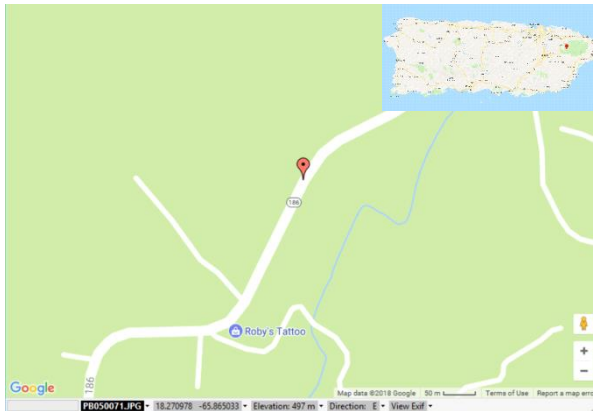
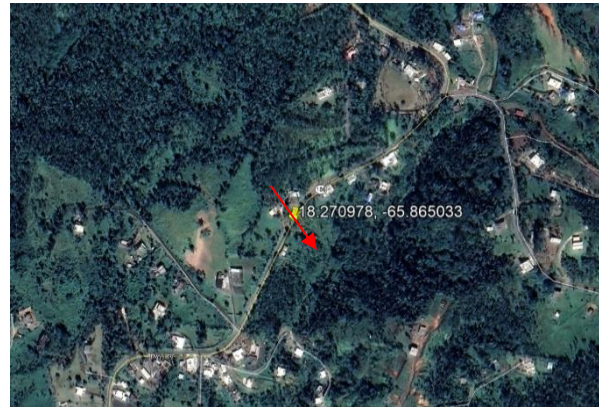
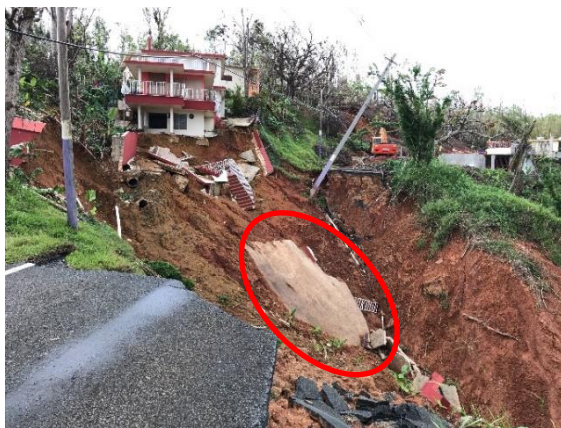
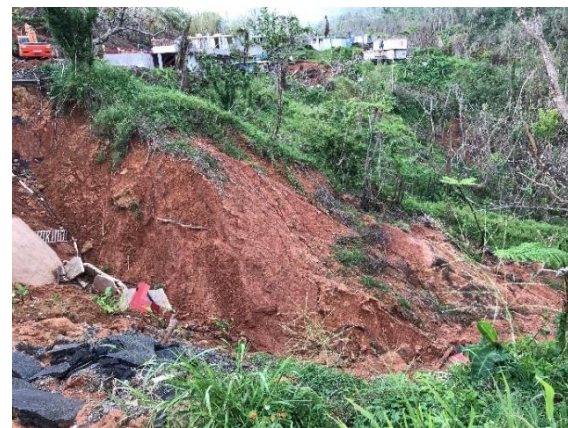
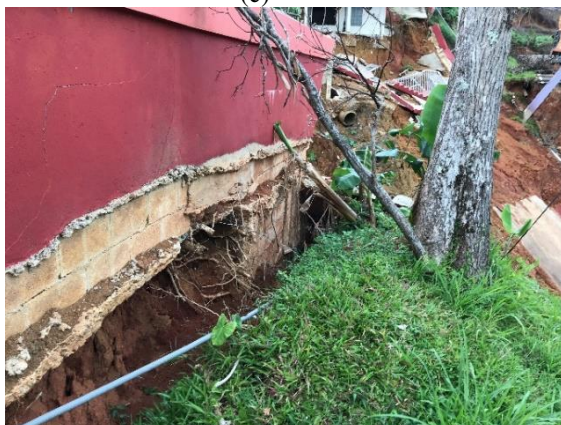
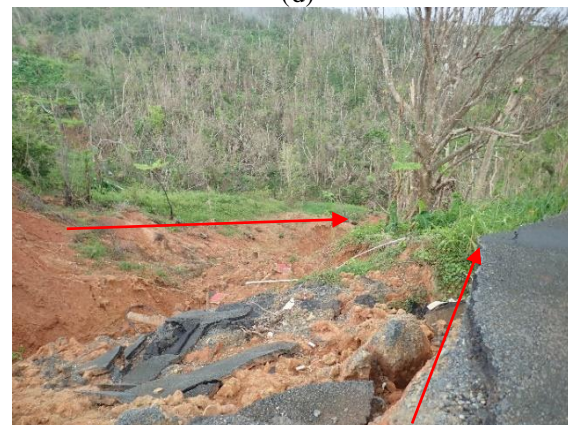
Figure 23. Road failure affecting PR-186 (GEER mission Site 7; Silva-Tulla et al., 2018).

Figure 23(a) shows the location of a road failure on the northeast side of the island near the west boundary of the El Yunque National Rain Forest, along road PR-186. The failure affected the full width of PR-186 and the entrance driveway of a residence on the west side of the road (upslope side). The arrow shown in Figure 23(b) points toward the slope failure direction (southeast). Figure 23(c) shows the upper portion of the failure that resulted in a complete cut-off of PR-186. Figure 23(c)

shows a portion of the concrete pavement driveway of a residence to the left of the image (residence not shown); the final position of the piece of concrete driveway is shown inside the red oval. Additional exemplifying photos are shown in Figures 23 (d), (e), and (f). The arrows in Figure 23(f) point toward the slope failure direction (southeast).
