Geotechnical Extreme Event Site Reconnaissance in Puerto Rico After The Passage of Hurricane Maria

Francisco Silva-Tulla, Consulting Civil Engineer, GeoEngineering and Environment, Lexington, Massachusetts, U.S.A.; email: silva@alum.mit.edu

Miguel A. Pando, Associate Professor, Department of Civil, Architectural, and Environmental Engineering, Drexel University, Philadelphia, PA, 19104, U.S.A.; email: miguel.a.pando@drexel.edu

Reference: Silva-Tulla F., and Pando M. A. (2020). Geotechnical Extreme Event Site Reconnaissance in Puerto Rico after the Passage of Hurricane Maria. International Journal of Geoengineering Case Histories, Volume 5, Issue 4, pp. 1-25, doi: 10.4417/IJGCH-05-04-01

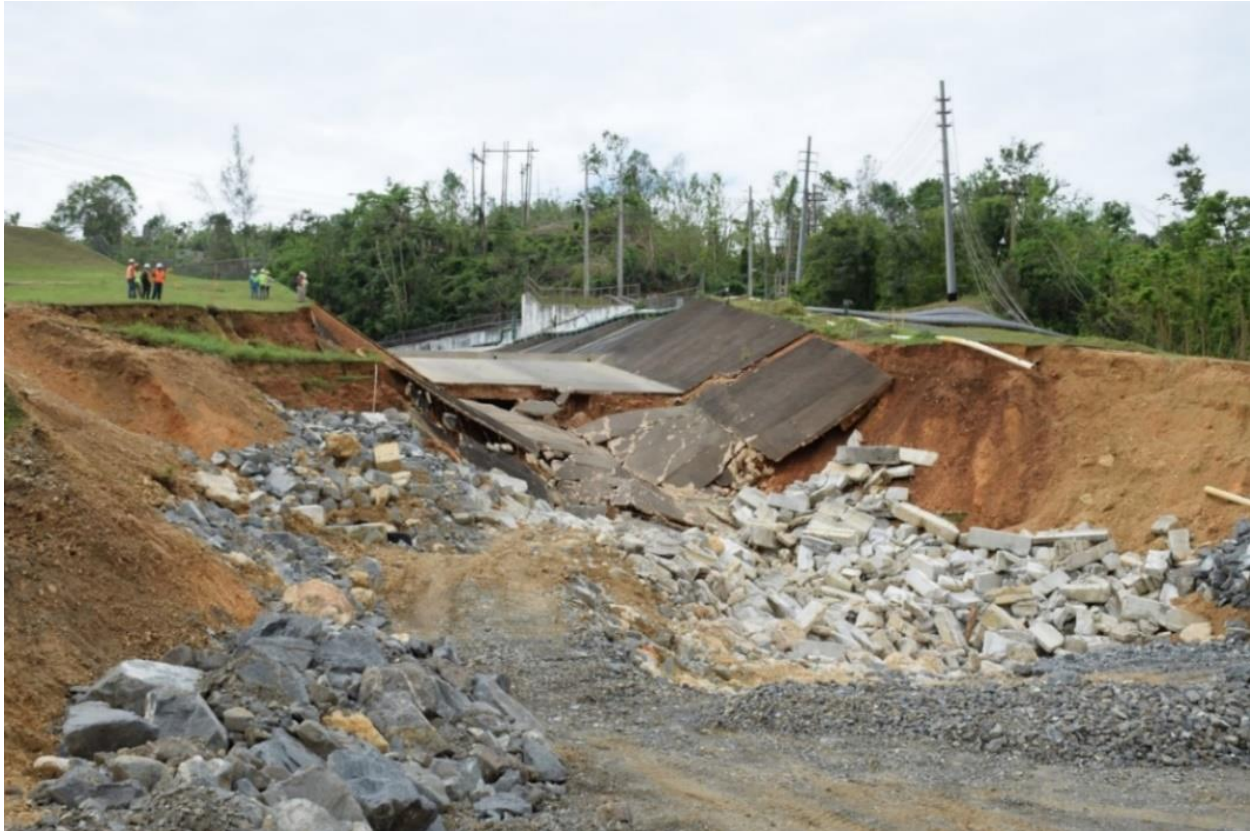
(Photo location: Lat. +18.39717° Lon. -66.92759°, photo taken 10/30/2017 looking south)

During Hurricane Maria, scour severely damaged the spillway and siphon at Guajataca Dam, as shown in Figure 10. The siphon, replaced by pumps after the damage from the hurricane, supplied raw water for the Aqueduct and Sewer Authority pump located near the reservoir. Concerns about the dam's stability prompted emergency remedial measures and the evacuation of about 70,000 residents located downstream of the dam. The maximum reservoir elevation that resulted from Hurricane Maria remains unknown.

Figure 10. Damaged condition of Guajataca Dam spillway (Silva-Tulla et al., 2018).

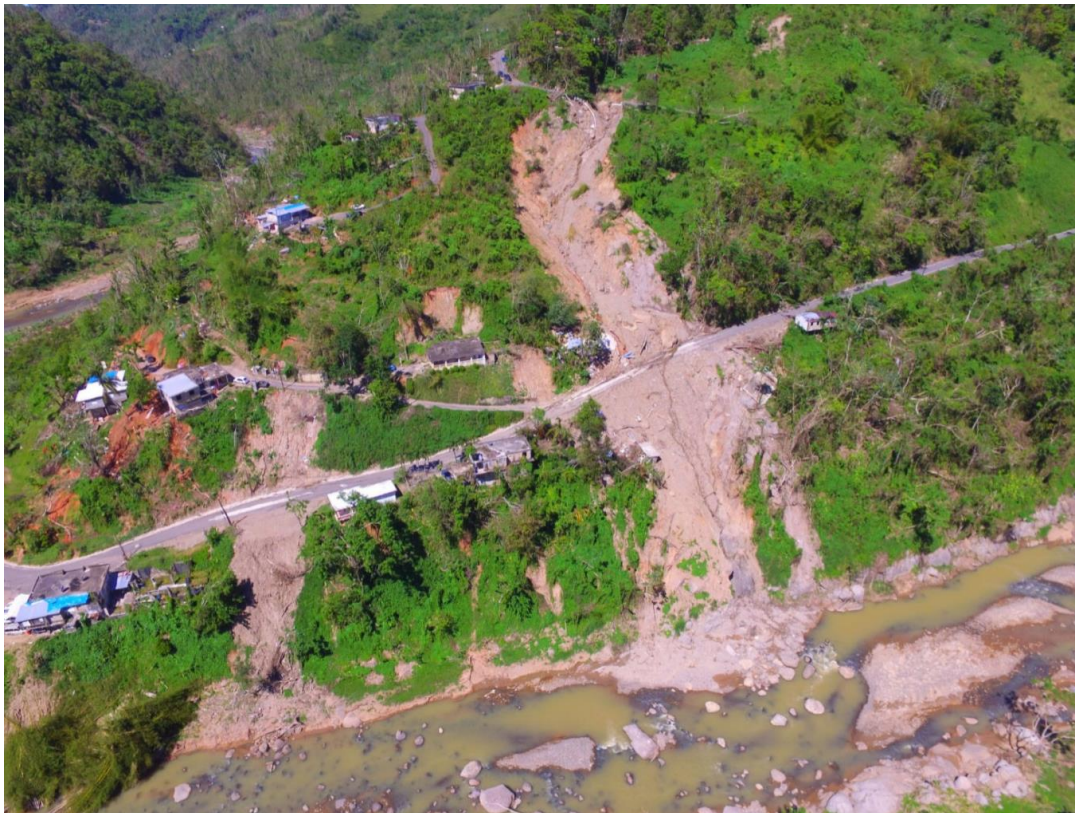
The majority of the slides shown in Figure 14 consisted of shallow debris flows. Figure 16 shows a site, visited by the GEER team, which was affected by some debris flows; this site is located along Puerto Rico State Road 4131 (PR-4131) near the Rio Blanco River in the municipality of Lares. The largest debris flow shown destroyed three homes along the lower road alignment (Silva-Tulla et al., 2018). Luckily, the inhabitants of those homes were not present at the time of the landslide. The debris flow initiated just above the highest road cut on a switchback along PR-4131. The upper area is the primary zone of volume loss, while the lower portion of the road was only covered by debris. The hillslope material slid directly into the river below, which carried much of the small- to medium-sized sediment downstream. Figure 17 shows aerial imagery of the landslide before and after Hurricane Maria.

Figure 16. Photo of debris flow above the Rio Blanco River along PR-4131 in Municipality of Lares (photo taken using UAV at location: Lat. +18.250348° Lon. -66.884155°, looking toward the North).

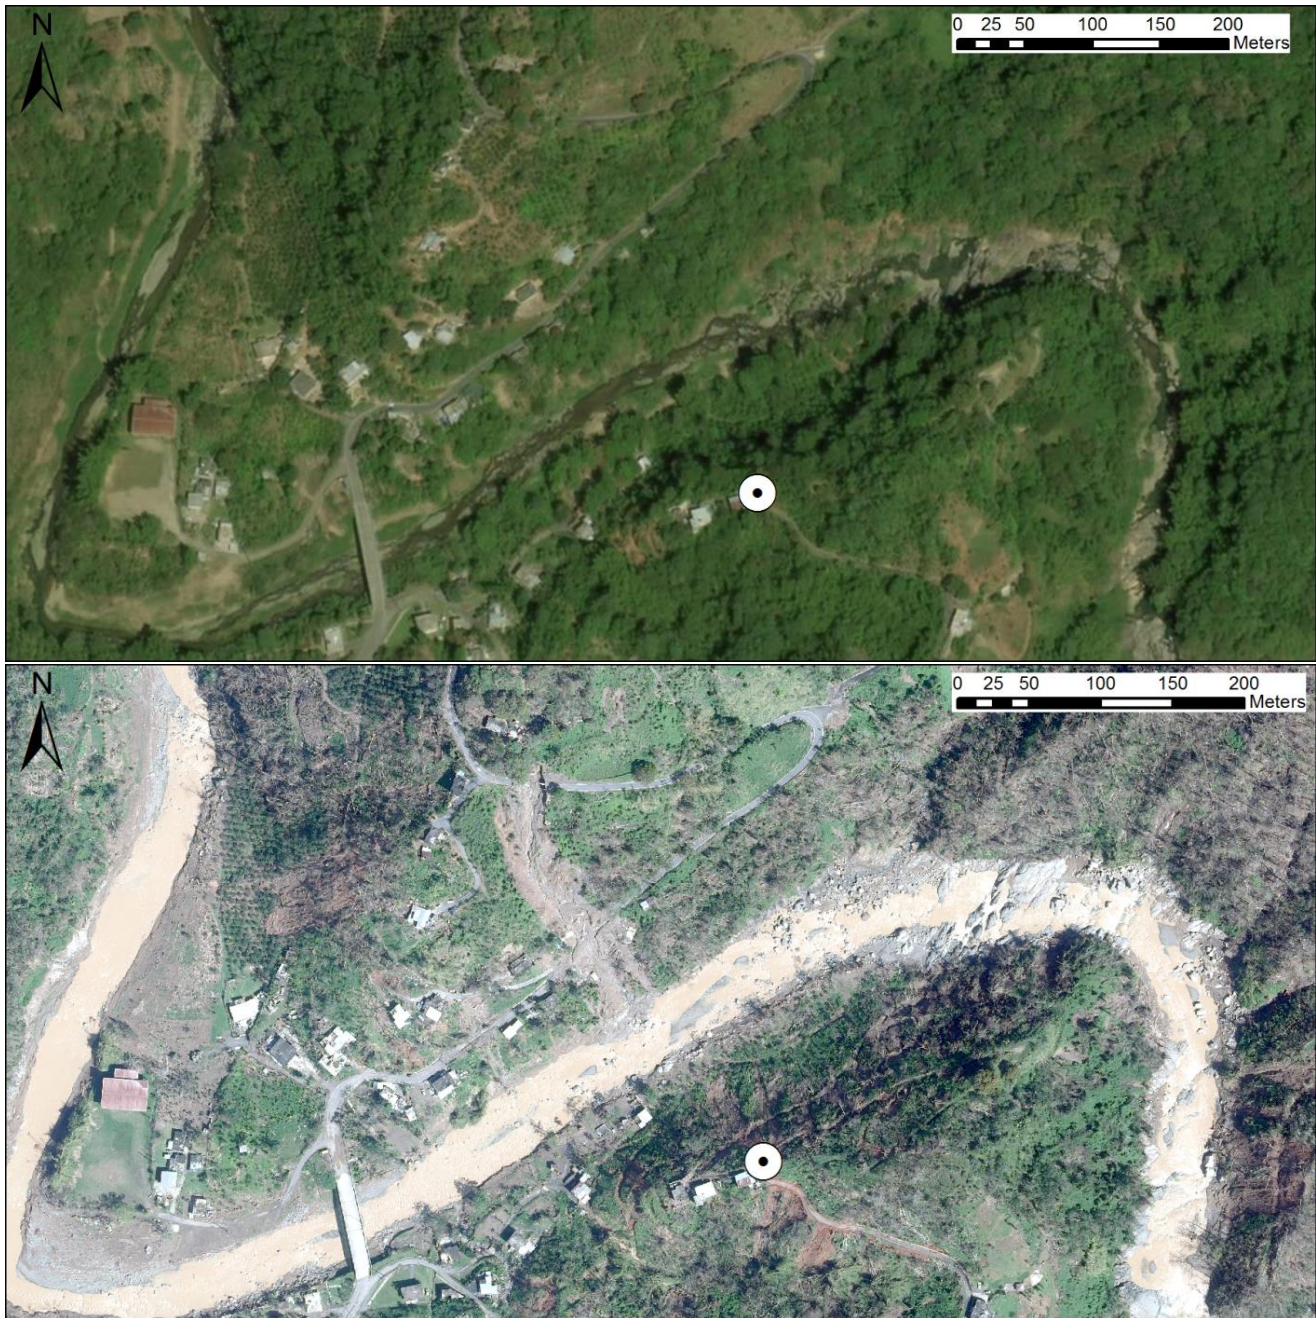
Figure 17. Aerial photos of debris flow site on PR-4131 in central Lares along the Rio Blanco (Silva-Tulla et al., 2018).

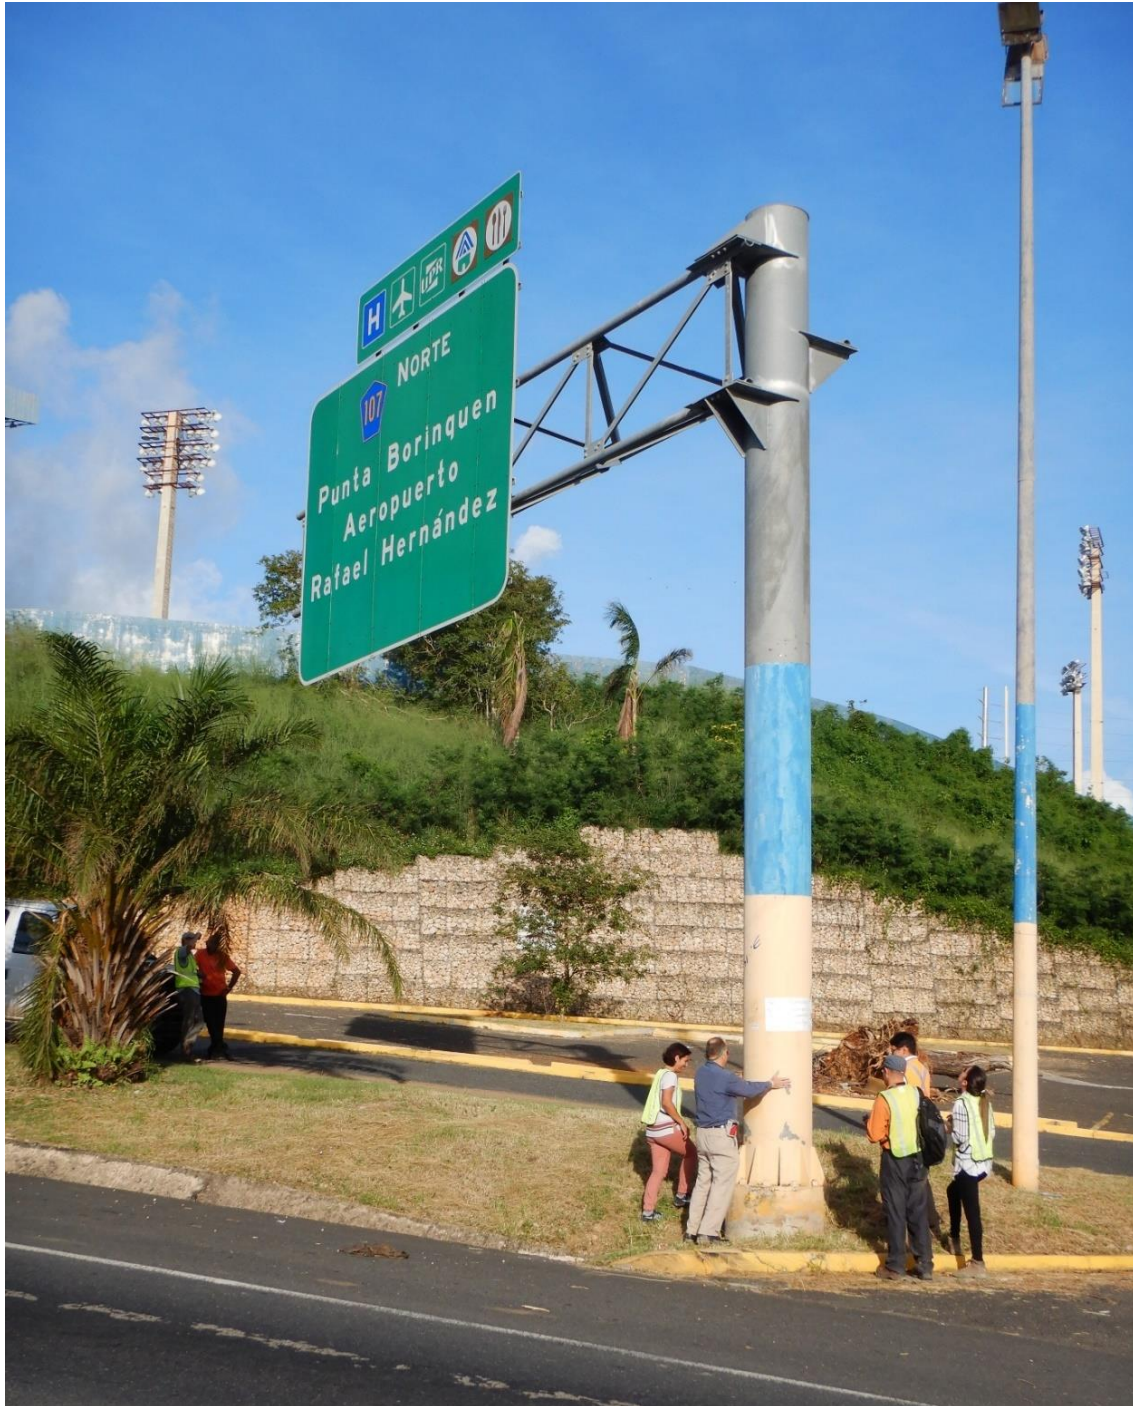
Note: Photo location: Lat: +018.436633°, Lon: -067.147746°; Date: October 30, 2017.

Foundation failures observed by the team included lighting towers, electrical transmission poles, and many road sign failures. Some of the road signs simply rotated about the axis of their circular drilled shaft foundation, while others also experienced bearing capacity failures. Although some electrical transmission poles failed from bearing capacity failures, the large number of reinforced concrete poles that had snapped at mid-height provided graphic evidence of the storm power. Figure 24 shows a representative torsional foundation failure of a highway sign structure.

Figure 24. Photo of cantilevered sign foundation failure (GEER Mission Site F2; Silva-Tulla et al. 2018).
