# Geotechnical Extreme Event Site Reconnaissance in Puerto Rico After The Passage of Hurricane Maria

ABSTRACT: The National Weather Service classified Hurricane Maria as a strong Category 4 Hurricane on the Saffir-Simpson hurricane wind scale at the time of its landfall in Yabucoa, Puerto Rico, U.S.A., on September 20, 2017. The immediate aftermath of Hurricane Maria was a devastated island with at least 64 people killed, severe infrastructure loss, a devastated electric power grid, and numerous geotechnical failures related to the intense rainfall and strong winds associated to this extreme event. This paper will summarize the event timeline and the geotechnical consequences of Maria's path across Puerto Rico. The impacts of Hurricane Maria on infrastructure and geomorphology are documented through the data and observations of the engineers and geologists that comprised the Geotechnical Extreme Events Reconnaissance (GEER) team. The main reconnaissance mission took place between October 25 and November 6, 2017, followed by a second field component involving terrestrial LiDAR surveys and UAV photogrammetry performed January 8 to 11, 2018.

Reference: Silva-Tulla F., and Pando M. A

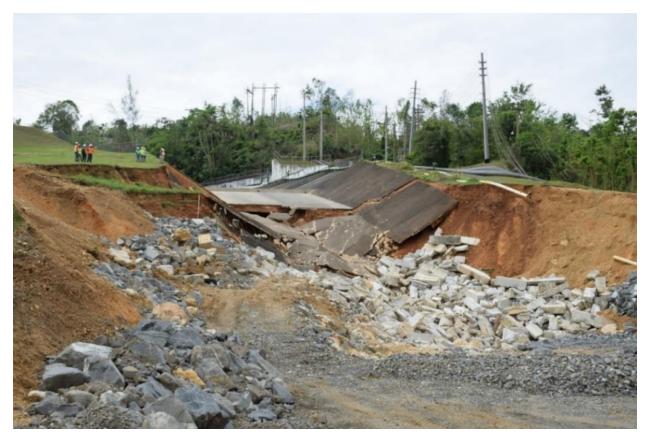
During Hurricane Maria, scour severely damaged the spillway and siphon at Guajataca Dam, as shown in Figure 10. The siphon, replaced by pumps after the damage from the hurricane, supplied raw water for the Aqueduct and Sewer Authority pump located near the reservoir. Concerns about the dam's stability prompted emergency remedial measures and the evacuation of about 70,000 residents located downstream of the dam. The maximum reservoir elevation that resulted from Hurricane Maria remains unknown.

Figure 10. Damaged condition of Guajataca Dam spillway (Silva-Tulla et al., 2018).

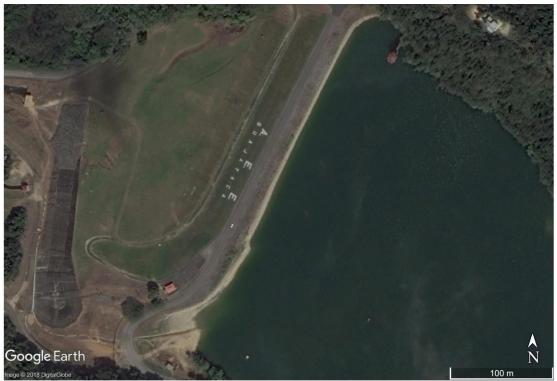
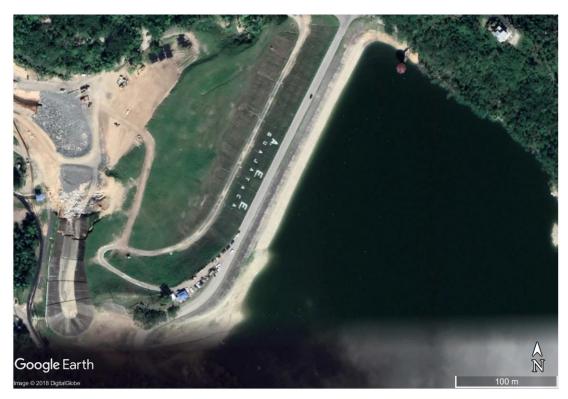
The Google Earth aerial image shown in Figure 11(a) shows the spillway, apparently in good condition in March 2017. In contrast, a Google Earth image from November 2017, shown in Figure 11(b), illustrates significant damage after Hurricane Maria. Figure 11(b) shows that about 100 m (300 ft) of spillway was completely destroyed (roughly 40 m of concrete and 60 m of riprap), and that an additional 25 m of concrete spillway was significantly undermined and displaced. A siphon located under the spillway was also destroyed. Aerial photographs taken during the aftermath of Hurricane Maria show water spilling out of the upstream side of the siphon (on the north side of the spillway), indicating that the siphon was operational during Hurricane Maria. Scour depths below the spillway could not be measured since the area had already been partly filled, but photographs and witness accounts indicate that extensive scour occurred.

Figure 11. Comparison of the Guajataca Dam condition between March and November 2017.

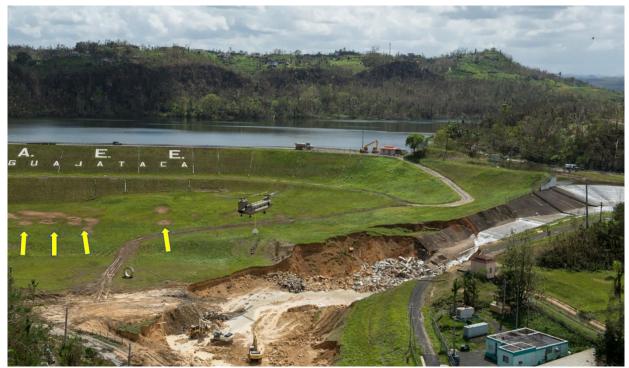
What appear to be sand boils along the toe of the earth dam suggest that its foundation materials were also subject to soil transport during Hurricane Maria (Figure 12). The seepage path and source of the eroded materials remain unknown, and considerable uncertainty exists about the origin and nature of the features shown in Figure 12. The GEER team observed water, soil, and other debris in the capped piezometer protective pipes consistent with a recent spike in groundwater pressures. During their visit, the team noted a large void approximately 0.3 m in diameter, located 10 m downstream of the toe and directly downstream of the "A" of the AEE sign on the downstream slope. Excavations, structures, poles, or posts were not reported or visible in aerial photographs near the location of the reported cavity. It seems possible that the void was either created or exacerbated by underseepage resulting from high hydraulic head during Hurricane Maria (Silva-Tulla et al., 2018).

Note: Yellow arrows show location of apparent sand boils downstream of the dam toe.

Figure 12. Apparent sand boils downstream of the dam toe (photograph from the Pennsylvania National Guard; figure adapted from Silva-Tulla et al., 2018).

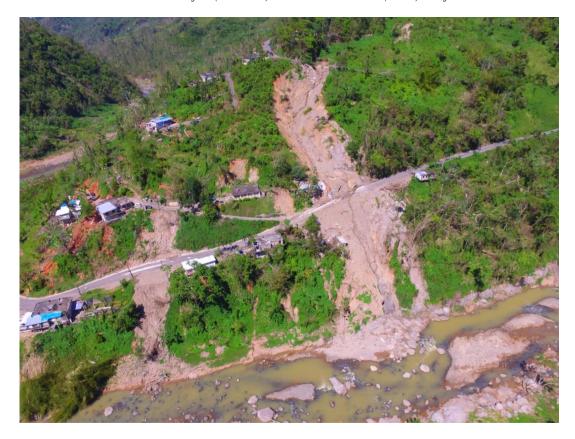
The majority of the slides shown in Figure 14 consisted of shallow debris flows. Figure 16 shows a site, visited by the GEER team, which was affected by some debris flows; this site is located along Puerto Rico State Road 4131 (PR-4131) near the Rio Blanco River in the municipality of Lares. The largest debris flow shown destroyed three homes along the lower road alignment (Silva-Tulla et al., 2018). Luckily, the inhabitants of those homes were not present at the time of the landslide. The debris flow initiated just above the highest road cut on a switchback along PR-4131. The upper area is the primary zone of volume loss, while the lower portion of the road was only covered by debris. The hillslope material slid directly into the river below, which carried much of the small- to medium-sized sediment downstream. Figure 17 shows aerial imagery of the landslide before and after Hurricane Maria.

Figure 16. Photo of debris flow above the Rio Blanco River along PR-4131 in Municipality of Lares (photo taken using UAV at location: Lat. +18.250348° Lon. -66.884155°, looking toward the North).

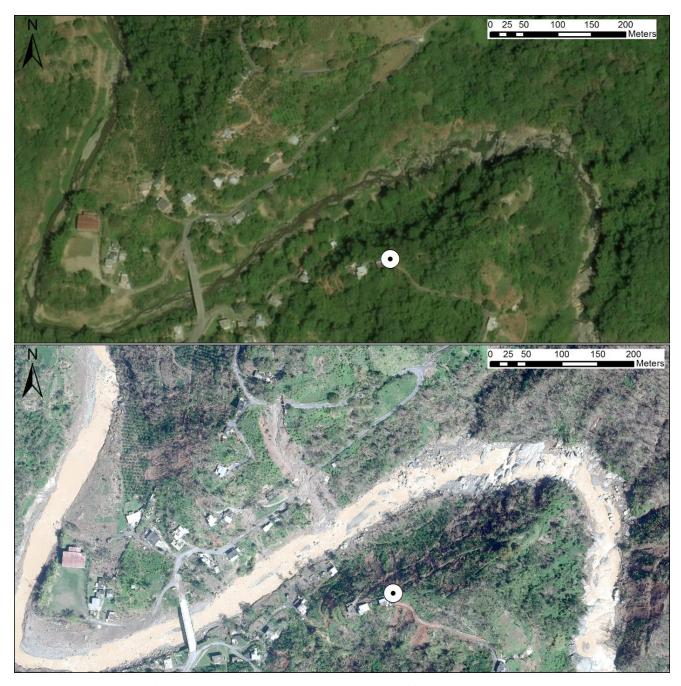
Note: Upper image taken before Hurricane Maria. Lower photo captured by FEMA on October 12, 2017. The white circle with black center dot indicates the location of the TLS Lidar performed in January 2018.

Figure 17. Aerial photos of debris flow site on PR-4131 in central Lares along the Rio Blanco (Silva-Tulla et al., 2018).

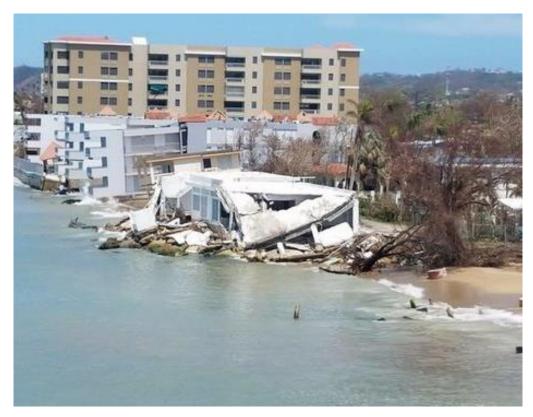
After Hurricane Maria, several buildings in the area of Site CE3 suffered severe damage, as shown in Figure 20. This figure shows extensive damage from waves or scour at the three-story Rincón Ocean Club I building, which was supported on shallow footings, and at the common areas of the terrace and swimming pool. A large volume of soil eroded from the front of the buildings and from beneath the swimming pool. Footings and beams supporting the terrace were exposed and sheared off from the building foundation. Part of Building A collapsed into the ocean and what remained standing was severely cracked. The Victoria Del Mar Condominium, the tallest building in this area and located to the north of Rincón Ocean Club I, also suffered extensive damage due to coastal scour. The terrace and swimming pool area of this condominium collapsed thanks to the storm.

The beachfront in the Córcega Beach area suffered extensive coastal scour. The approximately 6 to 9 m (20 to 30 ft) of beachfront shown in the pre-storm photo (Figure 19) was drastically reduced at the time of the site reconnaissance. The GEER Team did not observe sand washout deposits or shoreline erosion protection measures during the field reconnaissance of Site CE3. Unfortunately, there were no storm tide sensors available near Rincón to help assess tidal levels or the magnitude of wave action during this hurricane. However, NOAA (2017) reported highest water levels of 0.3 to 0.6 m (1 to 2 ft) above maximum higher high water (MHHW) for the northwest coastline of PR, where MHHW is defined as the average daily highest tide. This is consistent with a high-water elevation mark data recorded at USGS Stations (Silva-Tulla et al, 2018).

(Source: http://www.noticel.com/english/condo-in-rincon-collapses-due-to-hurricane-maria/638463446) Figure 20. Oceanfront damage in Córcega Beach area (Site CE3; Silva-Tulla et al., 2018).

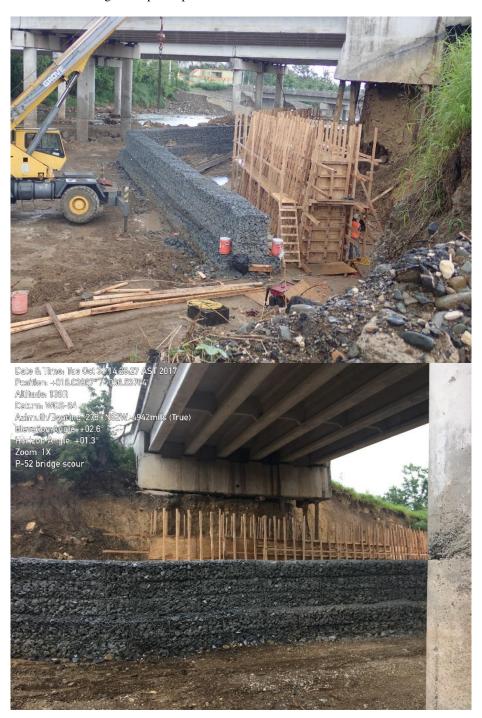
On October 31, 2017, the GEER team observed scour and erosion near the piers and abutments of Highway 52 bridges over the Inabón River at site RE1, just east of the city of Ponce, PR. Figure 21 shows select photos taken during the site visit. The photos show exposed abutment H-piles and ongoing emergency work, including the erection of formwork for abutment repairs and a temporary protective gabion wall. The gabion wall should protect the abutment and reinforced concrete shield under construction in front of the original exposed piles.

Figure 21: Photos of west abutment of westbound Highway 52 Bridge over the Inabón River (October 31, 2017; Silva-Tulla et al., 2018).

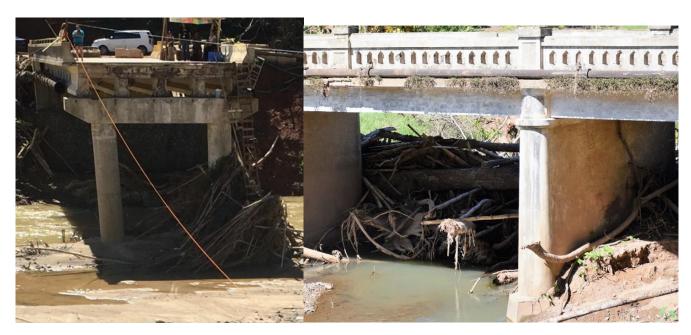
The GEER team visited several bridge sites and observed damage related to the large hydrodynamic forces from the increased volume and flow speeds associated with Hurricane Maria floods. Figure 22 shows photos from two bridge sites visited by the GEER team; these provide an idea of the magnitude of debris accumulation and the associated large hydrodynamic forces.

(Lat: +18.301439°, Lon: -66.698319°, 11/02/17) a) PR-123 bridge failure ("Los Olvidados") (Lat: +18.28683°, Lon: -67.10610°, 11/03/17) b) Debris blocked at bridge

Figure 22. Images showing debris accumulation and damage at bridges during Hurricane Maria (Silva-Tulla et al., 2018).

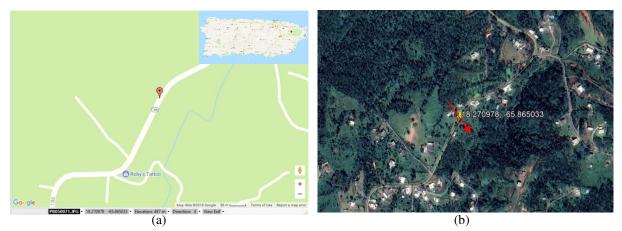
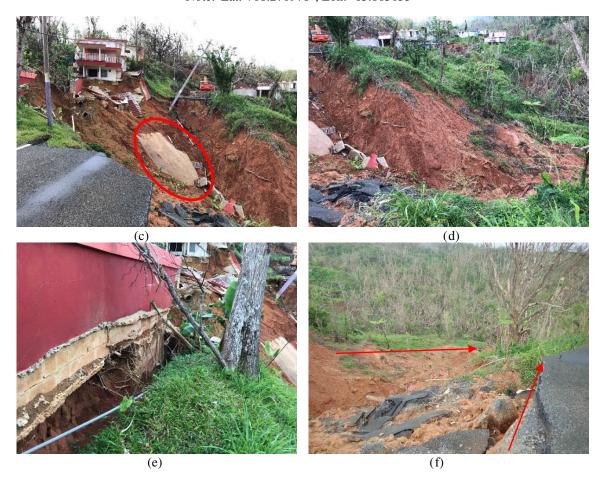
Figure 23(a) shows the location of a road failure on the northeast side of the island near the west boundary of the El Yunque National Rain Forest, along road PR-186. The failure affected the full width of PR-186 and the entrance driveway of a residence on the west side of the road (upslope side). The arrow shown in Figure 23(b) points toward the slope failure direction (southeast). Figure 23(c) shows the upper portion of the failure that resulted in a complete cut-off of PR-186. Figure 23(c)

shows a portion of the concrete pavement driveway of a residence to the left of the image (residence not shown); the final position of the piece of concrete driveway is shown inside the red oval. Additional exemplifying photos are shown in Figures 23 (d), (e), and (f). The arrows in Figure 23(f) point toward the slope failure direction (southeast).

Figure 23. Road failure affecting PR-186 (GEER mission Site 7; Silva-Tulla et al., 2018).

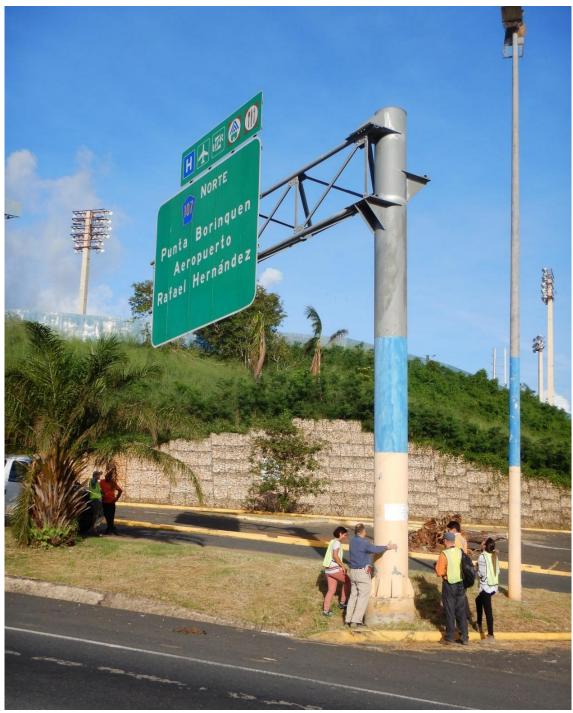
Foundation failures observed by the team included lighting towers, electrical transmission poles, and many road sign failures. Some of the road signs simply rotated about the axis of their circular drilled shaft foundation, while others also experienced bearing capacity failures. Although some electrical transmission poles failed from bearing capacity failures, the large number of reinforced concrete poles that had snapped at mid-height provided graphic evidence of the storm power. Figure 24 shows a representative torsional foundation failure of a highway sign structure.

Note: Photo location: Lat: +018.436633°, Lon: -067.147746°; Date: October 30, 2017. Figure 24. Photo of cantilevered sign foundation failure (GEER Mission Site F2; Silva-Tulla et al. 2018).
