# Geotechnical Extreme Event Site Reconnaissance in Puerto Rico After The Passage of Hurricane Maria

**Francisco Silva-Tulla**, Consulting Civil Engineer, GeoEngineering and Environment, Lexington, Massachusetts, U.S.A.; email: [silva@alum.mit.edu](mailto:silva@alum.mit.edu)

**Miguel A. Pando**, Associate Professor, Department of Civil, Architectural, and Environmental Engineering, Drexel University, Philadelphia, PA, 19104, U.S.A.; email: [miguel.a.pando@drexel.edu](mailto:miguel.a.pando@drexel.edu)

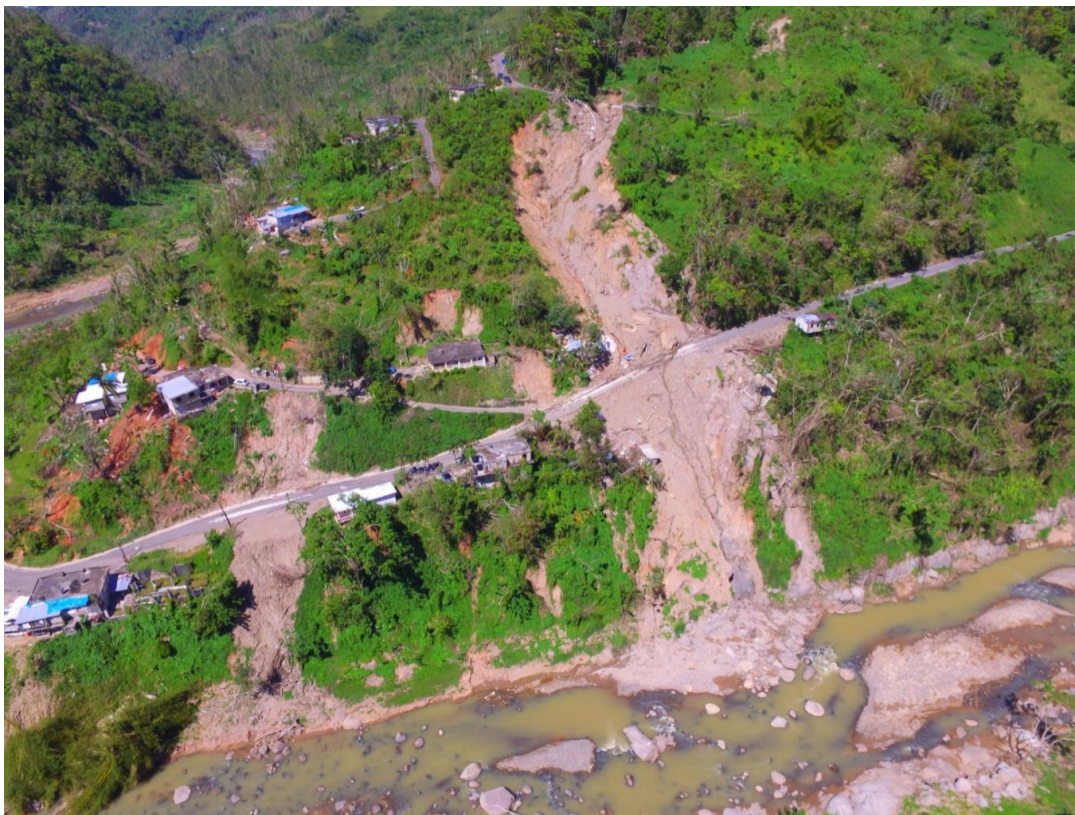
The majority of the slides shown in Figure 14 consisted of shallow debris flows. Figure 16 shows a site, visited by the GEER team, which was affected by some debris flows; this site is located along Puerto Rico State Road 4131 (PR-4131) near the Rio Blanco River in the municipality of Lares. The largest debris flow shown destroyed three homes along the lower road alignment (Silva-Tulla et al., 2018). Luckily, the inhabitants of those homes were not present at the time of the landslide. The debris flow initiated just above the highest road cut on a switchback along PR-4131. The upper area is the primary zone of volume loss, while the lower portion of the road was only covered by debris. The hillslope material slid directly into the river below, which carried much of the small- to medium-sized sediment downstream. Figure 17 shows aerial imagery of the landslide before and after Hurricane Maria.

Figure 16. Photo of debris flow above the Rio Blanco River along PR-4131 in Municipality of Lares (photo taken using UAV at location: Lat. +18.250348° Lon. -66.884155°, looking toward the North).
