Geotechnical Extreme Event Site Reconnaissance in Puerto Rico After The Passage of Hurricane Maria

ABSTRACT: *The National Weather Service classified Hurricane Maria as a strong Category 4 Hurricane on the Saffir-Simpson hurricane wind scale at the time of its landfall in Yabucoa, Puerto Rico, U.S.A., on September 20, 2017. The immediate aftermath of Hurricane Maria was a devastated island with at least 64 people killed, severe infrastructure loss, a devastated electric power grid, and numerous geotechnical failures related to the intense rainfall and strong winds associated to this extreme event. This paper will summarize the event timeline and the geotechnical consequences of Maria's path across Puerto Rico. The impacts of Hurricane Maria on infrastructure and geomorphology are documented through the data and observations of the engineers and geologists that comprised the Geotechnical Extreme Events Reconnaissance (GEER) team. The main reconnaissance mission took place between October 25 and November 6, 2017, followed by a second field component involving terrestrial LiDAR surveys and UAV photogrammetry performed January 8 to 11, 2018.*

Reference: Silva-Tulla F., and Pando M. A

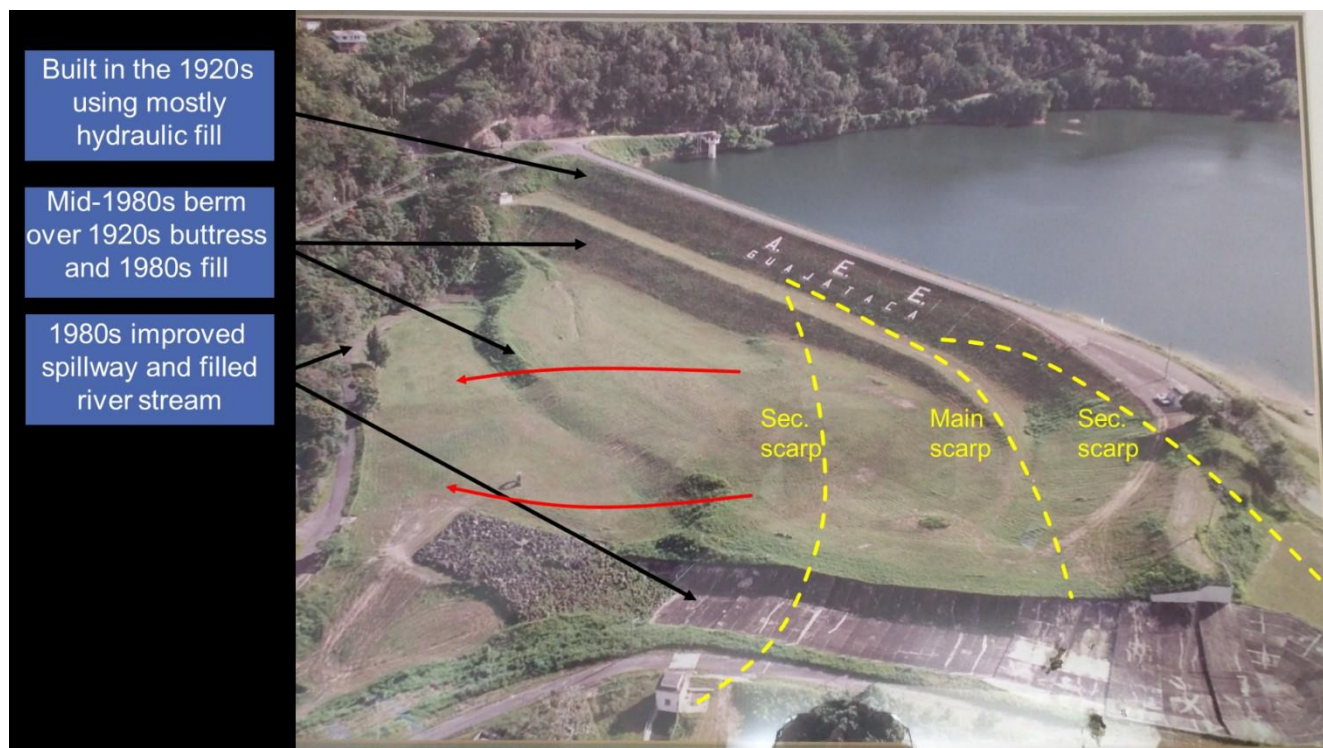
Note: Figure shows historical and landslide features remediated in the 1980s.

Figure 8. Photo of Guajataca Dam (Lat. +18.397895, Lon. -66.923725), taken a few decades before Hurricane Maria – exact date of photo unknown (adapted from Silva-Tulla et al., 2018).

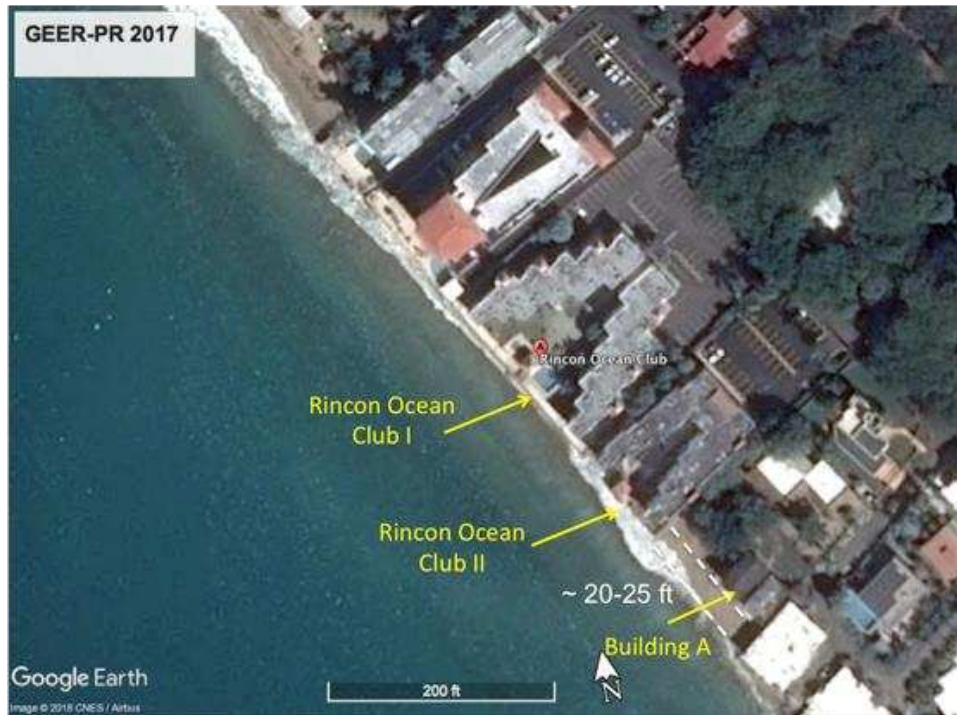
The beachfront in the Córcega Beach area suffered extensive coastal scour. The approximately 6 to 9 m (20 to 30 ft) of beachfront shown in the pre-storm photo (Figure 19) was drastically reduced at the time of the site reconnaissance. The GEER Team did not observe sand washout deposits or shoreline erosion protection measures during the field reconnaissance of Site CE3. Unfortunately, there were no storm tide sensors available near Rincón to help assess tidal levels or the magnitude of wave action during this hurricane. However, NOAA (2017) reported highest water levels of 0.3 to 0.6 m (1 to 2 ft) above maximum higher high water (MHHW) for the northwest coastline of PR, where MHHW is defined as the average daily highest tide. This is consistent with a high-water elevation mark data recorded at USGS Stations (Silva-Tulla et al, 2018).

Figure 19. Pre-storm aerial image of coastal scour Site CE3 (Silva-Tulla et al., 2018).

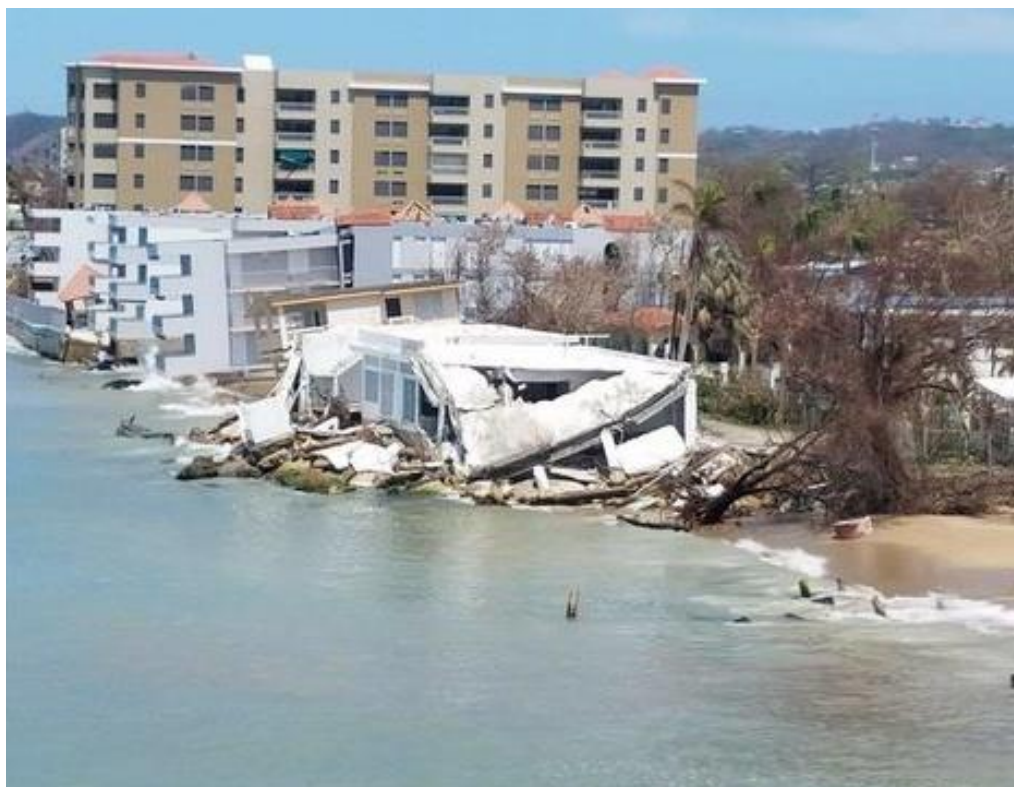
After Hurricane Maria, several buildings in the area of Site CE3 suffered severe damage, as shown in Figure 20. This figure shows extensive damage from waves or scour at the three-story Rincón Ocean Club I building, which was supported on shallow footings, and at the common areas of the terrace and swimming pool. A large volume of soil eroded from the front of the buildings and from beneath the swimming pool. Footings and beams supporting the terrace were exposed and sheared off from the building foundation. Part of Building A collapsed into the ocean and what remained standing was severely cracked. The Victoria Del Mar Condominium, the tallest building in this area and located to the north of Rincón Ocean Club I, also suffered extensive damage due to coastal scour. The terrace and swimming pool area of this condominium collapsed thanks to the storm.

Figure 20. Oceanfront damage in Córcega Beach area (Site CE3; Silva-Tulla et al., 2018).
