Hurricane Irma: Consequences of Intense Rainfall and Storm Surge from a Tropical Storm in North and Central Florida

Reference: Landon M. E., Hudyma N. W., and Sharma R. S. (2020). Hurricane Irma: Consequences of Intense Rainfall and Storm Surge from a Tropical Storm in North and Central Florida. *International Journal of Geoengineering Case Histories*, Volume 5, Issue 4, pp. 26-46, doi: 10.4417/IJGCH-05-04-02

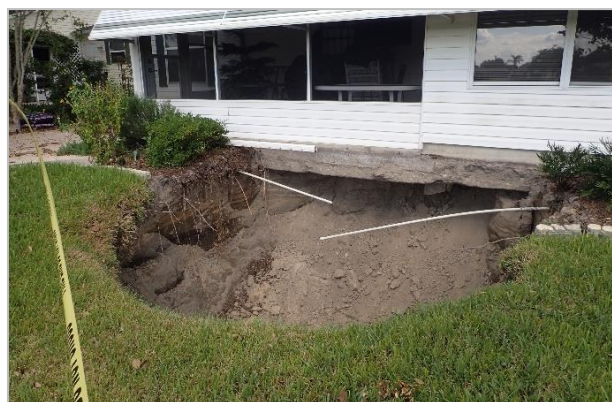
Sinkholes near the residential structures were easier to quantify during the site visit. The sinkhole that formed beneath the edge of the slab-on-grade foundation at 2536 Botello Avenue (Figure 6) was roughly elliptical in shape, approximately 4.0 m by 4.5 m (13 by 15 ft), with a depth of 2.5 m (8 ft), and exposed a small diameter, shallowly buried irrigation pipe that was unsupported over the hole. A repaired sinkhole with unknown dimensions was found at the edge of the road at 2532 Botello Avenue (Figure 7). There, the asphalt pavement showed no indication of distress, and it is unknown if the sinkhole extended under the road. The GEER team visited two other locations in The Villages where sinkholes formed, affecting retention ponds and a golf course irrigation infrastructure, and causing two houses to be classified as unsafe for occupancy by the local building official. The team heard anecdotal reports of dozens of other sinkholes that formed in The Villages, but were unable to visit them. Ruiter (2018) reports more than 400 sinkholes formed in north and central Florida as a result of Hurricane Irma.

Figure 6. Sinkhole undercutting a foundation at 2536 Botello Road at $28^{\circ}57'11.67''N$ latitude and $81^{\circ}59'30.05''W$ longitude (Hudyma et al., 2017).
