Hurricane Irma: Consequences of Intense Rainfall and Storm Surge from a Tropical Storm in North and Central Florida

ABSTRACT: Hurricane Irma affected the Florida peninsula from September 9-11, 2017, with high winds, rainfall, and storm surge. Although the storm made landfall on the west coast of Florida, impacts of the rainfall and storm surge affected central and northeast Florida. A GEER team mobilized on September 23, 2017, spent three days documenting sinkhole damage in central Florida, coastal scour and erosion along the northeast coast of Florida, and infrastructure damage in northeast Florida. Numerous sites with geotechnical damage were documented but this case history focuses specifically on sinkhole damage in The Villages, erosion and scour at Vilano Beach, failure of a concrete cover earth dam at Hampton Lake, and bridge embankment damage on US-17 over the Trout River. The most notable challenges to reconnaissance were the widespread and varied nature of the damages from Hurricane Irma and the rapid repair of damaged infrastructure that required the team to work closely with local, state, and federal officials to obtain documentation of the damage prior to repair.

Refe

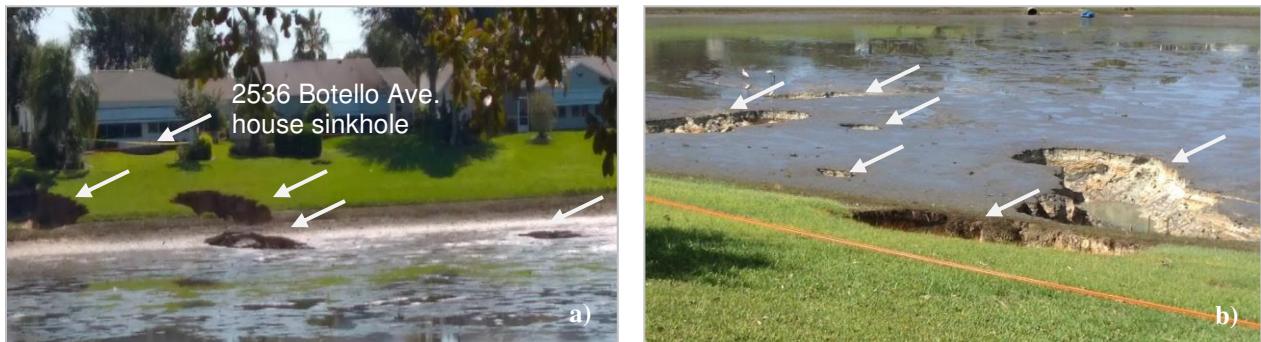
Residents graciously provided the GEER team with an account of the sinkhole events and photographs taken prior to the GEER team's arrival. On September 11, the water level in the pond was above the inlet pipes. On September 12, the water level decreased to approximately the midpoint of the inlet pipes. By the morning of September 13, the pond was empty. Digital photographs from residents show five sinkholes in the retention pond basin and two sinkholes on the bank behind the house at 2536 Botello Avenue (Figure 5). During the site visit 14 days following Hurricane Irma on September 25, repair of

the sinkholes within the basin and along the bank was being completed. Repair was performed using a Caterpillar D4 bulldozer to end dump granular fill near the holes, infill them, and then compact the fill with the machine's weight. The dimensions of the sinkholes themselves could not be estimated from either the pre-repair photos or the repairs.

Figure 5. Sinkholes on the bank of and within the retention pond between Alhambra Way and Botello Avenue at 28°57'11.92"N latitude and 81°59'31.49"W longitude (Images courtesy of Sheila Huffman Dailey, Dan Snyder, and Barbara Beveridge; from Hudyma et al., 2017).

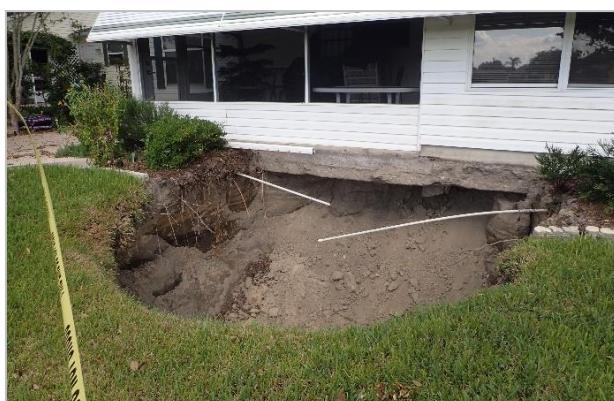
Sinkholes near the residential structures were easier to quantify during the site visit. The sinkhole that formed beneath the edge of the slab-on-grade foundation at 2536 Botello Avenue (Figure 6) was roughly elliptical in shape, approximately 4.0 m by 4.5 m (13 by 15 ft), with a depth of 2.5 m (8 ft), and exposed a small diameter, shallowly buried irrigation pipe that was unsupported over the hole. A repaired sinkhole with unknown dimensions was found at the edge of the road at 2532 Botello Avenue (Figure 7). There, the asphalt pavement showed no indication of distress, and it is unknown if the sinkhole extended under the road. The GEER team visited two other locations in The Villages where sinkholes formed, affecting retention ponds and a golf course irrigation infrastructure, and causing two houses to be classified as unsafe for occupancy by the local building official. The team heard anecdotal reports of dozens of other sinkholes that formed in The Villages, but were unable to visit them. Ruiter (2018) reports more than 400 sinkholes formed in north and central Florida as a result of Hurricane Irma.

Figure 6. Sinkhole undercutting a foundation at 2536 Botello Road at 28°57'11.67"N latitude and 81°59'30.05"W longitude (Hudyma et al., 2017).

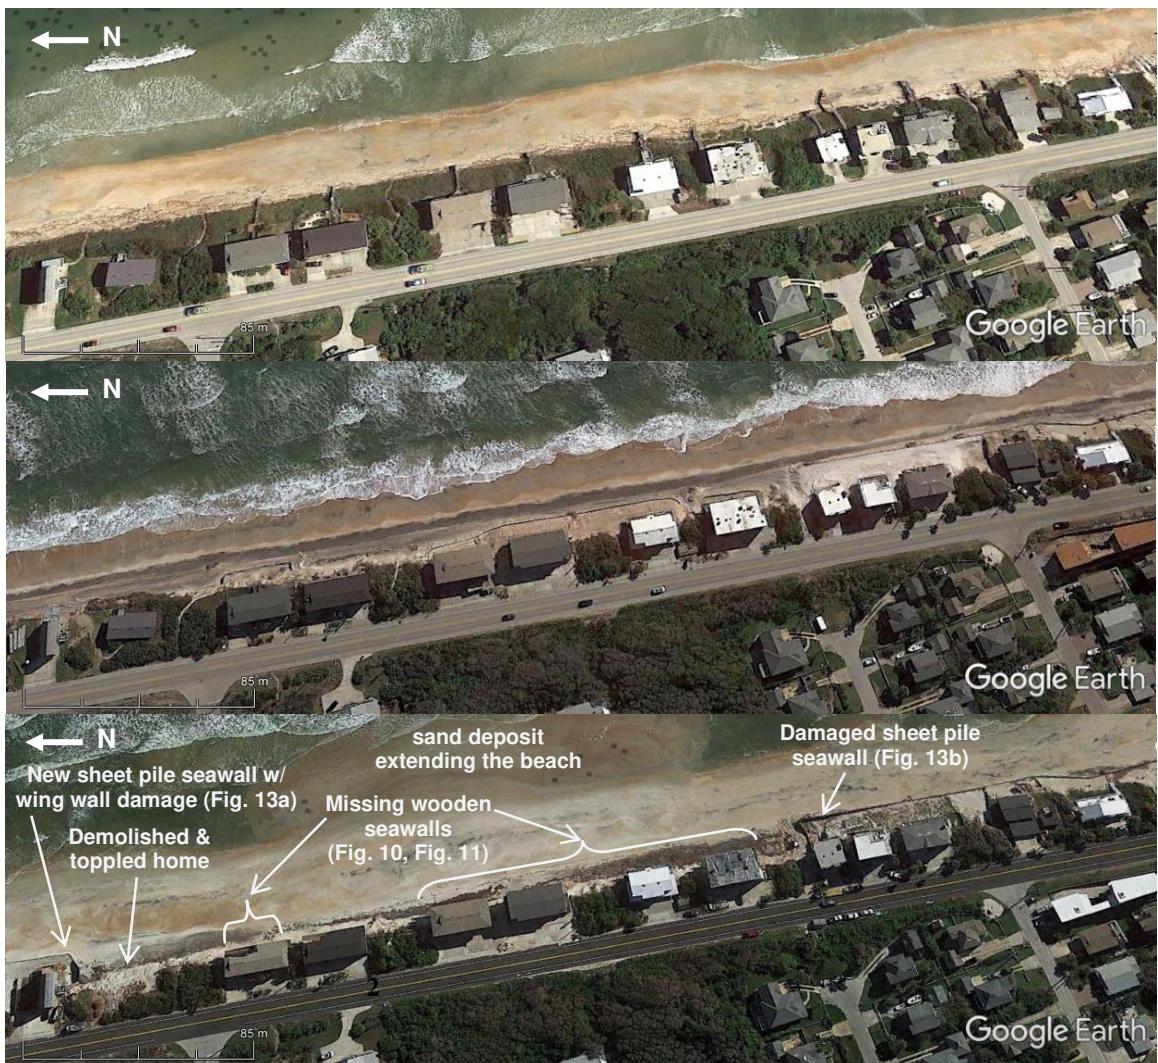
Vilano Beach has been experiencing consistent dune erosion during major storm events since 1994. Figure 9 illustrates how significantly and quickly the seemingly stable dune system changed because of extreme storms. The majority of erosion occurred after 2015 from both Hurricane Matthew (October 16, 2016) and Hurricane Irma (September 11, 2017). Figure 9c is annotated to show Hurricane Irma damage identified by the GEER team. To prevent erosion, seawalls of varying types were installed to protect residences from destructive wave action. The walls ranged from simply constructed walls to more complex walls with anchors. Many of the more complex systems were vinyl sheet pile walls anchored by either helical or dead man anchors connected to either pressure-treated wooden wales 100 mm (4 in) square in cross-section or cylindrical wooden piles secured at the front of the sheet piles. Several residences with more complex seawalls still experienced some damage and scour. The unprotected areas adjacent to seawalls were at greater risk of erosion and scour as the wave energy was directed around the seawalls and focused on the unprotected beach, dunes, and structures. Several residential structures with limited or no seawalls had their timber pile foundations exposed. In one extreme case, a residence supported by shallow foundations was completely undermined and toppled onto the beach.

Figure 9: Changes to the Vilano Beach coastline from 4020 to 3880 Coastal Highway, St. Augustine, Florida, at $29^{\circ}56'49.30"N$ latitude and $81^{\circ}18'9.37"W$ longitude dated: (a) November 2015, with few seawalls present; (b) March 2017, with seawalls installed following 2016 Hurricane Matthew, and; (c) October 2018, following damage from 2017 Hurricane Irma (Google Earth, 2018).

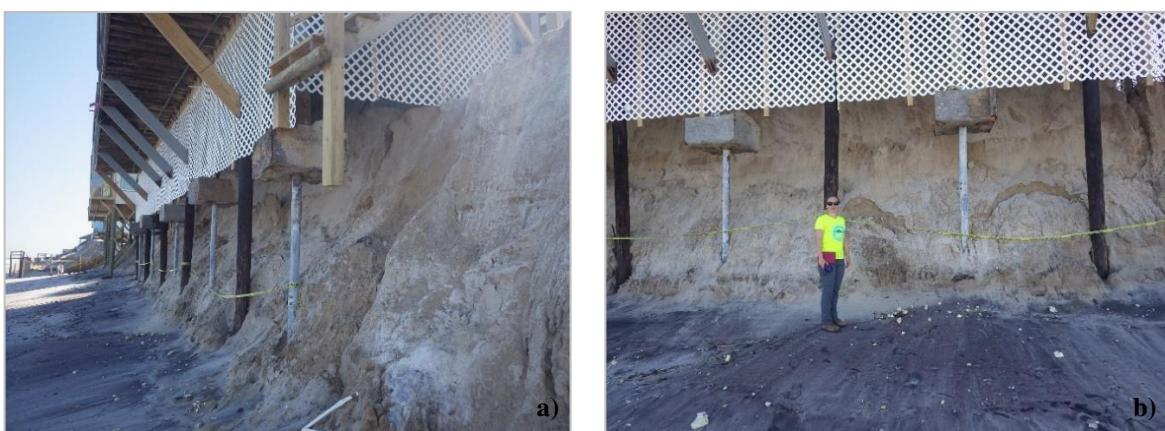
Figure 10 provides an example of damage to a residence that had been constructed on the dunes and protected by a wooden seawall of unknown design installed a distance away from the structure on the beach. The residence and its balcony are supported by alternating deeply embedded pressure-treated timber piles and pressure-treated lumber columns supported by concrete footings, presumably at the previous ground level, and micropiles. This structure experienced substantial erosion, where foundation elements became exposed over more than 10 m (~30 ft) height and both the footprint of the balcony area and structure itself were undercut. The seawall was itself destroyed (see Figure 9c). Minor slope failures were evident on the remaining dune face (Figure 10b). Drying and loss of capillary suction in the sand during the heat of the day made the exposed slopes more prone to sloughing and put the structures at greater risk of being undermined.

Figure 10: Erosion undercutting both the timber pile supports and micropile supported concrete footings for a beach house with continued slope failures in drying sand at $29^{\circ}56'47.00"N$ latitude and $81^{\circ}18'8.10"W$ longitude after Hurricane Irma.

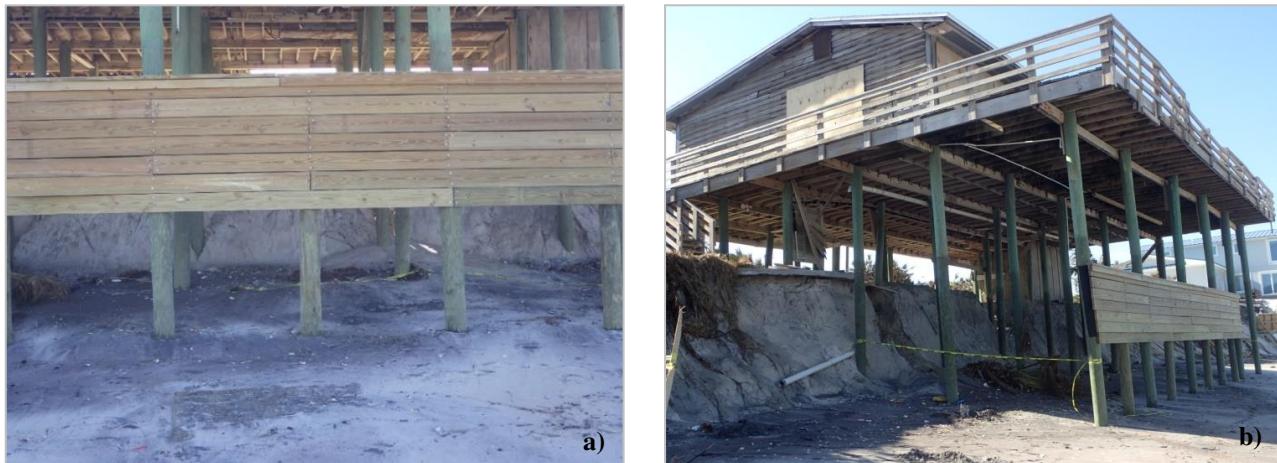
Figure 11 shows a wooden seawall left partially intact after Hurricane Irma. The seawall was constructed from pressure-treated lumber approximately 50 mm by 150 mm (2 in. by 6 in.) in cross-section nailed to pressure-treated timber piles supporting upper levels of the residence. The lumber was either not embedded or minimally embedded into the soil. The wall itself remained intact and undamaged, likely because it was attached to the piles. While the wall may have been initially effective at preventing erosion, soil was eroded from beneath and around the sides of the wall, undercutting three rows of timber piles. Notice also the underside of the elevated structure. The GEER team was uncertain how developed the ground floor of this structure was; however, there was evidence that walls and utilities were eliminated by wind and wave activity.

Figure 11. (a) Shallowly embedded timber seawall at approximately 29°56'49.30"N latitude and 81°18'9.37"W longitude, showing significant erosion (about 2 m or 6.6 ft) below a residential structure; and (b) subsequent beach erosion and removal of the first story walls by wind and water.

Timber pile and wooden lagging did not fare well in the extreme conditions brought on by Hurricane Irma (Figures 11 and 13). Lagging for these barriers may not have extended deep enough into the beach and retained soil was subject to basal erosion, leaving wooden walls unsupported and subject to even greater wave loading. Additionally, the impact of waves carrying entrained debris and sand likely amplified the rate of damage for these timber walls. Nearly all the wooden face

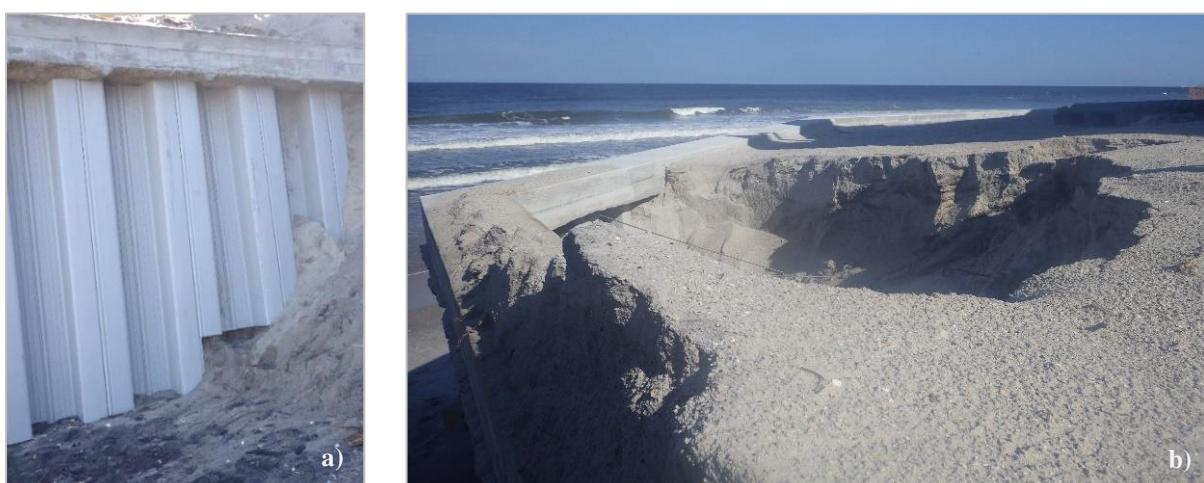
Figure 12: Sheet pile retaining wall failure from undercutting at 29°56'58.16"N latitude 81°18'11.96"W longitude, showing: (a) the exposed wall base, and (b) a funnel-shaped depression following basal soil escape (Hudyma et al., 2017).

The undercutting of shallowly embedded walls is evident in Figure 12a, which shows exposure of the base of a sheet pile wing wall that was scoured to a depth that provided a pathway for retained soil to escape from under the wall. This created a funnel-shaped depression behind the seawall at this location (Figure 12b). Figure 13a shows erosion into the dune and around a wing wall. The face and part of the wing wall were made of embedded vinyl sheet piling. However, the part of the wing wall extending into the dune was of timber pile and wooden lagging. Erosion past the sheet piling into the more open structure of the wooden lagging resulted in break-up of the wall, erosion of the retained soil, and exposure of shallow foundations previously supporting the deck (not shown). Lastly, Figure 13b illustrates the consequences of an incomplete seawall. The wing wall was a temporary timber pile and wooden lagging installed to accommodate a possible future extension of the sheet pile wall face to the neighboring property. The timber seawall was compromised by the storm. The four residences protected by the wall experienced damage, with the most damage adjacent to the temporary wing wall.

The structure with face and wing walls constructed similarly with vinyl sheet pile in Figure 12 experienced some undermining damage; however, the impenetrable material of the wall (vinyl) provided excellent resistance to wave action that was likely intensified by entrained sand and debris from adjacent damaged structures. The walls that the GEER team found to be minimally damaged during Hurricane Irma had sufficient vertical embedment into the beach sands or lateral embedment back into the dune to maintain their structural integrity, even if basal or side exposure of the wing wall resulted in some erosion. The reconnaissance identified two concerns for vinyl sheet pile walls. Walls are installed with weep holes to allow water to drain from the retained sand behind the wall at the beach elevation. Following Hurricane Irma, the weep holes were approximately 0.5 m to 1 m (1.6 ft to 3.3 ft) above the new beach elevation. In many walls with soil still retained, the vinyl sheets bowed out of plumb below the weep holes. This is likely because of both the loss of basal support on the outside face of the wall and pore pressure in the confined soil from trapped water behind the wall. While the vinyl sheet piling is ductile and corrosion resistant, inspection found areas with previous cracks and repairs, possibly due to impact from wave-borne debris.

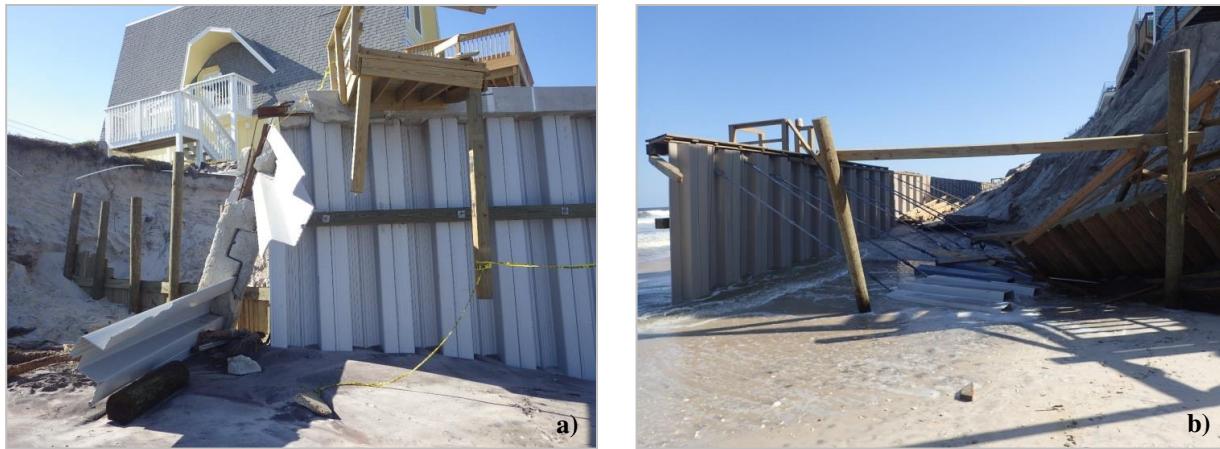
Figure 13: Failure of two residential sheet pile retaining walls from side erosion following Hurricane Irma, showing: (a) a partial sheet pile wing wall that was extended into the dune using timber piles and wooden lagging at 29°56'55.10"N latitude and 81°18'13.49"W longitude, and (b) the backside of the wall and anchors from the side where the wing wall was not yet installed at 29°56'46.05"N latitude and 81°18'7.5"W longitude (Hudyma et al., 2017).

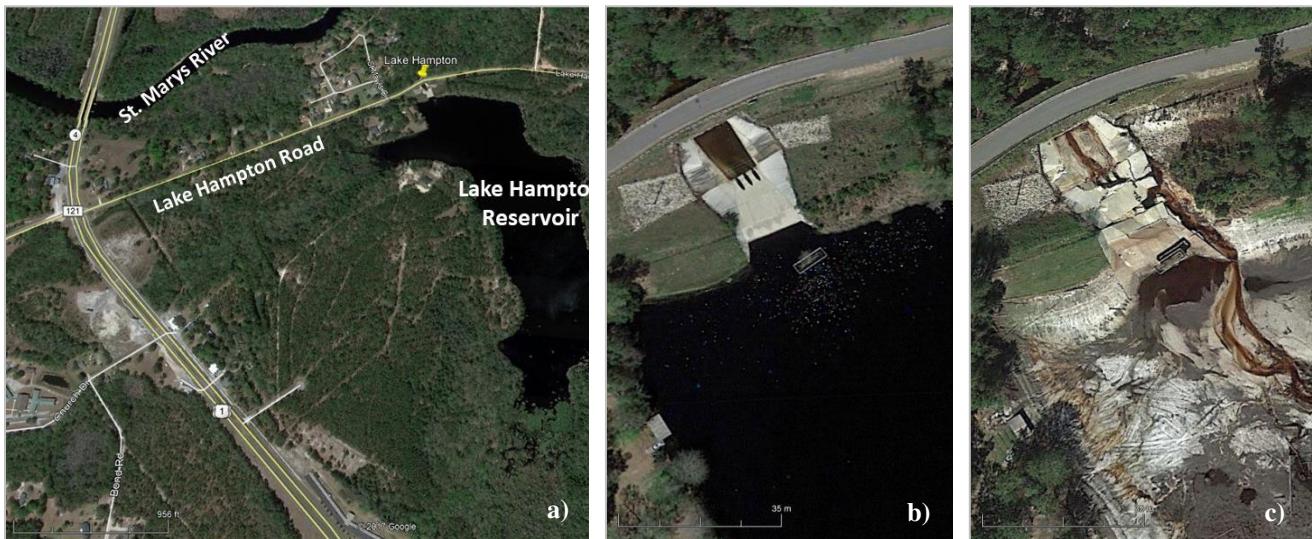
where a concrete structure with four 2.1 m (6.9 ft) diameter concrete pipes passed water from the spillway pool into the downstream tributary (Hudyma et al., 2017). Figure 14 shows aerial images of the dam prior to and after the dam's failure.

Figure 14. (a) Lake Hampton Dam reconnaissance site location with aerial photos of the dam (b) before (March 2017), and (c) after (October 2017) the failure (Google Earth 2018).

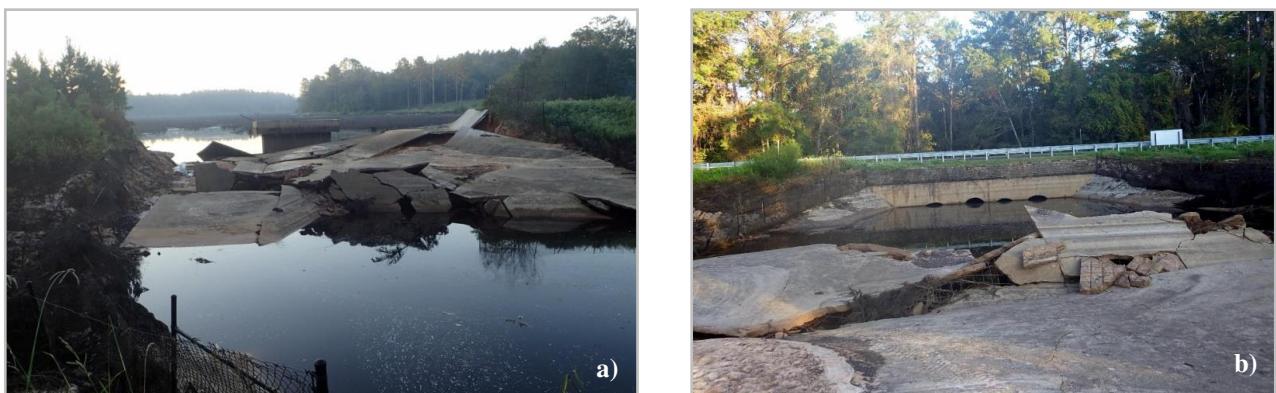
Figure 15 illustrates the remains of the failed dam and surrounding infrastructure. The inlet structure remained intact and in position; the embankment and soils supporting the spillway, however, were washed away and the concrete cover was left cracked and in disarray. Figure 16 shows the significantly eroded eastern embankment and the remaining organic debris as well as the newly formed drainage path for Pigeon Creek. The post-failure erosion channel was located on the east side of the dam, while limited soil erosion was observed along the western embankment. Figure 16 shows two colors of soil in the east embankment, and we speculate the gray soil to the right may have been modified with cement or lime to minimize seepage.

Figure 15: Failed Lake Hampton reservoir dam at $30^{\circ}46'40.1''N$ latitude and $81^{\circ}58'13.0''W$ longitude: (a) looking south from, and (b) looking north toward Lake Hampton Road.

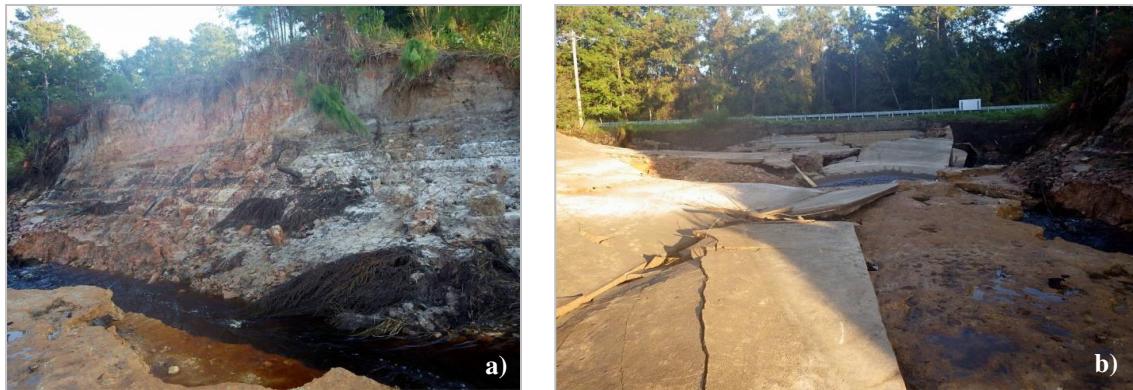
Figure 16: Erosion of the eastern natural embankment and dam soils showing: (a) eastern embankment and post failure outlet stream, and (b) eastern dam and embankment erosion south of Lake Hampton Road at $30^{\circ}46'33.89''N$ latitude and $81^{\circ}58'15.47''W$ longitude.

A combination of rainfall and overland flow filling Lake Hampton upstream of the dam was likely the major cause of the dam's failure. The GEER team found significant erosion along the eastern bank of the dam (Figure 16a), which likely led to undermining of the concrete spillway and complete erosion of the soil below it. The GEER team found evidence of plant debris high up on the intact embankment at the west side, indicating a high reservoir water level. It is uncertain why the eastern embankment was preferentially eroded. However, photographic evidence shows muddier sediment to the east along the spillway and downstream floodplain, and Figure 14c shows the new breach channel across the east embankment post-failure.

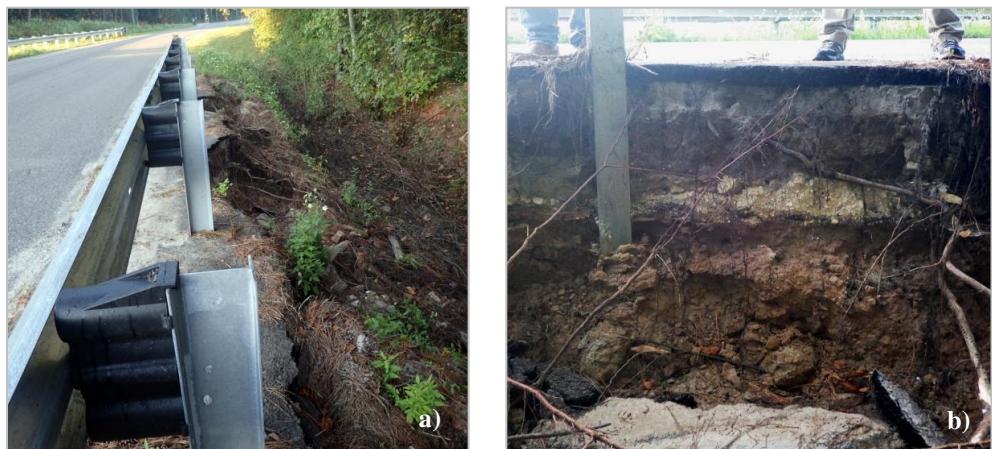
Lake Hampton Road was also subject to damage, and Figure 17 illustrates the erosion that occurred downstream of the dam and road. Erosion of both pavement and road base resulted in guardrail posts becoming exposed. Figure 15b shows the road crossing from the south, where soil and infrastructure remained relatively intact. Figures 17 and 18 comparatively show the road crossing from downstream with significant erosion of embankment soils at either side of the concrete pipe culvert. The downstream floodplain (Figure 18) had low vegetation removed and/or covered with sediment; large brush was denuded to a certain elevation, and trees were destabilized and uprooted. Surface soil remaining on the downstream embankments and the denuded floodplain was dark brown and muddy; Figure 18b, however, shows areas of lighter brown soil that may indicate dried in-place soils or in-place soil mixed with eroded dam embankment soil.

Figure 17: Erosion damage of the northern section of Lake Hampton Road at the Pigeon River crossing north of the dam near $30^{\circ}46'45.19''N$ latitude and $81^{\circ}58'24.6''W$ longitude.

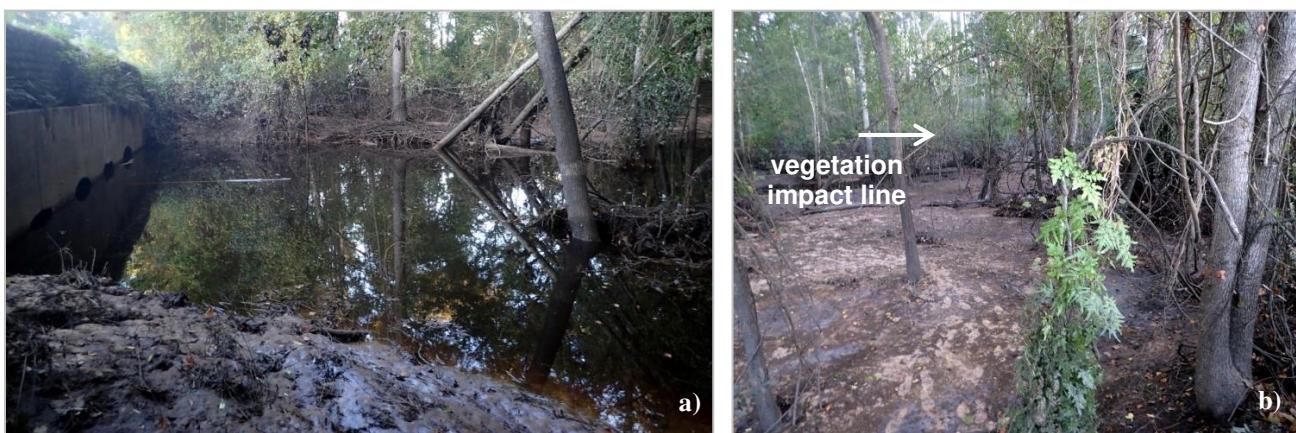
Figure 18: Downstream view of the road crossing at Pigeon Creek near $30^{\circ}46'45.19''N$ latitude and $81^{\circ}58'24.6''W$ longitude after the failure, illustrating: (a) the dam outlet under Hampton Road with four small diameter openings in a concrete culvert, stacked concrete sack wall stabilizing the roadway, and evidence of high water levels; and, (b) evidence of high water levels, sediment buildup, and debris within the floodplain.

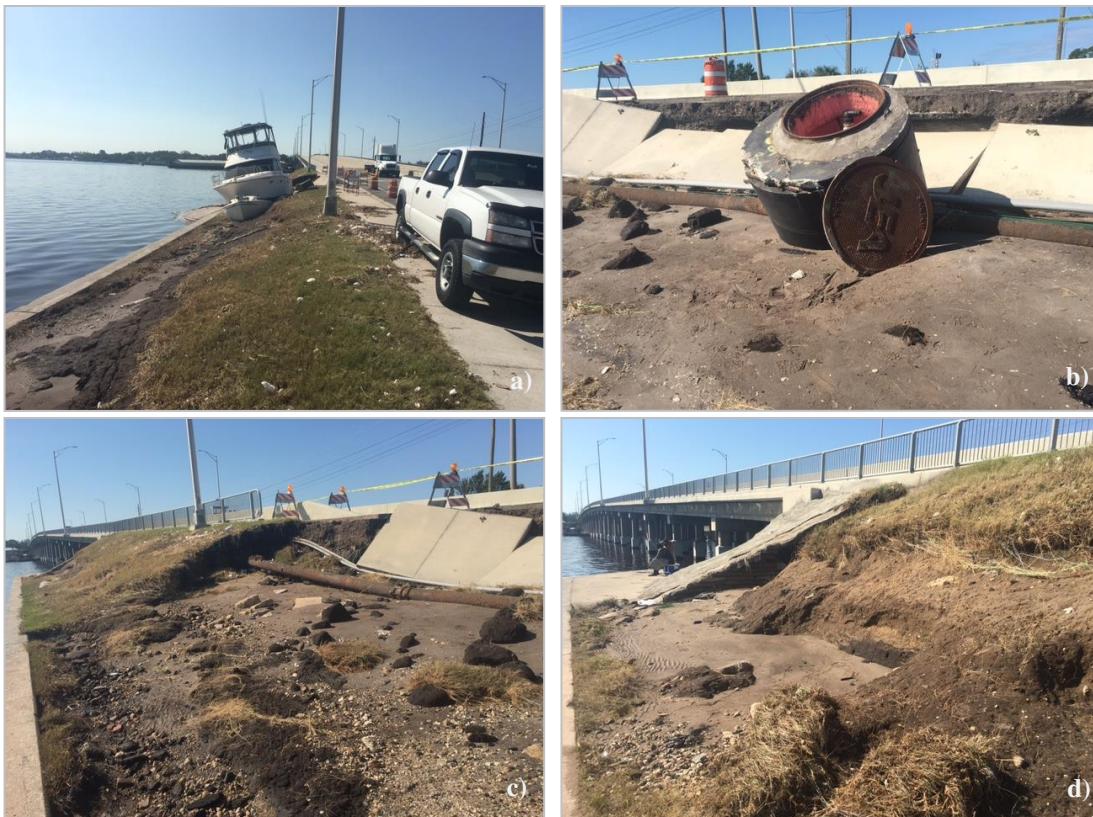
Figure 21. Erosion along the northeast embankment of the US 17 bridge over the Trout River at $30^{\circ}23'45.44''N$ latitude and $81^{\circ}38'53.95''W$ longitude shown from the north southward, including: (a) vessel washed ashore exacerbating scour, (b) an exposed sewer pipe and access structure, (c) exposed sewer pipe and electrical conduit and failed sidewalk, and (d) the terminus of scour at the stacked concrete sack wall where embankment cover was present (Hudyma et al., 2017).

The storm surge generated by Hurricane Irma ranged from 1.2 m to 1.6 m (3.9 ft to 5.2 ft) (Cangialosi et al., 2018) in height and extended into the Trout River, elevating water levels, overtopping the embankment support wall at the river level, and subjecting the northern embankments to erosion. Significant erosion occurred along the northeast bridge embankment on September 10, 2017, extending from the concrete cover of the embankment to approximately 140 m (459 ft) north into the grass- and brush-protected area embankment. The northernmost section of the embankment was protected by woody brush and small trees, and experienced minimal scour. The grass-protected, taller section of the embankment was scoured significantly into the slope (Figure 21b, c, d) to the extent that the edge of the road was undermined, concrete sidewalk panels were dislodged, and underground utilities were exposed and unsupported. The embankment section nearest the transition between the grass and concrete cover experienced the most scour, where the concrete cover was undermined to the stacked concrete sack wall and toward the bridge abutment (Figure 21d, Figure 22a). Localized scour also occurred along the northwest embankment at, and just beyond, the transition between the grass and concrete cover (Figure 22b), likely caused by an eddy current that developed after the high winds and surge accelerated the water through the constriction in the river. During the hurricane, several vessels broke free from their moorings and washed up on the embankment (Figure 21a), which created additional erosion as turbulent water flowed around these obstacles.

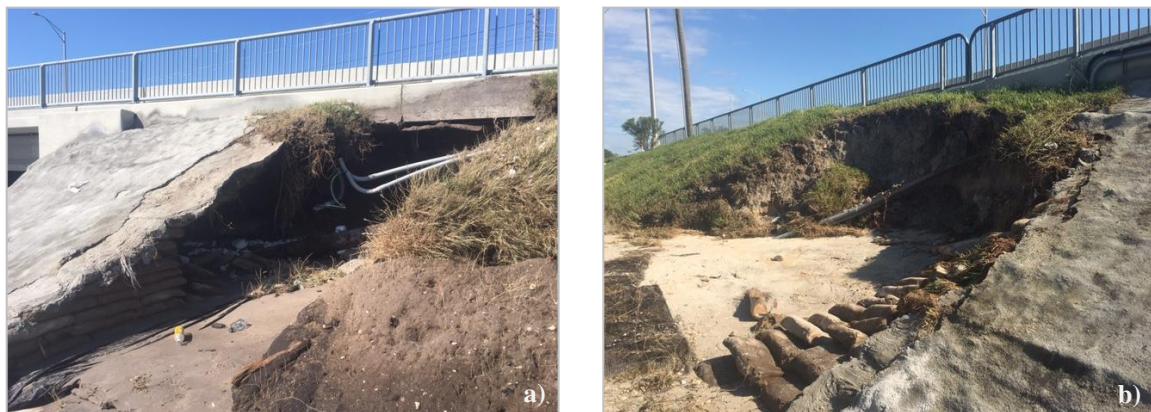
The GEER team visited the site two weeks after the scour damage occurred and repairs were partially completed. Construction crews had partially rebuilt the embankment to the design elevation and placed excavatable flowable fill into vertical trenches near the roadside to stabilize soil below the road and around underground utilities. Figure 23 shows a flowable fill trench adjacent to the northeast abutment (approximately 5 m long, 1 m wide, 6 m deep, or 16.4 ft by 3.3 ft by 19.7 ft) and adjacent to the northeast section of road (approximately 21 m long, 1 m wide, 2 m deep, or 69 ft by 3.3 ft by 6.6 ft).

Figure 22. Scour damage along the (a) northeastern and (b) northwestern bridge embankment of the US 17 bridge over the Trout River at 30°23'44.43"N latitude and 81°38'54.13"W longitude (Hudyma et al., 2017).
