Hurricane Irma: Consequences of Intense Rainfall and Storm Surge from a Tropical Storm in North and Central Florida

Reference: Landon M. E., Hudyma N. W., and Sharma R. S. (2020). Hurricane Irma: Consequences of Intense Rainfall and Storm Surge from a Tropical Storm in North and Central Florida. International Journal of Geoengineering Case Histories, Volume 5, Issue 4, pp. 26-46, doi: 10.4417/IJGCH-05-04-02

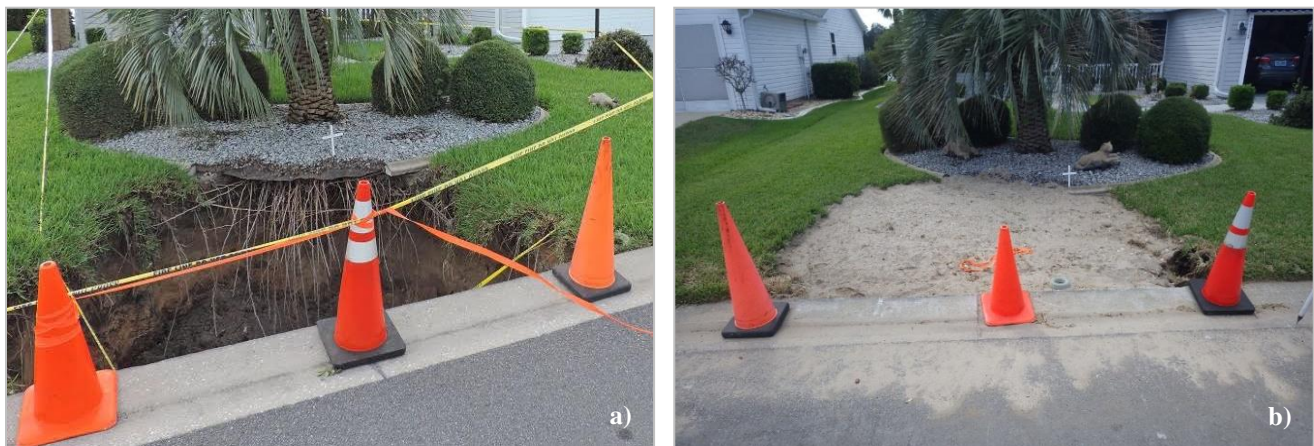
The constructed detention/retention ponds in the area used as surface water control measures may have accelerated bedrock dissolution. During the construction of a pond, the ground surface elevation is reduced along with sediment cover above the shallow weathered limestone that helps mitigate water intrusion. As rainfall is funnelled into the pond, it subsequently infiltrates, erodes, and transports the overlying soil into the limestone. Rainfall totals for The Villages Alhambra prior to, during, and after Hurricane Irma were 11.2 mm, 14.2 mm, 227.8 mm, and 0 mm (0.44 in, 0.56 in, 9.0 in, and 0 in) for September 9-12, 2017, respectively (CoCoRaHS, 2017). The predominant triggering event for sinkhole formation in The Villages is likely excessive rainfall on September 11 following a period of drought (Bodenner, 2018). However, irrigation for lawns and golf courses in the area provided sustained diffuse water infiltration and possible leakages in piping systems. Limestone dissolution and sinkhole formation may be compounded in areas having leaky underground water, sewer, stormwater, and irrigation distribution systems, and can be further accelerated by extreme rainfall events such as Irma.

Figure 7. Sinkhole at 2532 Botello Avenue at 28°57'10.60"N latitude and 81°59'30.50"W longitude: a) prior to repair (Villages News 2017), b) following repair (Hudyma et al., 2017).
