Hurricane Irma: Consequences of Intense Rainfall and Storm Surge from a Tropical Storm in North and Central Florida

KEYWORDS: reconnaissance, hurricane, sinkhole, karst, erosion, scour, beach, dam, infrastructure

Reference: Landon M. E., Hudyma N. W., and Sharma R. S. (2020). Hurricane Irma: Consequences of Intense Rainfall and Storm Surge from a Tropical Storm in North and Central Florida. International Journal of Geoengineering Case Histories, Volume 5, Issue 4, pp. 26-46, doi: 10.4417/IJGCH-05-04-02

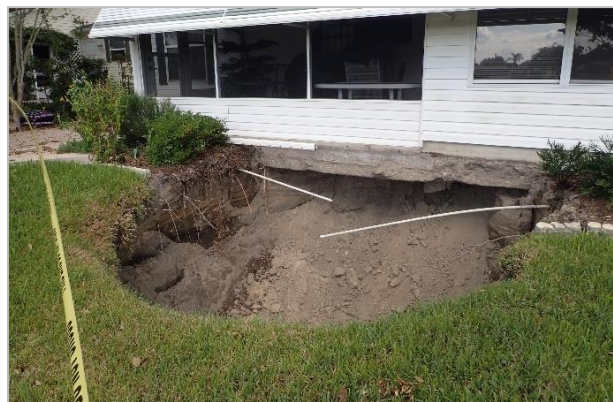
Sinkholes near the residential structures were easier to quantify during the site visit. The sinkhole that formed beneath the edge of the slab-on-grade foundation at 2536 Botello Avenue (Figure 6) was roughly elliptical in shape, approximately 4.0 m by 4.5 m (13 by 15 ft), with a depth of 2.5 m (8 ft), and exposed a small diameter, shallowly buried irrigation pipe that was unsupported over the hole. A repaired sinkhole with unknown dimensions was found at the edge of the road at 2532 Botello Avenue (Figure 7). There, the asphalt pavement showed no indication of distress, and it is unknown if the sinkhole extended under the road. The GEER team visited two other locations in The Villages where sinkholes formed, affecting retention ponds and a golf course irrigation infrastructure, and causing two houses to be classified as unsafe for occupancy by the local building official. The team heard anecdotal reports of dozens of other sinkholes that formed in The Villages, but were unable to visit them. Ruiter (2018) reports more than 400 sinkholes formed in north and central Florida as a result of Hurricane Irma.

Figure 6. Sinkhole undercutting a foundation at 2536 Botello Road at $28^{\circ}57'11.67''N$ latitude and $81^{\circ}59'30.05''W$ longitude (Hudyma et al., 2017).

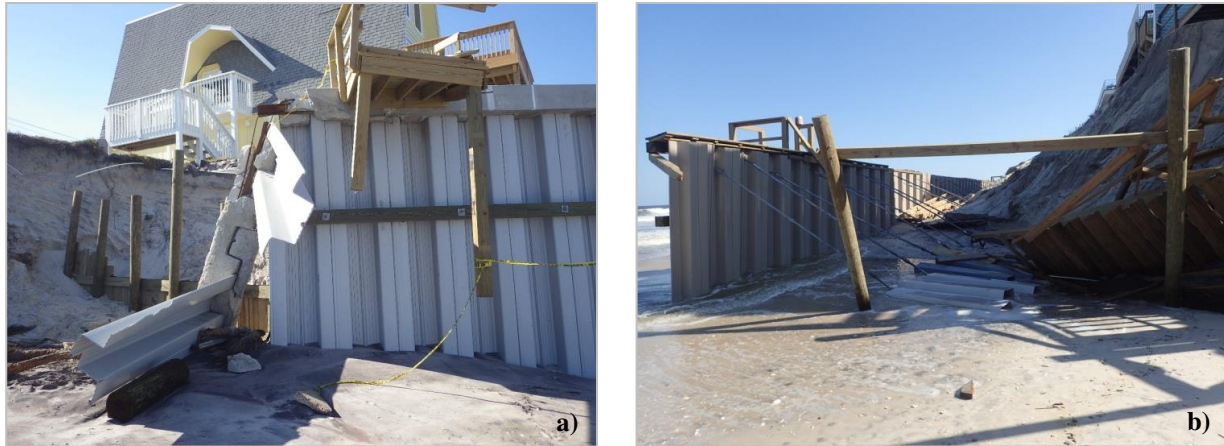
Of the sites investigated, anchored vinyl sheet pile seawalls fared better than timber seawalls, but still suffered significant damage. The faces of the sheet pile walls were parallel to the beach and remained intact, showing no signs of failure or undermining from wave action. This is likely because the vinyl sheet piles were embedded to a sufficient depth. Several of the sheet pile walls had wing walls approximately parallel to the direction of wave action, and were keyed into the dunes to prevent wave action from eroding the retained soil. However, each of the wing walls observed by the reconnaissance team was compromised in one or more of the following ways: (1) the sheet pile depth was too shallow and erosion of retained sand occurred under the wall, (2) the key length into the dune was insufficient and erosion occurred into the dune around the wing wall into the retained sand, or (3) the wing wall was not completed.

Figure 13: Failure of two residential sheet pile retaining walls from side erosion following Hurricane Irma, showing: (a) a partial sheet pile wing wall that was extended into the dune using timber piles and wooden lagging at $29^{\circ}56'55.10''N$ latitude and $81^{\circ}18'13.49''W$ longitude, and (b) the backside of the wall and anchors from the side where the wing wall was not yet installed at $29^{\circ}56'46.05''N$ latitude and $81^{\circ}18'7.5''W$ longitude (Hudyma et al., 2017).

Timber pile and wooden lagging did not fare well in the extreme conditions brought on by Hurricane Irma (Figures 11 and 13). Lagging for these barriers may not have extended deep enough into the beach and retained soil was subject to basal erosion, leaving wooden walls unsupported and subject to even greater wave loading. Additionally, the impact of waves carrying entrained debris and sand likely amplified the rate of damage for these timber walls. Nearly all the wooden face
