Post-2017 Hurricane Season Assessment of Civil Infrastructure Impacts on Beach and Near-Beach Environments

ABSTRACT: *This paper presents an overview of observations and preliminary measurements of coastal infrastructure in the aftermath of Hurricanes Harvey and Irma in 2017. Two teams mobilized by the Geotechnical Extreme Events Reconnaissance (GEER) Association were sent to document perishable data along the Texas coastline (Port Aransas, Holiday Beach, East Matagorda Peninsula, and Follets Island) and Florida Keys (Simonton Beach, Sombrero Beach, and Coco Plum Beach). Significant damage from sediment overwash and road undercutting was observed at beach access paths and roads that transect dune fields. It was also observed that beach access points weaken the line of coastal defense provided by dunes, vegetation, and structures. The lessons learned from these field reconnaissance missions indicate that longshore non-uniformity in the dune system should be well-documented. Measurements of the geometry of beach access pathways and dunes, including the height, width, length, and vegetation coverage, should be collected prior to recovery of the system post-storm.*

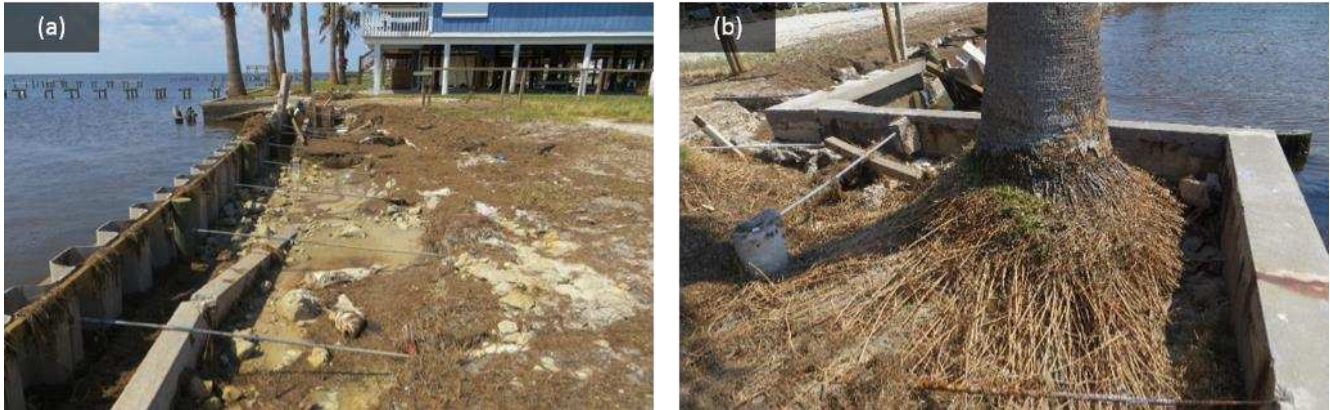
During the reconnaissance survey, houses in Holiday Beach were found heavily damaged by wind and bay surge, particularly those located on the bayfront street that parallels the canals. Anchored bulkhead retaining walls constructed along the bayfront property line were overtopped during Hurricane Harvey and severely eroded on their backsides, exposing supporting steel rods (Figure 6a). Scouring around trees and other fixed obstacles was also observed (Figure 6b). Although Holiday Beach is located on Copano Bay and is not subject to GoM wave action, the damage due to hydrodynamic forces in this region was extensive. Observations show the bulkhead was overtopped during Hurricane Harvey, leaving fish and other debris on land. As the water levels retreated, sediment appeared to be transported from the backside of the bulkhead and around the base of fixed objects, leaving these structures damaged and in need of repair. The condition of the bulkheads and service life

Figure 6. (a) Supporting steel rods were exposed after storm surge retreat scoured the backside of a bulkhead, and (b) scour was also observed around other fixed objects (collected September 3, 2017; location $28^{\circ}10'11.24''N$, $97^{\circ}1'2.03''W$).

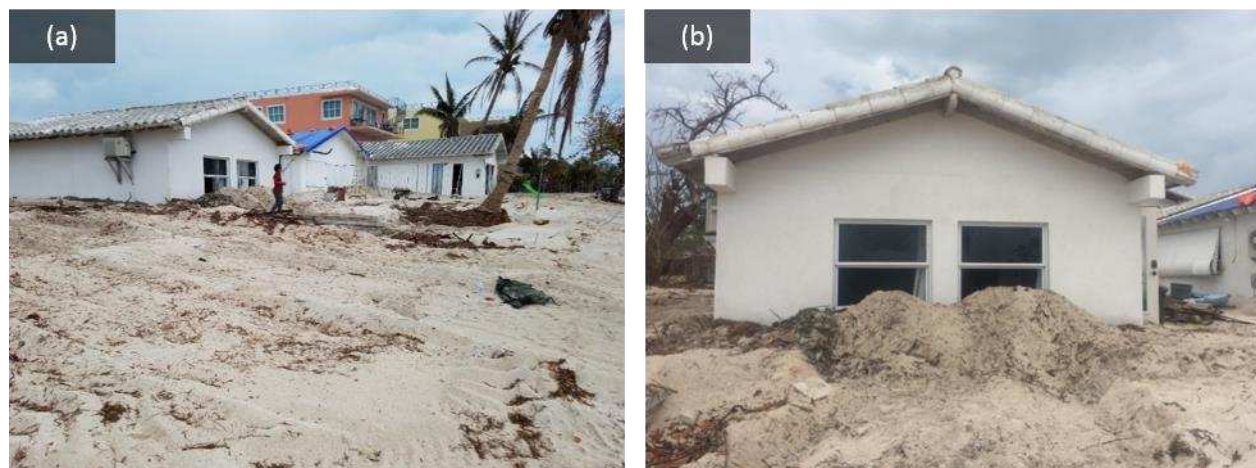
Figure 13. (a) Large volumes of sediment were deposited around houses and other structures and (b) buried them with approximately 1 m of sand, reaching the bottom of window sills (collected September 26, 2017; location 24°41'31.52"N, 81°4'56.31"W).

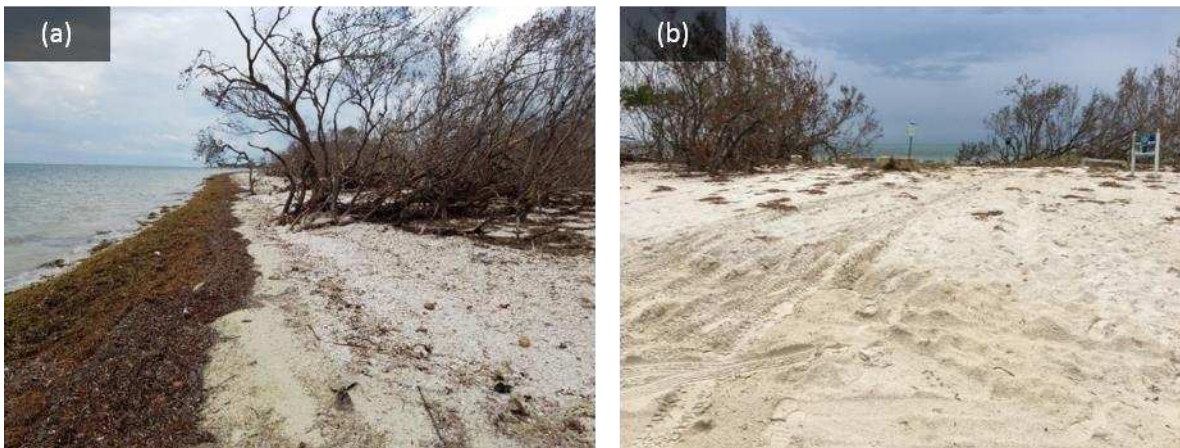
width, and deposited in the parking area (Figure 18). From the observations, the densely vegetated regions of the island trapped much of the sediment in a 20 m to 25 m zone, except at the beach access point where the transect in the vegetation served as a transport pathway through which sediment was channelized.

Figure 18. (a) The beach width was narrowed due to erosion and algae washed up on the beach, and (b) sediment approximately 0.3 m in depth was deposited in the beach access area (collected September 26, 2017; location $24^{\circ}43'48.42''N$, $81^{\circ}0'5.81''W$).
